**ARCHAEOLOGICAL WATCHING BRIEF  
ON THE SITE OF A PROPOSED MEMORIAL  
AT THE MOUND, ROYAL CITADEL, PLYMOUTH**

**Prepared on behalf of Le Page Architects Ltd  
for the Ministry of Defence**

**Exeter Archaeology**

**Report No. 10.88**

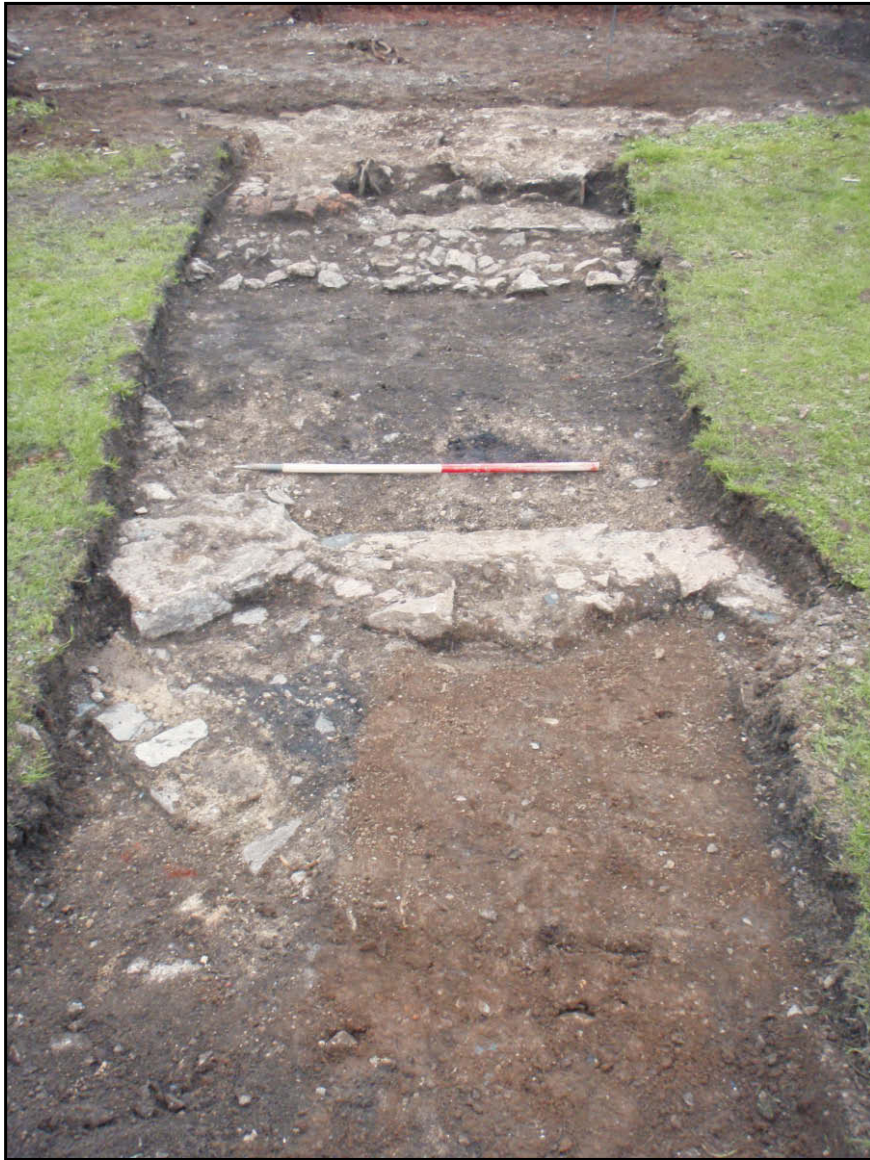
Plate 1 The exposed features. Barrack Office wall [1010] in foreground looking south. 1m scale.

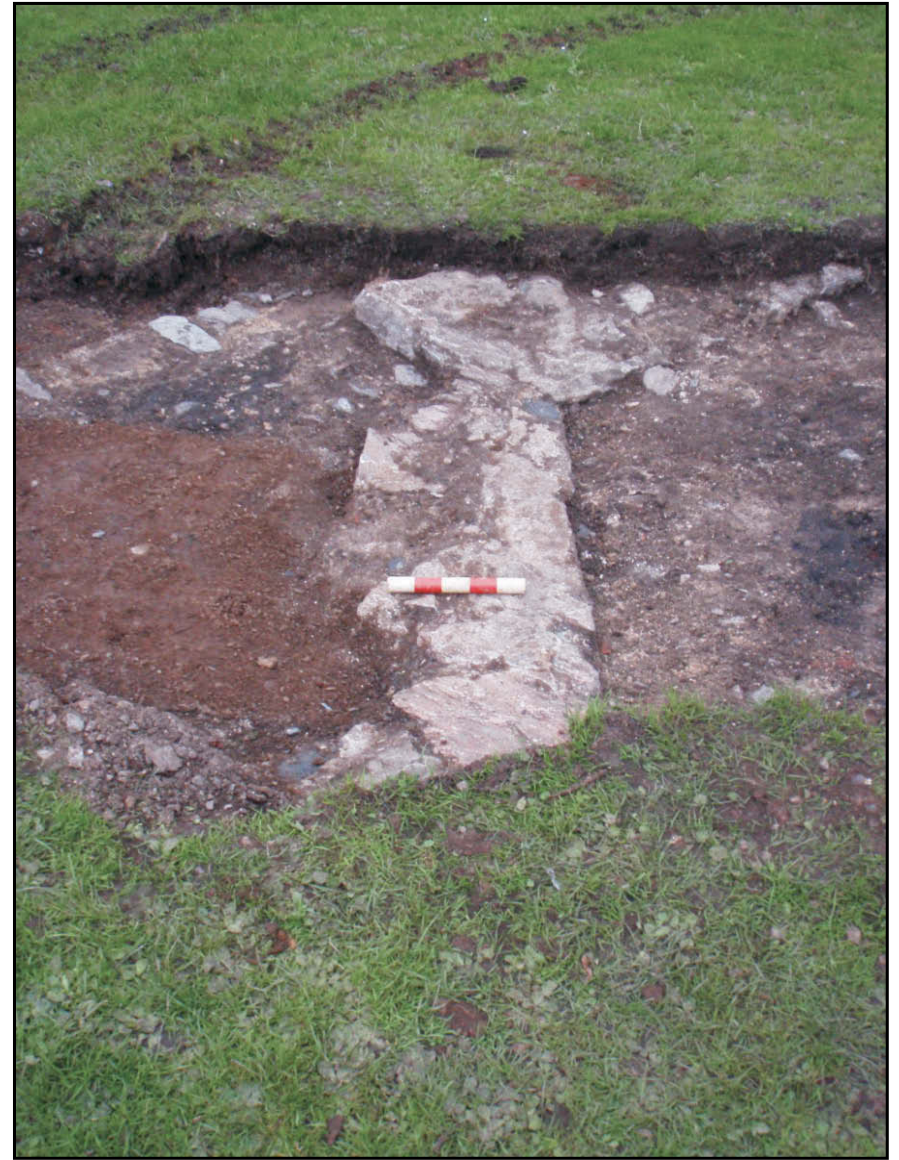
Plate 2 Detail of Barrack Office wall [1010] looking east. 25cm scale.

Monitoring of ground reduction in the vicinity of the southern end of Trench 4 of the evaluation exercise revealed evidence of a wall [1010] the lower course of which comprised roughly cut limestone blocks (Fig.5, Plate 2). This wall overlies the wall footings exposed in the evaluation exercise as [406] which, with [1008] and [1011], appear with some certainty to be the walls of the Barrack Office very clearly seen on the plan of around 1856 located in the forward apex of the ravelin courtyard. Between the front and back walls of the Barrack Office a layer of limestone fragments [1025] was recorded. This layer was found to include large pieces of limestone densely packed and it was originally interpreted in the evaluation as the core of the ravelin wall. However, it is now suggested to be demolition debris within the Barrack Office following its demolition.

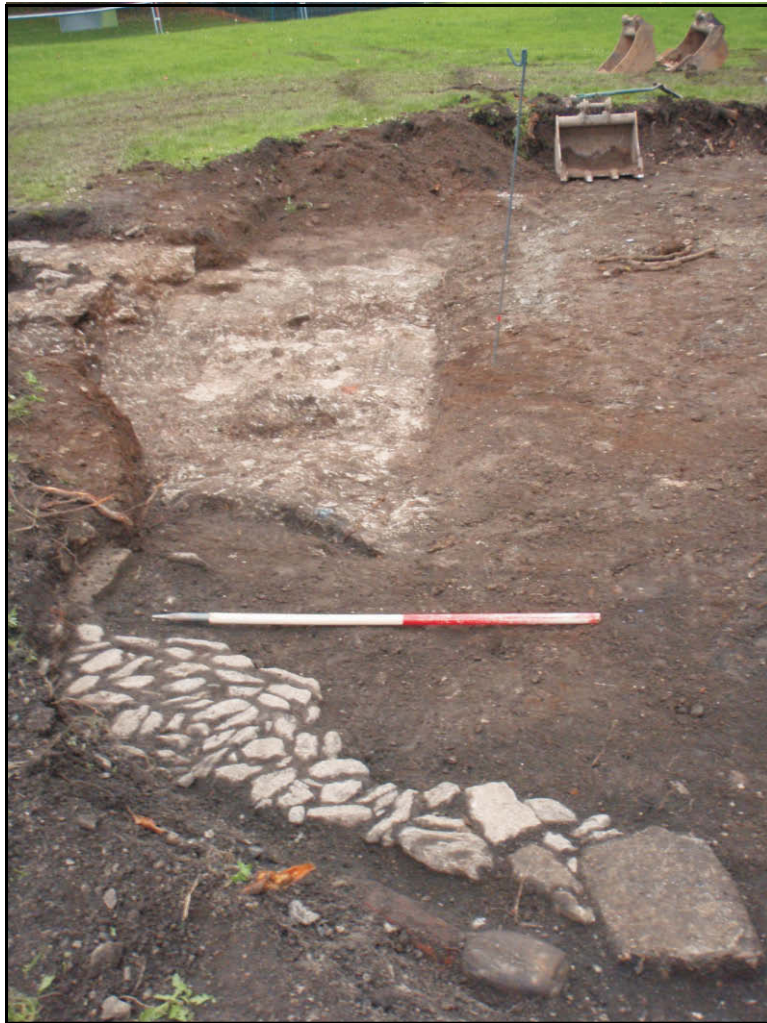
Plate 3 Base of steps [1017] and surviving cobbles [1018] looking east. 1m scale.

About 2.5m forward (south) of the Barrack Office limestone footings [1015] and [1016] were exposed. These are interpreted as the footings for a set of steps which would have provided a formal approach to the Barrack Office from the courtyard (Plate 4). The steps were provided with brick paving [1014] some of which has survived (Fig. 5). The splayed lower footings of the steps [1017], depicted again on the OS plan of 1856, formed a semi-circular area fronting the Barrack Office steps at the courtyard level (Fig. 5, Plate 3). A small area of cobbling [1018] survived to the west of the steps; this surface was almost certainly open and in use during the late 18<sup>th</sup>- early 19<sup>th</sup> century when a token (see below) was dropped and lost upon it (Fig. 5, Plate 3: foreground).

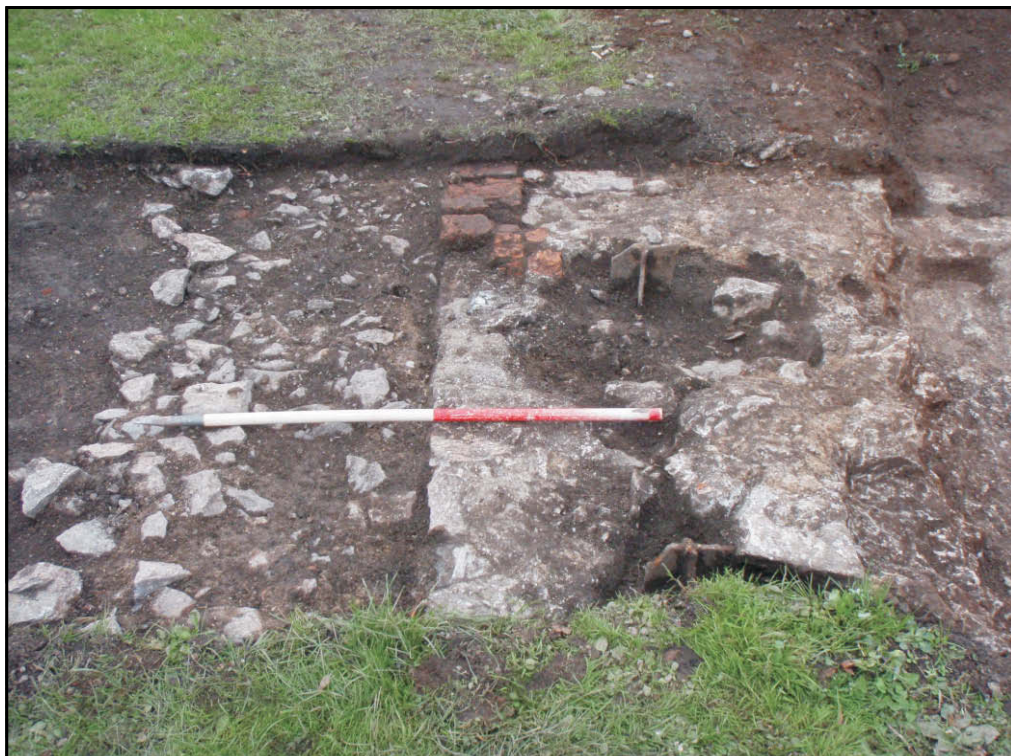
Plate 4 Foundation for top of steps [1015] looking east. 1m scale.

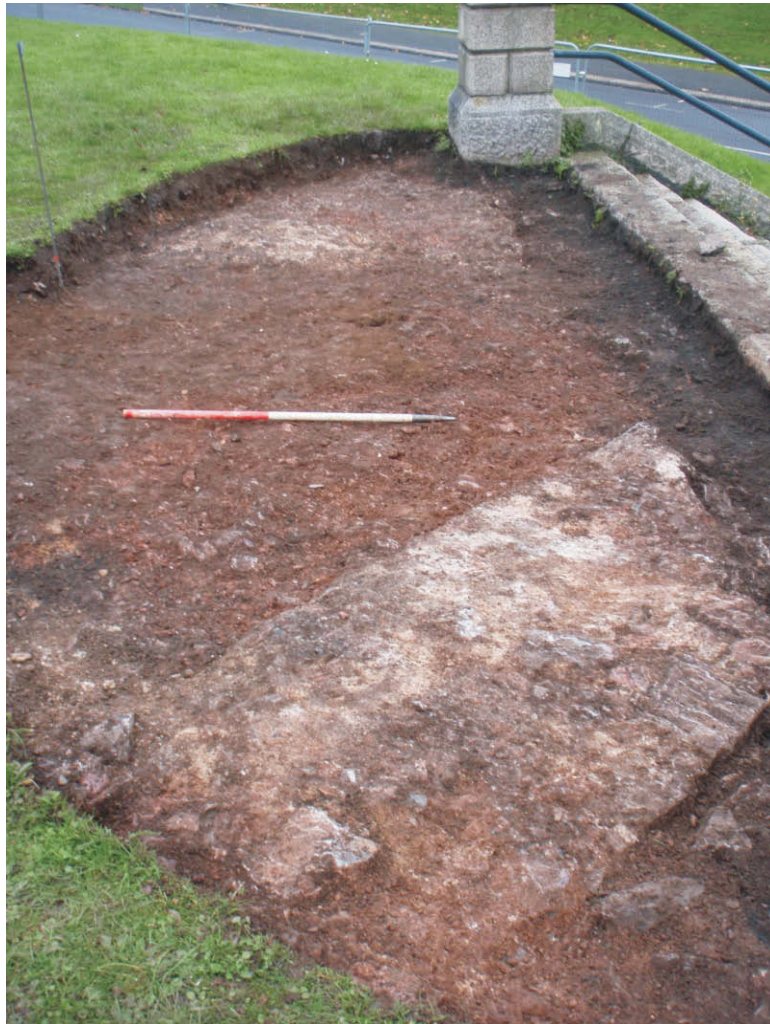
Plate 5 Ravelin revetment walls [1007] (foreground) and [1006] (background) looking west. 1m scale.

The area had previously been investigated by evaluation trench 4 (Steinmetzer, 2010). During monitoring of previously undisturbed ground (reduced for the purposes of a paved access to the memorial) new observations were made both north and south of the previous evaluation (Fig. 4). Exposed were the ashlar-faced limestone blocks of the inner revetment wall of the ravelin [1006] and [1007] (Fig. 5). This wall also served as the rear wall of the Barrack Office (shown on OS plan of c.1856, Fig. 3). The apex of the wall was lost during the construction of the ornamental steps to The Mound during its incorporation into the Hoe Gardens (Fig. 5; Plate 5).

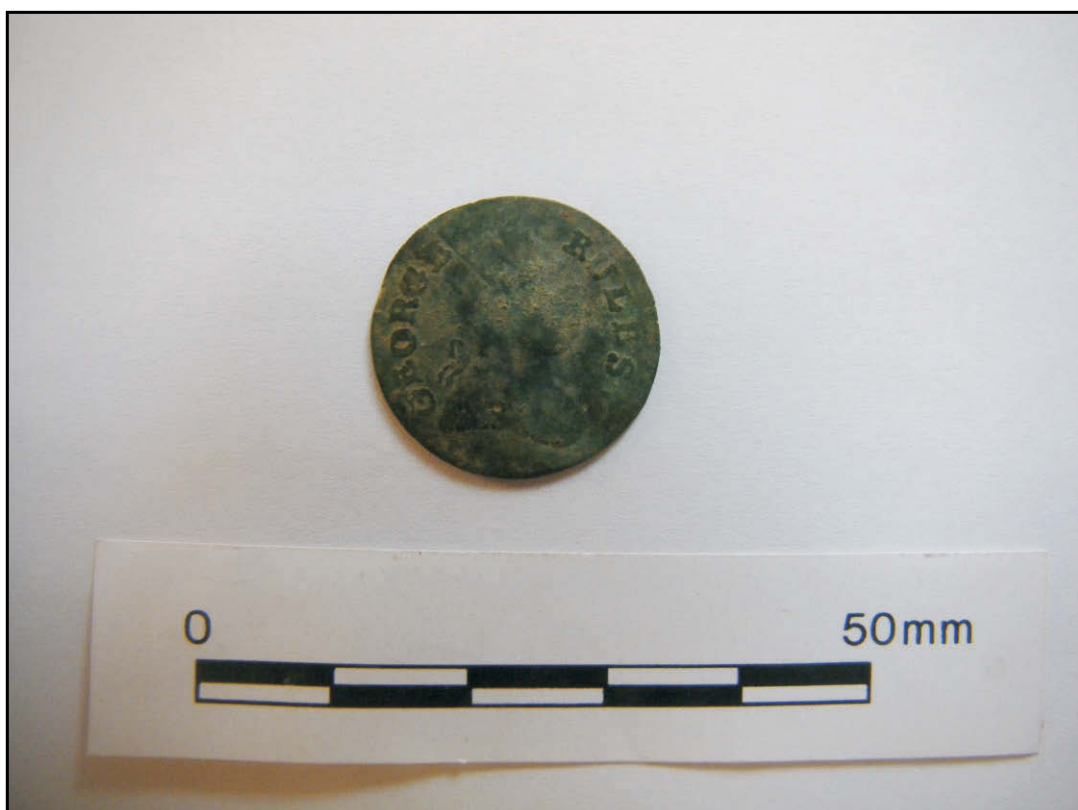
Plate 6 Evasion token of the late 18th - early 19th century. Obverse. GEORGE RULES is legible.

A worn copper alloy token was retrieved from context [1018] a cobbled pathway south of the Barrack Office. It measured 21mm in diameter and weighed less than 1g. On one side of the token is the bust of George III with the legend '*GEORGE RULES*' and on the opposite side there is a depiction of Britannia with the legend '*BRITANNIA'S*' (Plate 6). These counterfeit coins were produced after 1771, when it became an imprisonable crime to mint exact copies of legal tender; although this did not cover counterfeits where the coins closely resembled the originals but where the legends were only subtly changed. The law did not therefore apply to these imperfect counterfeits which were known simply as tokens. Tokens became accepted into general usage as there was a great shortage of small change at this time. The token was based on a George III penny implying that it would have been produced between 1771 and 1820.
