**BUILDING RECORDING
AND ARCHAEOLOGICAL MONITORING
AT MASON'S YARD, HOLBETON, DEVON**

Exeter Archaeology

Report No. 10.84

June 2010

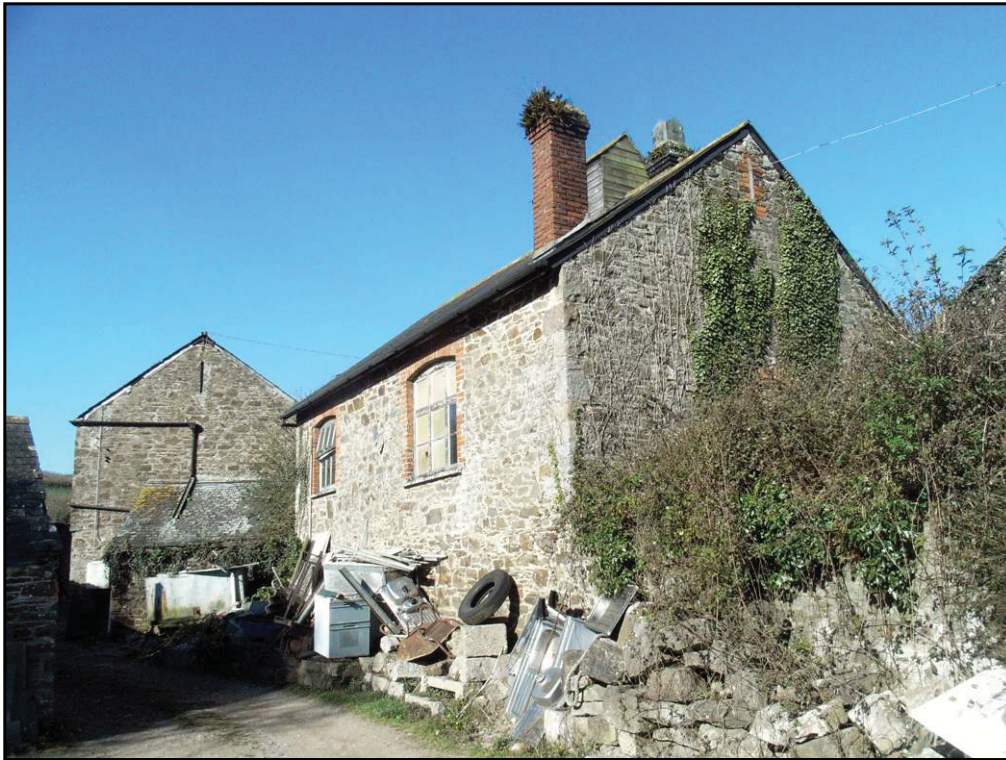
Plate 1 The smithy, southeast elevation. View to west.

This is a single-storey building constructed on the raised bank on the northern side of the yard (Plate 1). The building has raised footings on the south-east side and is entered via doorways in the north-east and north-west elevations. It has a pitched roof with a dovecote near the centre of the apex.

The walls of the building are 0.42m thick and constructed of coursed Devonian slate rubble. Larger stone of a variety of materials is used for the quoins, including limestone and at least one possible block of breccia. The bonding is a white lime-based mortar with large grit inclusions. The wall openings have segmental machined red-brick arches. The jambs of the windows have additional brick dressings, with brick alignment alternating in pairs. The windowsills are of thick slate.

This elevation has raised footings and two high-set windows. The southernmost window has a four-light top-tilting wooden frame, whilst the northernmost has a three-light wooden frame.

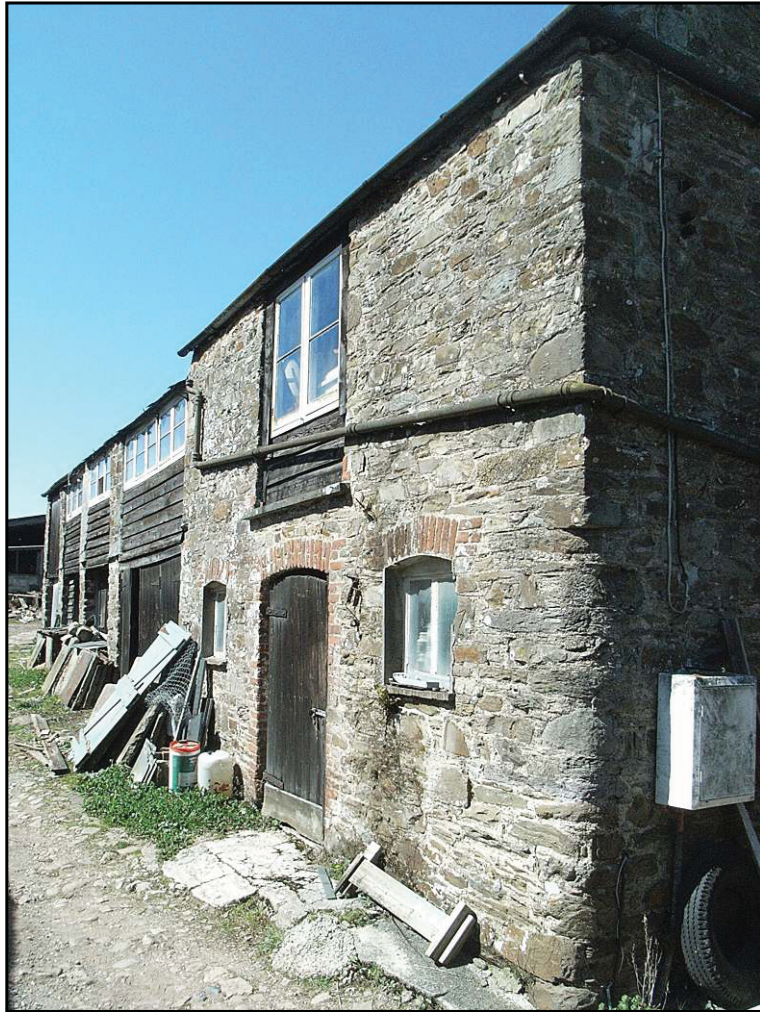
Plate 3 The stable, southeast elevation. View to west.

The stable is a two-storey, roughly south-facing building with symmetrical fenestration (Plate 3). It is almost square in plan, measuring 5.49m x 4.96m internally. The linhay adjoins its western end and it is abutted to the north and east by the shippen and former wood shed, respectively.

The front wall of the building has a window either side of a centrally placed doorway, above which is a wide loft doorway. This is a typical 19th-century layout, although the proportions are slightly unusual; the windows are fairly small and the doorways are notably wide, particularly the doorway at loft level.

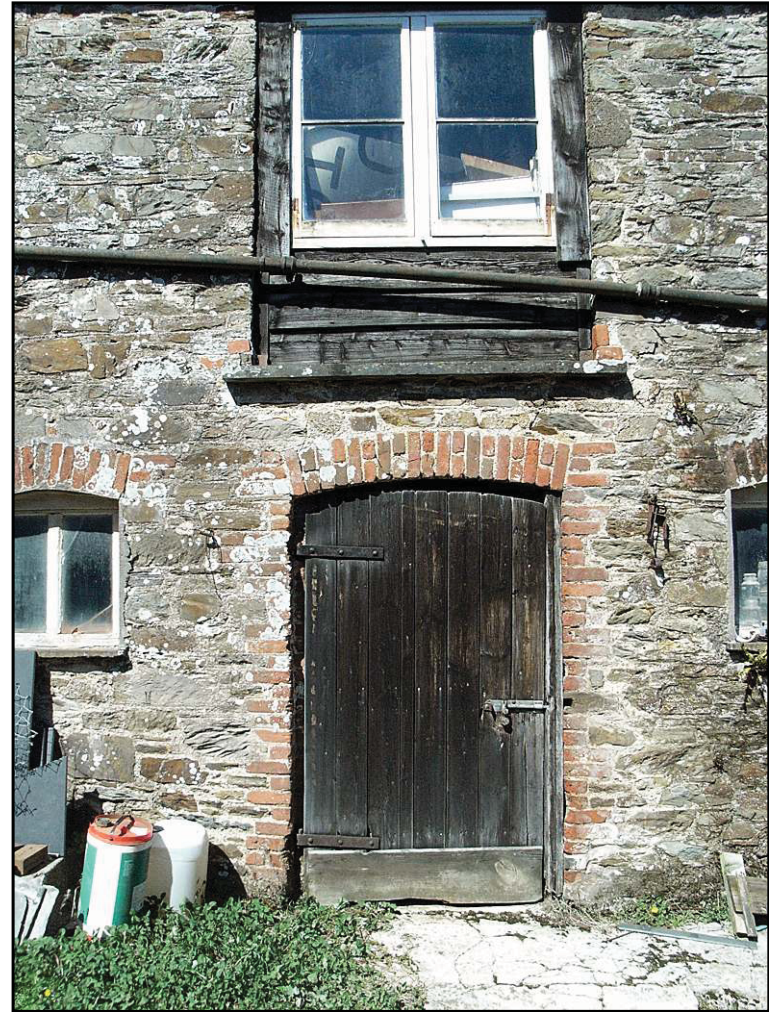
Plate 4 The stable door showing inconsistency in the brick dressings.

The ground floor openings have coarse brick-dressed segmental arches and the doorway also has dressed jambs. The dressings of the jambs are notably inconsistent (Plate 4). Those along the east jamb generally alternate in pairs, whilst some of those on the western jamb alternate singly.

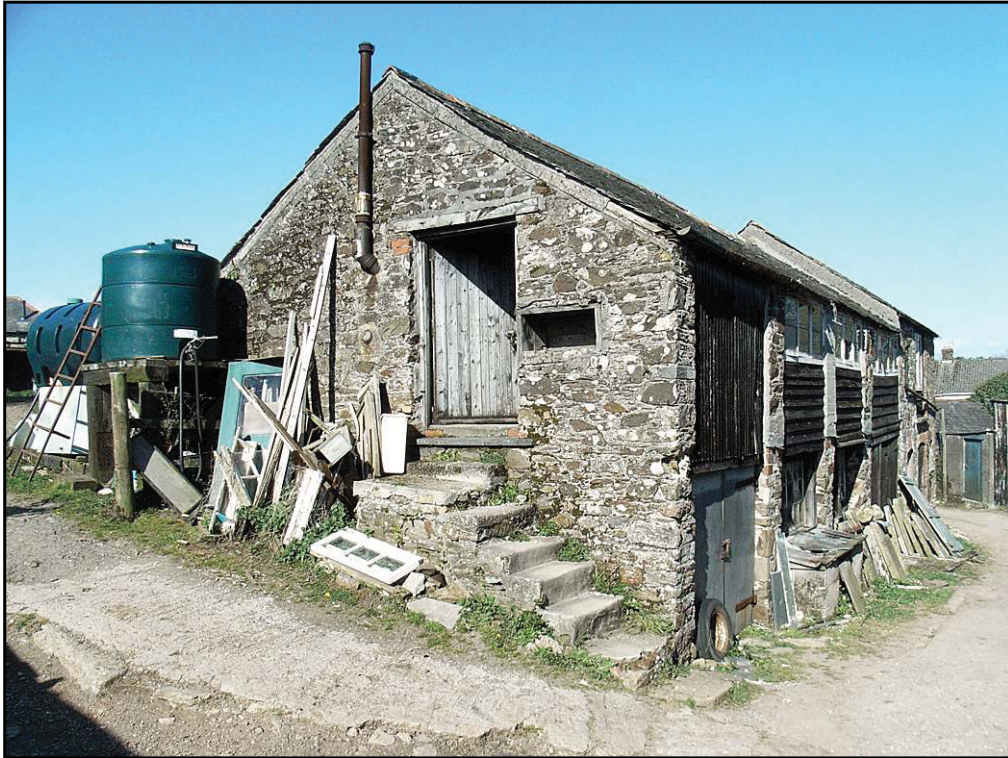
Plate 5 The linhay, west and south elevations. View to northeast.

This south-facing building adjoins the western end of the stable and measures 10.96m x 4.84m. internally. The linhay was built in a traditional two-storey open-fronted style with three pillars along the front (Plate 5), although the openings have now been blocked. At the rear are 20th-century lean-to looseboxes and the western end of the lean-to shippen.

The walls of the building are 0.41m thick and of random slate rubble construction, bonded with white lime-mortar with large grit inclusions. The three pillars are built of large pieces of slate and other stone, with later concrete-block and brick repairs. The infill between the posts is of weatherboarding and corrugated metal sheets.

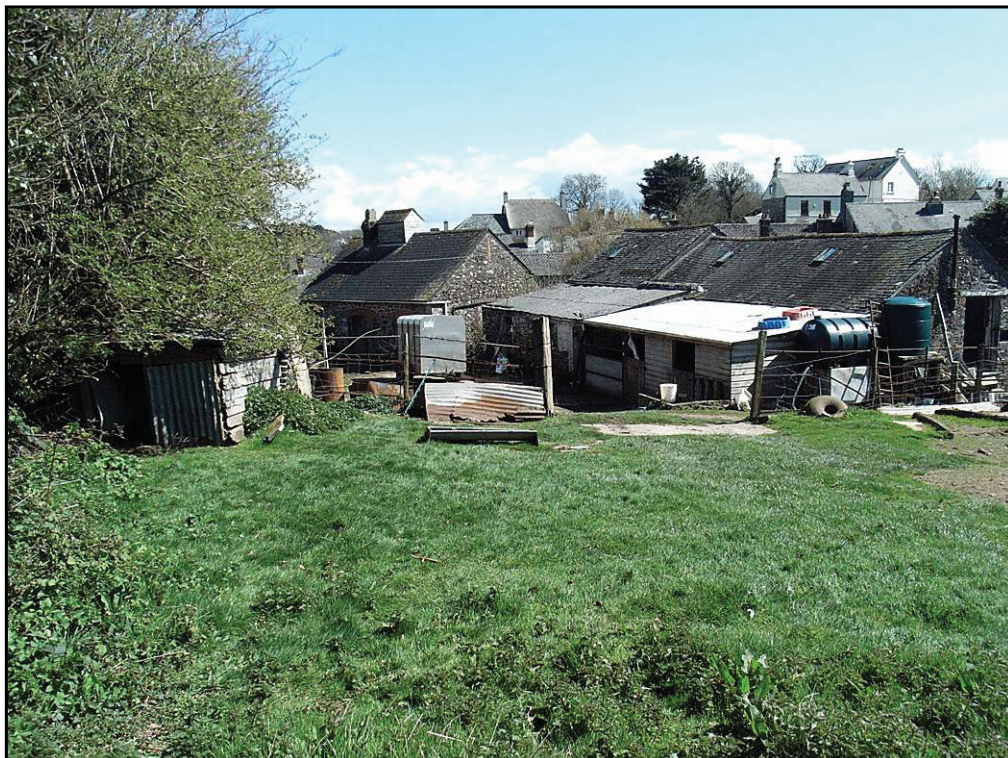
Plate 6 North sides of the main historic buildings (lean-to shippen in centre). View to southeast.

This north-facing structure is built against the rear walls of the stable and linhay (Plate 6). Being positioned on the higher ground behind these two structures, its floor level is comparable to that of their loft floors. Internally the building measures 8.95m x 3.22m.

The front of the shippen contains two doorways and two windows. The eastern window was formerly a third doorway, which has been partially infilled with concrete blocks and a metal top-tilting window inserted. The external pintles have been left in situ.

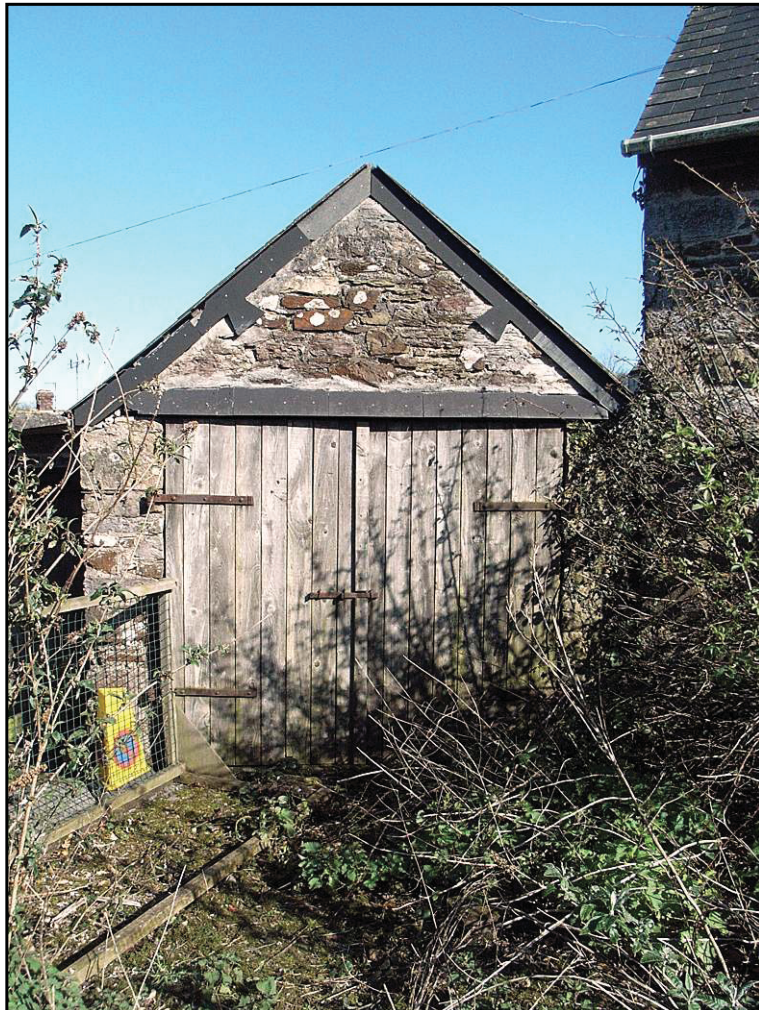
Plate 7 The office and wood shed, northwest elevation. View to east.

This is a small single-storey rectangular building opposite the smithy, measuring 5.02m x 4.05m externally (Plate 7). The greater part of the building is used as an office/store whilst the western corner forms a separate small unit, formerly a coal shed⁶ and now a woodshed. A late 20th-century concrete block shed adjoins the south-western wall and this is in turn adjoined by various other 20th-century sheds.
