**ARCHAEOLOGICAL RECORDING
DURING CONSTRUCTION OF A
SEWAGE TREATMENT PLANT
NEAR HOLLOCOMBE BARTON,
WINKLEIGH, DEVON**

Prepared on behalf of South West Water

Exeter Archaeology

Report No. 11.13

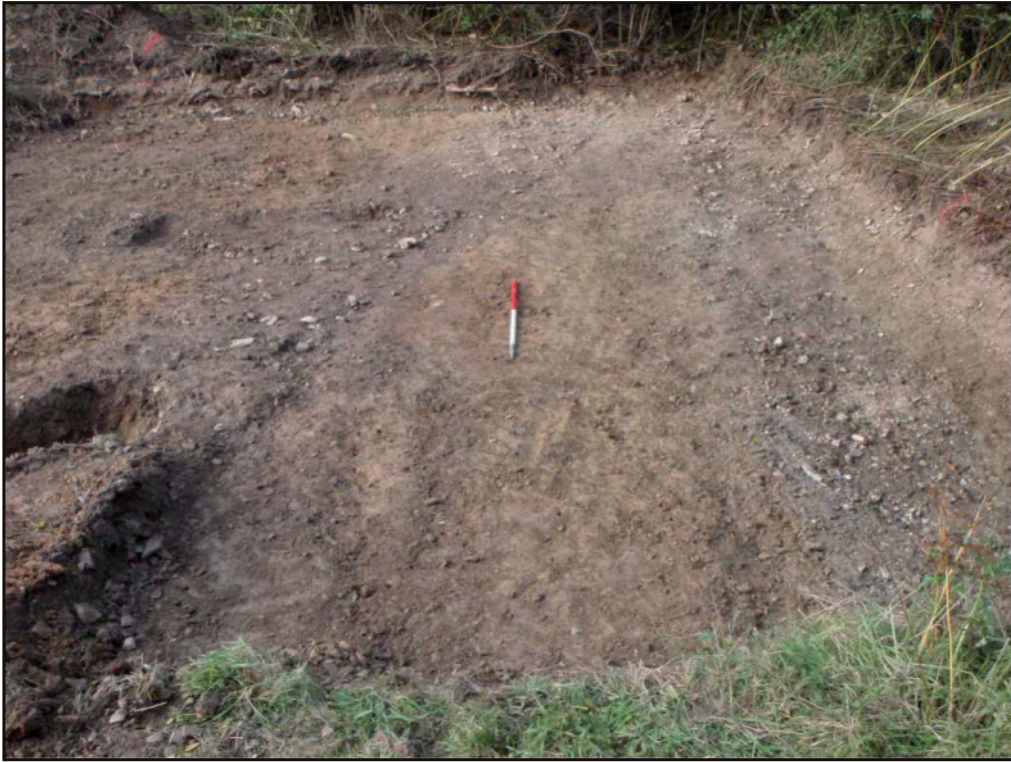
Photo. 1 Chamber area, looking southwest, showing ditches 1013 and 1009 to right and left of scale respectively. 1m scale.

An area of 9m by 9m was excavated for the insertion of the new chamber. Removal of the topsoil exposed three ditches (Photo. 1). Ditch 1013 was aligned northeast to southwest and had a V-shaped profile (Fig 3, Section 1 and Photo. 2). The ditch contained two fills (1014 and 1015), the lowest of which contained 10 sherds of 13th-14th-century pottery. To the south of, and at a right angle to, this feature was ditch 1011 (Fig. 3, Section 3). This was very shallow and its fill (1012) contained no finds. The northern terminus of this ditch had been truncated by the excavation of feature 1009 – a ditch aligned east to west, which may have

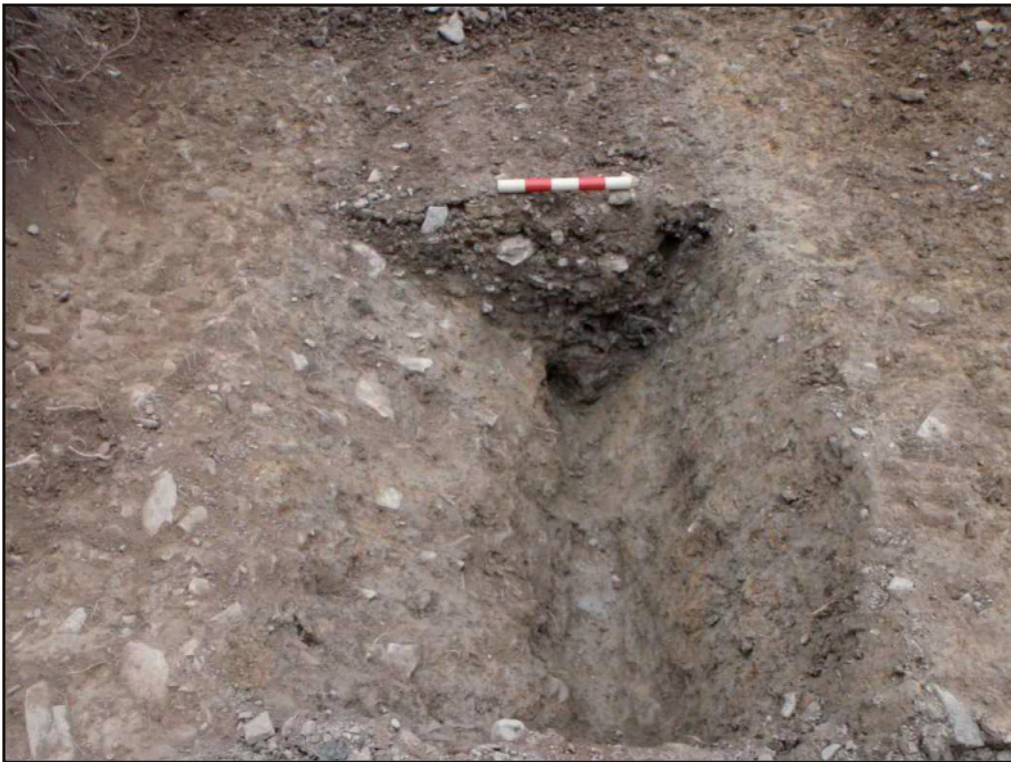
Photo. 2 Chamber area, section through ditch 1013, looking northeast. 0.25m scale.

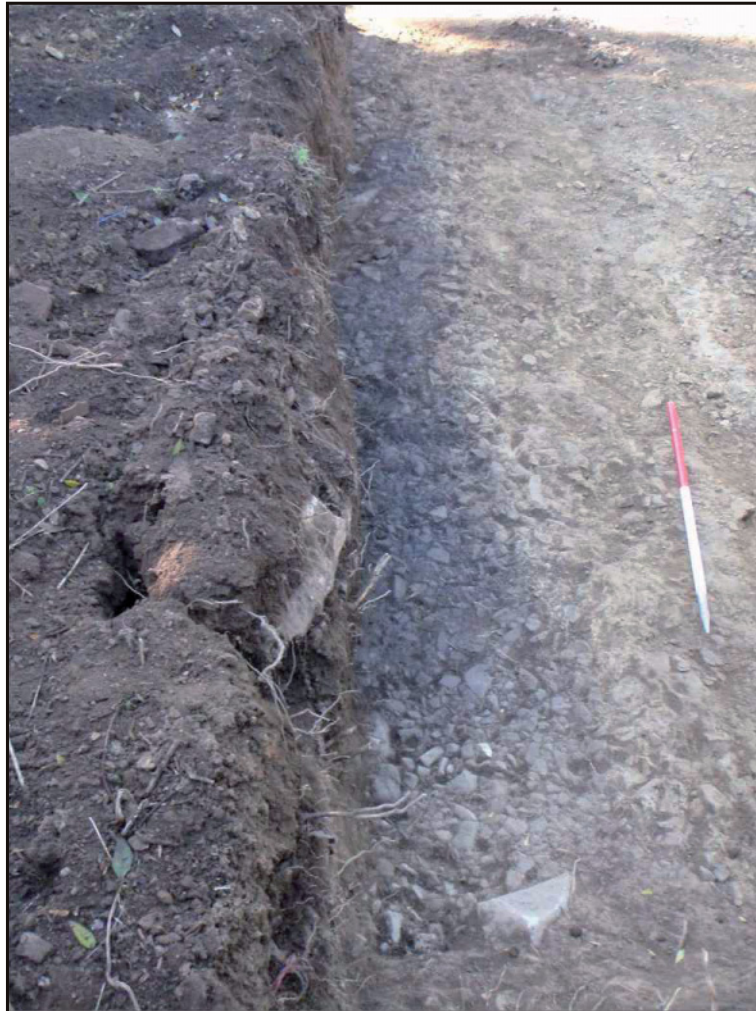
Photo. 3 Lay-by area, showing metallated surface 1016, looking west. 1m scale.

In the south part of this area the remains of a metalled surface was exposed cut into the natural bedrock (1016; Photo. 3). Two sherds of post-medieval pottery and two fragments of 18th-/19th-century tile were recovered from this surface. During excavation of the access track, hedgebank 1028/1029 was breached (Photo. 4). The bank was constructed from light yellow-brown stoney clay (1028) faced on the north side by 8 courses of unbonded local stone from which 2 sherds of post-medieval pottery were recovered (Fig.4, Section 4). To the north of the hedgebank remains of soil layers (1022 and 1023) were exposed (Fig. 4, Section 6). Deposit 1023 was truncated by a v-shaped feature possibly a small ditch or more probably a posthole (1025). Above these deposits dumps of modern material were present, these having been dumped on the site during the demolition of Bowdens. These were sealed by a patchy layer of topsoil (1017) that was also present overlying hedgebank 1028/1029.

The development was designed to avoid impacting on the former settlement of Bowdens. The alignment of hedgebank 1028/1029 corresponds with the entrance splay into Bowdens as depicted on historic mapping (see Figs 7-8). Surface 1016 represents the remains of the courtyard to the north and east of the house forming part of the access to the property. The function of ditches 1009 and 1011 exposed in the chamber excavation are unclear. Ditch 1009 is post-medieval in date and may have functioned as a drain or channel leading to the well. Ditch 1011 is stratigraphically earlier, and could be associated with medieval or early post-medieval agriculture, perhaps a remnant of a boundary feature. A former post-medieval field boundary – 1006 – was also recorded.

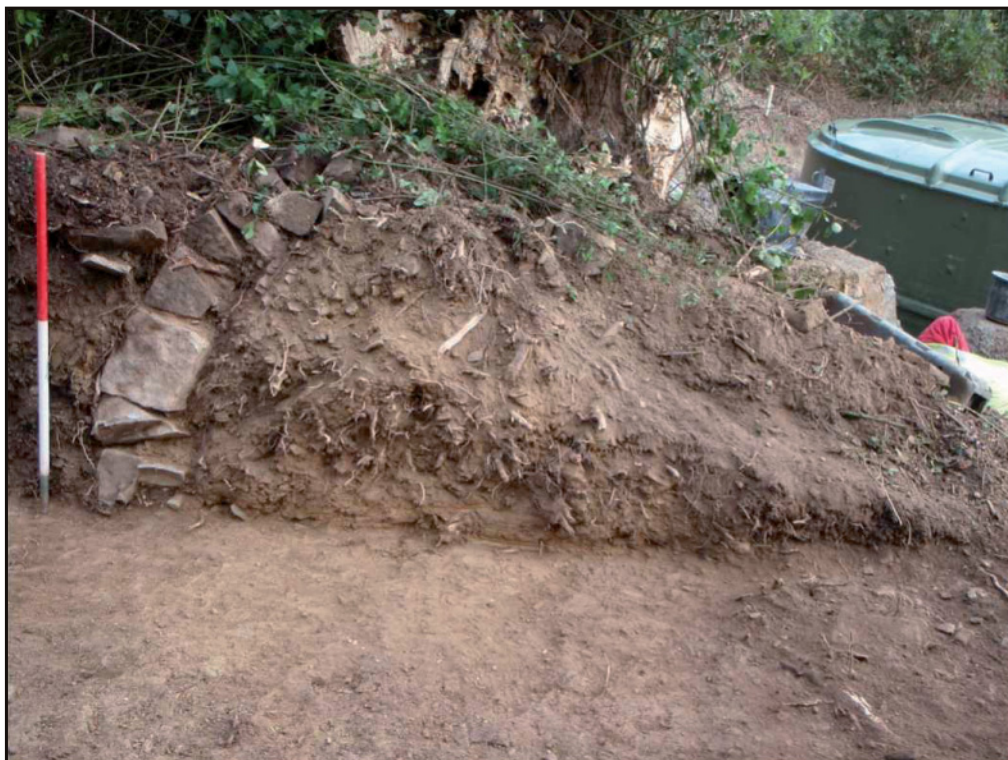
Photo. 4 hedgebank 1028/1029, looking northeast. 1m scale.
