**195 HIGH STREET, EXETER:  
A TOWN HOUSE AND SHOP OF C. 1700**

**Prepared for Greggs PLC**

**Exeter Archaeology**

**Report No. 11.19**

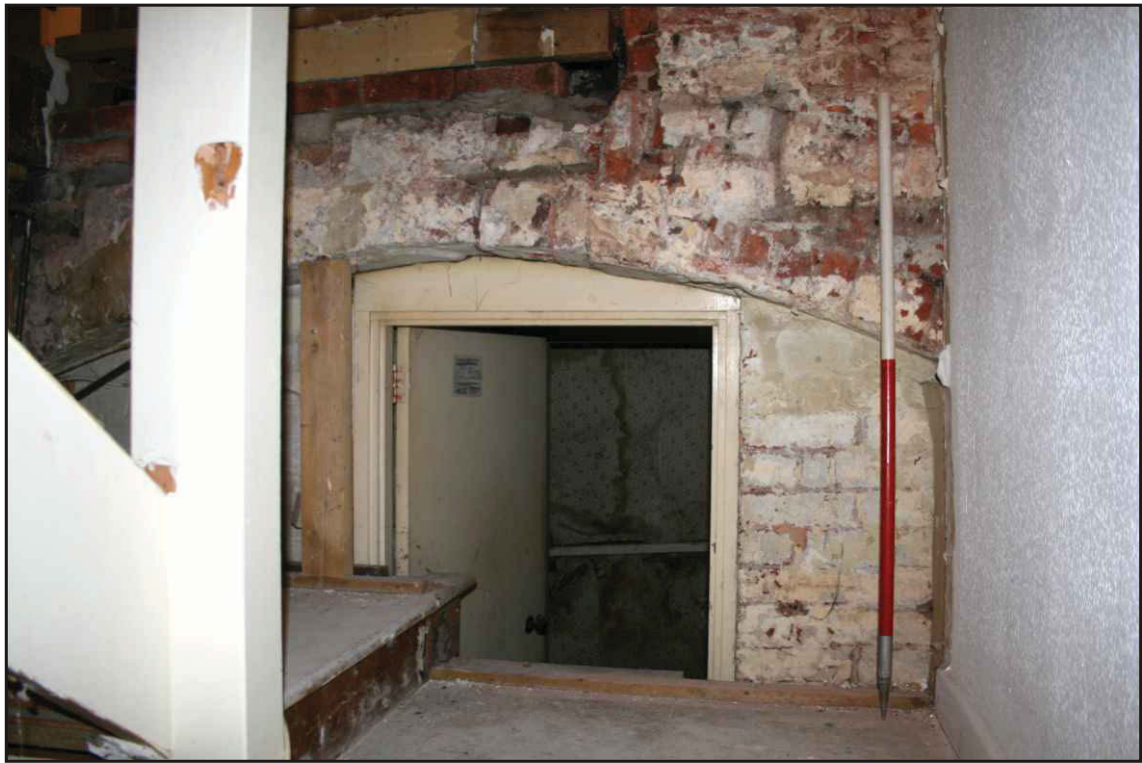
The northern cellar has an arched opening and a doorway set back from the front face (Photo. 1). It has a concrete floor that supports two concrete block walls, possibly separating a former cubicle from a larger toilet. The southern cellar has a rectangular door opening, as well as a second slightly smaller, now blocked, opening (Photo. 2). Part of the vaulted ceiling has been removed, and this void has been utilised for the new lift between the two floors.

Photo. 1 The arched cellar opening in the rear wall of the basement, looking northwest. 1m scale.

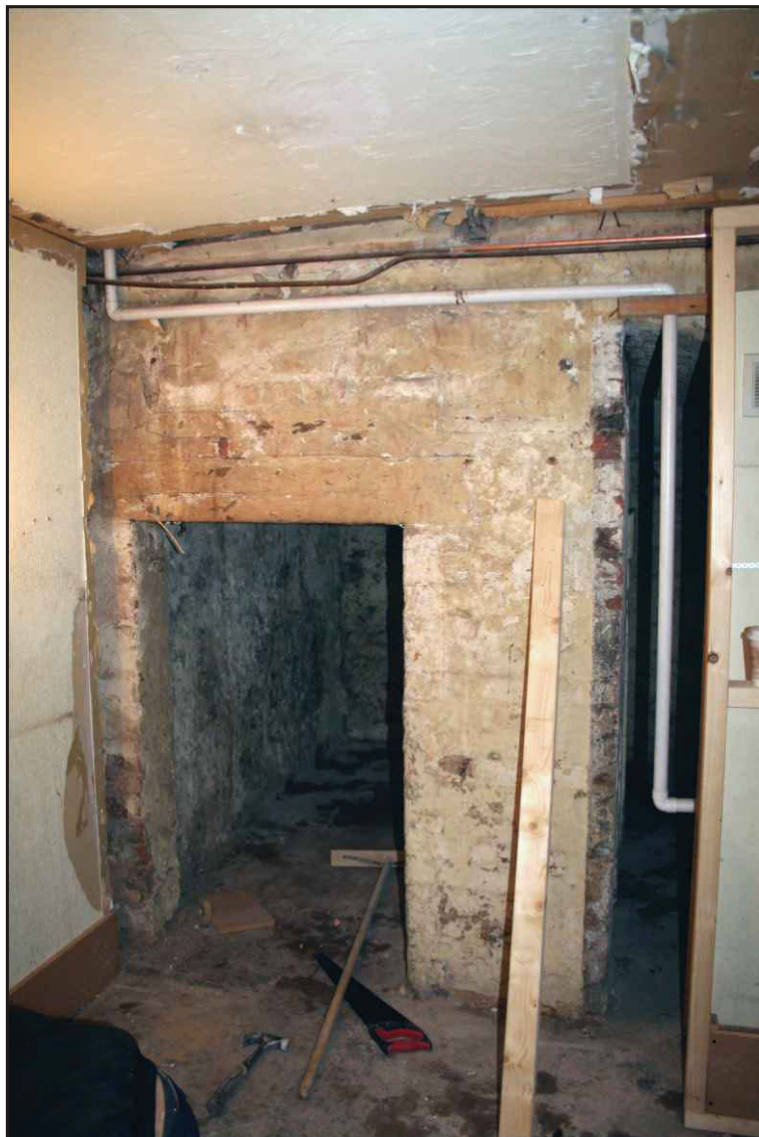
Photo. 2 The low door in the cellar in the basement, looking northwest.

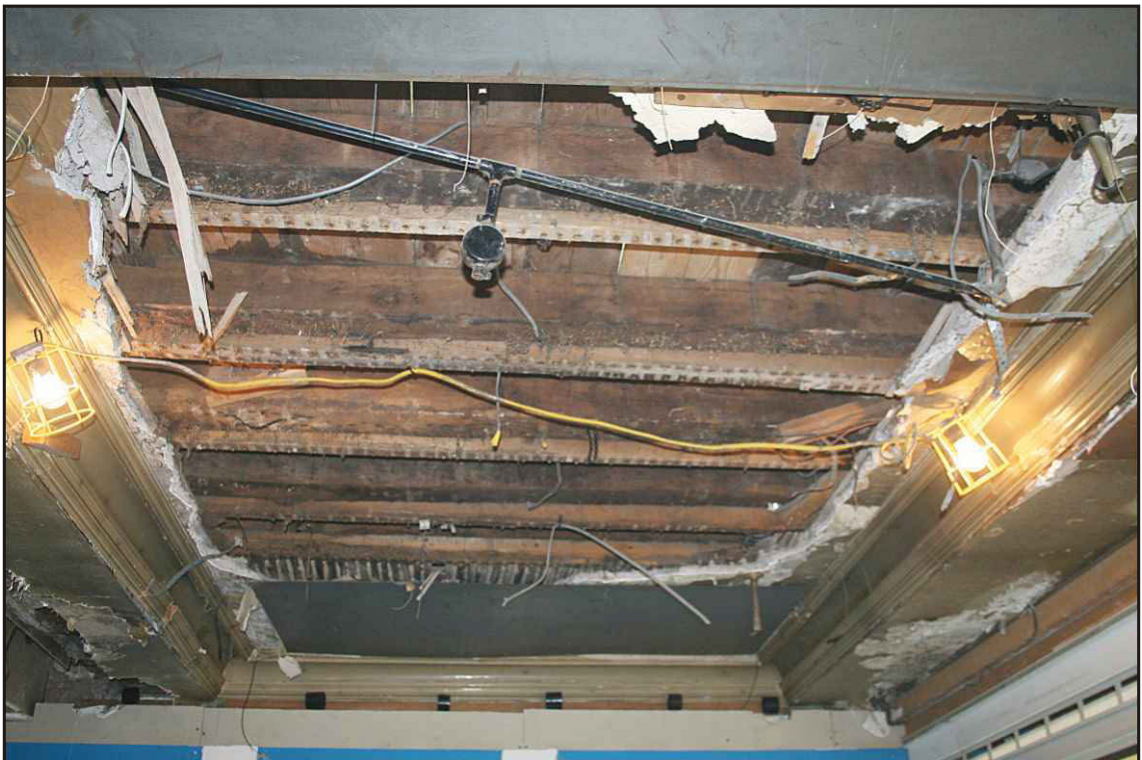
The ceiling arrangement divides the ground floor into four bays – two equally-spaced middle bays, a front bay containing the shop front, and a larger rear bay. The presence of a larger rear bay may add weight to the arguments that domestic accommodation was situated to the rear of the shop. The three main beams have been boxed over and are largely obscured. Contemporary joists were exposed within the front bay, and both the beams and joists display scars of a lath and plaster ceiling. One joist contains three pegholes. This may represent the position of a partition below or could be an indication of reuse. This ceiling was replaced in *c.* 1800 by a lower ceiling supported on new, thinner joists; the beams were boxed over at this time (Photo. 4). The new ceiling was of lath and plaster and supported a wooden cornice, much of which survives. Curiously there is a break in the cornice in the middle bay that appears to be an original feature. This could simply represent the ends of the wood used, but appears to represent something further, now missing, perhaps a thin decorative feature or the position of a partition. Elsewhere in this bay historic fabric had been disturbed by the insertion of a modern beam. In one location the later lath and plaster was also visible overlying an earlier thick layer of grey-painted plaster. The cornice in the rear part of the building, noted as being of early date in the 1998 and the 2010 appraisal, is actually a modern wooden feature.

Photo. 4 The ground-floor ceiling showing two phases of joists and the wooden cornice, looking northeast.
