**CROSSMEAD HALL, ST THOMAS,
EXETER**

Prepared for Taylor Wimpey

Exeter Archaeology

Report No. 11.29

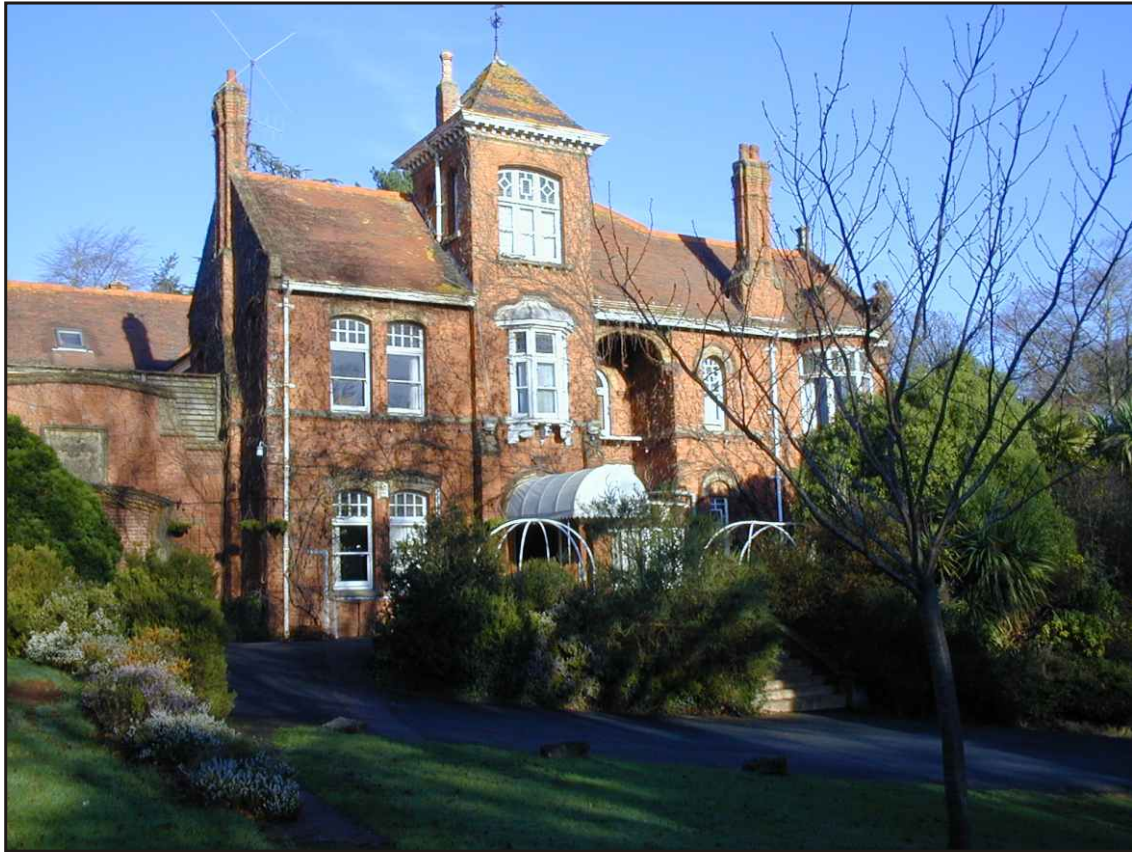
Photo. 1 The south elevation photographed in 2005, looking north (Exeter Archaeology).

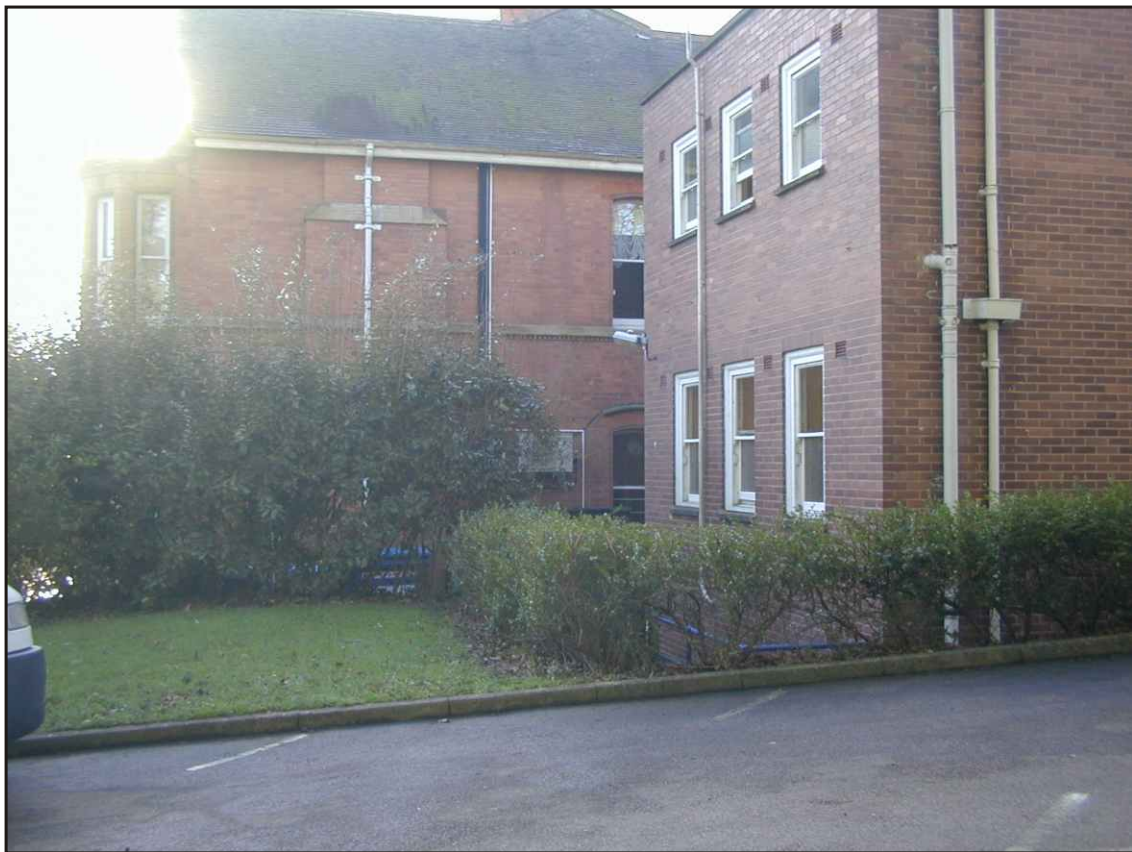
Photo. 2 The north elevation photographed in 2005 showing late C20 extension, looking south (Exeter Archaeology).

By 1955-6 an extension had been added to the north elevation. This was a two-storey brick building with plain elevations incorporating sash windows and vent bricks. It is assumed that openings were made in the north elevation of the house to enter this extension, although no evidence for these has come to light. During the 1980s a covered walkway was added to the west end of the building to connect with a previously-constructed detached dining hall.

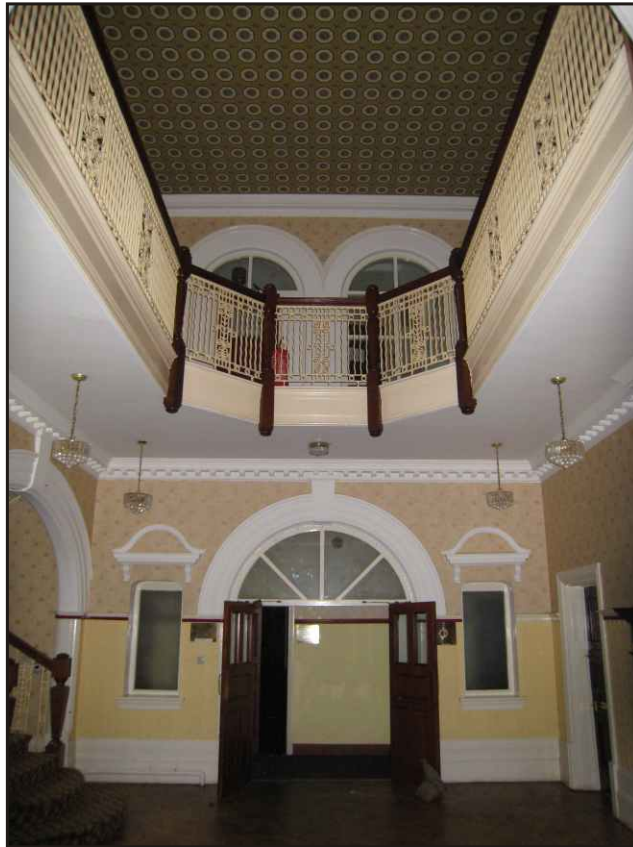
Photo. 3 The hall showing cornice with the gallery above photographed in 2007, looking east (Kathy Metcalfe, Exeter City Council).

The internal decoration was lavish with fine fireplaces, particularly that in the hall, as well as mouldings around the internal doors and windows. Selective use of stained glass – lighting the stairs and the dining room – also provided a contrast in colour and light. The principal rooms were provided with cornices, the finest being in the hall in a modillion style (Photo. 3). The others behind the east elevation are described as being swagged, and these rooms also had reeded skirting boards. The first floor was approached via a staircase with a central landing, above which it divided into two flights (Photo. 4). The underside of these upper flights of stairs was panelled. The balustrades of the stairs and the railings of the first-floor gallery appear to be cast- or wrought-iron, with alternative spiral and curving patterns. Photographs of the building taken in 2007 show the rooms had modern carpets. James

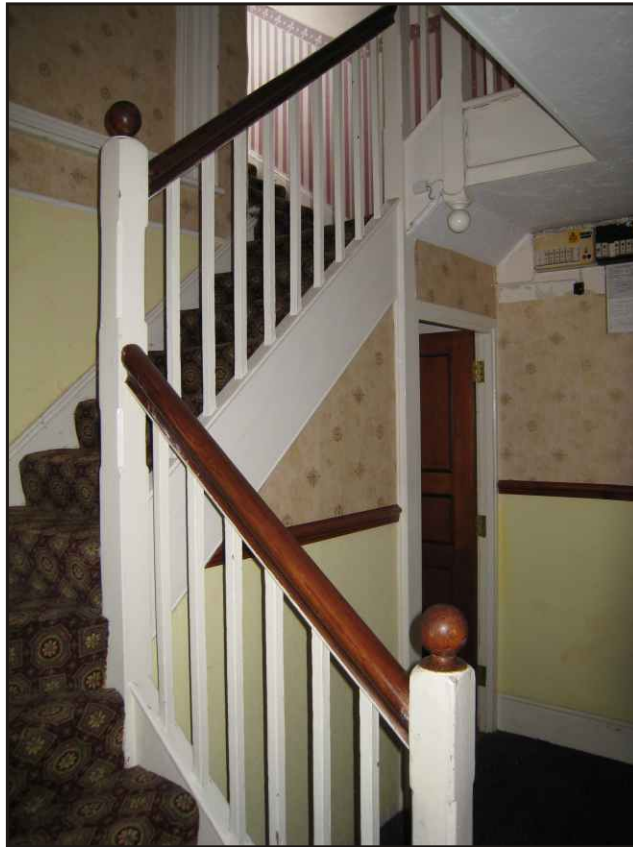
The service rooms were situated along the north side of the corridor and comprised stores, a china cupboard, housemaid's pantry, kitchen, scullery, larder, a coal store and a dairy. To the south of the corridor was a wash house and stairs to the first floor, below which was a lavatory (Photo. 5). The stairs had chamfered newel posts with slender, plain balustrades. Only the kitchen and wash house in this range were heated.

Photo. 5 The servants' stairs to the first floor photographed in 2007, looking southwest (Kathy Metcalfe, Exeter City Council).

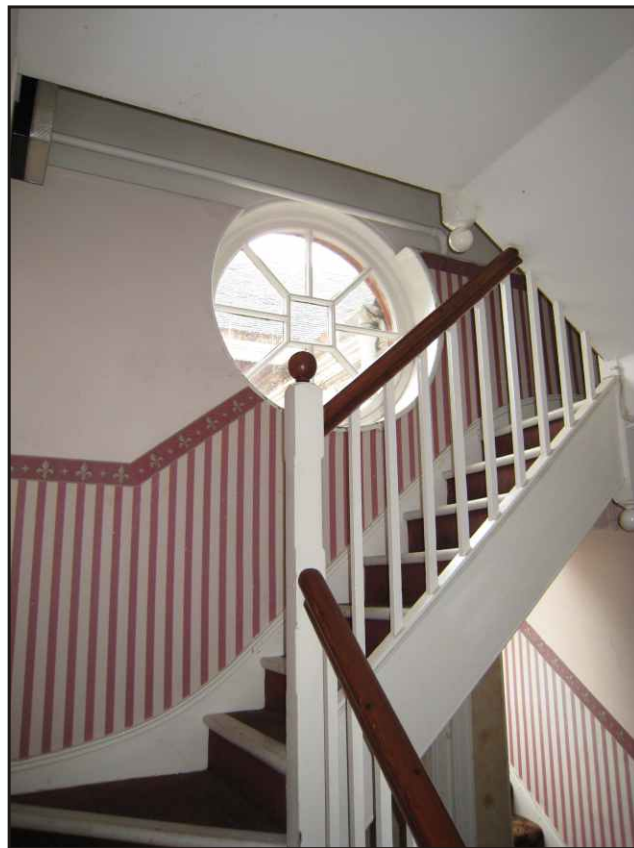
Servant's accommodation was provided in the lower part of the roof space; the top of the roof structure was ceiled. These rooms were lit by dormer windows and by round windows in the north elevation; there are further windows in the third floor of the tower. These rooms may have been heated using fireplaces set into chimney stacks recorded on the lower floors. The layout of the rooms is unknown, but accommodation was provided along the length of the west side of the building (comprising at least four rooms), as well as along the south side of the building. The central area (over the gallery) was probably not used as a bedroom and was open to the roof. This area may however have been utilised as a walkway to the rooms on the southern part of the building. The floor was accessed via a flight of stairs in the 'stair turret' attached to the servants' wing (Photo. 6). The stairs were identical to those on the floor below having chamfered newel posts with slender, plain balustrades.

Photo. 6 Servants' stairs to the second floor photographed in 2007, looking west (Kathy Metcalfe, Exeter City Council).

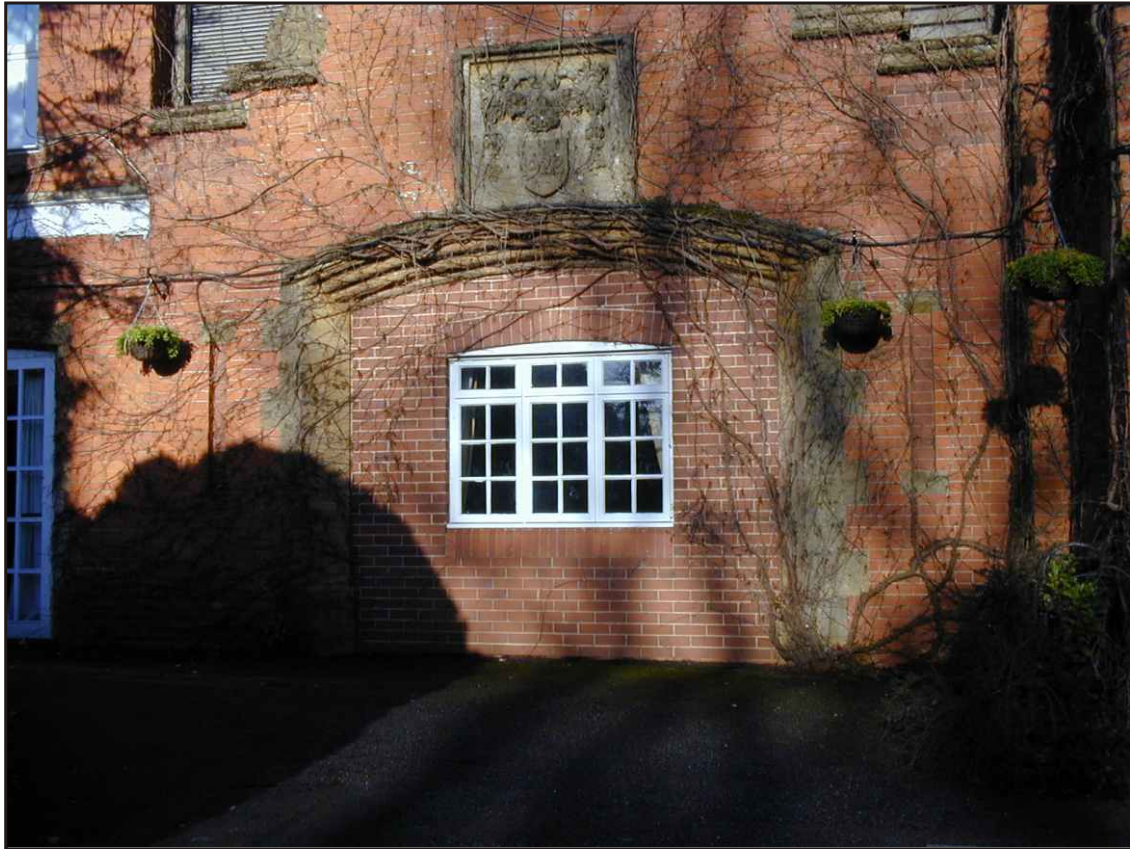
To the east of this extension, a wall was constructed across the courtyard and this appears to be contemporary with this extension. A wide carriage opening within this wall had been blocked, presumably in the second half of the 20th-century (Photo. 7). Above the opening was a plaque dated 1922.

Photo. 7 The blocked carriage entrance in the 1922 wall enclosing the courtyard photographed in 2005, looking northwest (Exeter Archaeology).

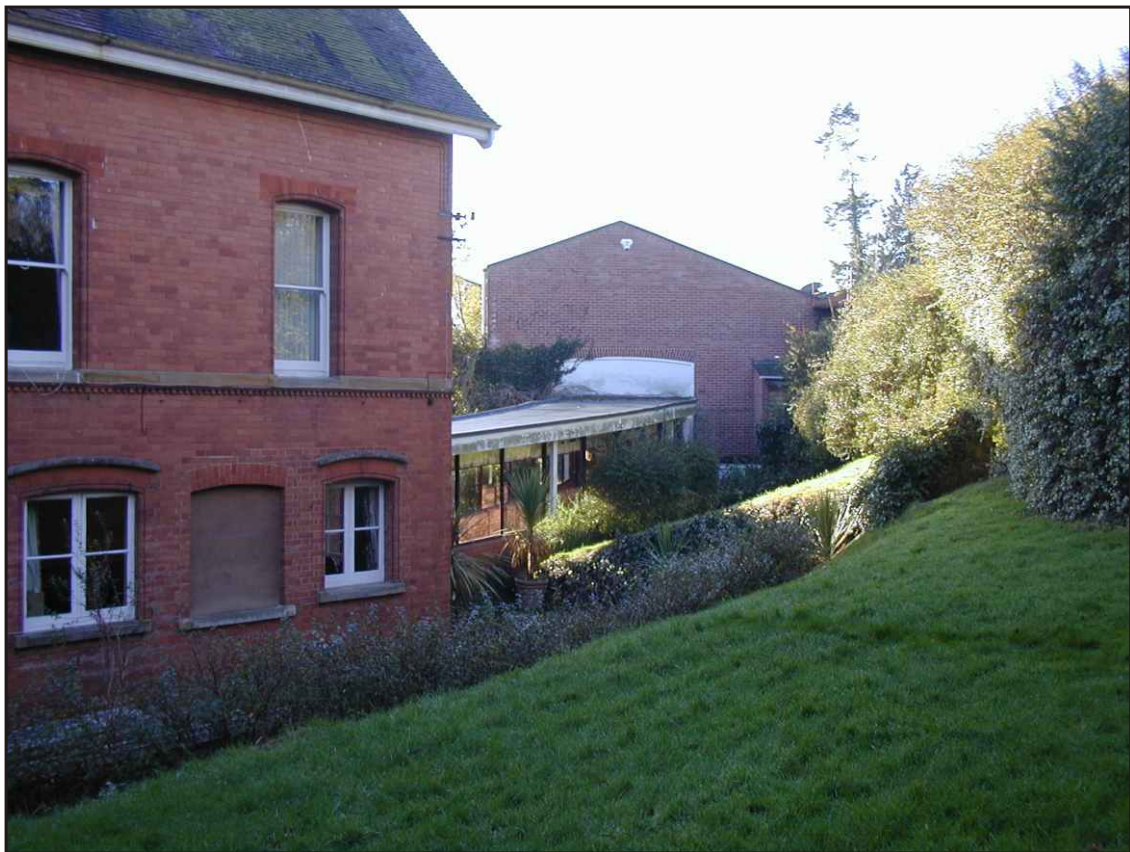
After ownership transferred to the University College of the South West in 1944 few changes were initially made to the interior of the house. The main identified alteration was the removal of the servants' entrance and adjacent windows and their replacement with four windows copying the style of those on the first floor above (Photo. 8). The treatment of the brick voussoirs and window heads was however slightly different. More recently the courtyard had been covered over to form a lounge and bar, and elsewhere kitchen equipment had been fitted with extraction vents and ducts added over the lounge and bar.

Photo. 8 The north elevation photographed in 2005 showing C20 replacement window openings and link to the dining hall, looking west (Exeter Archaeology).
