**THE FORMER RD&E HOSPITAL SITE  
HEAVITREE ROAD, EXETER  
ARCHAEOLOGICAL ASSESSMENT, TRENCH EVALUATION  
AND EXCAVATION**

**Prepared for Waitrose and Midas Property**

**Exeter Archaeology**

**Report No. 10.04a**

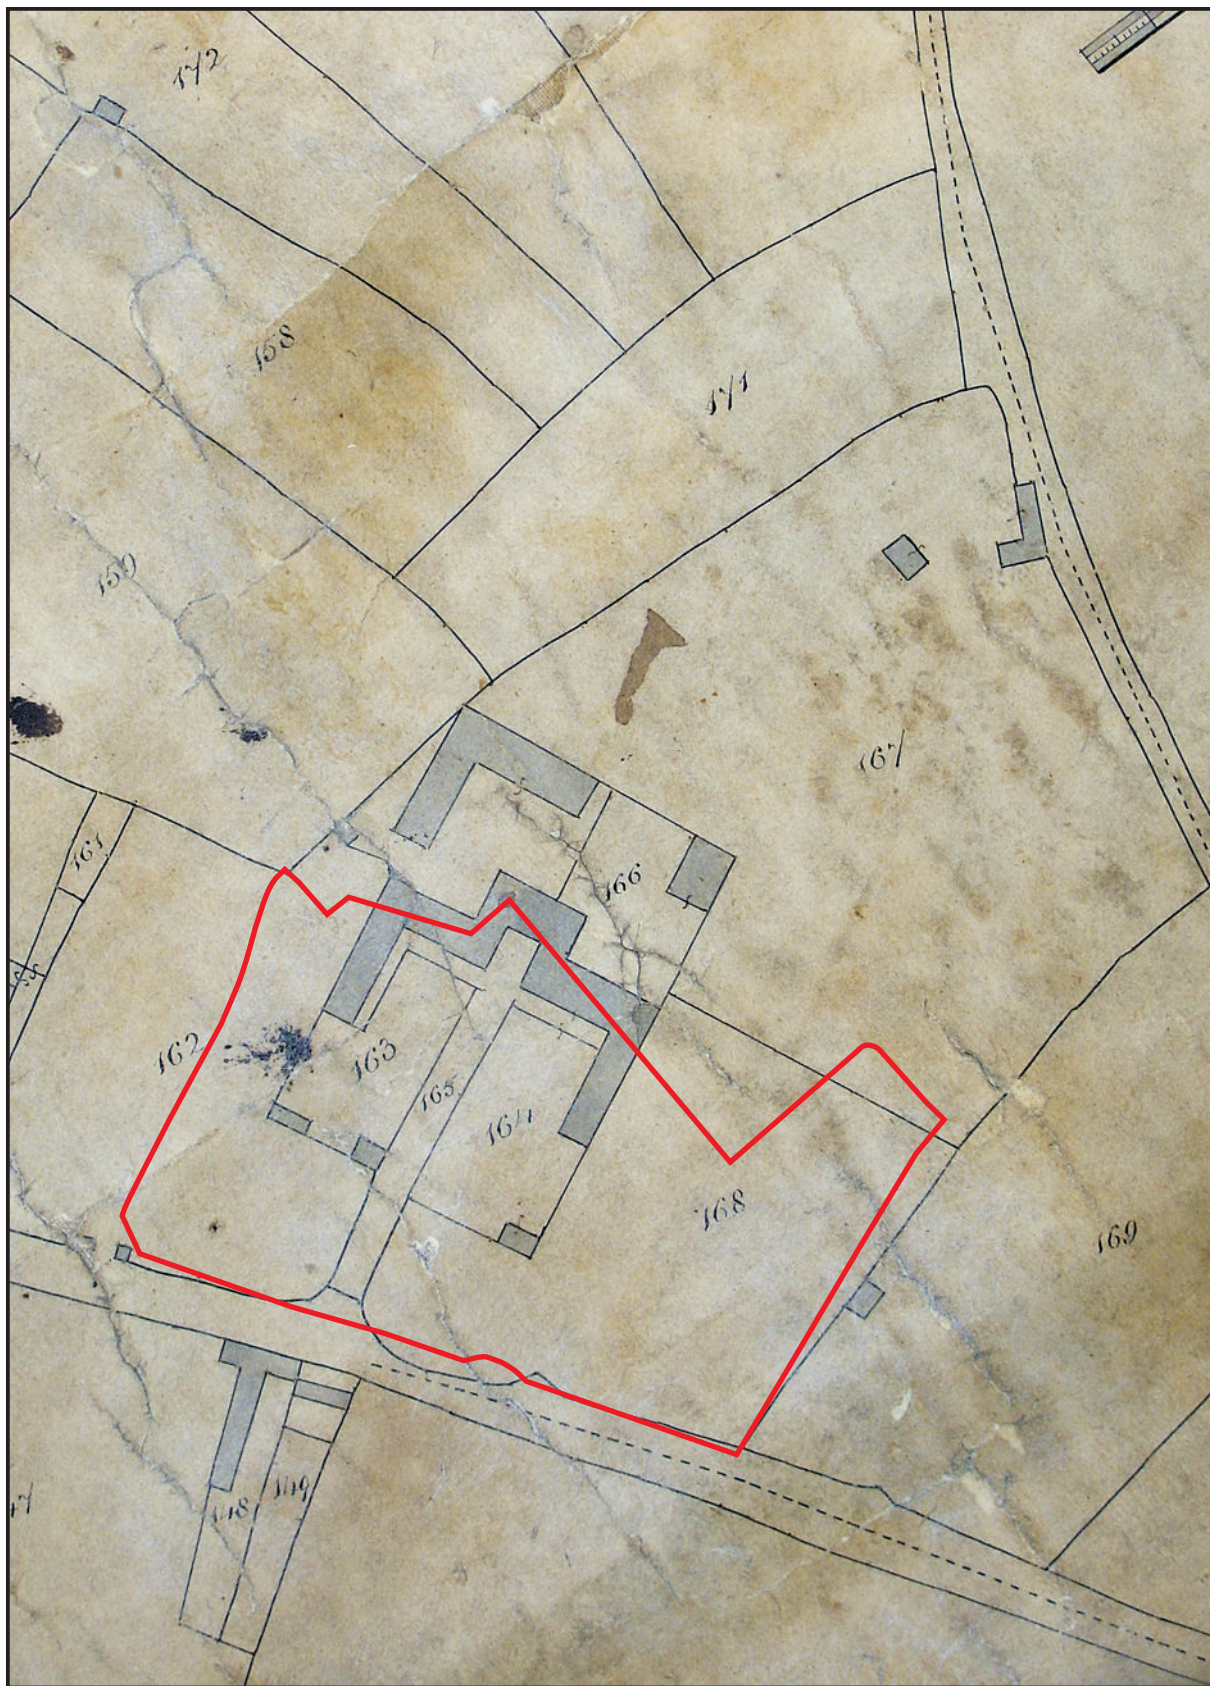
Fig. 5 Extract from the 1810 Exeter Corporation of the Poor Map Book (Map 1, reduced to 1:2000) showing the approximate position of the site. Reproduced by courtesy of Devon Record Office (Exeter City Archives Book 58A).

The next located depiction dates from 1810 when the Corporation produced a map book of its properties, with Map 1 showing the site (Fig. 5). To the west of the drive lay the Garden, with what appear to be vegetable plots extending down to the road. Building work continued with an infirmary was added in 1821,<sup>26</sup> although its location is not obvious from a comparison of the 1810 map with that produced in 1842 for the parish's tithe survey (Fig. 6). A newspaper report of 1828 records the leasing of the large garden adjoining the workhouse to the nurseryman and florist Mr C. Sclater 'who has engaged to erect two handsome lodges fronting the Heavitree-road', while a hot house and conservatory were also planned.<sup>27</sup> It is not obvious from maps that more than one lodge was ever present. While the Poor Law Amendment Act of 1834 changed the situation of most of the destitute for the worse, its effect on the Exeter workhouse buildings appears to have been slight. However, it may have been responsible for the decision taken two years later to discontinue brick-making on the site, when 300,000 bricks were offered for sale.<sup>28</sup>

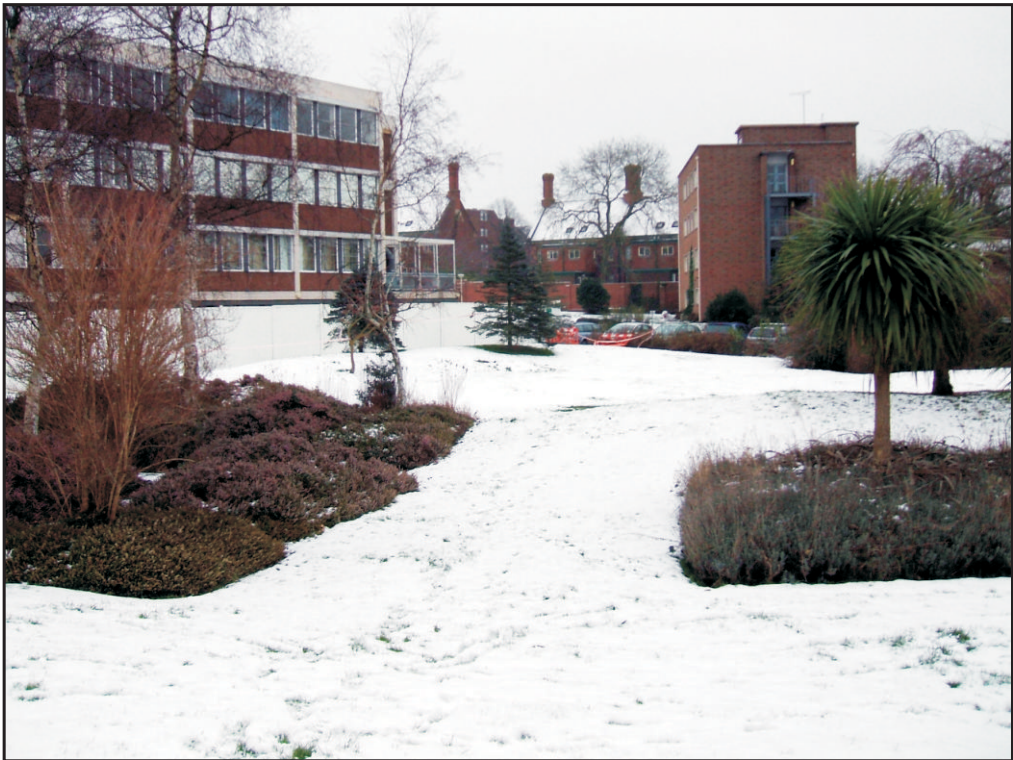
Plate 1 The former Children's Home, showing two phases of low brick wall alongside Heavitree Road. Looking north-east.

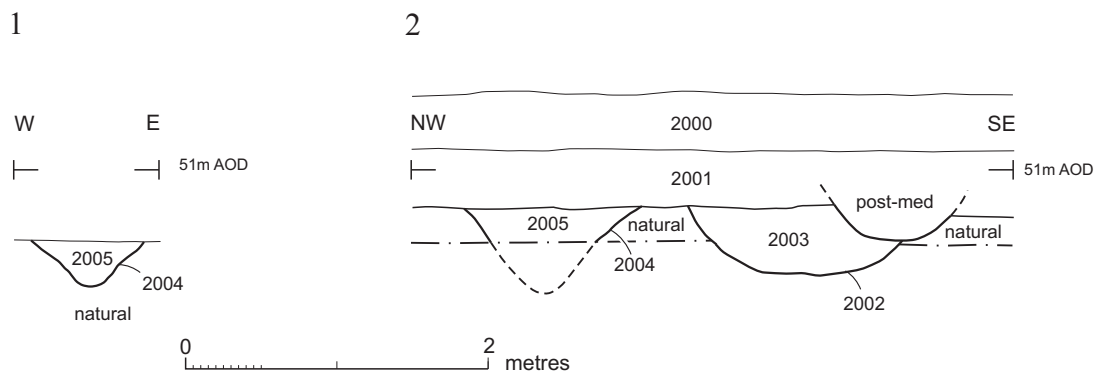
Area II  
Plan

Fig. 18 Area II plan and sections.

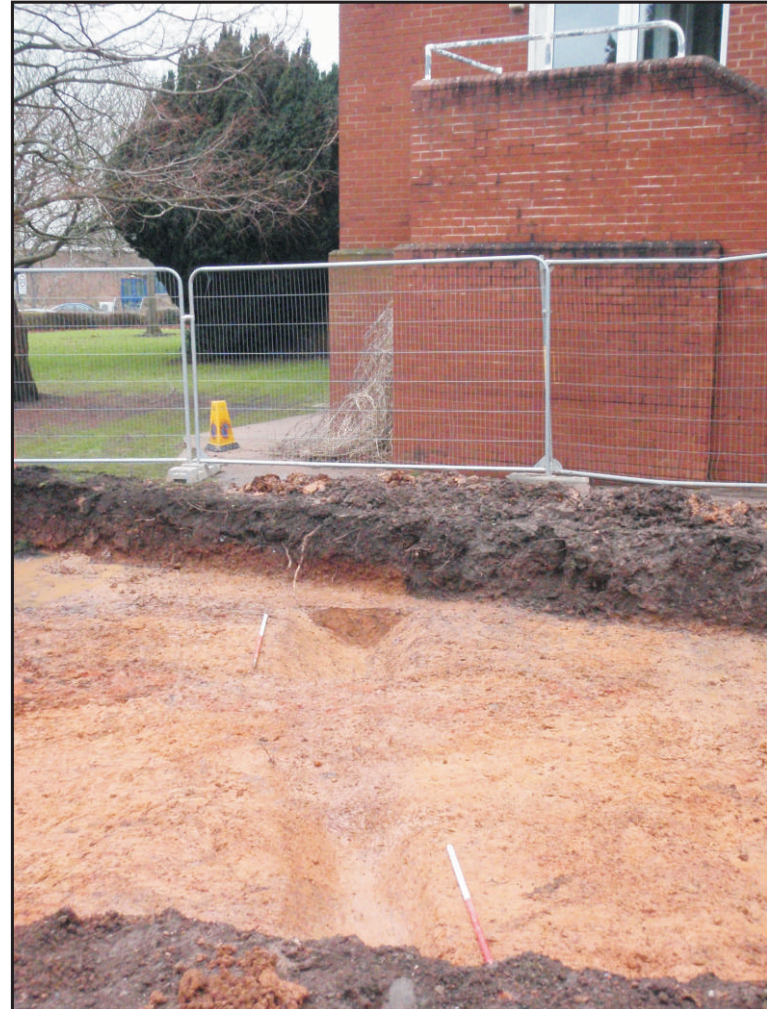
Plate 4 Area I, showing Roman ditch 403. Looking west, scales 1m.

Removal of the cultivation soil exposed an E-W aligned ditch (403), up to 800mm wide and 300mm deep, filled with yellowish-red silty clay (404). This produced a quantity of fired clay mould, possibly foundry waste of probable Roman date. The trench was expanded during stage 2 mitigation works (see below).

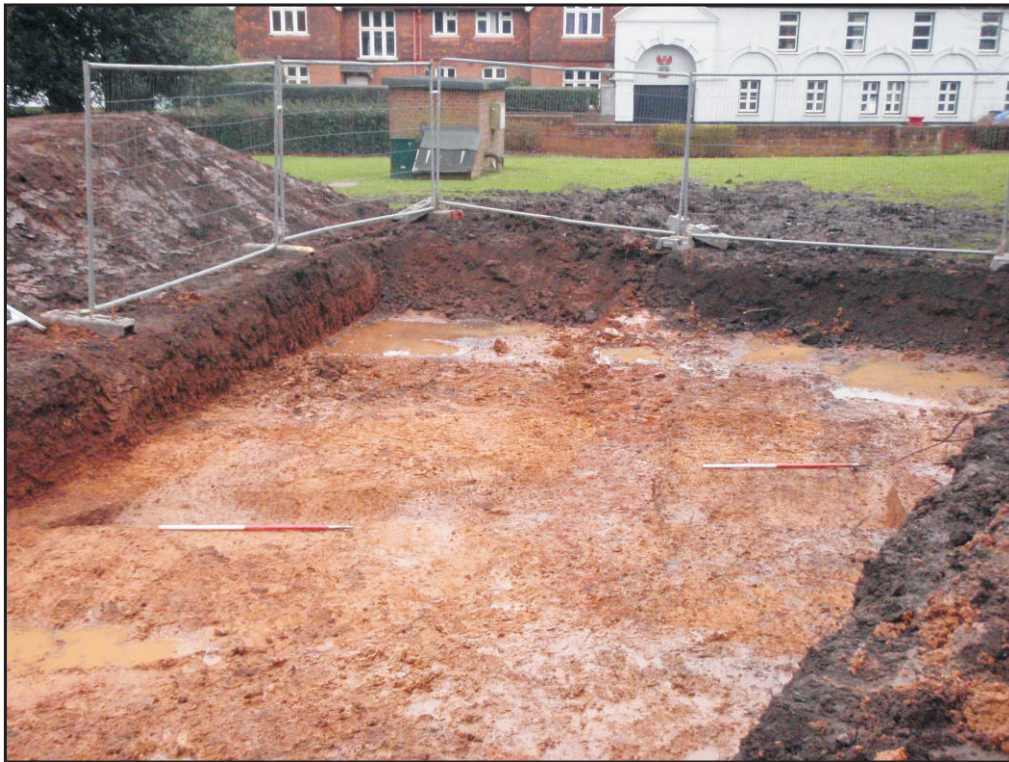
Plate 5 Area I, showing Roman ditch 403 (between scales) parallel to Heavitree Road (top of view). Looking south, scales 1m.

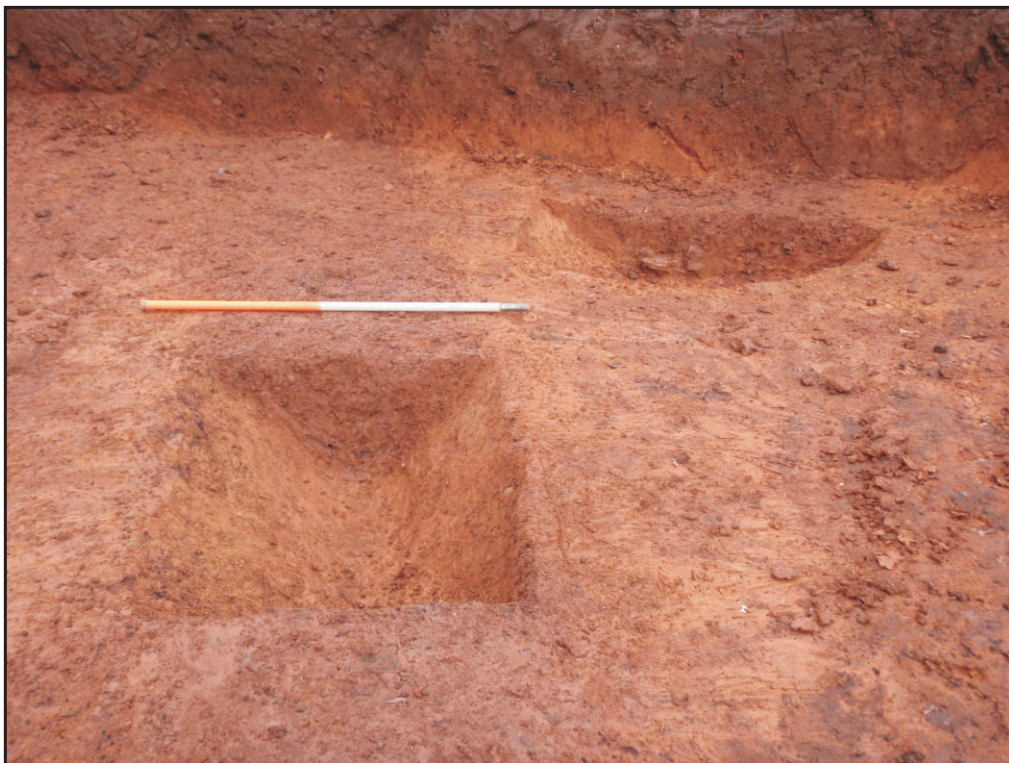
Plate 6 Area II, showing earlier, possibly prehistoric ditch 2004 (under scale). Looking north, scale 1m
