**ARCHAEOLOGICAL RECORDING
AT CRICKLEPIT MILL, EXETER 2010**

Prepared on behalf of Devon Wildlife Trust

Exeter Archaeology

Report No. 10.74

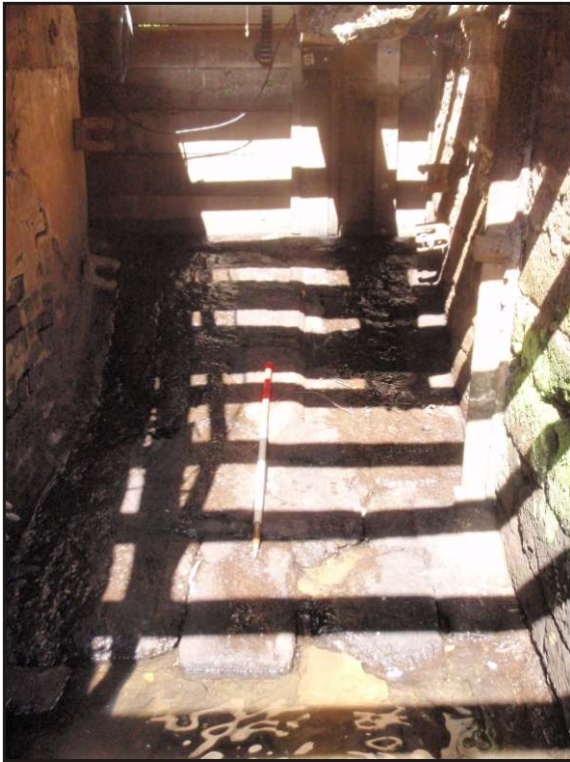
The base of this wheelpit was laid in flagstones (7), with brickwork (6) forming the curved breastwork at the head of the wheelpit. The latter material may be a replacement for earlier stonework, since further brickwork (8) was also present to the south (Pl. 1). This material is however easier to manipulate into the curved shape required for a breastwork than the flagstones used elsewhere and the two materials could therefore be contemporary. On the basis of this observation and the earlier historic building recording the waterwheel was c. 2.60m (8ft 6in.) diameter by 0.56m (1ft 10in.) wide. The flagstones terminated along the axis of the east wall of the mill where the remains of a wooden cill (9) were exposed (Pl. 3). At this point the gap between the end of the cill and the north leat wall was narrower (0.40m) possibly to increase the flow of water to a waterwheel within the Cricklepit Fulling Mill downstream (see below), or perhaps a third central waterwheel. The superstructure above the cill has been removed, but nails and a nut and bolt attached to the cill may have supported further timberwork including sluices (Pl. 2). Downstream of the cill beam a socket in a flagstone (10) may also have supported a timber associated with a sluice. This socket may have been contemporary with the cill beam, but could be earlier or later in date.

Plate 1 Base of northern internal wheelpit showing masonry 7 to right of scale, looking west. 1m scale.

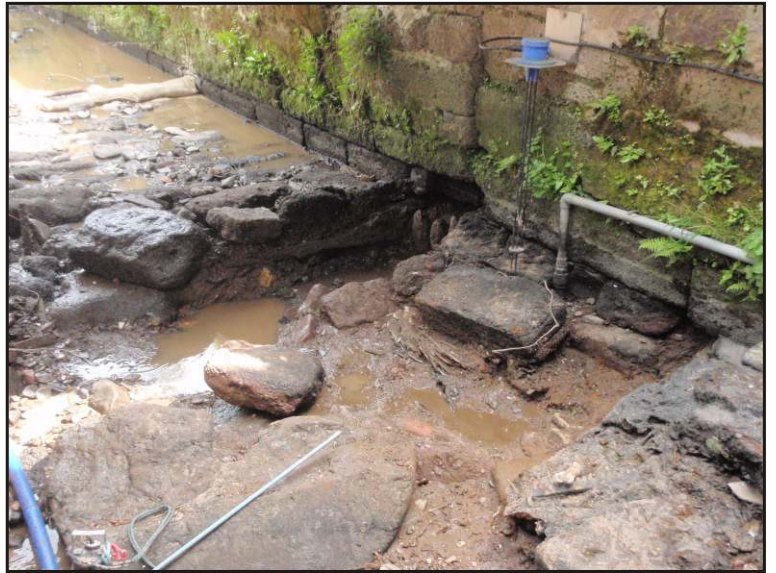
This had been disturbed by water action and within the west end of the mill only the remains of flagstone surface 11 survived. To the east of this washout, the base of the leat (13) was lined with breccia (and occasionally volcanic trap and granite). This surface continued beyond the limit of the building. The same materials were used for the base of the bypass channel (14) leading from the Miller's House, although a break between these two surfaces was observed.

At one location below the leat's south wall rows of three stakes (19) were partially exposed supporting the masonry above. These coincided with a break in masonry and may relate to a rebuild of the leat wall (3).

Half of a granite edge-runner millstone (20) was situated within the washout in the base of the leat. The stone is probably of later 19th or 20th century date and may have derived from the manure mill housed within the former fulling mill from 1854, or from the Lower Mills.

Plate 2 Area of washout showing surfaces 11 and 13 (foreground right and background), stakes 19 below leat wall and millstone 20 (foreground, centre), looking southeast.

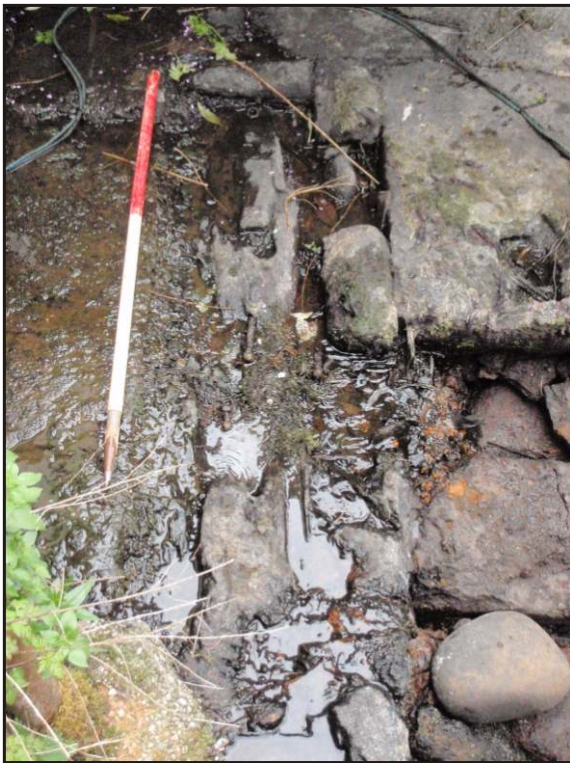
Cill beam (9) terminates 0.56m (1ft 10in.) from the south wall of the leat. Flagstones (11) are present forming the base of the leat both sides of and adjacent to the end of the cill beam. Although there is no evidence from the flagstones to indicate the position of a narrow waterwheel it seems likely that the gap between the leat wall and the cill beam represents the downstream end of a narrow 18th-century (or potentially earlier) wheelpit (i.e. presumably within the grist/malt mill rather than within the fulling mill).

On the basis of documentary evidence Henderson *et al* (1996, stages 4-9) place a third waterwheel centrally within the wheelpit. This arrangement is known from mainland Europe, and indeed Bonhay Mill further upriver from Cricklepit Mill is depicted on the 1756-8 Chamber Map Book with several wheels within a single wheelpit. Firm archaeological evidence is lacking; there is not for example any evidence for the position of the shaft. In the position suggested by Henderson *et al* any fabric or fittings associated with this waterwheel (such as timber framing) must have been removed when the present waterwheel was erected and wall 12 constructed. Alternatively, it is possible that the wheel could have been located outside the present building, which may explain the presence of cill beam 9, the latter supporting sluice gates above the wheel.

Plate 3 Beam 9 with socketted stone 10 to right, looking north. 1m scale.

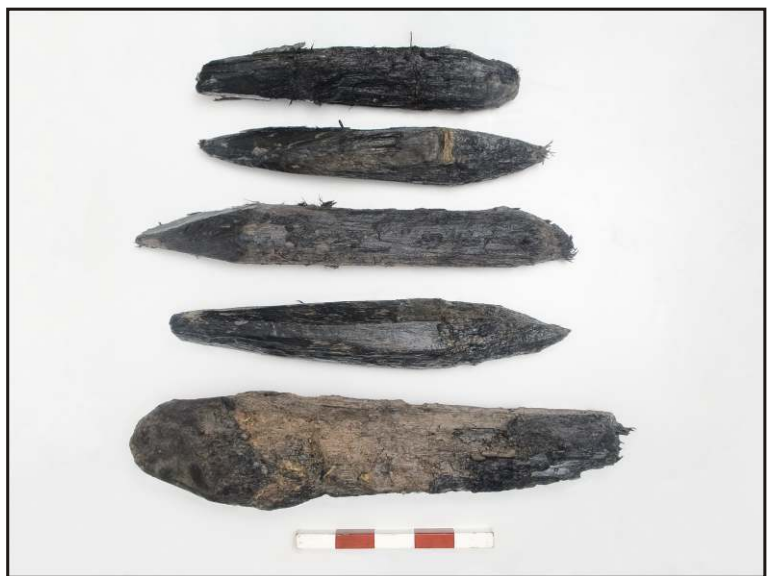
A number of stakes were recovered from the base of the leat (18) to assess their potential for dendrochronological or radiocarbon dating. These were oak and measured from 0.40m to 0.60m in length with diameters of between 80mm and 150mm. Their lower tips were smooth and pointed before becoming roughly hexagonal in profile. The stakes were shown to Vanessa Straker, the English Heritage Regional Science Advisor for the South West Region, who advised they were unlikely to be suitable for dendrochronology, and that (if they are post-medieval) radiocarbon dating was unlikely to provide an accurate enough date range to be meaningful. No further analysis was undertaken.

Plate Timbers recovered from the base of the leat. 0.25m scale.
