**An Archaeological Watching Brief at  
Handlye Farm, Barcombe, East Sussex**

**Planning Reference LW/10/1549  
Listed Building Consent LW/10/1548**

**ASE Project No: 4849  
Site Code: HFB11**

**ASE Report No: 2011093  
OASIS id: archaeol6-102491**

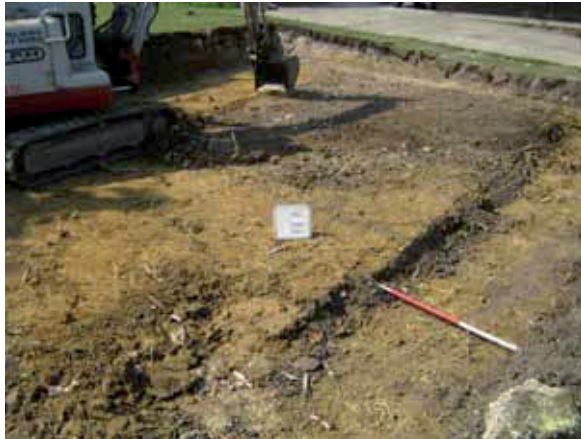
4.2.3 Three contexts were recorded during the watching brief monitoring, the topsoil [001], a layer of brick rubble interpreted as made ground [002] and the natural clays [003]. The topsoil [001] was a loose and friable greyish mid-dark brown clayey-sand which was between 0.20m and 0.30m thick. The made ground [002] overlay the clay natural, and in turn was overlain by the topsoil. Deposit [002] comprised brick rubble, broken tile, flint and chalk cobbles. There were no finds associated with the made ground to enable a date to be established although the bricks were frogged suggesting they came from a later building (mid 18<sup>th</sup> century onwards– Sarah Porteus *pers. comm.*). The rubble was undoubtedly from a demolished building but it was not *in situ* and did not form a surface. It seems likely, given the undulating nature of this area of the garden, that this material had been imported and used to landscape a low spot before the area was grassed over to form part of the lawn. It has been suggested that this area may have been a vegetable patch as late as 1976 when the current owners took over the property (Robin Beech *pers. comm.*). The made ground was located in the north half of the garage footprint and was thickest in the north-west corner.

Garage area, looking north-west

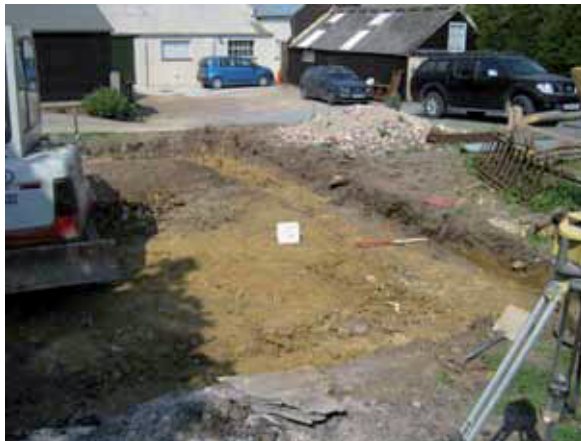
Garage area, looking north-east

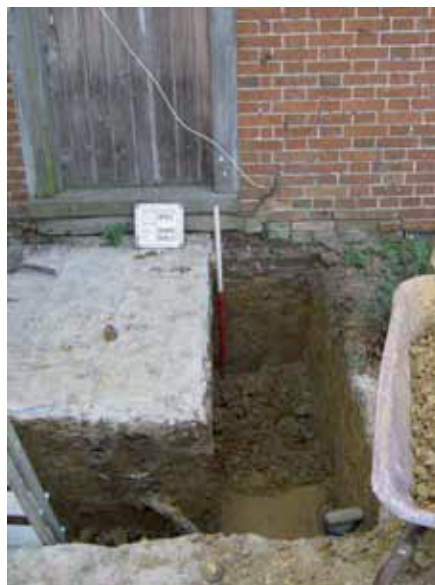
4.3.1 A hand-excavated trench (c. 1m deep and 0.5m wide) was dug for the footings of a proposed porch. These excavations revealed a thin layer of concrete directly over the top of natural geology [003]. No topsoil was recorded in this area and no archaeological finds, features or deposits were observed. The porch will reuse the existing aperture to the building.

Porch area, looking west
