**An Archaeological Evaluation at  
The Dullingham Motors Site, 12 Brinkley Road,  
Dullingham, Cambridgeshire**

**Project No: 4941  
Site Code: ECB 3595**

**ASE Report No: 2011201  
OASIS ID: archaeol6-107847**

**August 2011**

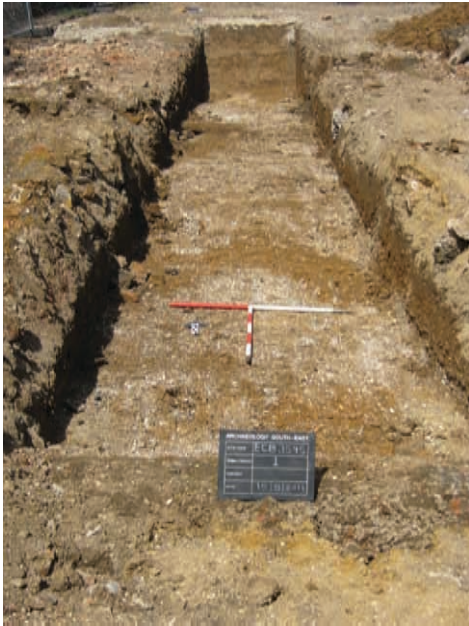
Natural geology was overlain by subsoil [1/002] and demolition material [1/001]. Natural geology [1/003] was encountered at 80.12m AOD in the south of the trench and sloped down to 79.48m AOD in the north. A small modern water pipe was revealed crossing the middle of this trench on a rough east-west alignment. Modern truncation of the natural horizon was also witnessed to the north of this pipe.

Trench 1, looking north

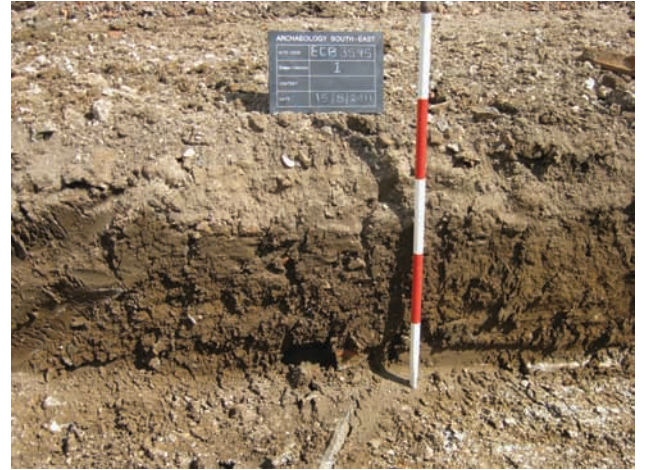
Trench 1, west facing section

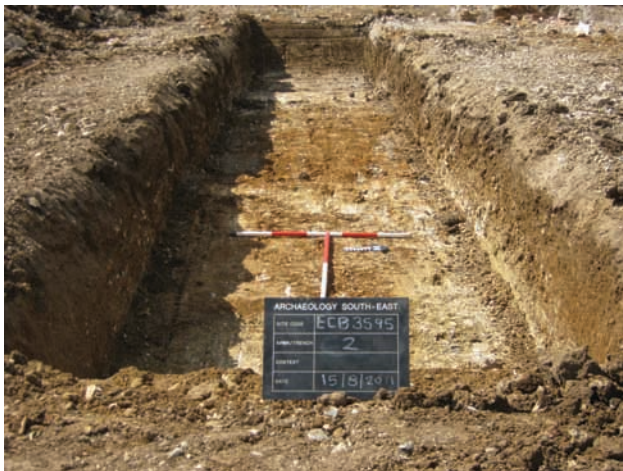
Natural geology [2/003] was encountered at 79.86m AOD in the northwest of the trench and 79.95m AOD in the southeast. The natural horizon was overlain by subsoil [2/002] and demolition material [2/001].

Trench 2, looking north-west

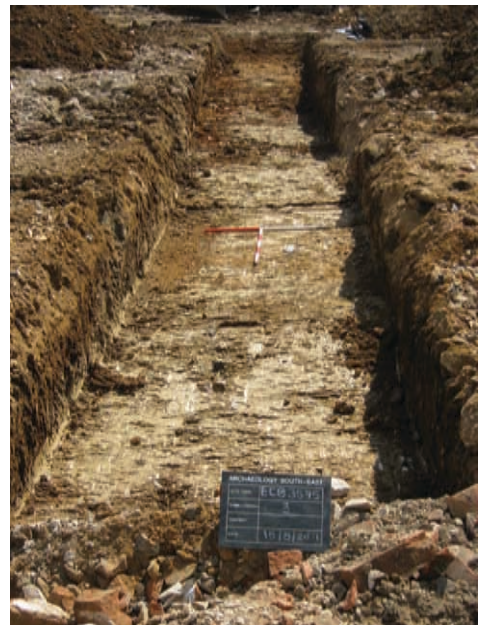
Natural geology [3/003] was encountered at 79.84m AOD in the north of the trench and 80.19m AOD in the south. The natural horizon was overlain by subsoil [3/002] and demolition material [3/001] (as described in 4.2).

Trench 3, looking south
