**An Archaeological Watching Brief Report  
Former Southlands Hospital Land St Giles Place  
Upper Shoreham Road, Shoreham by Sea  
West Sussex**

**ASE Project No: 4257  
Site Code: SSH10**

**ASE Report No: 2011224  
OASIS id: archaeol6-110272**

**September 2011**

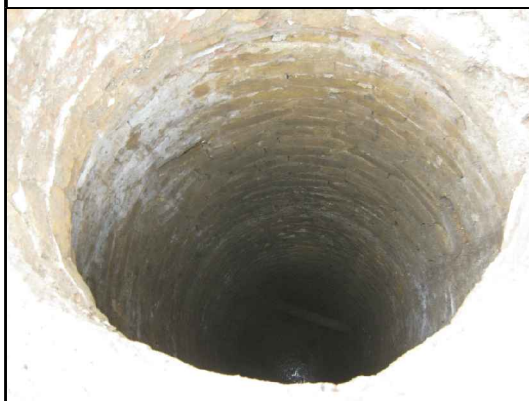
Fig. 3.1: Brick well

- 4.4 Two sub-surface brick structures were observed during the course of watching brief (Fig. 3).
- 4.5 The first of these relates to a brick-built well, measuring 1.10m in diameter, with a depth in excess of 30m, located in the north-east part of the site. The structure was constructed of a red and yellow brick, bonded by a concrete mortar. Some evidence of corbelling at the top of the structure was noted (Fig. 3.1).

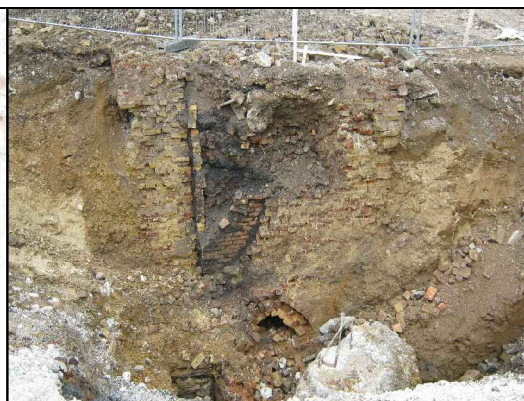
Fig. 3.2: Chimney stack

- 4.6 The second relates to a substantial brick built structure in the same north-east corner of the site (Fig 3.2). This comprised a very substantial squared structure in plan, with a NW-SE orientated stretch of adjoining wall in the northwest-corner. The structure measured c. 3.55m by c. 3.67m, with a depth of c. 3.10m exposed, and had been cut into the underlying natural. The outer skin was constructed of 19<sup>th</sup> to mid-20<sup>th</sup> century brick bonded with a cement mortar; context [004]. An inner 'lining' to the structure built of unfrogged machine made brick in a creamy yellow fabric was also noted. These bricks were of later-19<sup>th</sup> or 20<sup>th</sup> century date, and had been bonded with a cement mortar; context [005]. An arched stokehole or culvert was visible towards the base of the structure, and at the base of the trench a concrete duct or manhole was noted. To the south and east, additional stretches of brick walling were partially exposed at depth, representing a continuation of the structure which is thought to represent the subterranean part of a substantial chimney, part of the boiler house used to provide heat and hot water for the workhouse/hospital. Due to the depth of the excavations, and the instability of the trench sides, the structure was not accessed, and was recorded from the trench edge only.

- 6.2 Two brick built subterranean structures were noted during the programme of fieldwork. The well and chimney base were both observed within the north-east part of the site, within the core of the Steyning Union Workhouse complex. The chimney base is thought to be structurally associated with the boiler house which was located to the north of the main administration block (Morrison, 1999, 115). The boiler house building is shown on the 1912 12" Ordnance Survey map (Fig. 3) and is still present on the 1984 Ordnance Survey, but had been demolished by 2001. Brick samples confirmed a late Victorian / early modern date for this structure.
