**An Archaeological Watching Brief at No. 5 Denton Rise,
Denton, Newhaven, East Sussex**

**Project No. 5067
Site Code: DRN11**

**ASE Report No. 2011246
OASIS ID: archaeol6-112159**

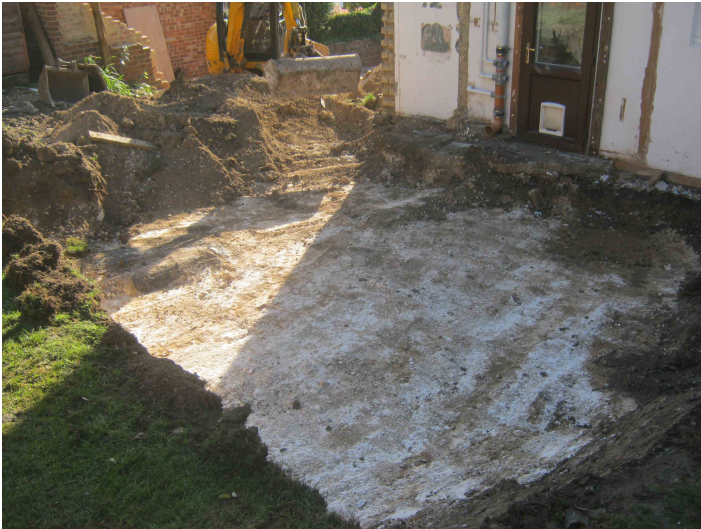
House extension

- 4.4.1 A third visit was made to the site on 18th October 2011 to monitor the groundworks for the rear extension to the house. The mechanical excavation was undertaken by the same machine. An area measuring c.5m by c.6m was reduced to a maximum of 1.1m below the current surface. The overburden consisted of three distinct layers.

- 4.4.2 The most recently deposited was context [005] a 300mm thick layer of brick rubble resulting from the latest demolition work at the site. Towards the house, this layer lay directly over the 'natural' chalk, recorded as context [008], but further to the north the two layers of overburden were similar to those encountered during previous visits. The topsoil, context [006] was a maximum of 510mm in thickness, and the sub-soil, context [007], which was more orangey brown in colour than elsewhere, was a maximum of 100mm in thickness. It directly overlay the chalk, context [008].

- 4.4.3 The surface of the chalk has been heavily truncated close to the house and in the eastern part of the stripped area during the laying of services. No archaeological deposits, features or finds were encountered.

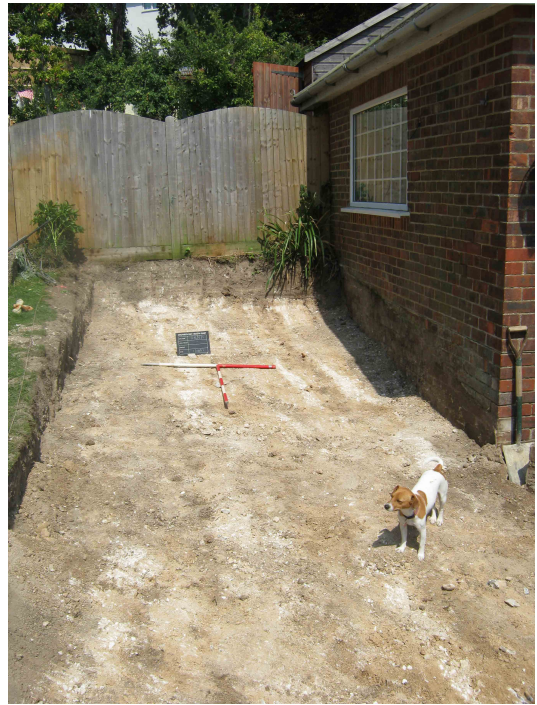
Garage extension

4.1.1 Mechanical excavations by a 3 tonne 360° excavator for the extension to the garage were monitored during a site visit on 1st August 2011. An area measuring c.8m by c.3m was stripped. The overburden consisted of two distinct layers. The uppermost was context [001] a mid-brown clayey silt topsoil, which was a maximum of 500mm in thickness. It overlay a greyish brown deposit of subsoil, context [002], which was a maximum of 100mm in thickness, which directly overlay 'natural' weathered chalk (context [003]).

4.1.2 The only anomalies encountered were either modern garden features or trenches for services or foundations for the garage. No archaeological deposits, features or finds were encountered.

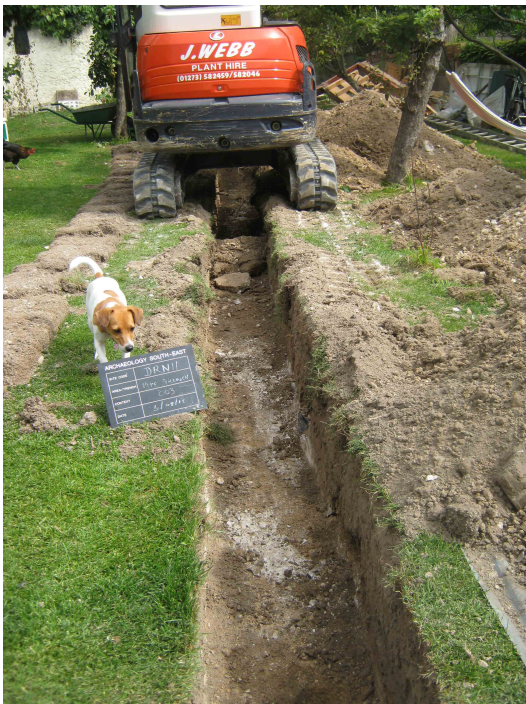
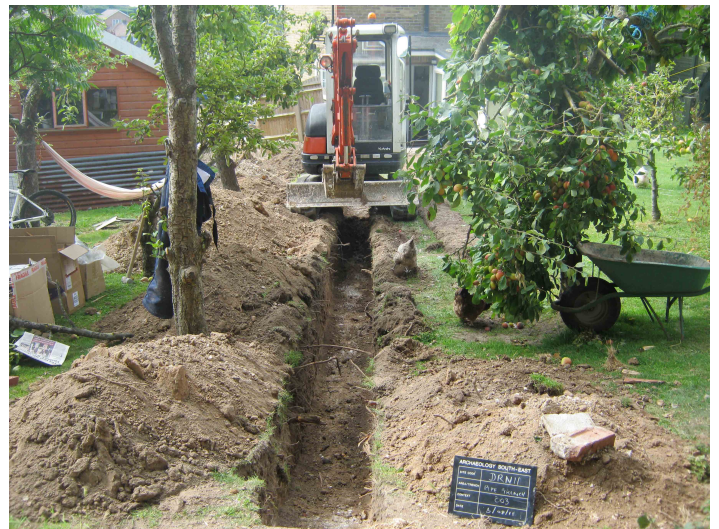
Drainage trench

4.2.1 A trench measuring 13m long by 500mm wide was excavated by the same machine on 3rd August 2011, leading from the area of the new garden structure towards the existing buildings. Initial excavation was taken down to the surface of the 'natural' chalk to allow the identification and recording of archaeological features. The two layers of overburden were found to be similar in character to those observed during monitoring of the garage extension.

4.2.2 At the north-eastern end of the trench context [001] was 400mm in thickness and context [002] was a maximum of 200mm in thickness. At the opposite end context [001] was also 400mm thick, but context [003] had thickened to a maximum of 300mm. No archaeological deposits, features or finds were encountered.
