**STAMBRIDGE MILLS, STAMBRIDGE, ESSEX**

**HISTORIC BUILDING RECORD**

**(NGR TQ 8870 9038)**

**Report No. 2011262**

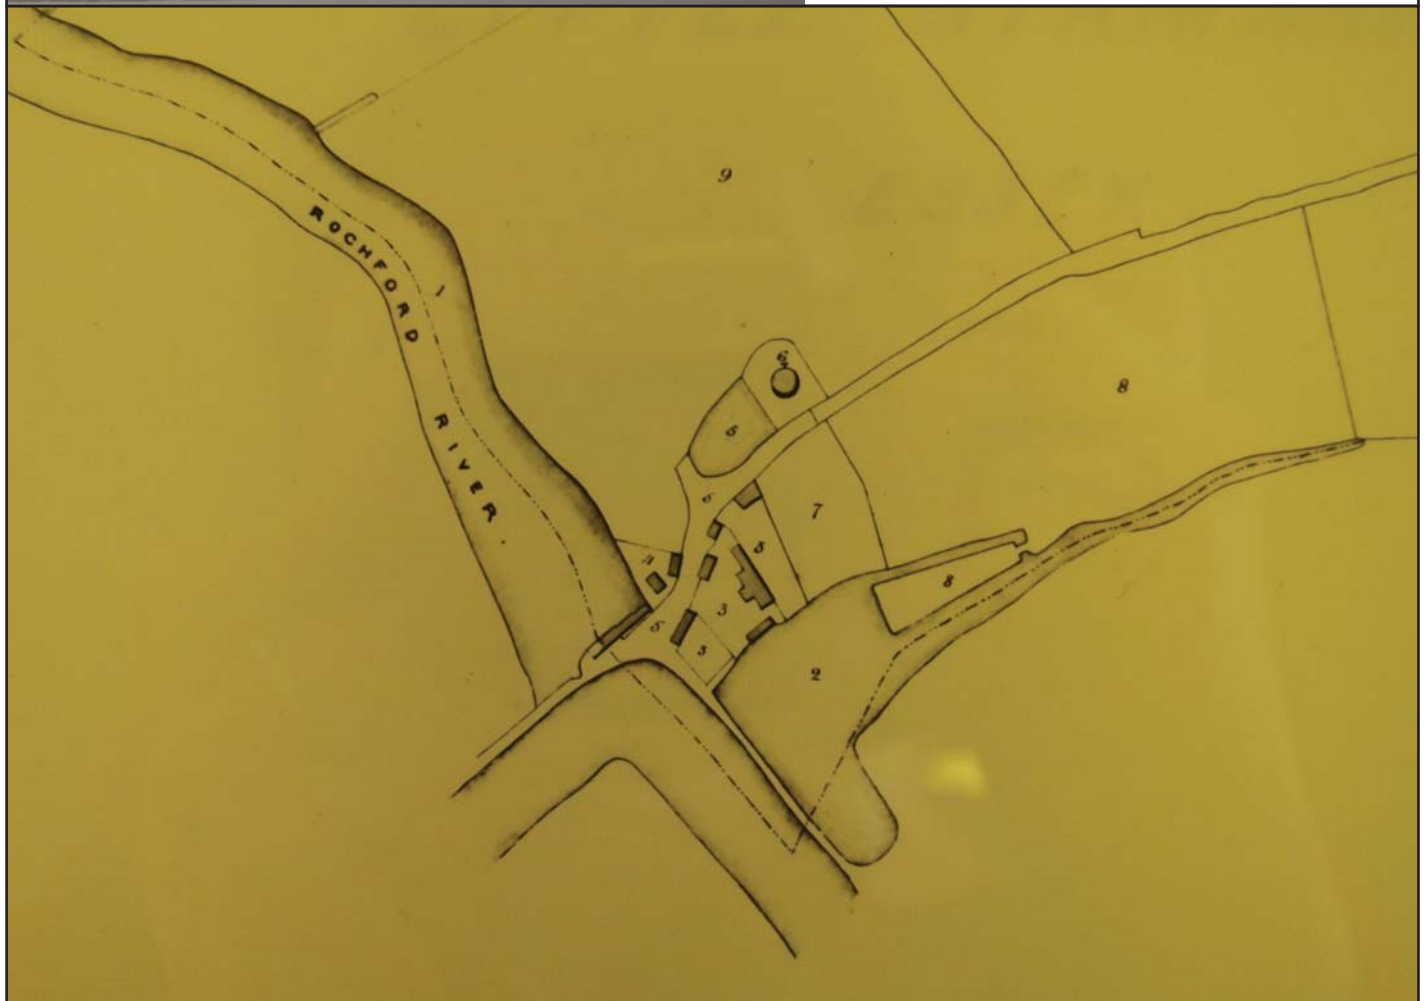
© Archaeology South-East		Stambridge Mills, Stambridge, Essex	Fig. 3
Project Ref: 5220	Nov 2011	Historic maps	
Report Ref: 2011262	Drawn by: JFB

Below: 1838 Tithe map (Little  
Stambridge)  
(D/P 395/27/1)

the dwelling house. The other buildings on the site are also listed, each described with their construction fabric. The granary and kiln – those built in 1811 – are of brick and slate, suggesting that they are fully brick-built. There is also a lean-to waggon shed adjacent which is of timber and tiled. The granary is not identified on the tithe map or on the later O.S. maps: it may be one of the “Outhouses” on plot 3. In addition, there was a stable (timber and tiled), and a “barn, stable and piggeries” which were timber, tiled and thatched. These, joined in the same valuation, were probably part of the same structure. There were two small buildings, each valued at £25, half of the valuation of the separate stable and a sixth of the value of the barn, one listed as a workshop and one as a hen house, both timber and tiled. Based upon the size and footprint of the large, irregular structure on the earliest maps, this was probably the barn, with the stable or piggery extending to the west (shown on the Tithe map, Fig. 3).

There were also listed detached workshops and hen houses, said to be on the opposite side of the road from the farm yard, suggesting that the western small buildings shown on the tithe map and 1st edition O.S. map (Figs. 3 and 5), as well as that accompanying the sale particulars (Fig. 4) were the workshop and hen house. Around the farm yard are listed the barn, shed, "Nag's stable", stabling for 5 cart horses, piggeries, granary, kiln, large coal yard, good garden. The inclusion of the granary and kiln in this list suggests that indeed, these two structures were on the eastern side of the site. The post windmill was also included in the sale. This is described as being on brick piers, with two patent sails and two common sails driving two pairs of stones. The whole property comprised 37 acres, 2 rods and 12 perches. It is also stated that the mill was let to Messrs W.H. and Alfred M. Rankin on lease for £275 per year.

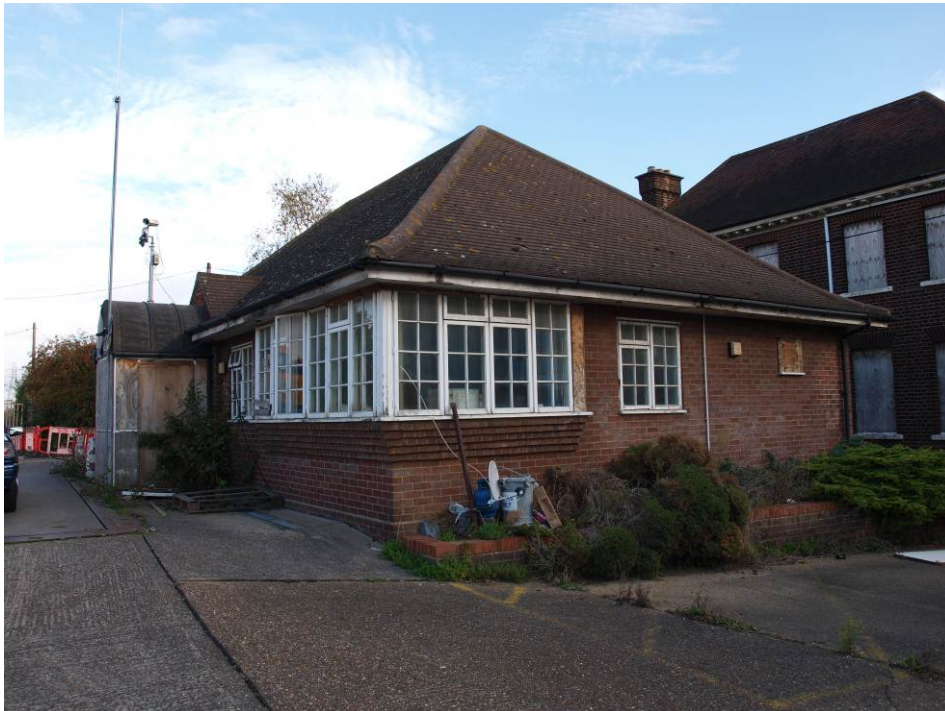
Plate 1

- 4.1 Building 1 (Plate 1) is located to the east of the weighbridges to the south of the main entrance. It is a single-storeyed, brick-built building with a hipped, tiled roof and a projecting entrance-way under an arched roof. There is a large timber window set on a slightly-corbelled section of brickwork wrapping around the south-western corner which seems to have allowed good visibility within the main open area of the site. This

suggests that it was probably used to oversee traffic going in and out of the site. A short corridor to the east (rear) of the building links this structure to Building 2.

Building 1 from the south-west

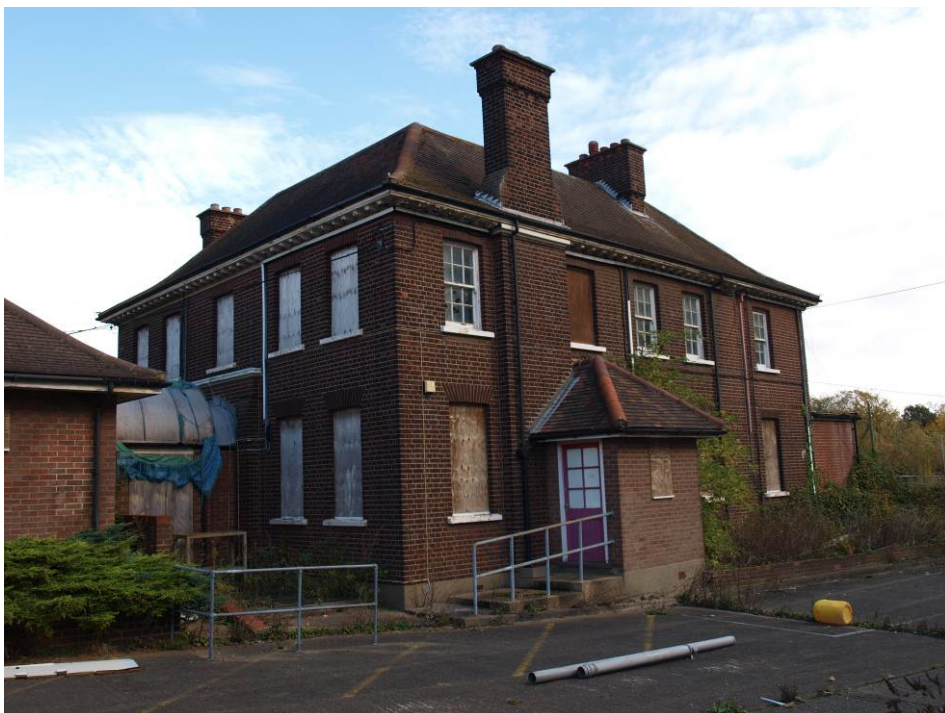
Plate 2

- 4.2 Building 2 (Plate 2) lies to the east of Building 1 and is linked to that structure by a short, enclosed corridor. In its initial form, this building was of 'L'-plan. It is capped with a fully-hipped roof arranged in 'U'-plan, the base of the 'U' to the west and the northern arm shorter than the southern. The structure has a central entry in the west elevation with rooms to either side and chimneys in each end wall. It is of two storeys. The external walls are brick-built using an unusual bond formed of alternating courses of six headers with a single stretcher at each end and six stretchers with single headers at each end. The bricks are a dark purple-brown colour and there are burnt headers incorporated randomly. At the top of the wall there is a deep, dentillated eaves cornice which supports the base of the slightly-kicked roof slope. The roof is covered with tiles.

- 4.3 The structure is lit by a number of sash windows with flat heads formed by splayed, rubbed bricks laid on end. The windows are all alike, where visible, being of six panes in each sash arranged 3x2, with plain external horns under the top sash. The window cills project slightly from the face of the wall and are all painted white.

- 4.4 A modern extension in the north-eastern corner has regularised the footprint of the building. The decorative eaves detail of the earlier structure has been copied on the extension but on this structure is formed in brighter red-brown bricks laid in stretcher bond. A flat-roofed turret to the rear (east) of the building is of the also original to the structure and probably housed services, perhaps the WCs. A further flat-roofed extension against the southern part of the east wall is only a single storey in height and constructed in red-orange stretcher-bonded bricks. A new entrance has been created against the south wall, where a small hipped-roof, single-storeyed extension has been built with a door in its west wall, accessed by a ramp.

- 4.5 This building was recently used as office accommodation. However, its appearance as a neat, well-appointed, early-20th-century structure suggests that it was originally inhabited as a house rather than as commercial space.

Building 2 from the south-west

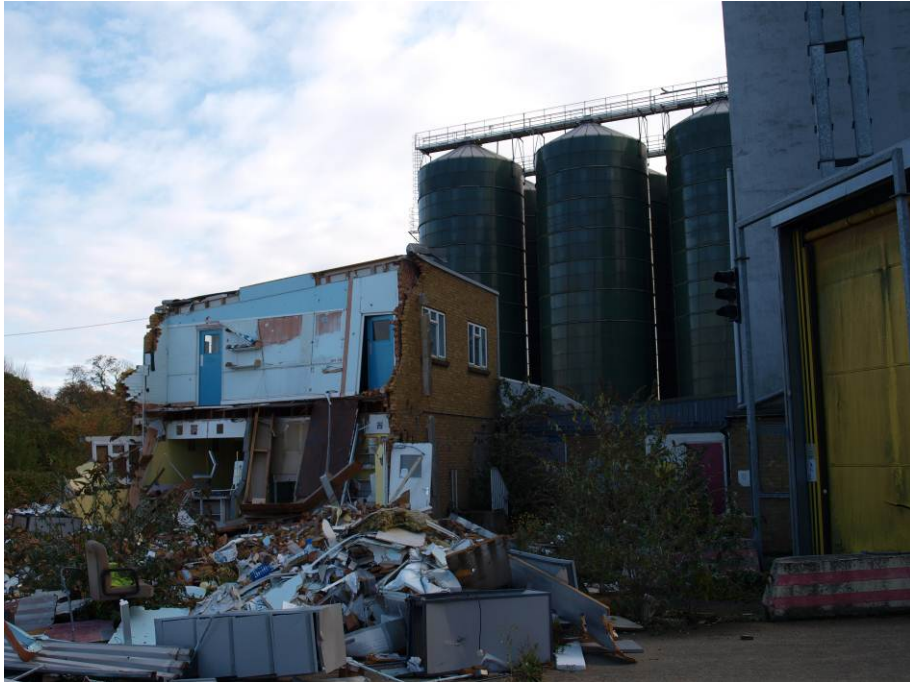
Plate 3

- 4.6 At the time of the site visit, two-thirds of Building 3 (Plate 3) had been demolished, although the debris had not been cleared and still lay where it had fallen. This structure is of two storeys and had a single-pitched
-

roof sloping to the north. It was built using yellow London brick with one frog stamped, in most cases, 'L B C', for London Brick Company. The external walls were cavity walls. In the surviving part of the northern wall there is evidence for a blocked window and a blocked door to each storey, suggesting either the location of a fire-escape or an earlier storage building, where external first-floor access was necessary. The internal walls, where visible, are of plasterboard and regular timber studwork. In its most recent use it functioned as offices: the modern office furniture was still partly visible.

The remaining section of Building 3 from the west, with the demolition rubble to the left and the silos (Building 8) in the background. Intake Pit 1 is on the right with a yellow door

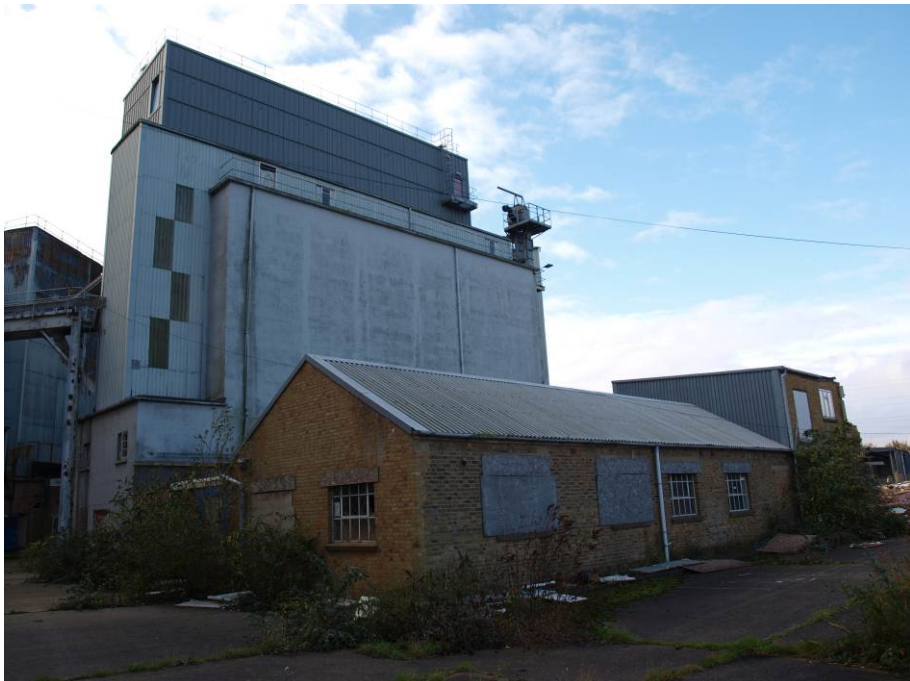
Plate 4

- 4.8 This is a single-storey structure aligned east-west, formed in yellow London brick laid in Flemish bond (Plate 4). It initially had five Crittall windows in the north wall, the western of which has been blocked. The eastern end wall has been rebuilt in brighter yellow brick forming a gable: there are two windows in this wall. Each window has a central, upper, pivoted opening, such as is often seen on workshops or storage buildings, and has a sloping brick cill. The roof is covered with corrugated metal which appears to be a modern covering.
- 4.9 Inside this structure the walls are of exposed and painted brick and the interior of the roof covering is hidden by boards. The roof is supported on metal trusses (Plate 5). The space was probably used as a workshop.

Building 4 in the foreground, showing the tall Building 6 behind, from the north-east

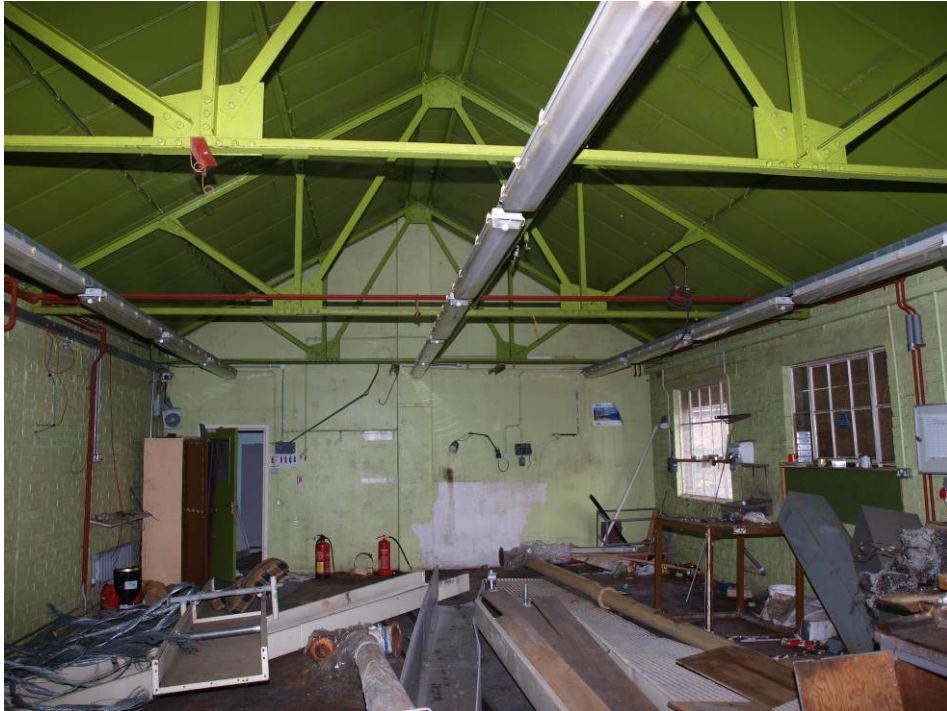
Plate 5

Interior of Building 4 facing west

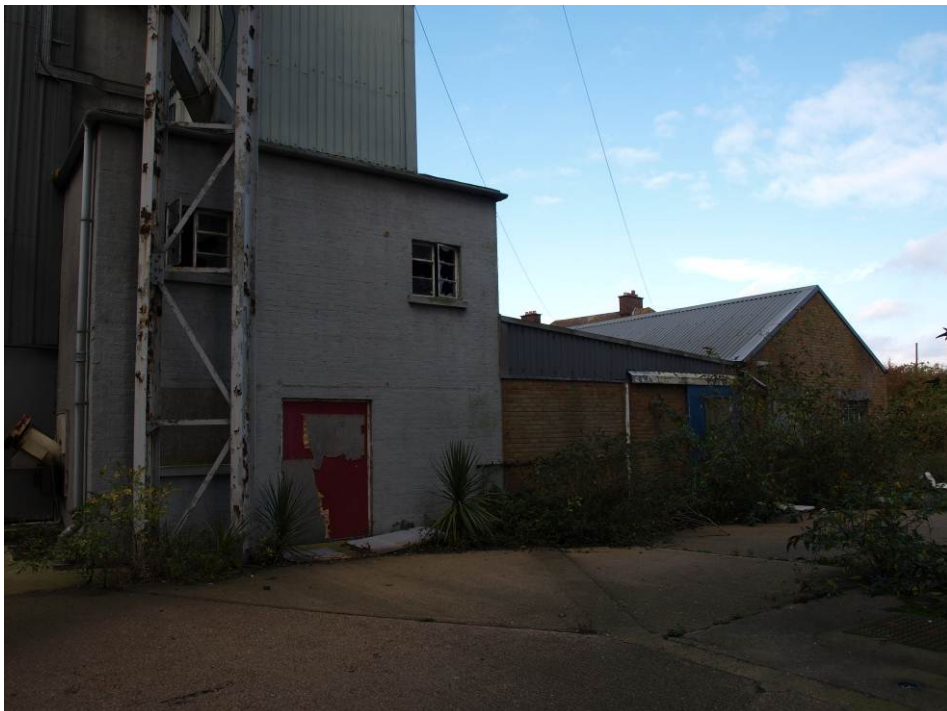
Plate 6

- 4.10 Building 5 (Plate 6) appears to have been constructed as infill between Buildings 4 and 6. It is covered with a corrugated-metal lean-to roof which slopes down from Building 6. The eastern end of the structure is constructed in the same yellow stock bricks as Building 4; indeed, the wall is continuous between the two structures, indicating that this structure was probably built at the same time that the end of Building 4 was truncated. There is a sliding door at the north end of the eastern wall leading to the interior.

- 4.12 This building (Plates 4 and 6) comprises a tall structure (approximately five storeys) with a two-storeyed structure projecting at the eastern end. The taller section is flat-roofed; a railing around the outer edge indicates that it was used as a walkway. The two-storeyed section has a roof hipped to the east, although it is mostly hidden below a tall corrugated-metal turret which rises at the eastern end of the taller section and continues for the full length of the building. The lower section has two-pane Crittall casement windows facing the east with concrete lintels, of a mid-20th-century style. There are two first-floor windows and a single ground-floor window on the southern side of the east elevation. In the centre of the ground-floor wall there is a wide, single doorway. The brick forming the walls, visible beneath layers of paint, is laid in Flemish bond.

The east ends of Buildings 4, 5 and 6 (right to left) from the south-east

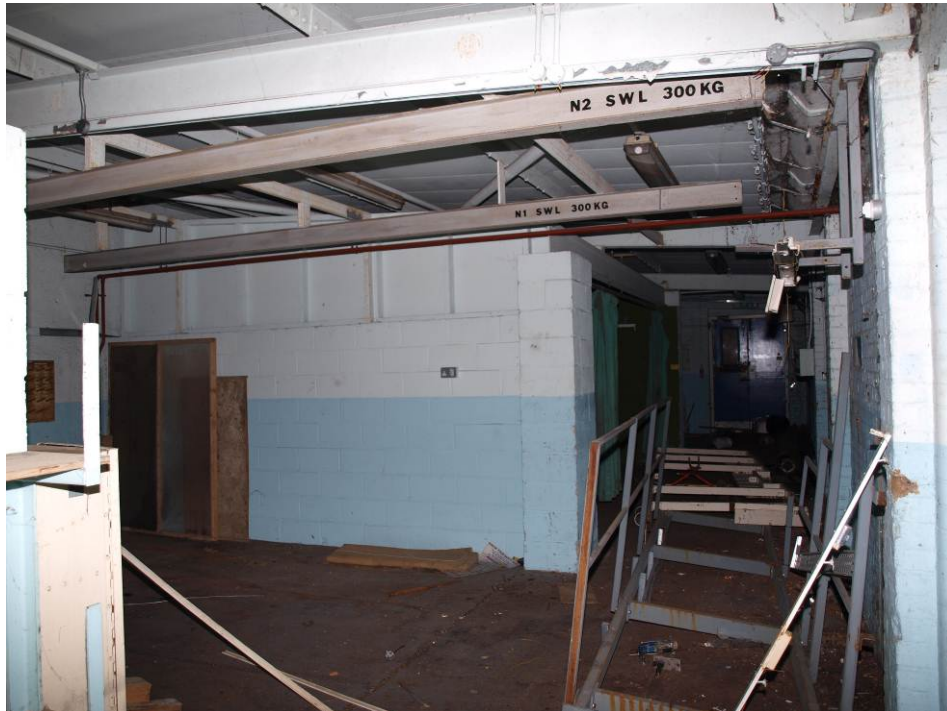
Plate 7

- 4.11 In this building the roof is also constructed using metal trusses, although these trusses are more substantial than those within Building 4 (Plate 7). The space in Building 5 is divided into two by a breeze-block partition. The smaller room is positioned in the south-western corner and leaves a corridor against the north wall leading to the western end of the building. The northern wall of the small room is formed by using curtains. This structure also appears to have been used for storage.

Interior of Building 5 from the east

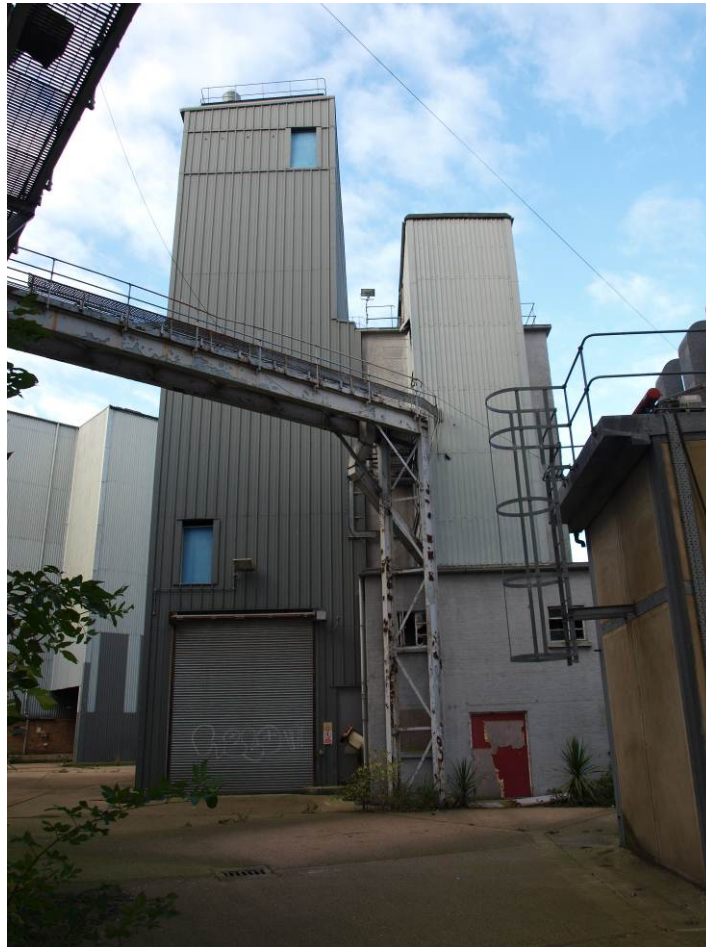
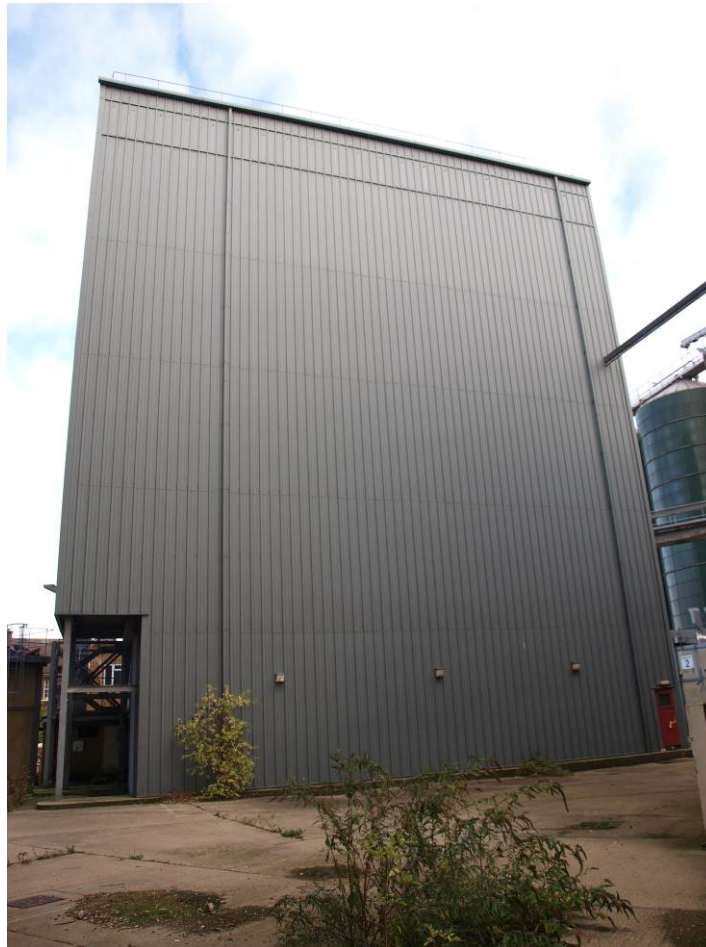
- 4.13 Building 7 (Plates 8 and 9) appears to be of late-20th-century date, rising to a height taller than the adjacent Building 6 and separated from that structure by a narrow gap, closed at each end by corrugated metal, which material also forms the walls of Building 7 for their full height. There is a large vehicular doorway at each end of the building on the ground floor, the western of which is set back into the structure a short way, the wall above being jettied over the opening. There is also a pedestrian doorway just above the large doorway and one at the very top in the eastern elevation. An additional ground-floor pedestrian doorway is positioned at the eastern end of the south elevation. Two high-level doors are sited at the western end of the north wall. The remainder of the walls are featureless.

Buildings 6 and 7 from the south-east

Building 7 from the south-west. Its scale can be ascertained from the comparative size of the pedestrian door at the bottom right.

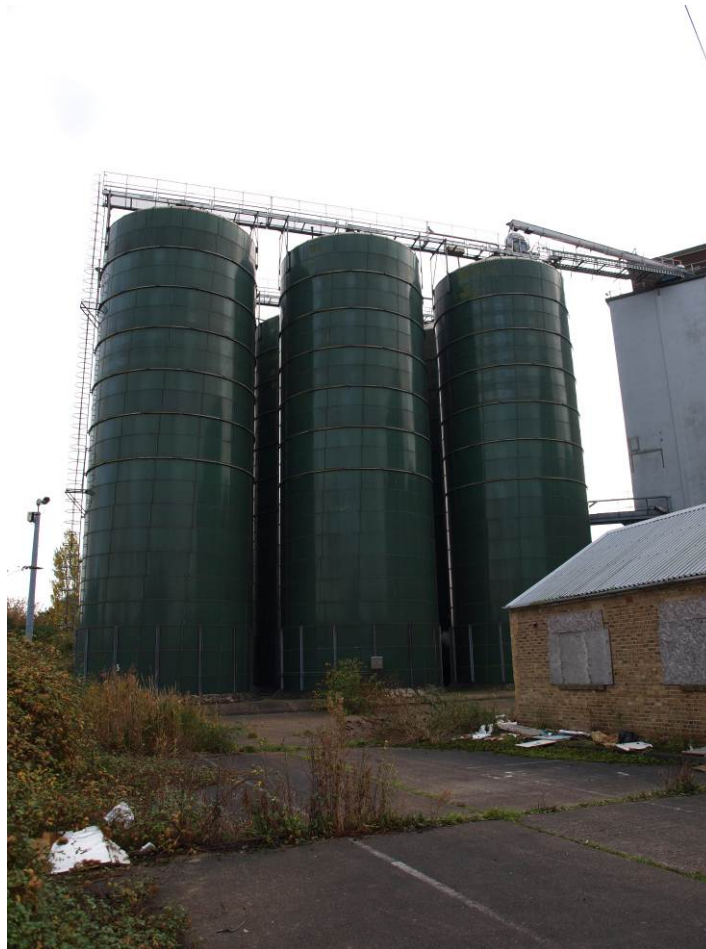
Plate 10

- 4.14 Building 8 (Plate 10) comprises six tall silos set into a concrete base and connected together at the top by a raised metal walkway which also protects pipes leading from the elevator which is positioned at the southern end. This elevator leads from Intake Pit 2. A second, lower elevator serves Building 9 via a suspended pipe. The silos are constructed using metal plates bolted together and were made by Simplex of Cambridge. The silos have rounded bases sunk into the concrete base below ground level; the concrete base is slightly raised above the level of the road to the west. Each silo has two large-diameter pipes set at 90 degrees to one another at the base which rise to vent heads positioned facing the centre of the group of structures.

Building 8 from the north-west

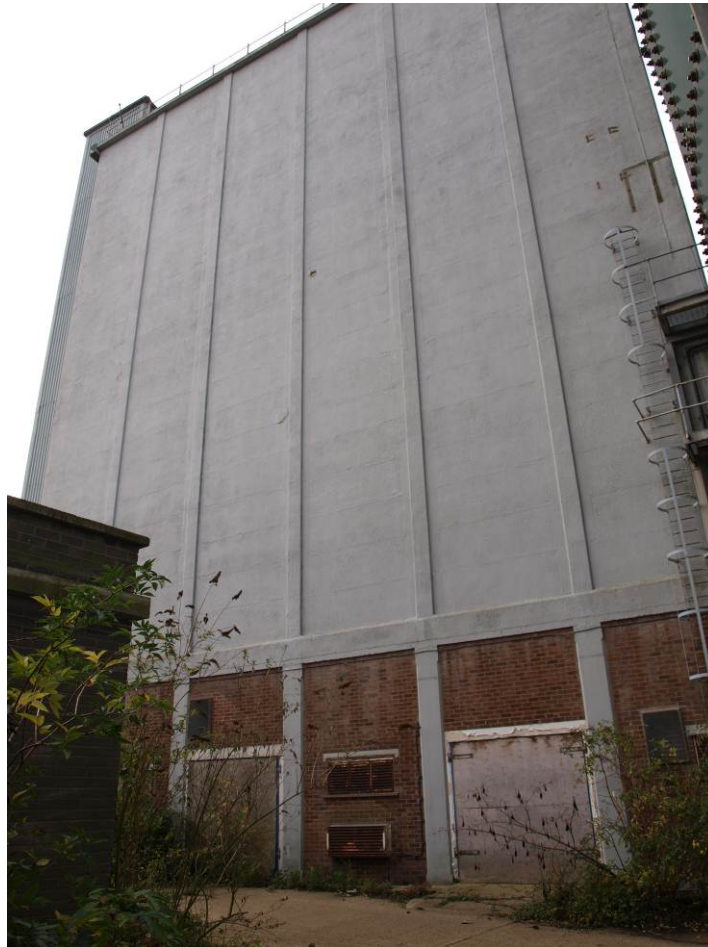
Plate 11

- 4.15 The ground floor of Building 9 (Plate 11) is constructed in panels of brick divided by chamfer-edged concrete columns. Doors and windows pierce

the brickwork in the north elevation, and in the east wall there are vents with louvres as well as doors. Above the ground floor the building rises with shuttered-concrete walls, ribbed at intervals. There are 22 sections of shuttered concrete. It appears to have originally been a rectangular structure, but has had a turret added against the south wall, constructed using brick on the ground floor and corrugated metal above. A white external metal chute leading from Building 11 enters the structure low in the south ground floor wall. The building can be entered at first-floor level in the south wall, and there is second- and third-floor access from Building 9 to Building 12 via raised metal walkways.

Building 9 from the north-east

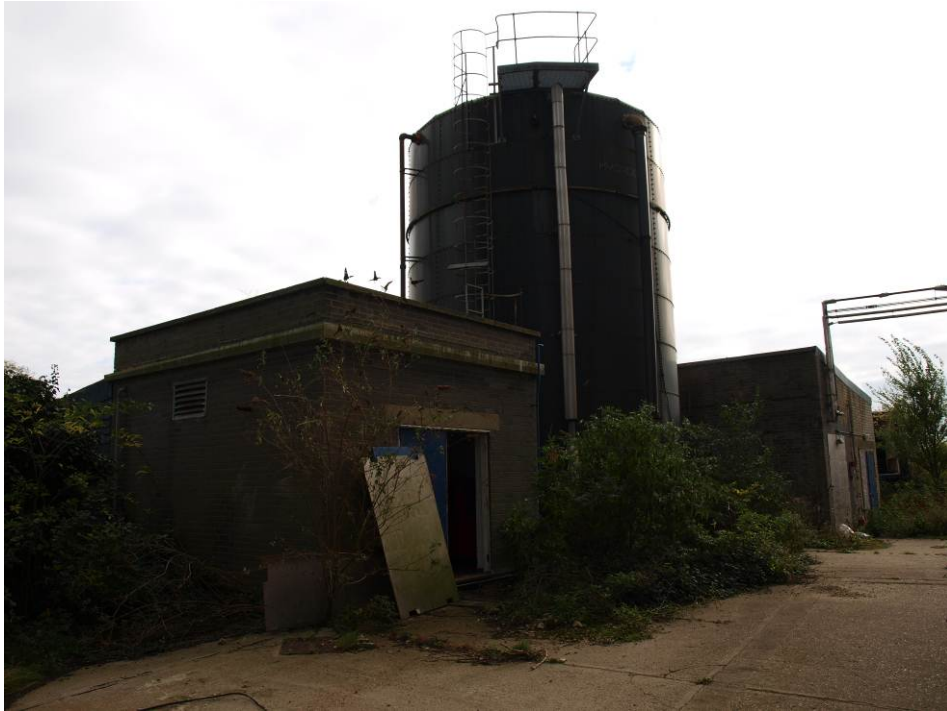
Plate 12

- 4.17 This building (Plate 12) comprises a small silo constructed of riveted plates bearing the name 'HYDROGLAS'. To the north of the silo is a square, flat-roofed structure of grey-blue brick, which is entered via a door in the western elevation. Inside the building is a series of cast-iron pipes: a fluid control system created by Armstrong. This company was founded in 1934 and expanded in 1952, so it is probable that this system post-dates 1952. The equipment has a well-cared-for appearance and seems to be of recent date. Two steam boilers, one by Cochran Ltd called the 'Wee Chieftain', are housed in a white-brick lean-to structure to the south of the silo. There is an opening in the west elevation of this lean-to blocked in dark purple-blue brick to the north of a double-width opening below a concrete lintel. The lean-to roof is covered with corrugated metal supported on 'I'-beams. To the east of this group of buildings and built around the east side of the silo is a second, large lean-to shed constructed by widely-spaced timber studs on a low brick sleeper wall, clad with narrow, softwood weatherboarding. There is a set of plywood doors hung on hinges common to the first half of the 20th century in the southern wall. The eastern and northern walls are clad with blue plastic as the weatherboarding has been removed. The roof is covered with softwood boards supported on scaffold poles: these may have been a temporary measure but have been installed for a number of years. The floor of the lean-to is laid with concrete slab. The structure appears to have been used as a storage shed.

Building 10 from the north-west

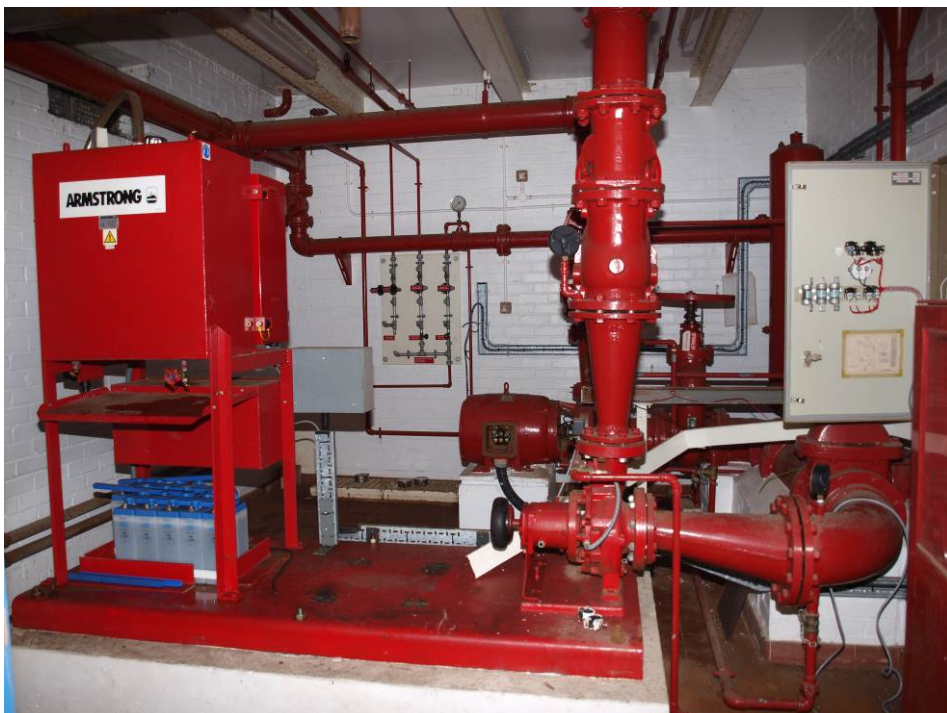
Plate 13

Interior of the northern lean-to of Building 10 from the west

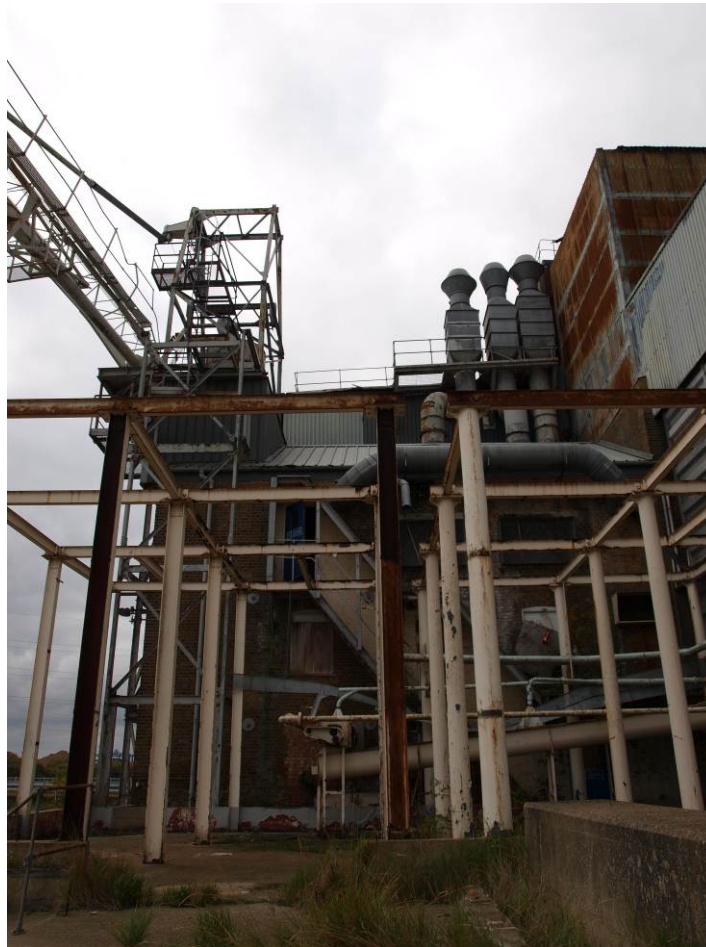
Plate 14

- 4.18 Building 11 is a brick-built, three-storeyed structure at the south-eastern corner of the group of mill buildings near the wharf. The bricks are golden-yellow stock bricks laid in English bond. At the point at which Building 11 abuts Building 12 to the north the brick rises above a third storey, but this brickwork is very slightly lighter in colour and appears to

be a later addition, suggesting that the two structures were originally separate. The eastern corner of this structure at ground-floor level incorporates bull-nosed bricks, which suggests that there was a thoroughfare between the two buildings.

- 4.19 The north-eastern wall originally had an arrangement of nine windows, three on each floor, capped with brick-on-edge segmental arches. The windows are biased to the north-western end of the building, with an area of blank brickwork to the south-east. These windows have been significantly altered: the second-floor windows being widened and having concrete lintels inserted; the first-floor windows being blocked. The northern window on the ground-floor, the central window on the first floor and the southern window on the second floor have been enlarged into doorways reached by an external metal staircase which has been capped by a roof to allow all-weather access. There are segmental-arched windows on the south-western half of the south-eastern wall. There is a door at ground-floor level in the north-eastern half of this elevation and blocked openings above: these appear to have been doorways but may have been altered from window openings.

- 4.20 The structure is capped with a shallow-pitched roof covered with corrugated metal sheets. A turret rises from the roof at the south-eastern end, above which is a ladder tower to allow access to the hoist arm which stands to the south of the building.

Building 11 from the east

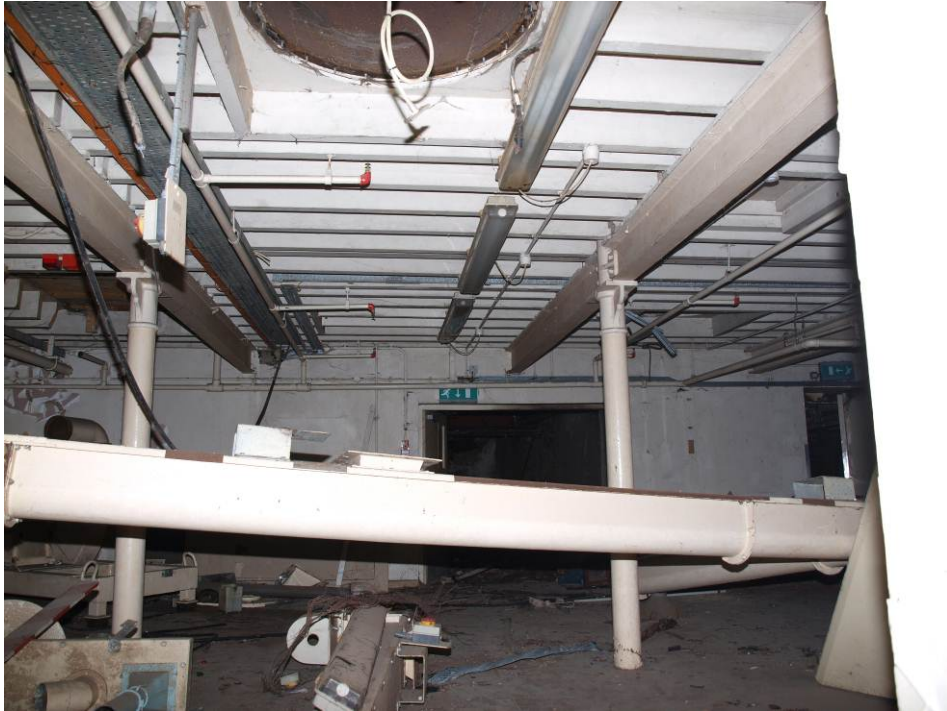
Plate 15

- 4.21 The ground-floor space within this building appears to have functioned as 'dead' space, for storage or as a thoroughfare, and to allow access to the base of any machinery. The tiled ground floor seems to have been raised, as the storey height is very low given the height of the building. The first-floor joists are NW-SE aligned and supported by perpendicular 'I'-beams. Cast-iron posts rise to these 'I' beams at centre span. There are trimmed hatches at intervals in the floor which allow grain to be passed from the first to the ground floor. A wide opening leads through from Building 11 to Building 13 in the adjoining wall; a window lights the space in the north-western corner. There are two adjacent doorways in the north-western wall which leads through to Building 12. The walls of Building 11 are plastered internally.

Interior of the ground floor of Building 11 from the east

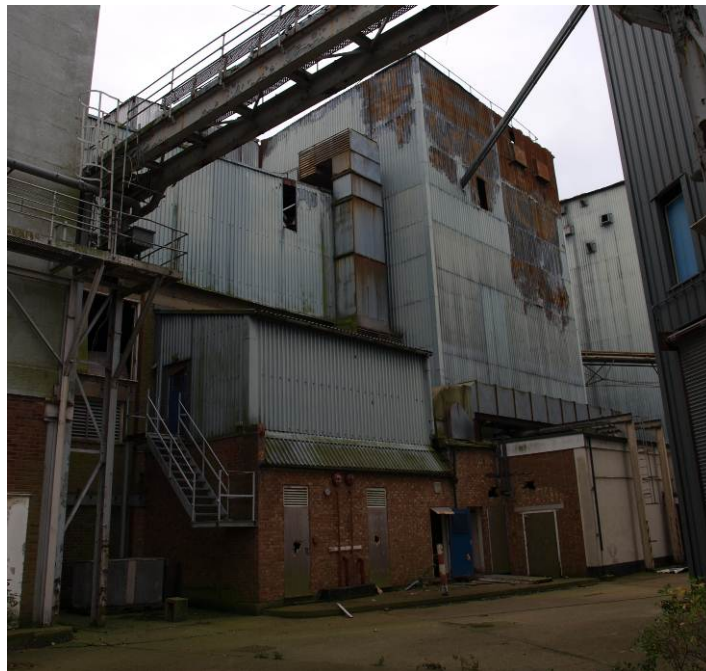
Plate 16

- 4.26 This structure has been built onto the north end of Building 12. It is a two-storeyed structure built in varicoloured orange-yellow brick which is typical of the mid-20th century. Like Building 12 the upper walls are of corrugated metal, which seem to have been added above an existing corrugated-metal roof. There is a lean-to roof of the same material sloping down from Building 12, above the first-floor part. A door in the north-eastern first-floor wall is accessed by an external stair. There are two doors with louvred fanlights above in the north-western wall, and one with no fanlight in the south-western part of the wall.
- 4.27 The north-eastern wall of Building 14 is continuous with the wall to the south-west, which forms part of Building 16.

Buildings 14 and 16 forming lean-tos against Buildings 12 and 15 (left and right respectively)

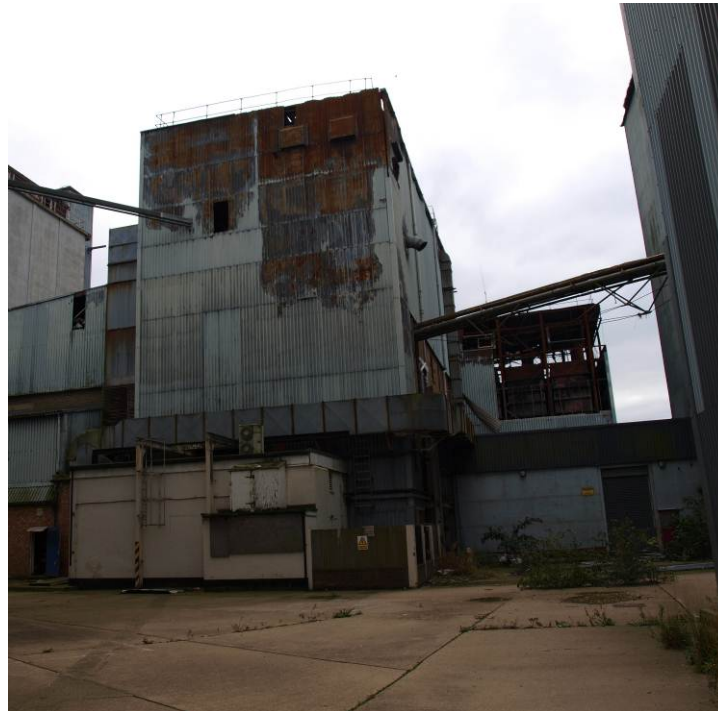
Plate 17

- 4.28 This structure is built in brickwork to the third floor and has corrugated-metal walls above that, standing taller than Building 13 to the south-east. The north-western end is formed of corrugated metal for its full height. Building 17 abuts the south-eastern elevation, obscuring all but the north-western part of the ground and first floors. There are plain, timber double doors positioned towards the end of the building, set into an area of rebuilt brickwork. The windows on the ground and first floor have brick-and-a-half, segmental-arched heads. These windows are also within areas of rebuilt brickwork. A row of windows on the second floor have been blocked in paler-yellow brickwork: if these windows were evenly positioned along the length of the building, there would have been five openings. Four are evidenced; the second to the north-west has been obscured by the cutting-through of a double door. This door has narrow side-lights and a rectangular fanlight, in a style typical of the second half of the 20th century. Four windows above the blocked openings can be seen lighting the third floor. The jambs of these windows are formed in pale yellow brickwork, suggesting that they have been cut in or reformed in the existing wall. The openings have one-brick, segmental-arched heads. Vents have been cut through the upper part of the wall. The surviving fenestration and doors indicate that there are no original windows remaining in this elevation. The north-western elevation is of corrugated metal; the ground-floor wall is obscured by Building 16.

Building 15 with Building 16 (lean-to) in the foreground, from the north-west.  
Building 17 lies to the right

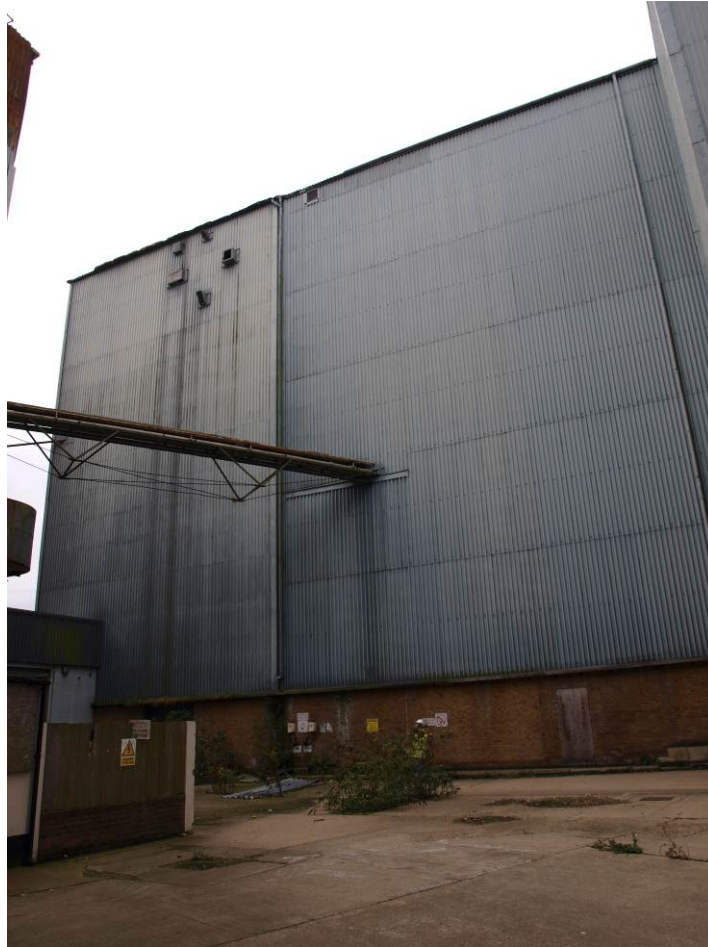
Plate 18

- 4.32 Building 18 is formed in two parts, the north-western part butted up to a smaller south-eastern part. Both sections of the building are of the same height. The ground-floor wall is built in stretcher-bonded brick, straight-jointed at the junction between the two parts, and the upper walls are formed in corrugated metal. The north-western end of the building incorporates four loading bays which each originally had a loading door opening out onto the bay. All but the north-eastern door has been blocked. A shallow sloping roof weathers these loading bays. A turret on the north-eastern side forms a drive-through loading bay, where hoppers positioned high over a tall 'carriage-way' would have deposited milled grain into a vehicle below. The grain appears to have been transported into Building 18 via pipes leading from Building 16 to Building 18 at a high level.

- 4.33 There are two inlet valves in the brickwork of the north-eastern wall, one for brown flour and one for white flour. The brown flour inlet valve is positioned in an area of blocking representing a former opening which may have been a loading door. A pedestrian door is sited just to the north-west of this loading door.

South-eastern part of Building 18 (18b) from the north-east

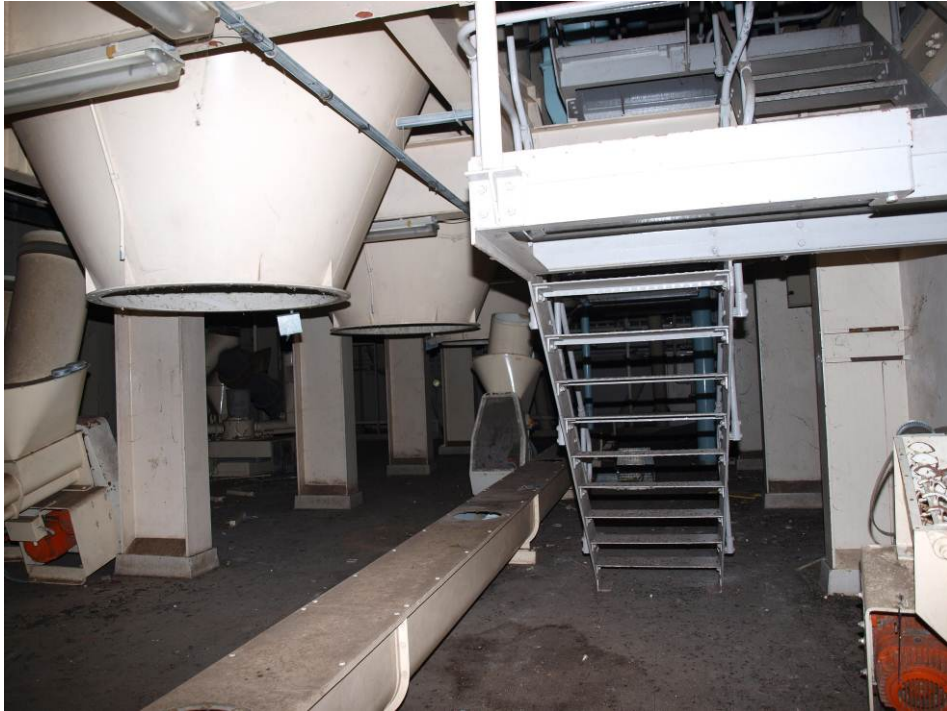
Plate 19

- 4.34 Inside the south-eastern end of the building the space is open to the second floor, with a series of pipes rising up the south-western wall. The second floor is constructed of narrow joists aligned along and across the building, supported from underneath by 'I' beams. The south-western wall is formed in breeze-block. To the north-west are visible the lower parts of large hoppers. This area was viewed remotely and therefore no further details were visible.

Second-floor interior of Building 18b showing base of large hoppers and access stair

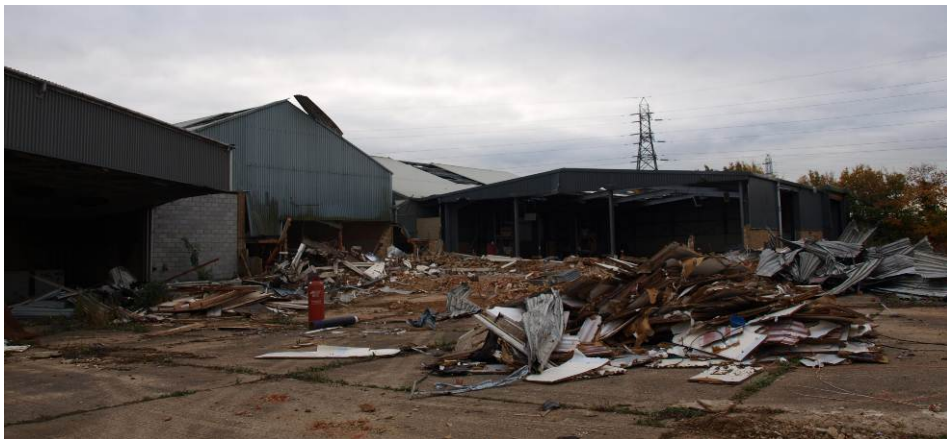
Plate 20

Buildings 19 to 22 from the north-east. Building 20 is demolished in the foreground, Building 22 to the right, Building 19 shows the gable on the left and Building 21 lies in the background between Buildings 19 and 22.

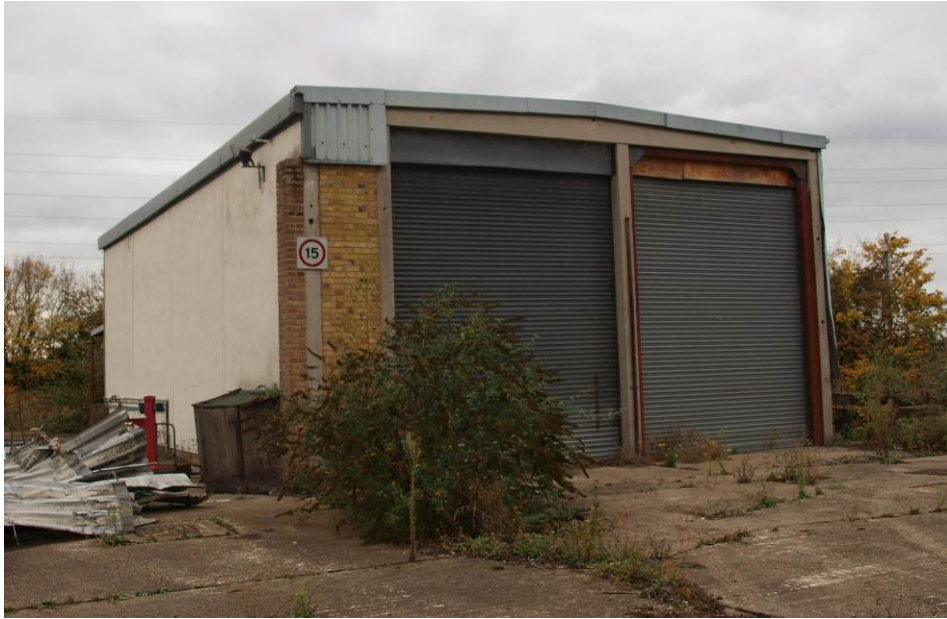
Plate 21

Building 23 from the south-east

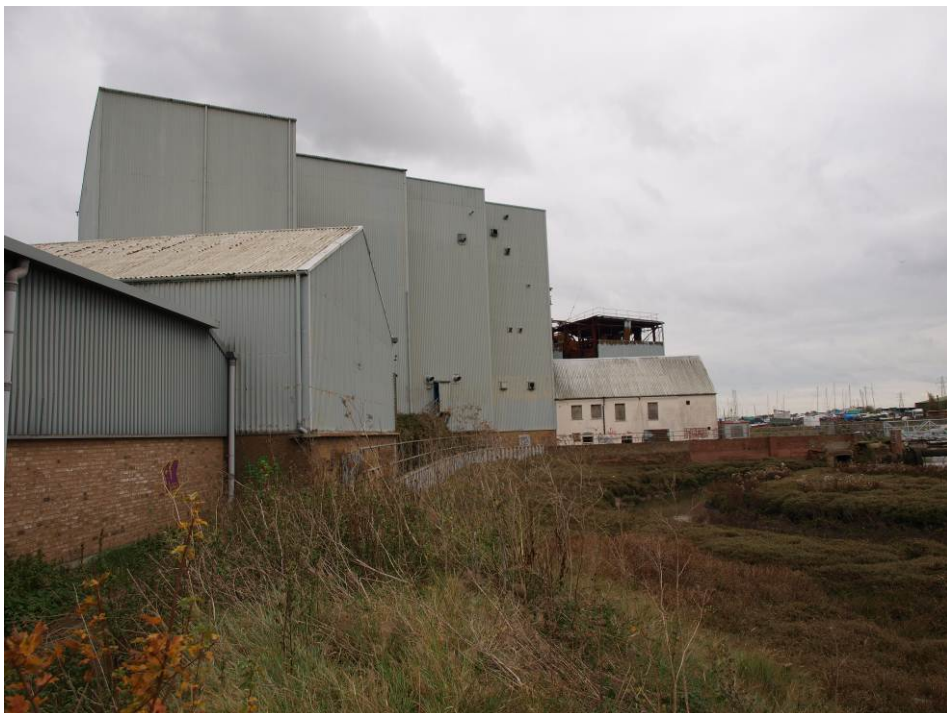
Plate 22

Buildings 21, 19, 18 and 24 (left to right respectively) from the west. The top of Building 13 can be seen above Building 24.

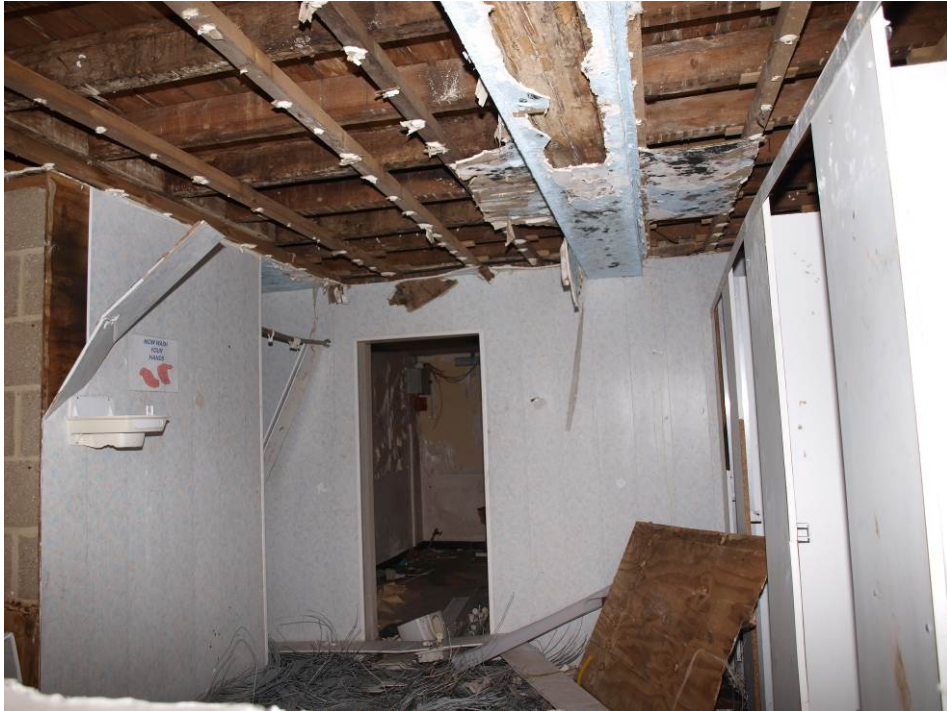
Plate 23

Interior of ground-floor of Building 24 from the north-west
