**STAMBRIDGE MILLS, STAMBRIDGE, ESSEX**

**HISTORIC BUILDING RECORD**

**(NGR TQ 8870 9038)**

**Report No. 2011262**

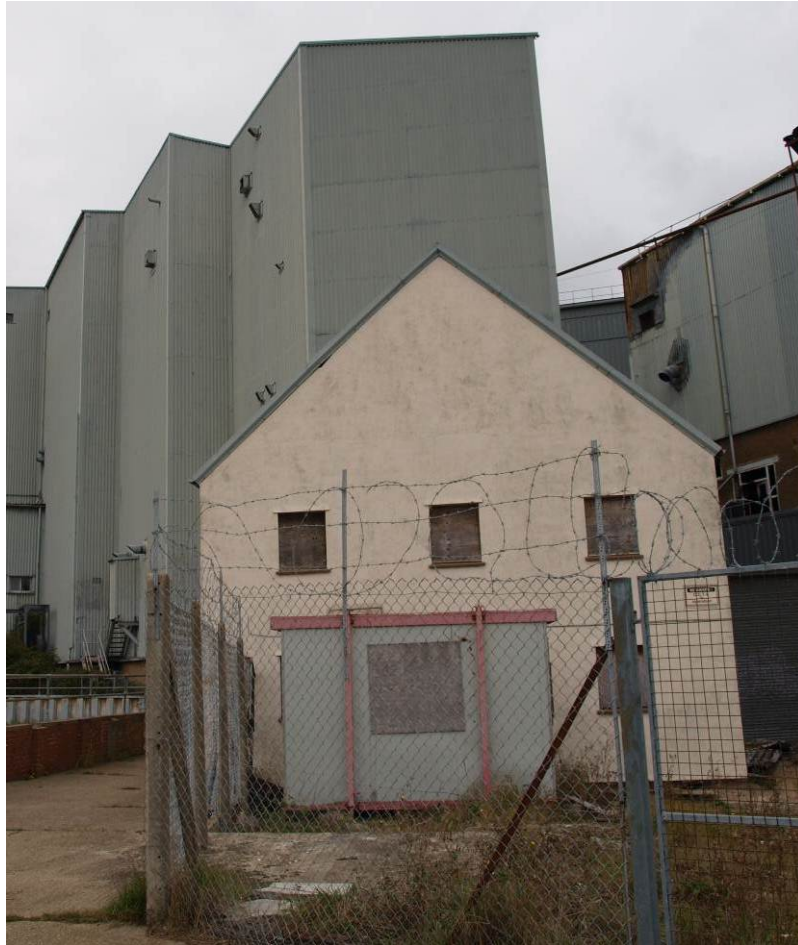
Plate 24

South-western end of Building 24 from the south. Building 18 can be seen in the background.

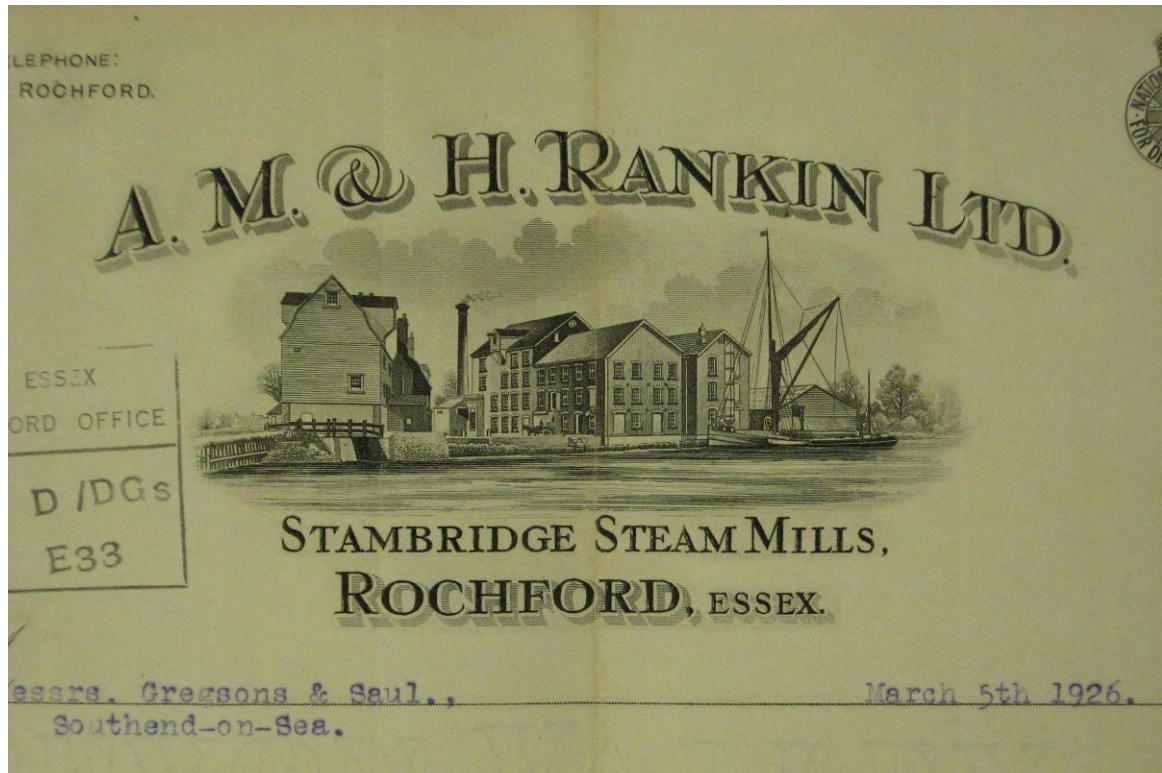
Plate 25

The letter head of A.M. & H. Rankin Ltd showing the mill from the south-west. The tidal mill lies to the left with the mill-house beyond, and the steam mill to the right (Buildings 13 and 11 fronting the wharf with Building 15 behind)

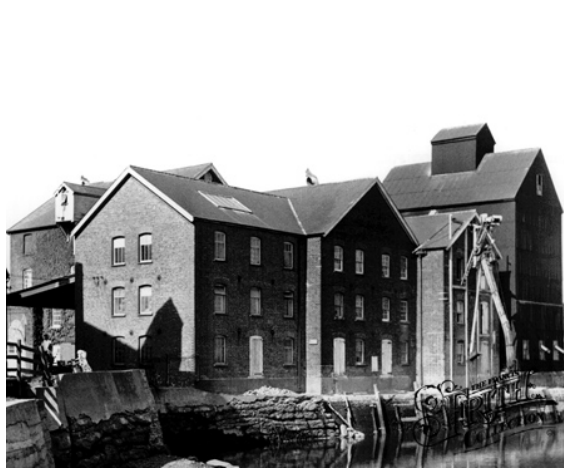
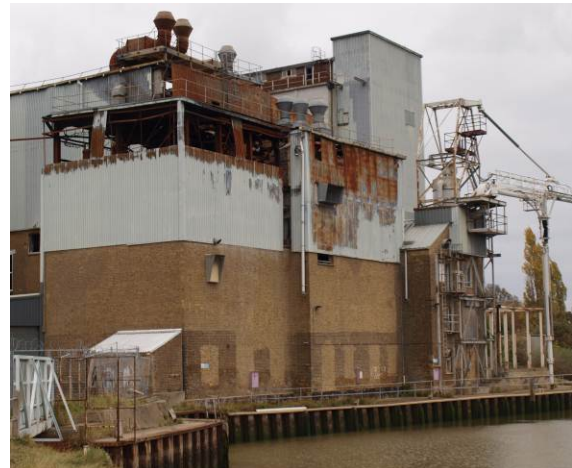
Plates 26 and 27

A photo of the mill c.1955 (© Francis Frith) from the south-west and the same view of the mill as at present, showing the changes which have taken place in the second half of the 20th century
