**A HISTORIC BUILDING RECORD
OF THE
FORMER FOREST LABORATORIES, BEXLEY, GREATER LONDON**

Report No. 2011292

A Historic Building Record
of the
Former Forest Laboratories, Weir Road, Bexley, Greater London, DA5 1NX

November 2011

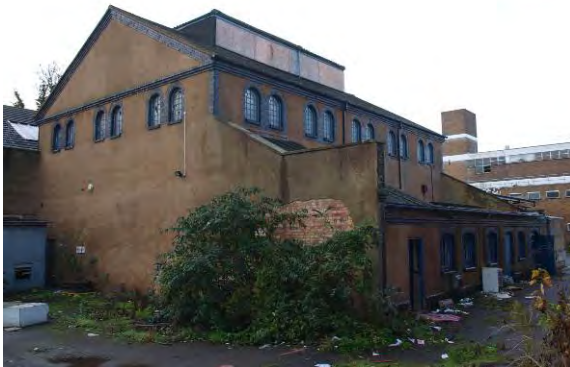
Exterior view of the locally-listed part of the present building (Block A) facing south

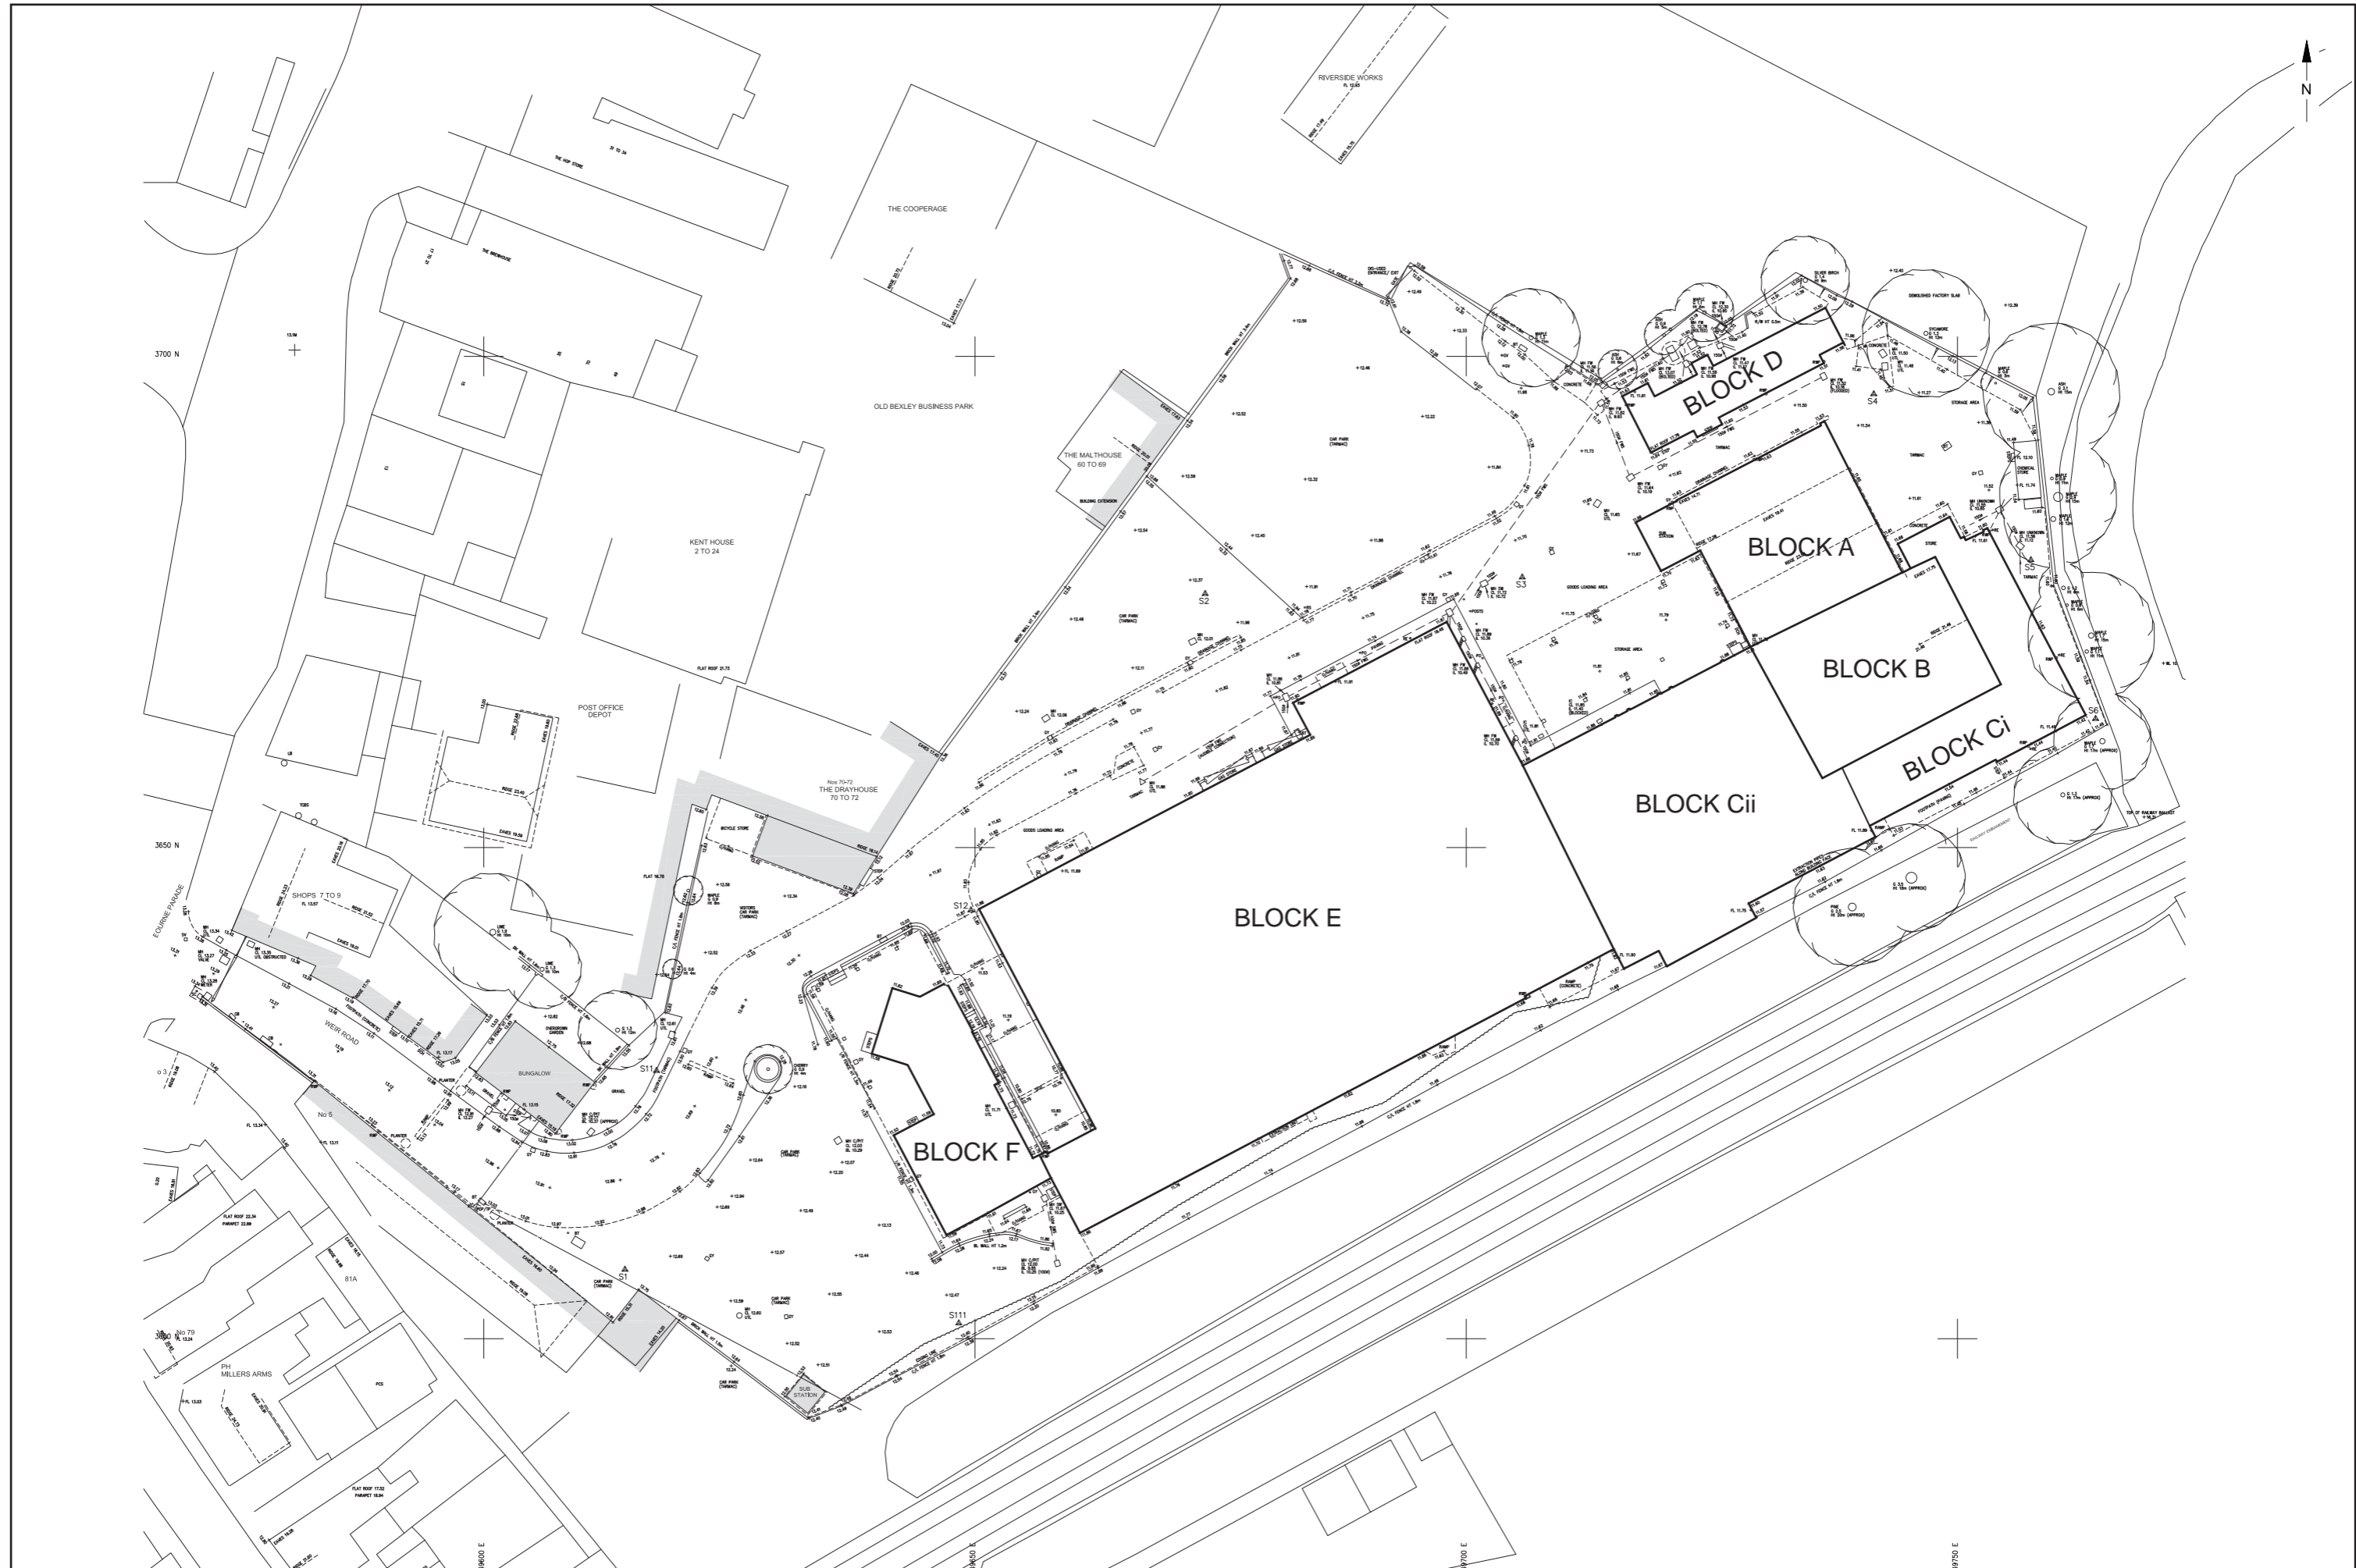
Fig. 2

© Archaeology South-East		Former Forest Laboratories, Bexley, Greater London	
Project Ref: 5223	Dec 2011	Site Plan	
Report Ref: 2011292	Drawn by: JFB

5.1 Summary of development of present structures (Fig. 2)

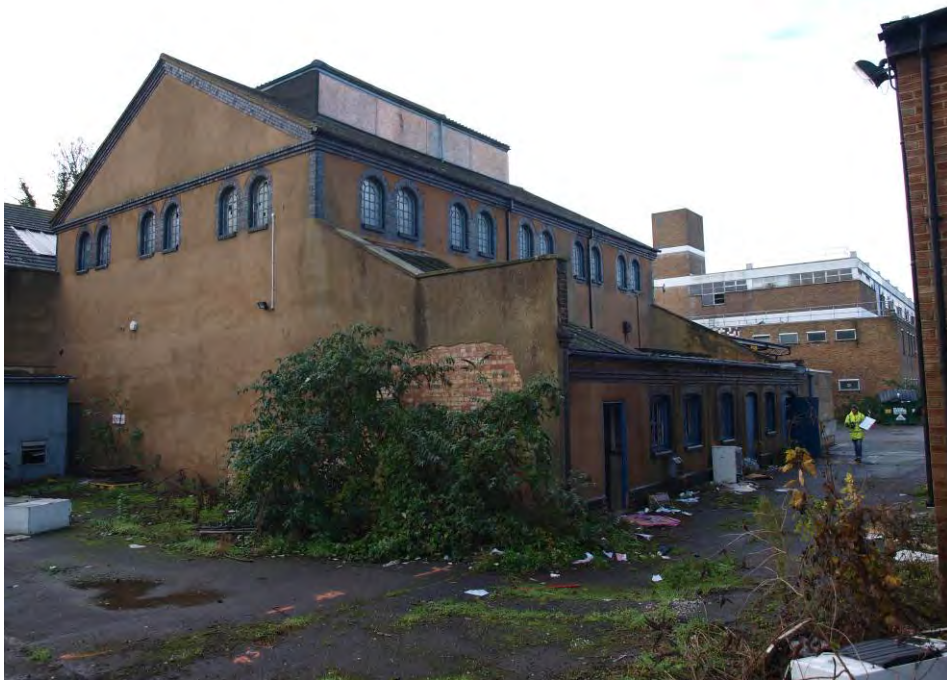
Plate 1

Block A from the north

- 5.2.2 This building is distinctive for its dark-blue brickwork and semi-circular-arched windows. The bricks are only exposed at the quoins, around each window and at the stepped brick courses just below the eaves and continuing horizontally around

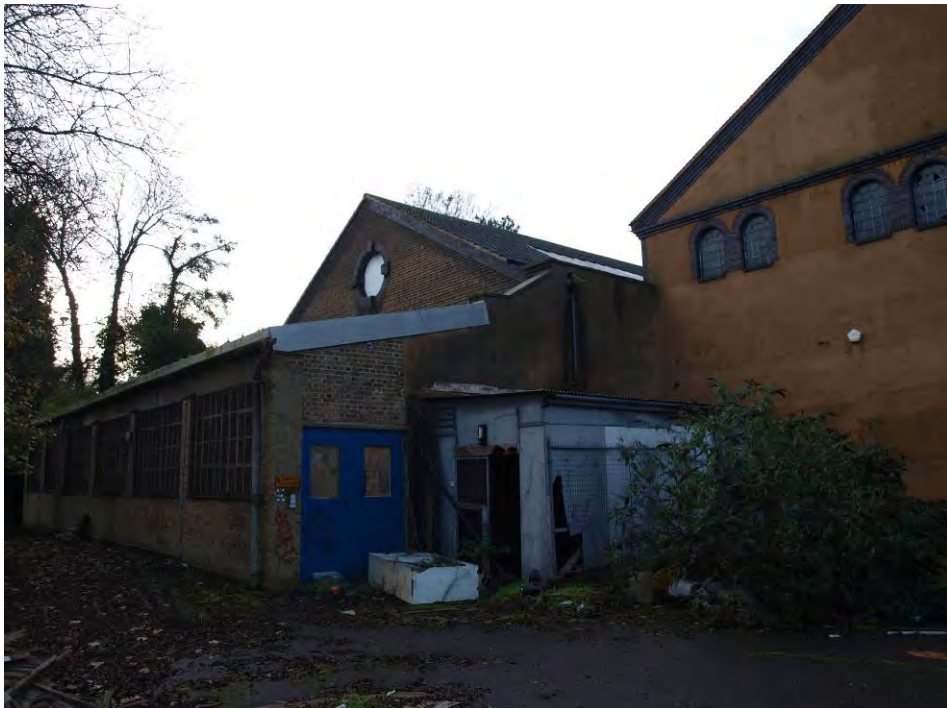
Plate 4

- 5.3.2 Block B has extensions wrapping around the north-eastern, south-eastern and south-western walls (Blocks Ci and Cii), which hide much of its structure (Plate 4). There are doorways leading into the structure from the south-west (Block Cii), south-east and north-east (Block Ci), as well as the large doorway inserted to the north-west to access Block A. The lobby in the western corner leads to an external door in Block Cii.

- 5.4.2 Block Ci is a single-storeyed lean-to which wraps around the eastern corner of the structure (Plate 4). The spaces inside are open to the sloping roof. The south-eastern part has a pair of small rooms at the south-western end but the remainder of the space is open. The north-western end of the north-eastern lean-to is separated off by a wall that extends up to the roof, and within this end part there are plasterboard partitions which divide the area into smaller office spaces. These office partitions stand to just above head height: they appear to be modern insertions. The two parts of the outshot were probably completely open when first built.

Block B from the north with Block Ci lean-to against the north-east wall

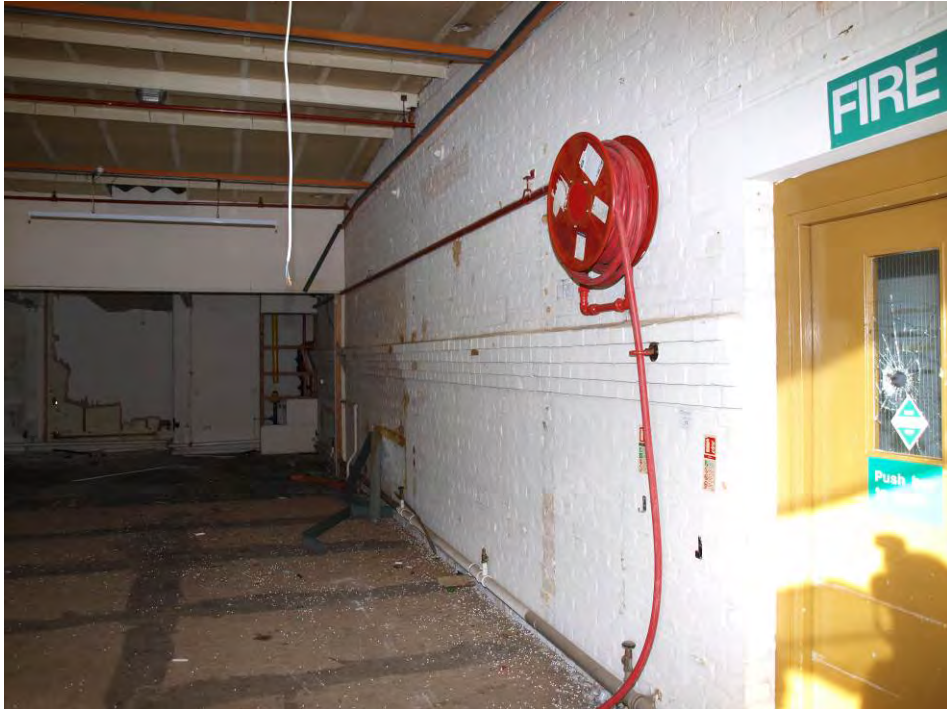
Plate 5

the structure, the horizontal courses of stepped brickwork return onto the side walls of the building for a short distance. The stepped brickwork can be seen in the adjoining blocks, and is especially visible in the north-eastern first-floor room in Block Cii (Plate 5).

The stepped courses at the base of the gable of Block B, within the north-eastern room of Block Cii. Photo from south-east

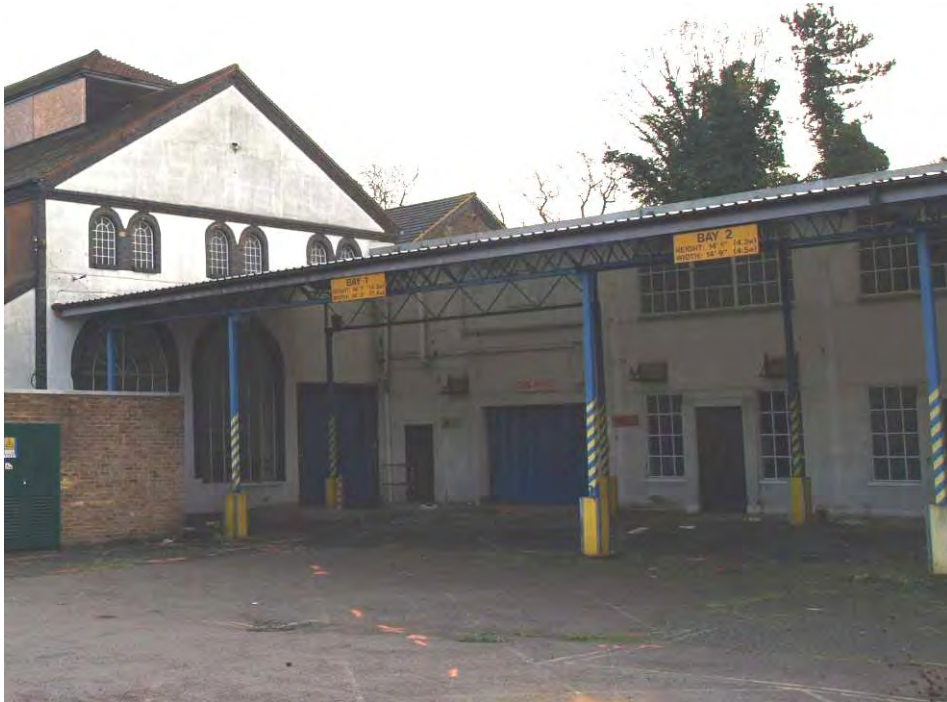
Plate 7

- 5.4.3 Block Cii is a rectangular, two-storeyed structure which extends from the south-western wall of Block 2 (Plate 7). Its northern corner kisses the south corner of Block A but there is no overlap. The ground floor of Block Cii comprises a large open space at the north-western side, divided from a corridor to the south-east with a temporary metal mesh partition and with a small room formed against the north-west wall which most recently functioned as a 'Label Store' (Plate 8). At the north-eastern end of this corridor is the door leading into Block B. Along the south-east wall are a series of small rooms accessed from a corridor which is separated from the main room to the north-west by a permanent wall (Plate 9). The first floor of this

Block Cii from the west showing Block A to the left

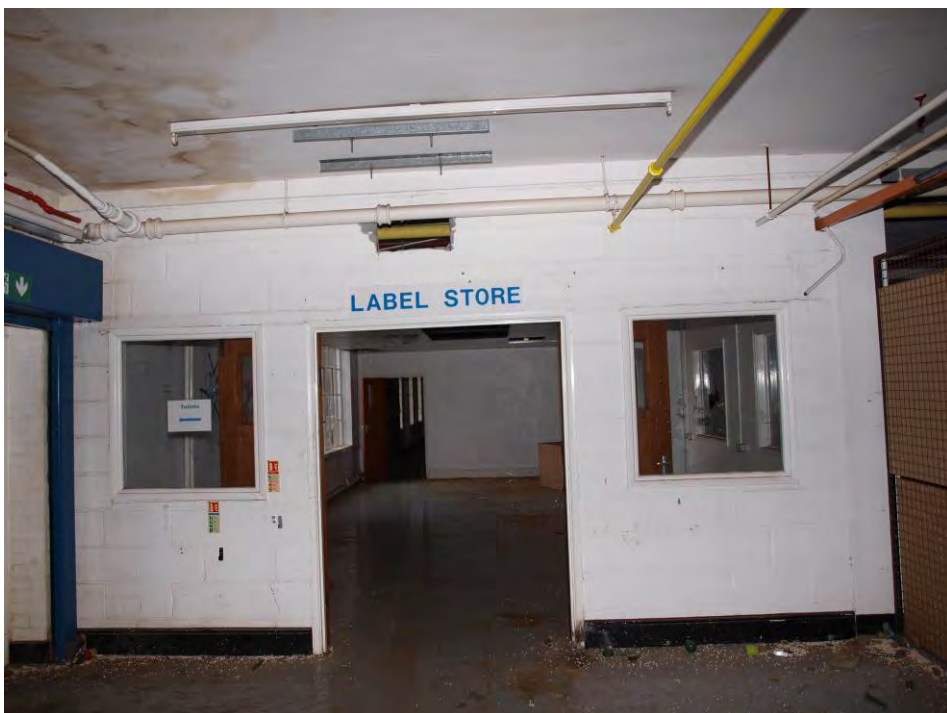
Plate 8

'Label Store' on ground floor of Block Cii, from south-west

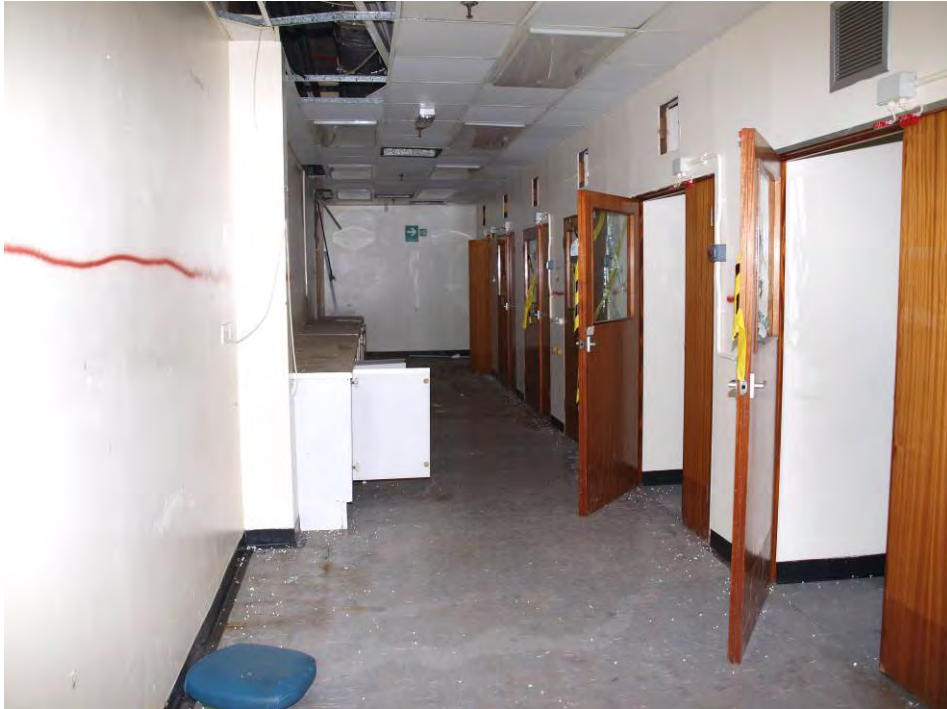
Plate 9

Small rooms to south-east of Block Cii from south-west

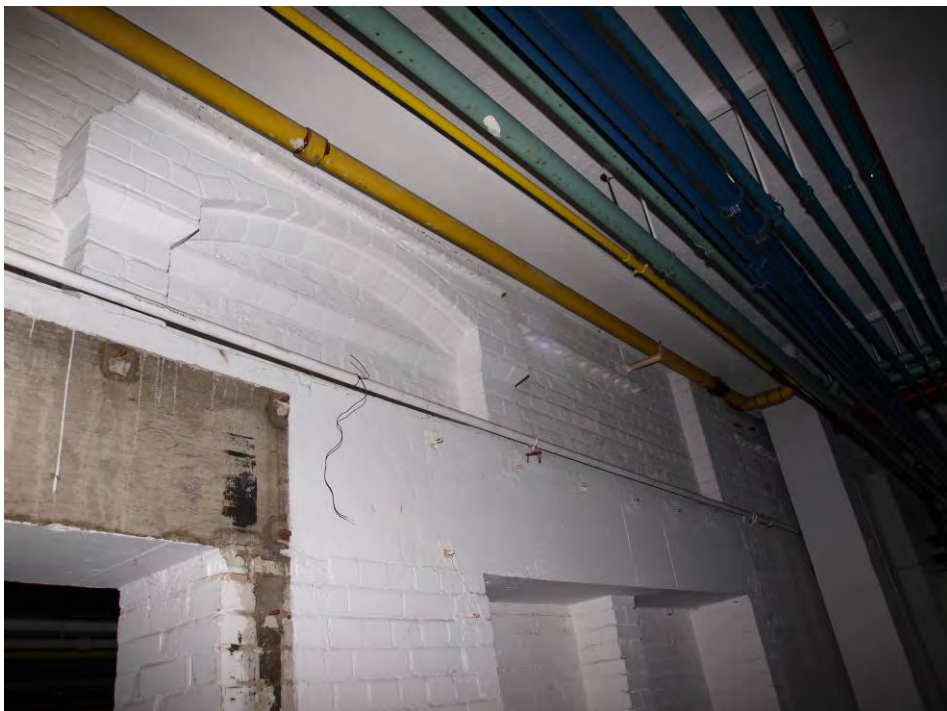
Plate 10

5.4.5 Although it is now only visible within Block E, the south-western wall of Block Cii originally had an elaborate central doorway, probably flanked by narrow windows at ground- and first-floor level (Plate 10). The head of this doorway is now all that survives above a later concrete lintel for a wide inserted loading door. This head, positioned high in the wall, has a segmental arch formed of chamfered bricks below plain bricks, with a tiled top, supported by piers on either side with projecting-brick capitals. The door itself originally had a segmental arch above the opening in the main wall. The cills of the first-floor windows survive in the wall on either side, but the openings have been blocked.

Former south-western doorway of Block Cii, now blocked and visible only in Block E. Photo from west.

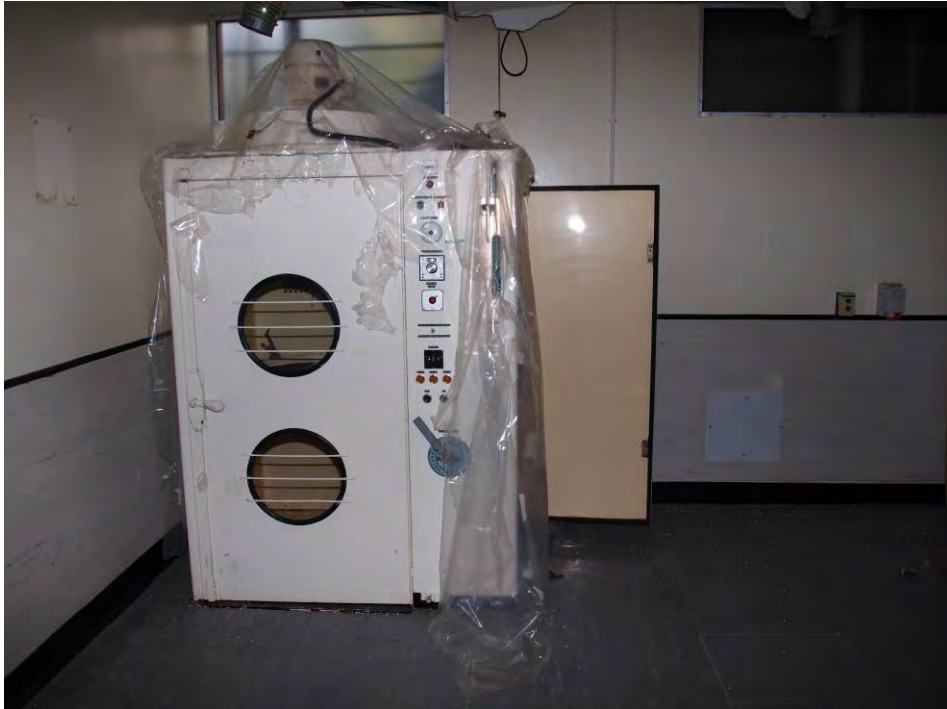
Plate 11

Equipment left in one of the small rooms in Block Cii

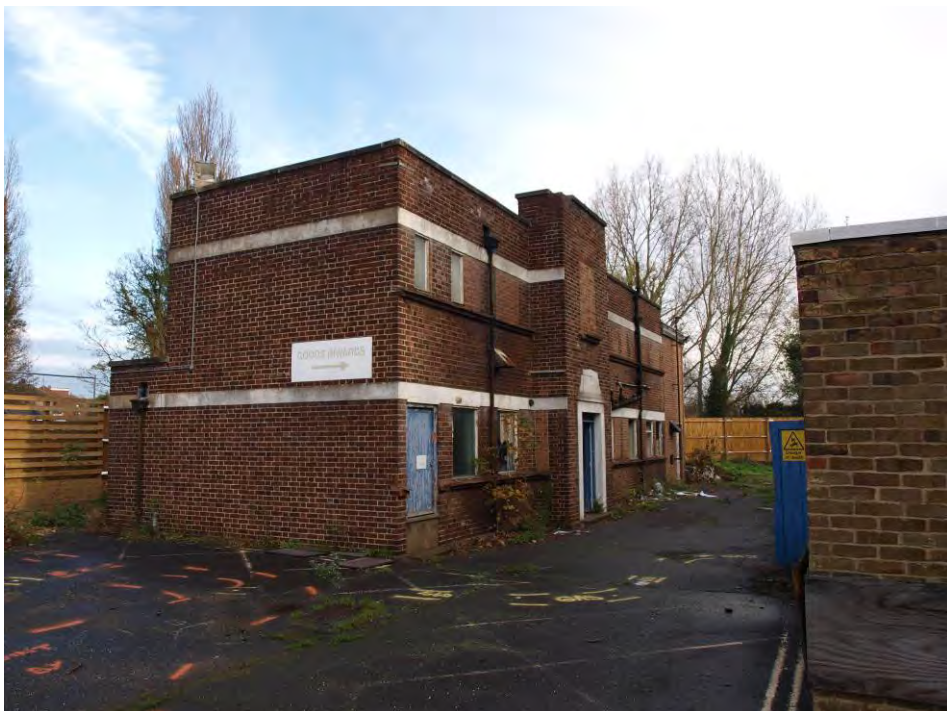
Plate 12

- 5.5.1 This is a separate structure laid out over two storeys in a long rectangle with an off-centre entrance projection to the south-east (Plate 12). It has been extended at the north-eastern end with a plain turret-like structure. To the north-east of the main entrance there is a corridor against the south-eastern wall with the rooms extending to the rear wall. There is a stair just to the south-west of the main door and a second stair against the south-west end wall, with a room between the two. On the first floor the corridor to the north-east is positioned at the rear of the structure, with the rooms on the south-eastern side.

Block D from the south

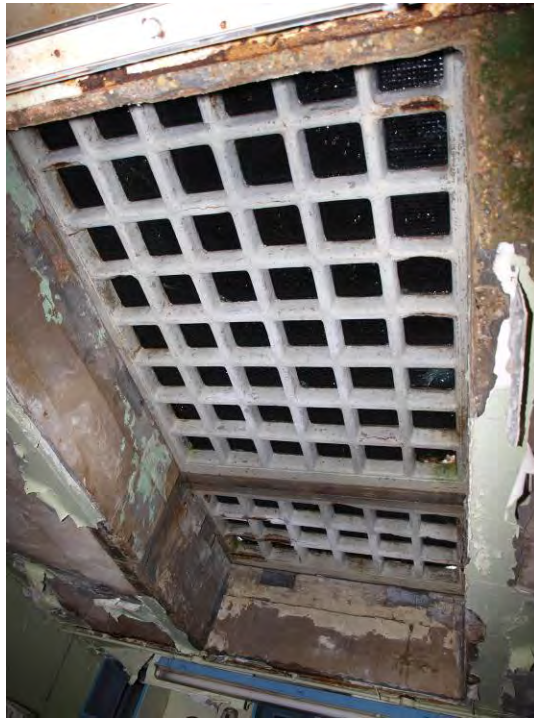
Plate 13

Concrete roof light in the end room of Block D

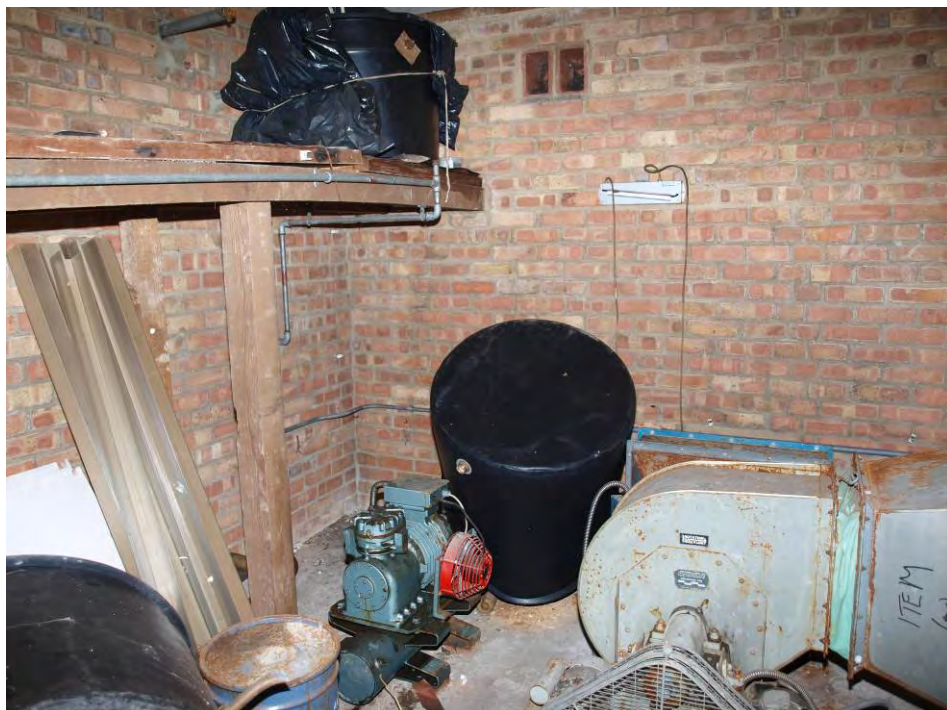
Plate 14

- 5.5.4 The walls on this interior of the building are plastered and painted, as are the ceilings. Both the ground and first floors are laid with tiles, although the stairs are plain and of pre-formed concrete. Shuttered concrete has also been used in the flat roof and to form roof-lights inset with square glazed bricks in the end rooms (Plate 13); that in the south-west end room has been blocked. The first-floor room in the north-eastern turret has exposed brick on the interior face of the wall, the bricks being of a more varicoloured, smoother type; this turret also has a flat concrete roof and first floor, and houses large pieces of machinery (Plate 14).

Machinery in the north-eastern turret to Block D

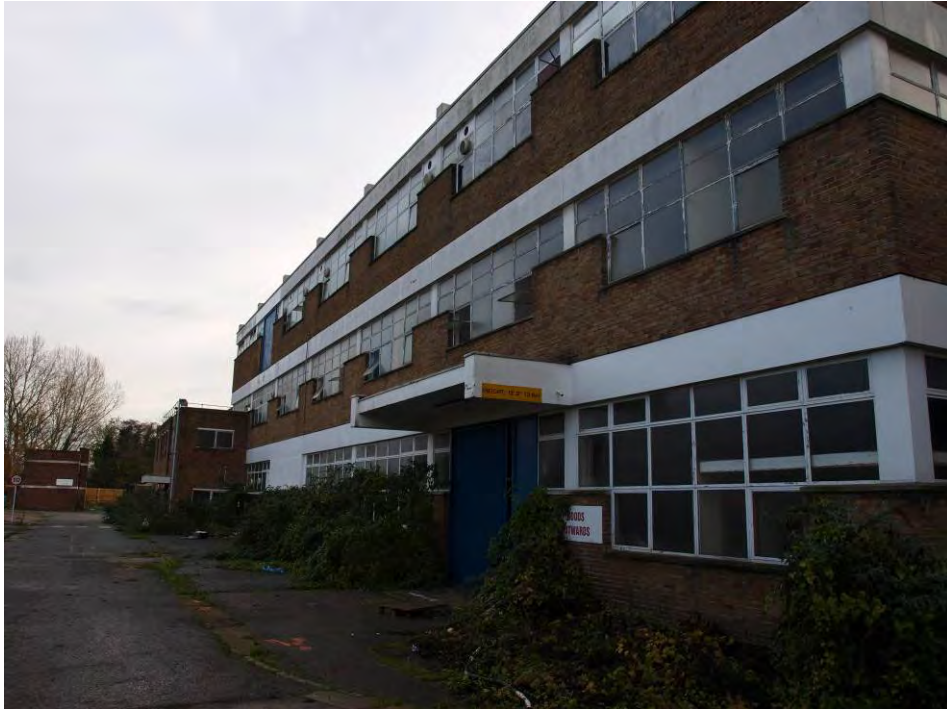
Plate 15

Block E from the west

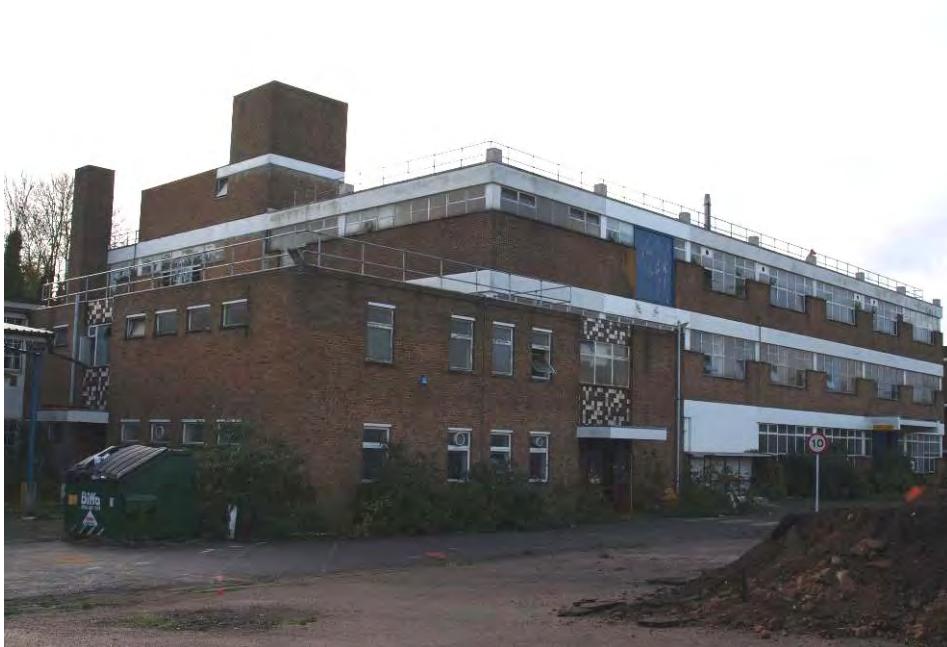
Plate 16

steel-framed windows. There is a continuous band of high windows with deeper windows at intervals, except in the north-eastern elevation, where there are only the high windows (Plate 16). The fenestration is only broken for doorways and where structures abut the block. Concrete pillars break the fenestration at intervals: these rise through the building to exit above the flat roof, supporting railings.

Block E from the north showing the two-storeyed section with decorative entrances

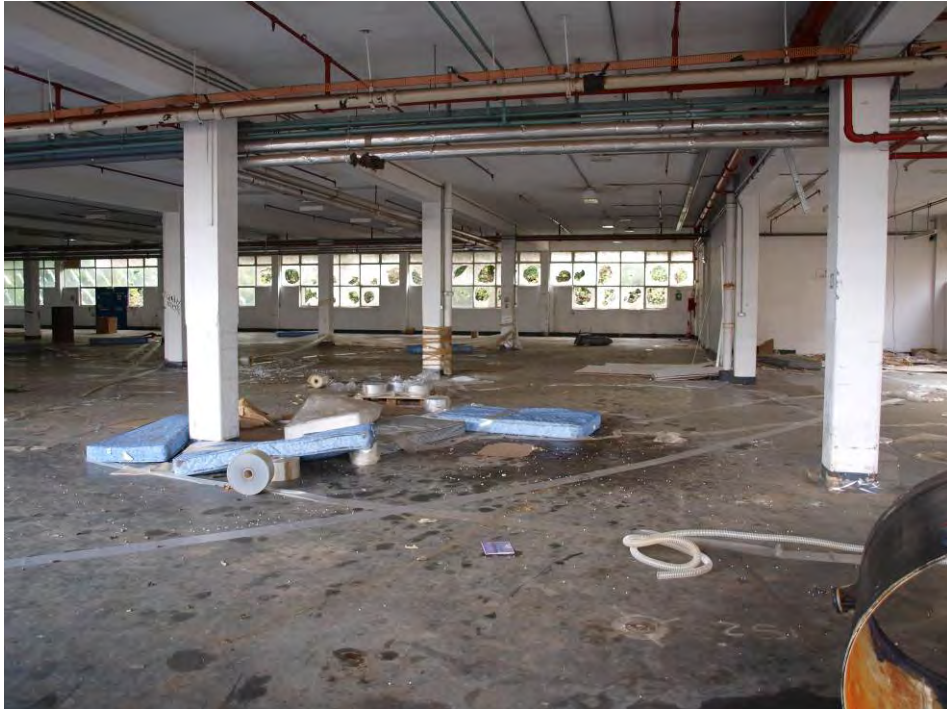
Plate 17

- 5.6.9 The open space on the ground floor has a series of square-section concrete pillars at intervals, which form part of the support for the first floor (Plate 17). In a similar manner to Block Cii, the pillars support concrete ribbing to the first floor. A network of pipes are suspended from the plastered and featureless ceiling. The floor is laid in concrete slab. In the northern corner, brick partitions separate this space from the two-storeyed structure at the north-eastern end.

Ground-floor open space of Block E from north-west

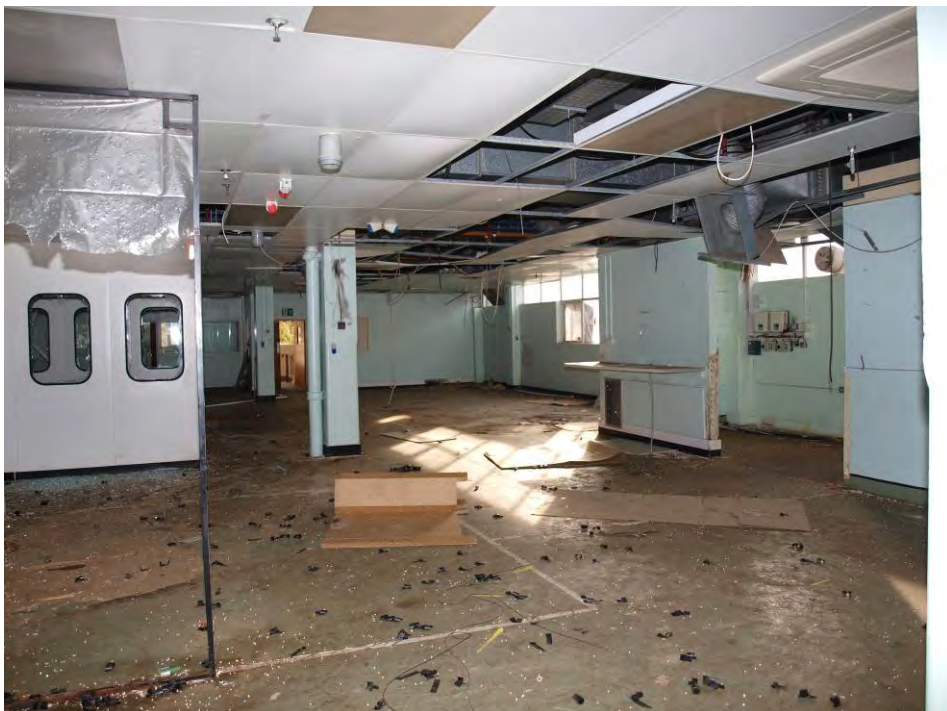
Plate 18

First-floor open space of Block E from the north-west showing inserted partitions to the left

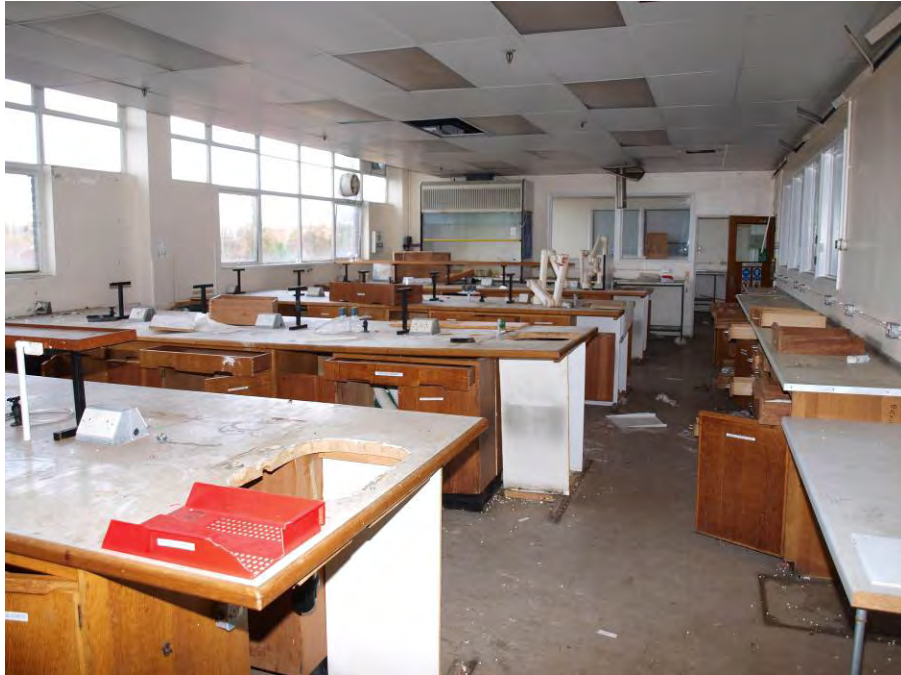
Plate 19

The Q.C. Laboratory (Block E, second floor) from the south

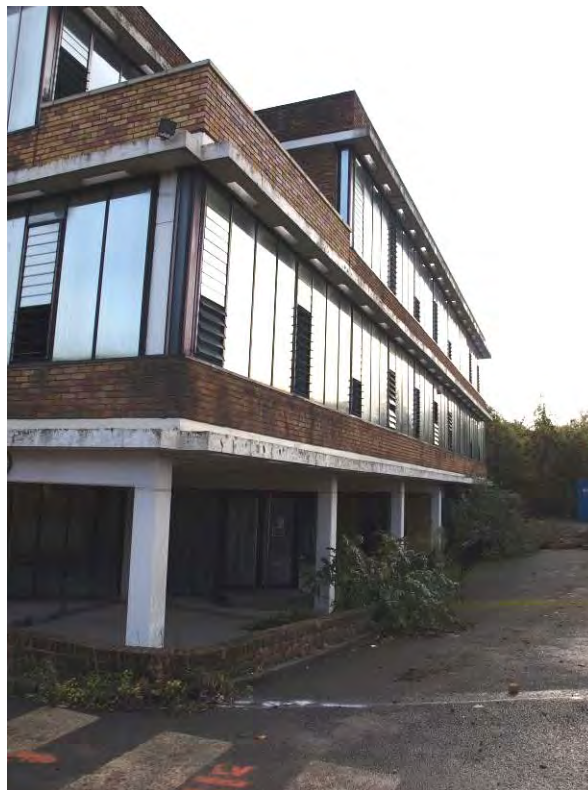
Plate 20

- 5.7.1 Block F is a small, three-storeyed, flat-roofed extension to Block E at the south-western end, designed to house dedicated office space (Plate 20). It has a recessed entrance, angled at 45 degrees. The first-floor is jettied out over the ground floor to the south-west and the north west, but as the first floor over the entrance forms a balcony, the first- and second-floor parts of the building are notched back in the corner. The second floor, in turn is jettied out over the first floor at the north-west end of the north-east wall, but is stepped back from the first floor on the south-eastern side. The smaller ground-floor area comprises a, entrance lobby at the north-west end, leading to a central NW-SE corridor which has offices on either side. There are stairs at each end of the block. The first and second floors have a large open-plan office at the centre of the block to the north-east, with small, enclosed offices on the other three sides. A large office lies at the north-western end of the first floor. Outside this office is a small ante-room, with a second, smaller office leading from this. The large office has a built-in cupboard and WC and also has private access to the balcony, suggesting that this was the director's office, with space for a secretary in the ante-room and a personal assistant in the smaller adjacent office.

North-west elevation of Block F from west

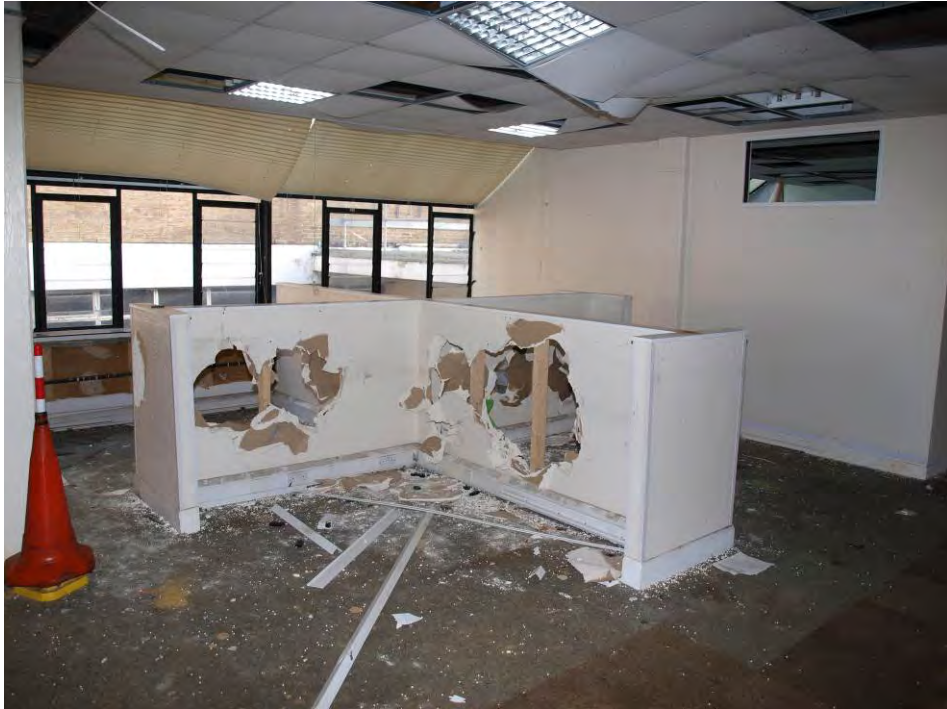
Plate 21

First-floor open-plan office in Block F from the west
