**THE FOUNTAIN INN,
HIGH STREET, HANDCROSS, WEST SUSSEX, RH17 6BJ**

**HISTORIC BUILDING RECORD
(ENGLISH HERITAGE LEVEL 3)**

Report No. 2012010

HISTORIC BUILDING RECORD

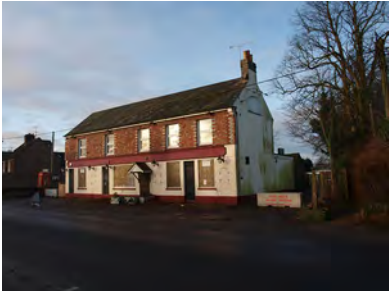
5310 (2)

- Plate 1 Photograph of the Fountain Inn, taken 1910 (Source: Ray 1987, 54)
- Plate 2 Principal (east) elevation and north elevation, looking south-west (2)

- 5.4 The principal (east) elevation comprises an unevenly-spaced five-window range, as defined by the first floor fenestration (Plate 2). Unless otherwise noted, the windows within the property are modern uPVC replacements, simulating the style of the former two-over-two pane sashes that can be seen in the old photograph (Plate 1). On the ground floor, just to the north of centre lies the principal entrance to the building, with 20th century part-glazed door. This is sheltered by a later 20th century gabled porch with tiled roof. South of the entrance is a wide window aperture (now with large uPVC window) with former door aperture adjacent. This has now been blocked to the level of the offset and boarded-over inside and out. South of this is a single window plus a further door aperture, similarly blocked and boarded-over. North of the principal entrance are two windows, between which is an inserted doorway (door missing).

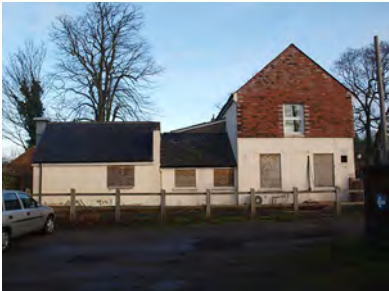
5310 (5)

- Plate 3 South elevation, looking north (5)
- Plate 4 Rear (west) elevation, looking east (8)
- Plate 5 Main bar area within southern end of principal range, looking south. Line of original partition wall highlighted (18)

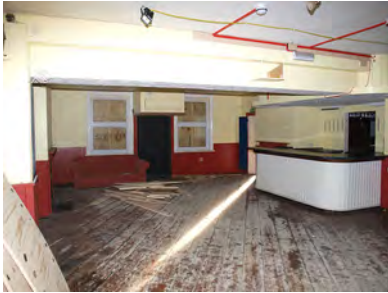
5310 (17)

- Plate 11 Northern bar area, looking south-east. Line of rear wall of principal range highlighted (17)
- Plate 12 Ground floor corridor showing differences in ceiling level, looking south (28)

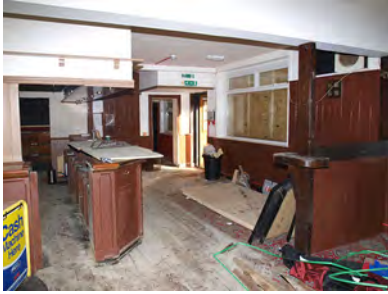
5310 (20)

- Plate 6 Main bar area within southern end of principal range, looking north-east. Boxing in ceiling marking possible original northern extent of building highlighted (20)

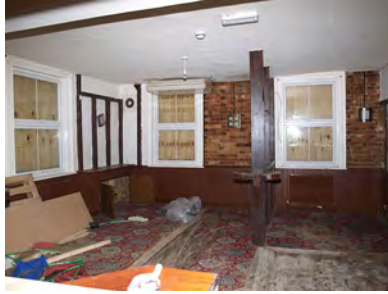
5310 (21)

- Plate 7 Main bar area within southern end of principal range: brickwork of south wall, looking south (21)
- Plate 8 Short section of sandstone walling visible at south-west corner of principal range, looking south-west (23)

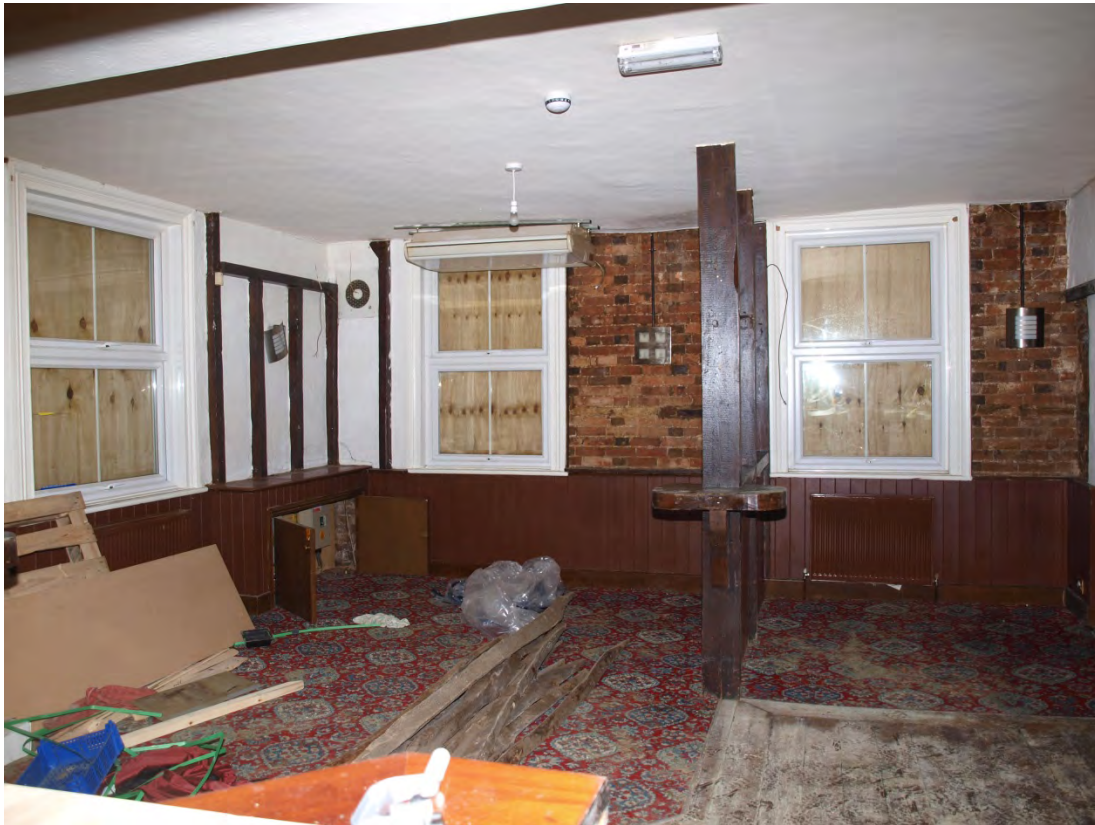
Plate 6: Main bar area within southern end of principal range, looking north-east. Boxing in ceiling marking possible original northern extent of building highlighted (20)

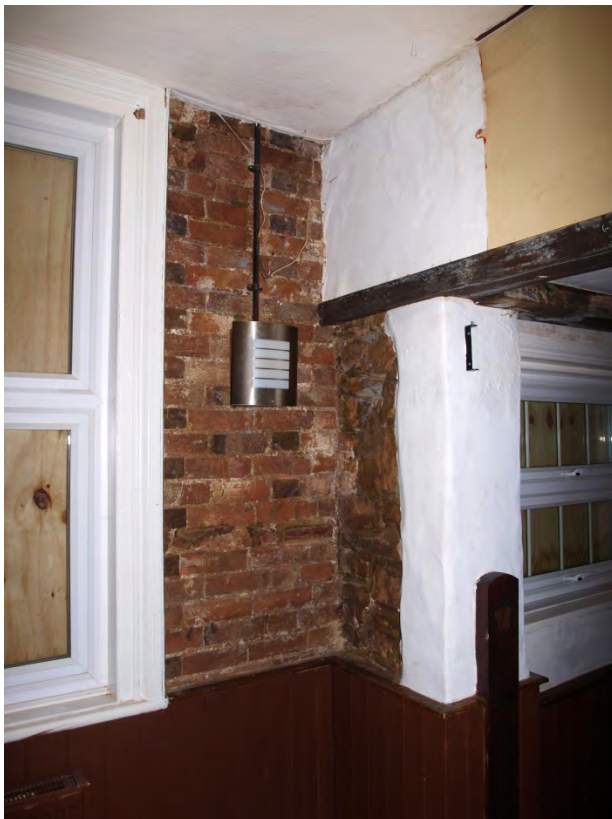
Plate 7: Main bar area within southern end of principal range: brickwork of south wall, looking south (21)

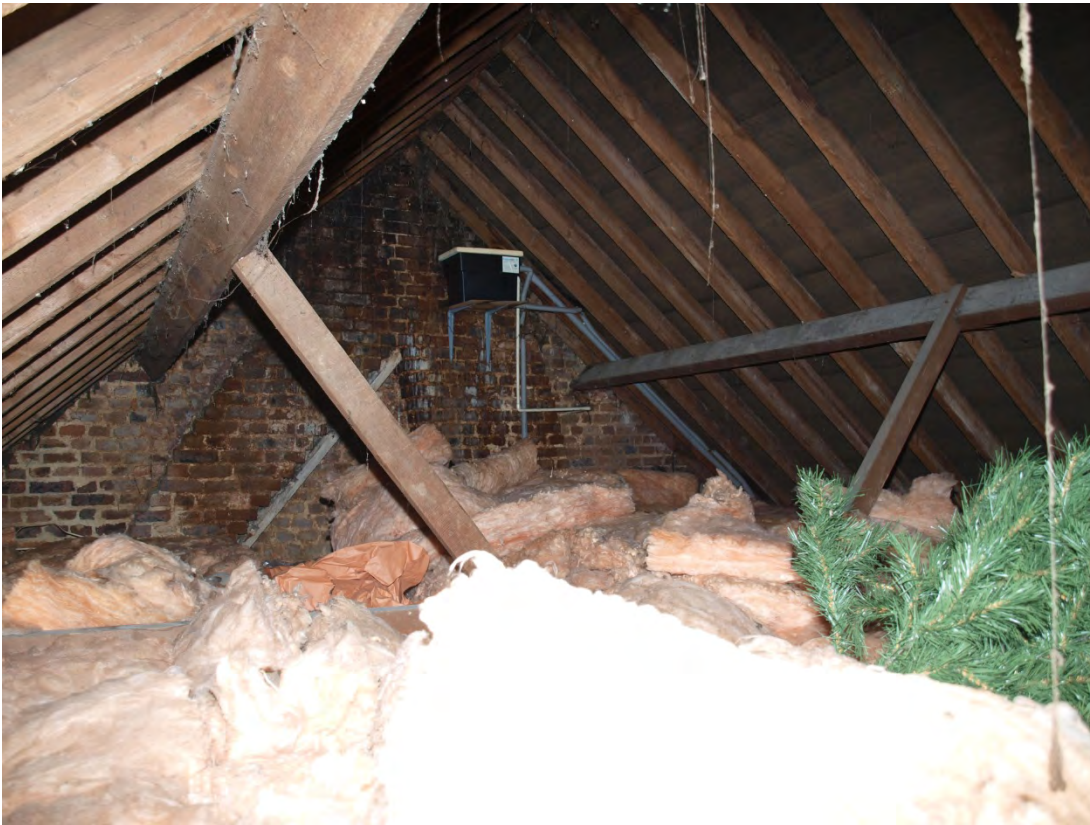
the building, is of 19th century date. Constructed in softwood, it consists of common rafter couples rising to a ridge-board at the apex. The rafters are supported by a single purlin in each roof pitch which is in turn given intermediate support by raking struts situated at widely-spaced intervals (Plate 19). Some are positioned at, and are directly supported by the trusses of an earlier roof (see Section 5.28 below). At approximately the half-way point within the southern roof area, the rafters of the east roof pitch are trimmed for the earlier chimney-stack.

Plate 18: Large room within southern end of principal range, looking north (18)

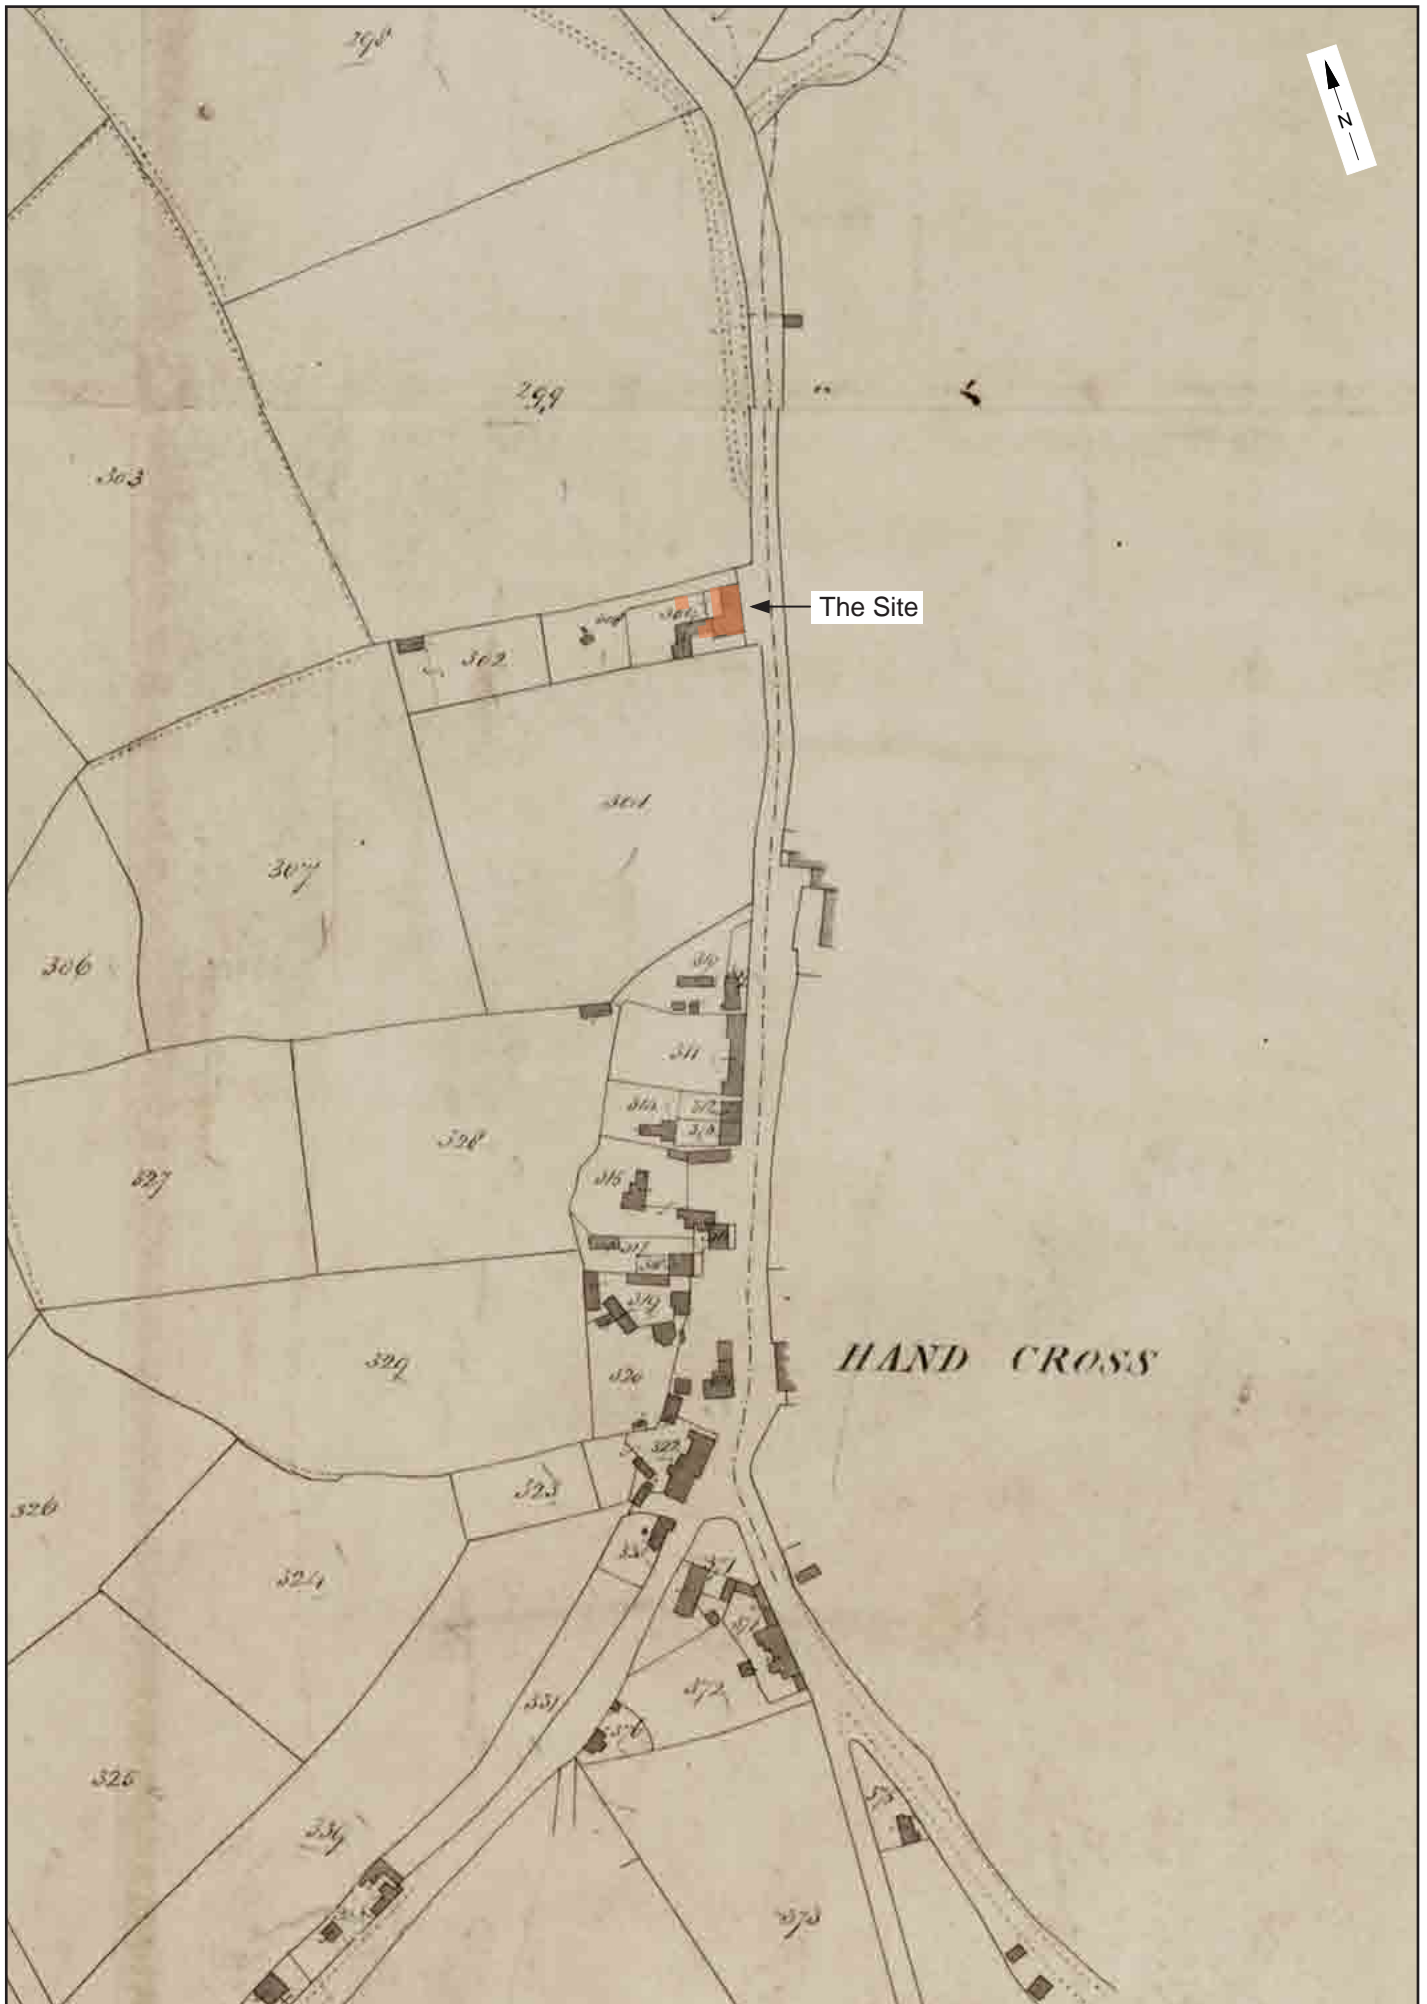
© Archaeology South-East		The Fountain Inn, High Street, Handcross, West Sussex, RH17 6BJ	Fig. 3
Project Ref: 5310	Jan 2012	Slaugham Tithe Map, c. 1841	
Report Ref: 2012010	Drawn by: AW

- 6.4 It seems that by c. 1841 (Fig. 3) the principal range had already been extended to the north, and the single-storey range added at the rear, as is reflected by its depiction on the tithe map of this date. This was likely in response to the need to cater for an increase in coaching traffic on the London to Brighton road, but could even represent the conversion from an initial dwelling-house to coaching inn. The rear addition seems to have comprised the main room which is now part of the bar area, together with the area now encompassed by the modern staircase and part of the adjacent WC area. The boxed feature within the ceiling in this area probably marks the northern limit, and corresponds with the extent of the roof above.

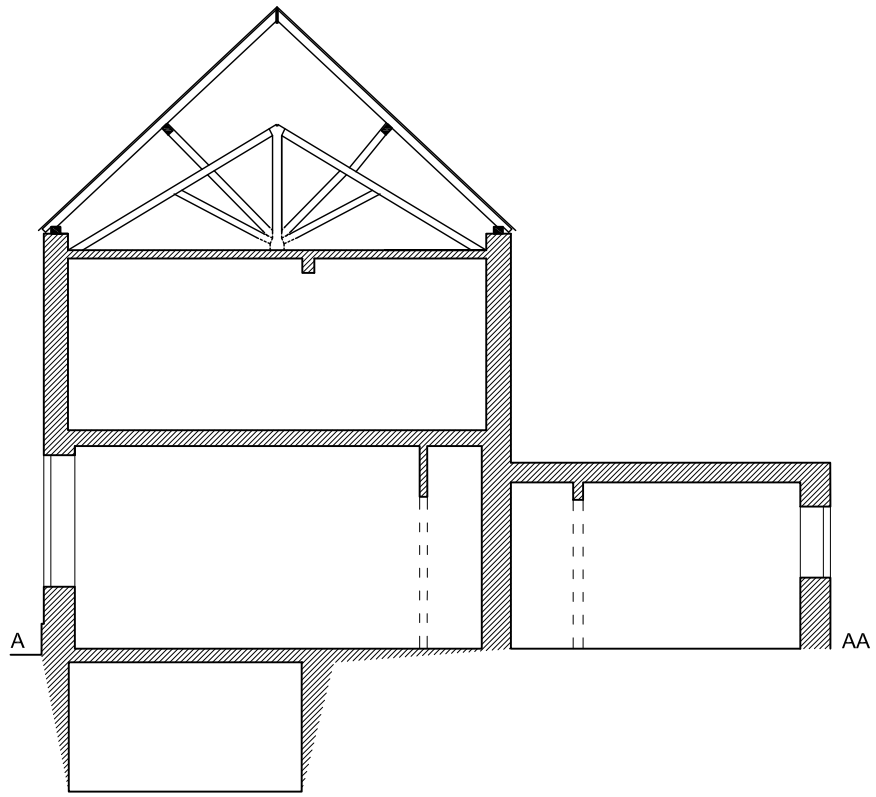
© Archaeology South-East		The Fountain Inn, High Street, Handcross, West Sussex, RH17 6BJ	Fig. 10
Project Ref: 5310	Jan 2012	Cross-Section	
Report Ref: 2012010	Drawn by: AW

CROSS-SECTION

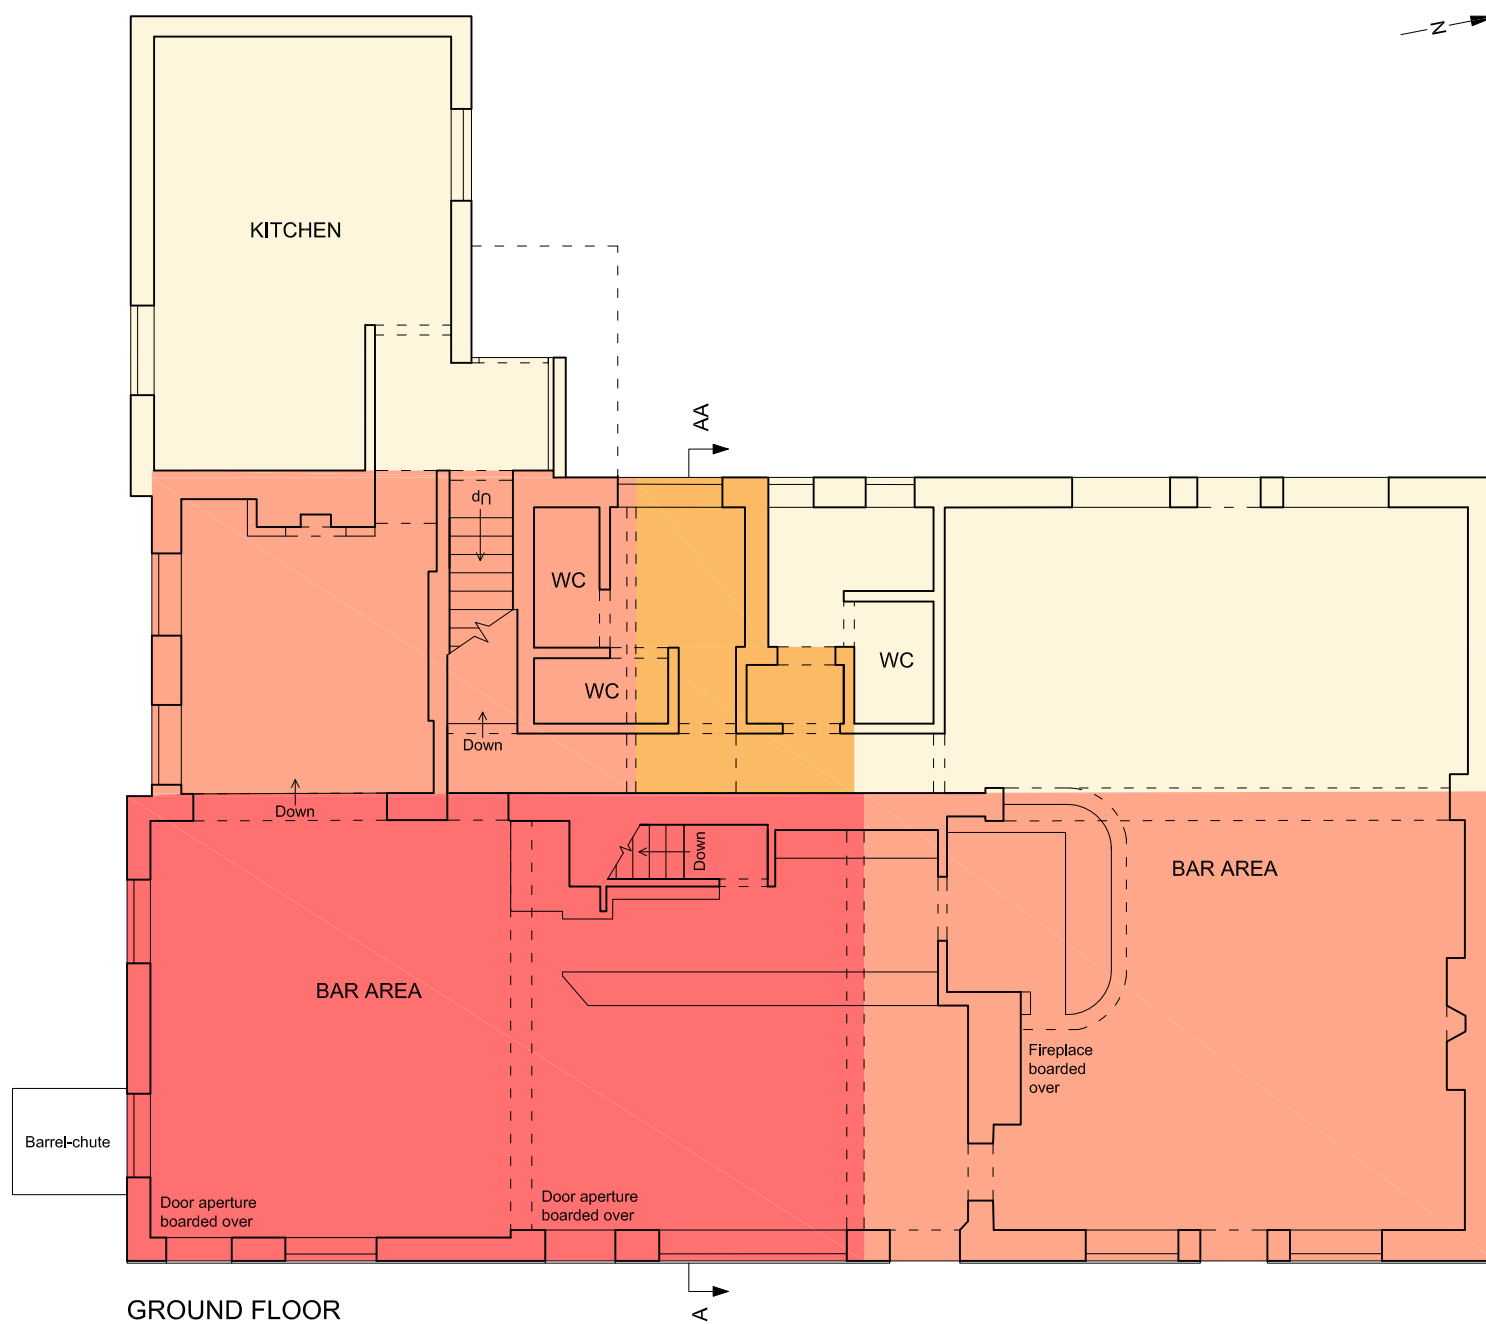
GROUND FLOOR

- Phase 1: Early-19th Century (prior to 1836)
- Phase 2: By 1841
- Phase 3: By 1875
- Phase 4: 1897 - 1910-11
- Phase 5: After 1967-8
