Archaeological Watching Brief Report Lynton House, 9 Northbridge Street Robertsbridge, East Sussex

Rother District Council Planning Consent: RR/2011/1891/P

ASE Report No. 2012038 OASIS id: archaeol6-118780

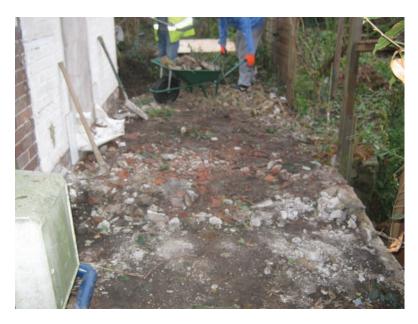
4.1 Demolition rubble [001] was removed to expose subsoil [002] beneath. This was approximately 0.4m thick. Natural geology, a yellowy-orange brick earth [003] lay beneath this. A footing trench for the new construction was dug into the brickearth.

Demolition rubble 001 clearance rubble viewed from the south

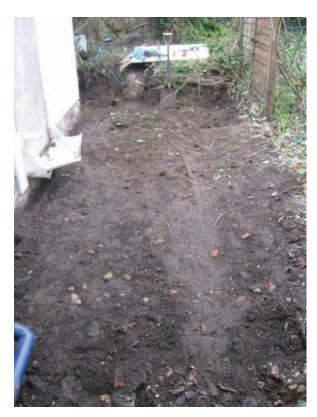
Subsoil horizon 002 viewed from the south

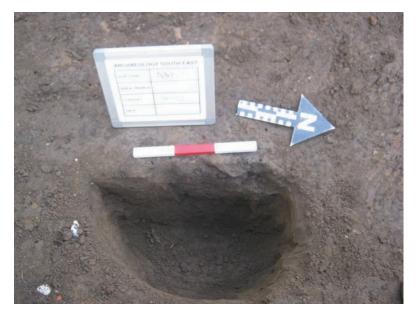
- 4.2.2 Post hole [006] was identified toward the south-east of the site, cut into the subsoil [002]. It was circular in plan, with steep concave sides turning into a concave base. It contained soft mid-brownish grey silty clay [007]. The fill was quite sterile and no finds were recovered from it.

Posthole 006 half-sectioned

- 6.3 Post holes [008] and [006] follow the line of the fence that is currently erected and no doubt delineate an earlier (18th to 19th century) fence line marking the property boundary.

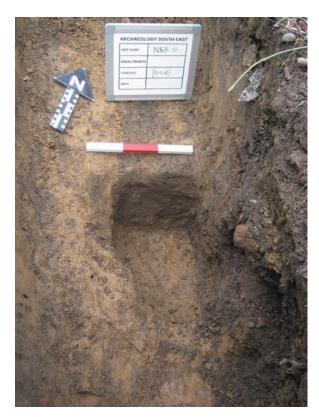
- 4.2.3 Post hole [008] was identified to the north of [006], at the east side of the site, cut into the subsoil [002] and the natural [003]. It was rectilinear in plan, but was not fully seen as it extends beyond the limit of excavation. It had vertical sides the gradual led to a flat base. This contained soft dark brown silty clay [009]. The section contained some degraded wood –prbably remains of the actual post, which was not recovered. Brick, CBM and a clay pipe stem were recovered from this fill.

Posthole 008 half sectioned

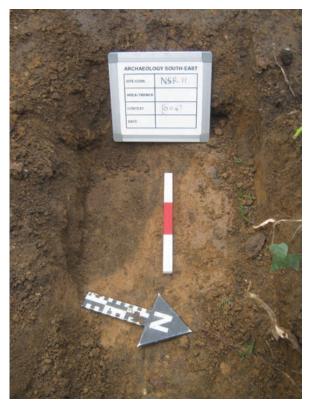
- 4.2.1 The construction cut [004] for the present house was identified in the north-east of the site and ran down the length of the monitored area, adjacent to the existing wall. This was cut into both the subsoil [002] and the natural [003]. It was filled by [005], a soft mid greenish brown silty clay containing recent broken bricks and CBM, and blue and white transfer ware pottery.

Building construction cut 004 in footings trench

- 6.3 Cut [004] clearly relates to the construction of the present house.
- The watching brief has demonstrated that the monitored construction work has not impacted on any significant archaeology.

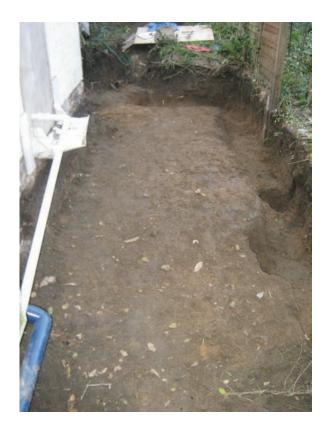
Brickearth horizon 003 and footings trench viewed from the south

- All of the recorded features were cut into subsoil [002] at between 11.48m AOD and 11.76m AOD. Natural geology was seen over some of the surface exposed particularly the footings, with exception of the south-west of the area, where the construction cut of a modern extension has previously disturbed the area.
