**An Archaeological Watching Brief and Historic Building Recording Work  
at Wick Farm, Truslers Hill Lane, Albourne, West Sussex**

**Project No: 5184  
Site Code: WFA11**

**ASE Report No: 2012064  
OASIS id: archaeol6-120551**

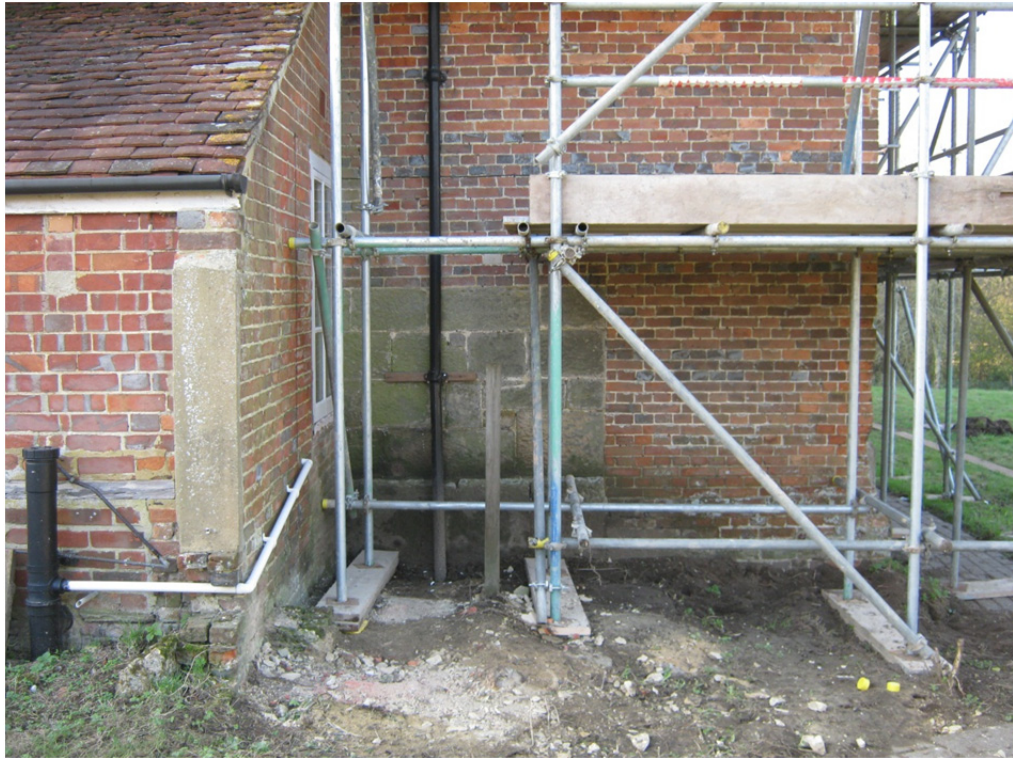
Plate 1: North end elevation with remnant c. 17<sup>th</sup> century masonry of the added lean-to outshot

Wall [1009] corresponds with the well-built section of stonework visible on the external face of the eastern façade of Wick Farm (Plate 1) comprising snecked ashlar blocks and a low chamfered plinth. A straight line exists between the masonry and the later brickwork which abuts it and continues over the upper limit of the masonry. At the base of the wall, a continuation of the masonry is just visible, and it is this that may mark the northeast corner of the footings observed within Room 1. The south external wall of the house also bears a section of masonry of similar construction; the remainder of the wall between the two visible areas of masonry is concealed by later construction (external outshot) and internal finishing and, as such, it was not possible to ascertain how much of the masonry construction between the two areas remained *in situ*.

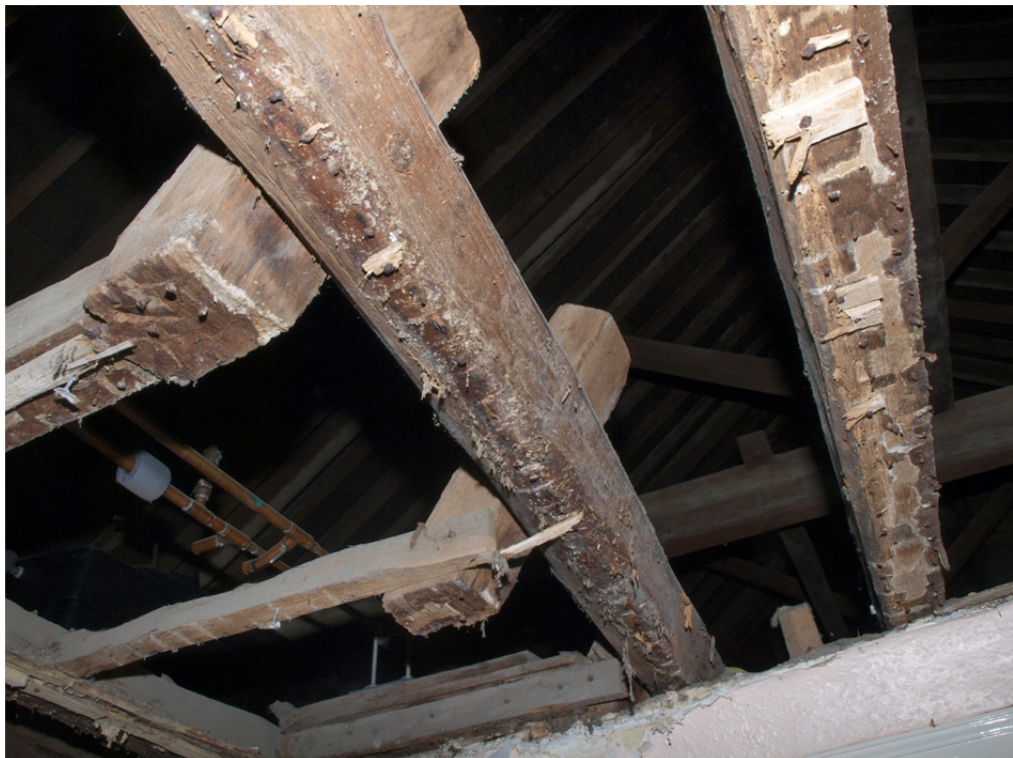
Plate 2: truncated rafters over the first floor staircase shows continuation of the Phase 1 roof

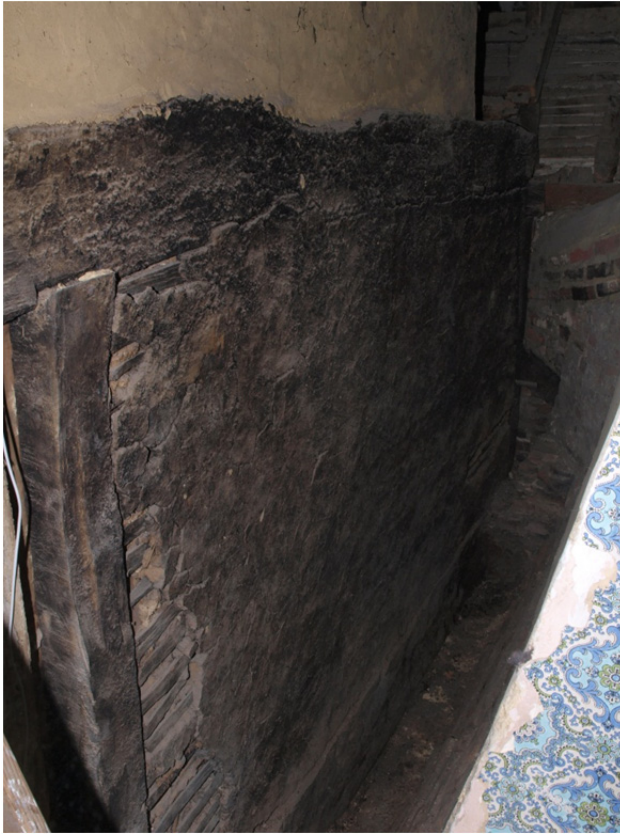
Plate 3: The north facing side of the soot encrusted smoke-bay truss partition of the Phase 1 building (wall-papered part of inserted stack just visible)

- 6.2.2 Evidence for the smoke bay and passage is very clear at first floor level where the partition to the west of the stack is abundantly soot encrusted (Plate 3). The timber framing of this partition survives well on the north side, with tie-beam, jowled post and wall plate in normal assembly. The soot staining continues along the wall plate and is evident on another truncated rafter just east of a post or stud: this post is not a principal one, bearing no jowl or tie-beam and as such is within the bay length; a final fairly clean rafter remnant is retained further to the east against a later brick stack. The presence of soot-stained and clean members within the same bay indicate

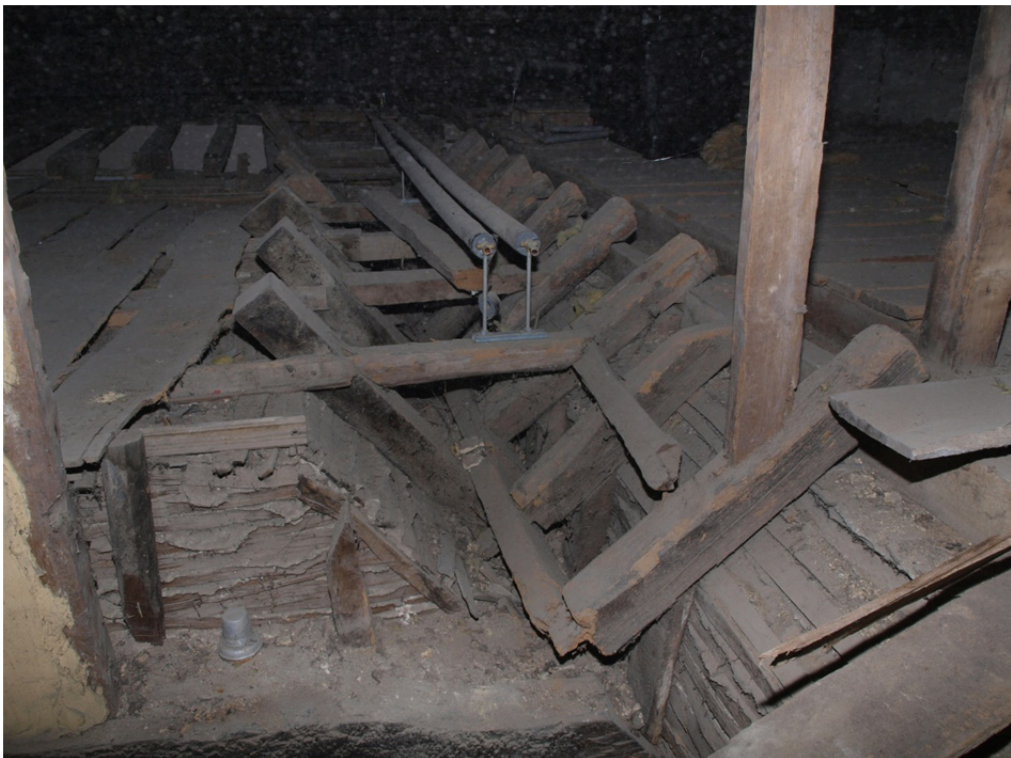
Plate 4: View towards the south of the Phase 1 roof over the Hall with the 18<sup>th</sup> C roof supported on a plate over the backs of the original rafters creating an M-profile roof (Truncated in the 19<sup>th</sup> C)

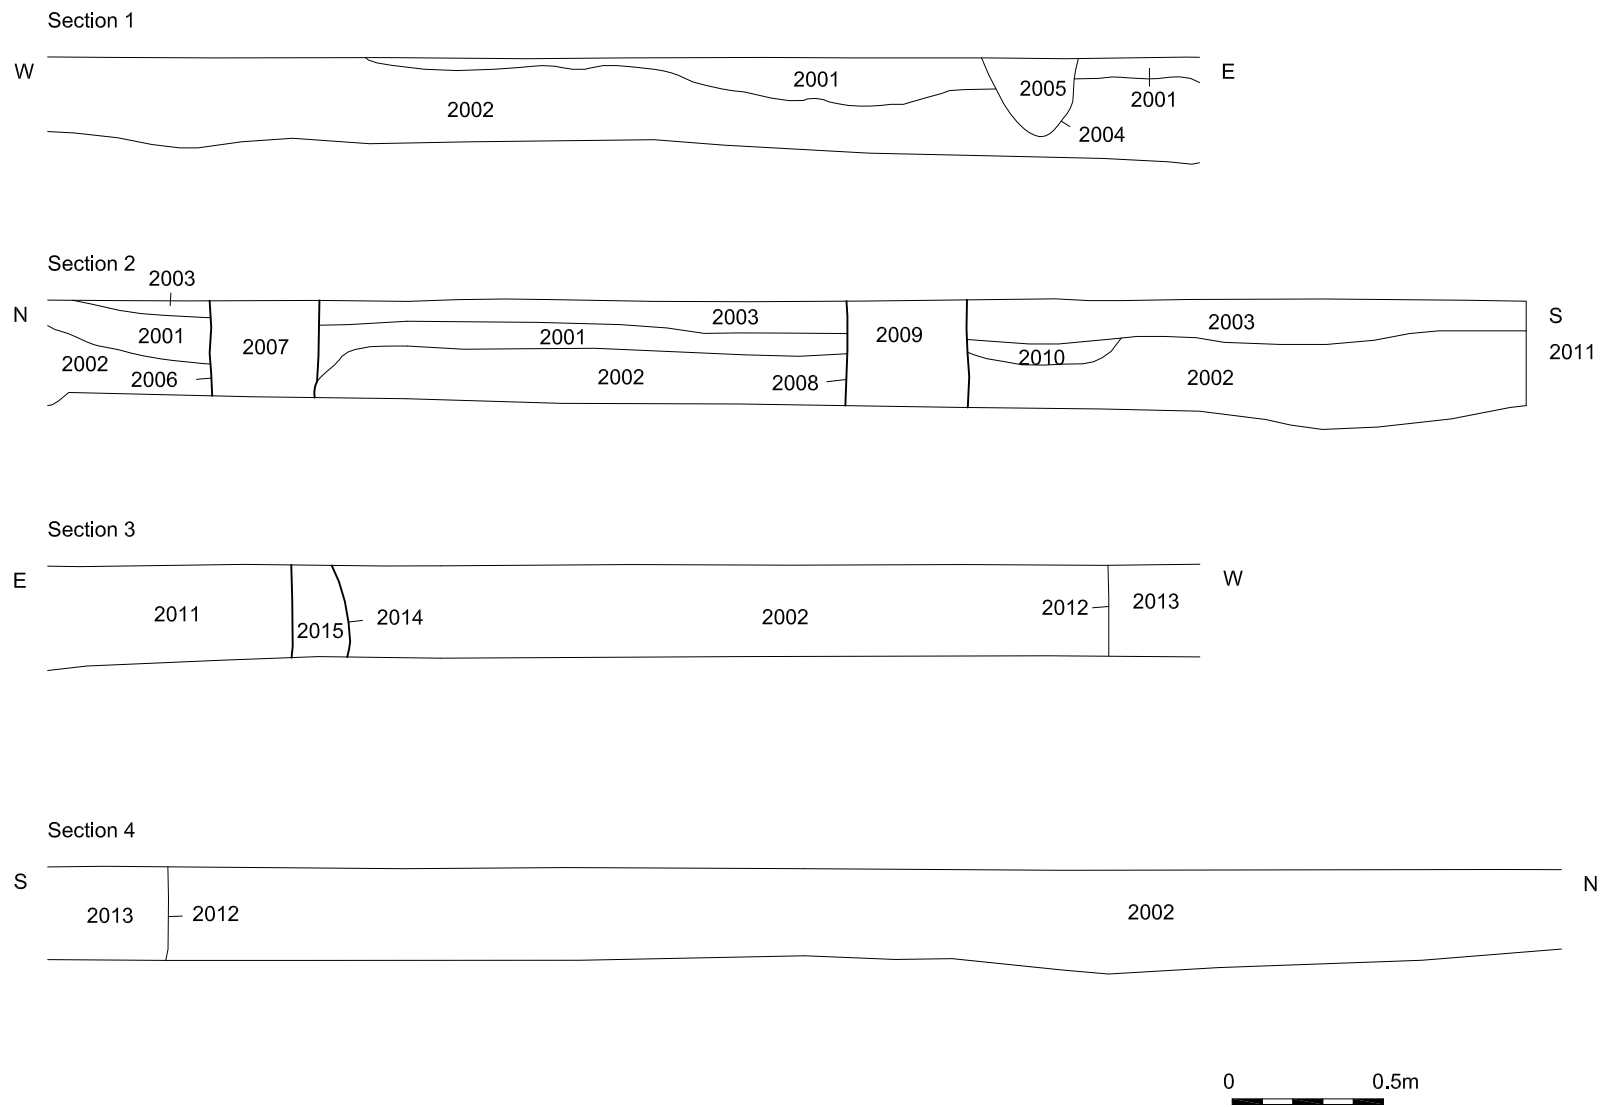
Two post holes were observed in the west facing section of the room in close association with the fireplace (Fig. 5, Section 2). These were barely exposed in plan by the ground reduction, but were clearly visible in section. The northern most of these comprised cut [2006] which had straight, almost vertical sides and was filled by [2007], a dark grey silty sand with common chalk fleck inclusions. Its full dimensions, as noted above, were not revealed but it was 0.30m wide in section. The second (cut [2008]) was situated further south and was similar in form and size, containing a similar fill, [2009]. It is possible that the post holes represent the location of the jambs of the former restricted smoke-bay, removed by the later insertion of the masonry and brick fireplace (See below).

A shallow gully or pit was noted in the south facing section of Room 2 in its north eastern corner, cutting made ground layer [2001] (Fig. 5, Section 1). This consisted of a 'u' shaped cut, [2004], which was filled by, [2005], a mid grey brown sandy silt with chalk inclusions. The exact form or function of this feature is unclear. It was not visible in plan during ground reduction works. Two relatively modern service features were noted in Room 2 (cut numbers [2012] and [2014]): both still contained water pipes.

A small section of the foundations of the southern elevation of Wick Farm, [2011] were revealed in the south-eastern corner of Room 2 (Fig. 5, Section 3). Mortar and the occasional brick were visible and the service /pipe trench [2014] truncated the wall suggesting that the water supply was added after its original construction.
