**OUTBUILDINGS AT STABLEBROOK,
STORRINGTON, WEST SUSSEX**

HISTORIC BUILDING RECORD

Report No. 2012062

February 2012

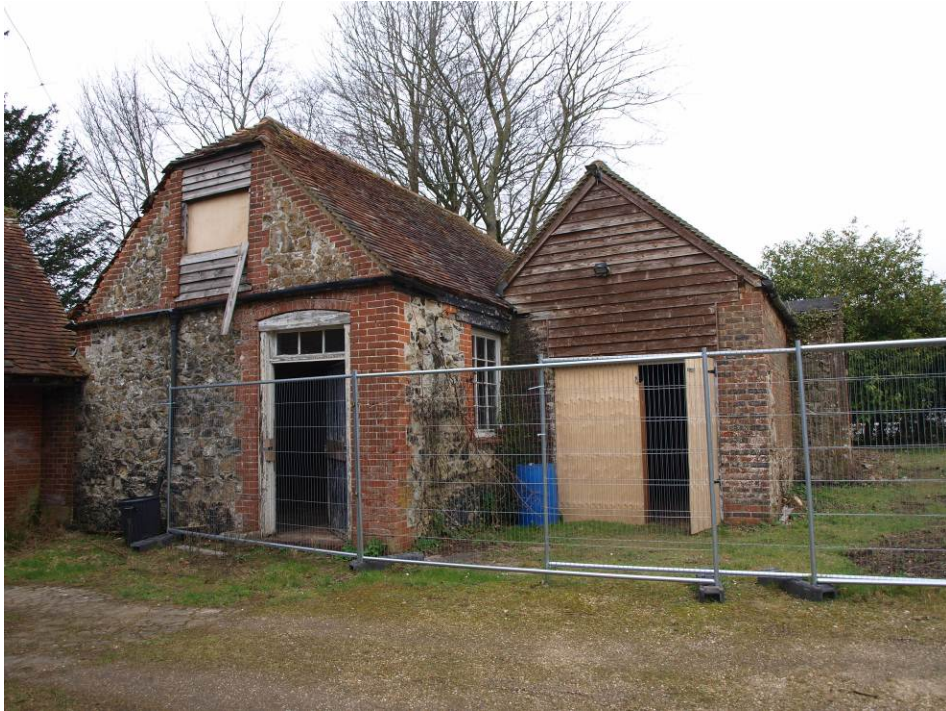
Plate 1

- 5.2 Block 1 is entered via a doorway in the eastern part of the southern wall (Plate 1). There is a high-level doorway accessing the first floor in the southern gable. There are two windows lighting the interior, both of which are sited in the eastern wall. The northern window is now internalised by Block 2 and the southern, external window is positioned immediately adjacent to the southern wall of Block 2. A stair in the north-eastern corner of Block 1 leads up to the first floor.

- 5.3 The external walls of Block 1 (Plates 1-4) are constructed in rough blocks of greensand stone positioned haphazardly within brick quoins at the corners of the structure. The north-eastern and north-western quoins, and the lower part of the south-western quoin, are formed using irregular, rough-arrised bricks of a dark pink-red colour, measuring 220-225 mm x 110 mm x 55 mm, arranged in alternating two courses of a half-brick and a whole brick. The upper part of the south-western quoin, above the eaves of the adjacent garage structure, and the south-eastern quoin are formed in roughly-uniform, orange-brown brick laid in thin bedding joints of white lime mortar. These bricks measure 220-225 mm x 110 mm x 65-70 mm and are laid in blocks of three, which are alternately one brick and one-and-a-half brick wide. These bricks also form the jambs and head of the ground-floor doorway and the high-level doorway in the gable wall, the jambs of the southern window in the east wall and the brick edging to the gable wall underneath the eaves. The northern window has jambs and head formed in the same brick as that in the older, narrower quoins.

The south elevation

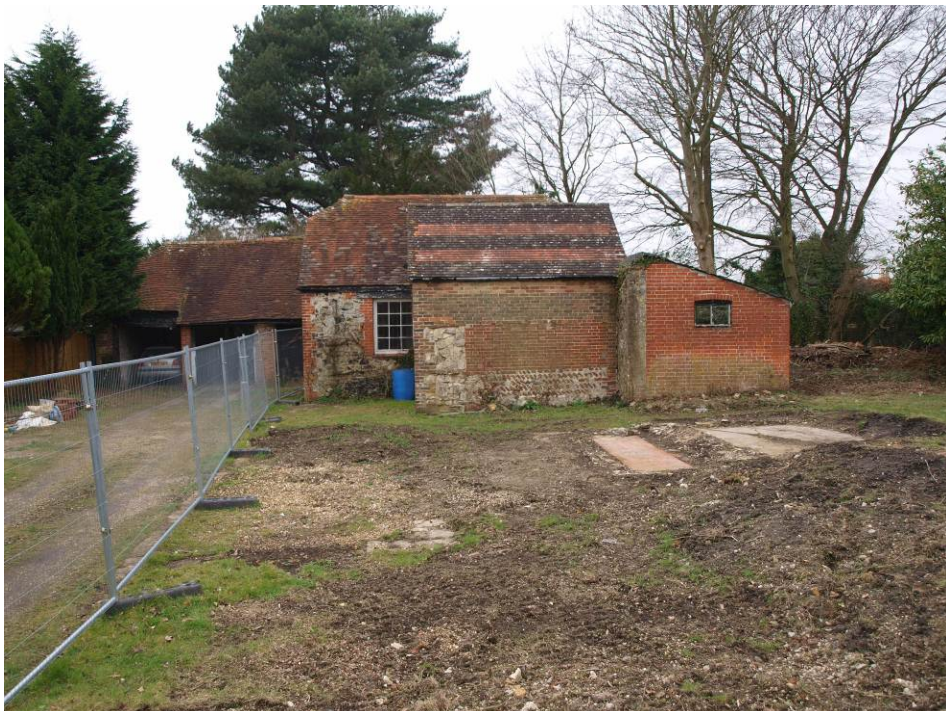
Plate 2

The east elevation

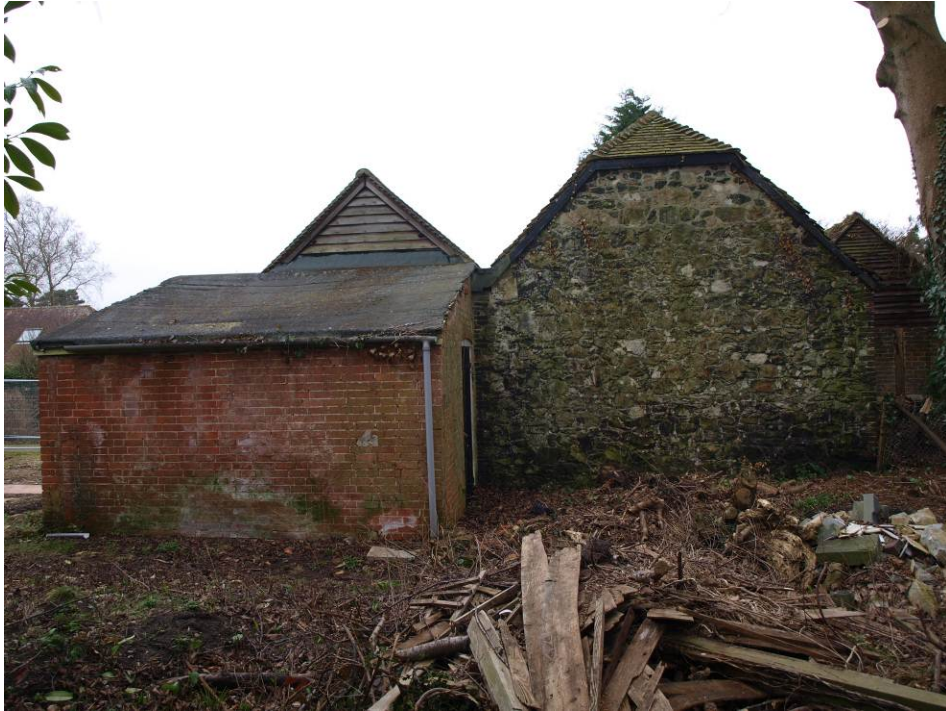
Plate 3

The north elevation

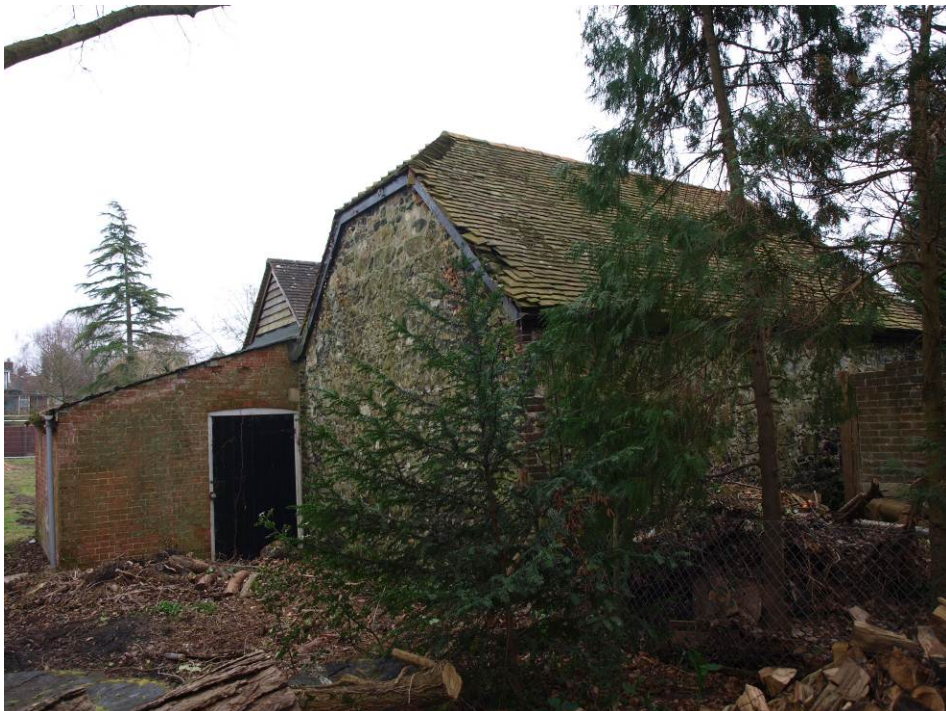
Plate 4

The west elevation

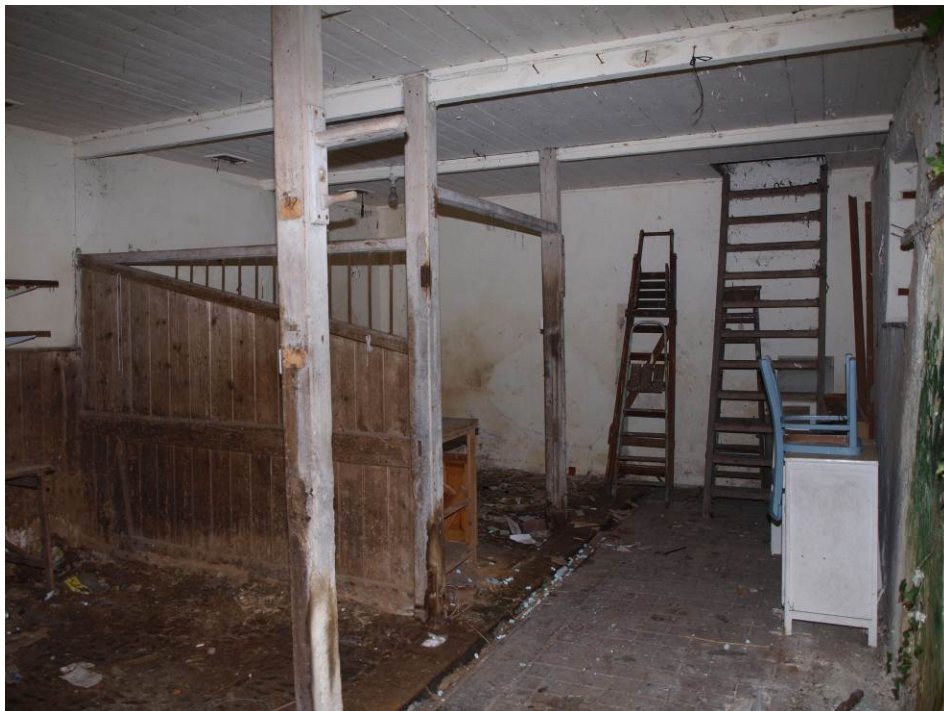
Plate 5

- 5.8 Block 1 has been used as a stable, and does not appear to have had an earlier function, although latterly the building has been used for storage (Plates 5 & 6). The stalls are positioned on the western side of the building, within the area of cobbled floor. The length of the stall area is divided into two equal parts by a timber board partition extending from the western wall to a stud in the approximate centre of the building. The stall to the south has half-height matchboarding and the upper parts of the walls are plastered. This half-height matchboarding is a common feature of stables, as it provided a softer wall surface than plastered masonry in the event that the horse kicked out. This stall was recently used as a single space: a timber partition extended from adjacent to the southern external doorway to a stud positioned close to the central stud. Between these two upright timbers was the stall door, probably hung on the central stud, with a saddle peg on the stud to the south. The timber partition has been removed, but is evidenced by four mortices in the stud and four empty holes on the interior face of the south wall, which would have supported the ends of horizontal ledges to which planks were fixed. The stall to the north has plastered walls but no half-height boarding. There is a stud in line with the central stud, positioned centrally to this half of the building which would have originally supported an east-west partition similar to the central partition.

Interior of Block 1 facing north

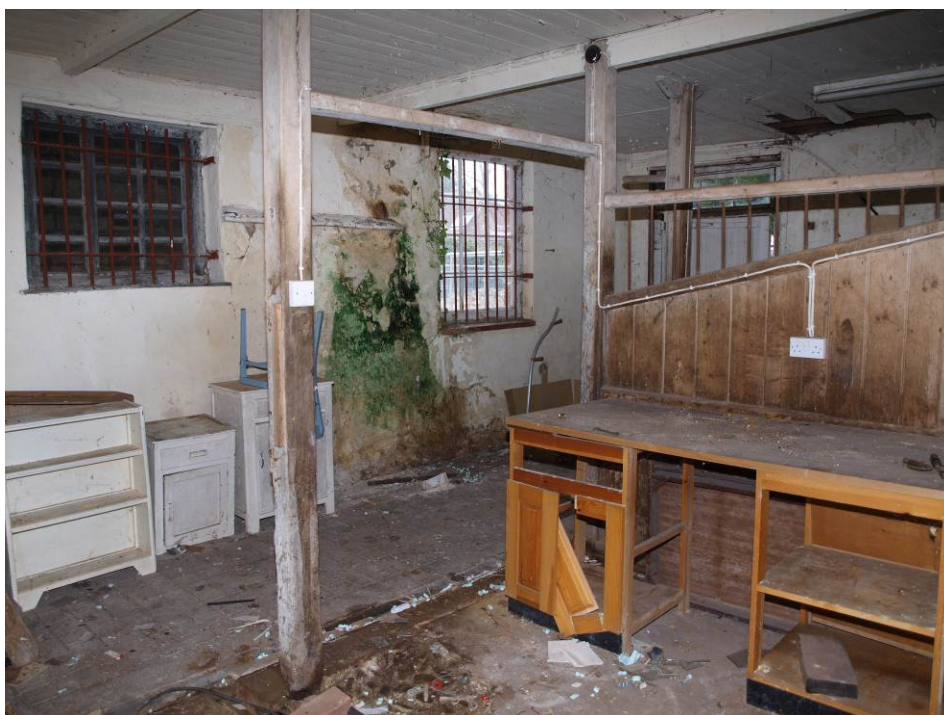
Plate 6

Interior of Block 1 facing south-east

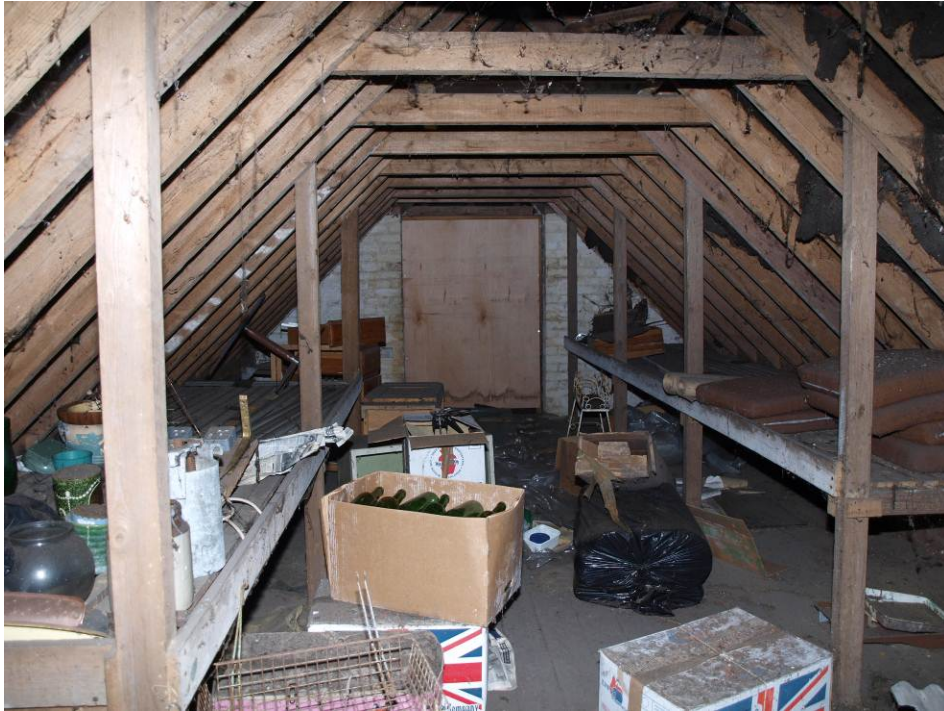
Plate 7

- 5.7 The roof over the building (Plate 7) is of paired-rafter construction, with the rafters nailed to a ridgeboard at the apex and supported on a wallplate which rests on the ends of the joists at the side walls. Alternate pairs of rafters are further supported by a collar nailed to the southern face. Each end of the roof is half-hipped, the half-hip being supported on the main rafters by narrow plank layboards. The rafters are all the same scantling, 50 mm x 115 mm, and the collars are of a similar size, being 50 mm x 105 mm. Felt is attached to the top

face of the rafters, below the battens which support plain clay tiles which cover the roof.

Roof of Block 1 facing south

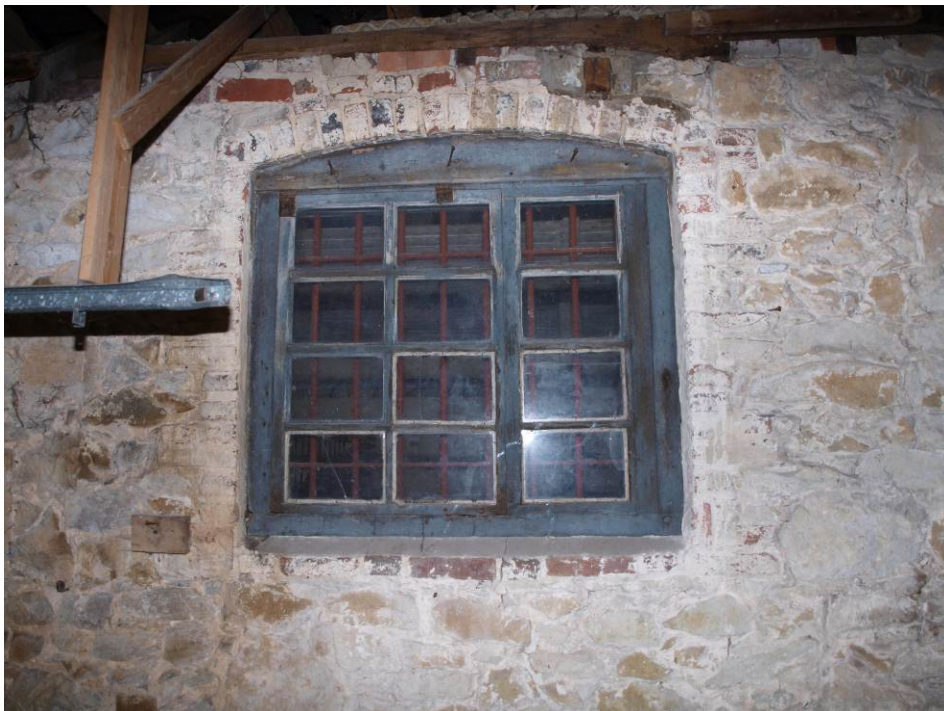
Plate 8

Original window in east wall of Block 1 from east

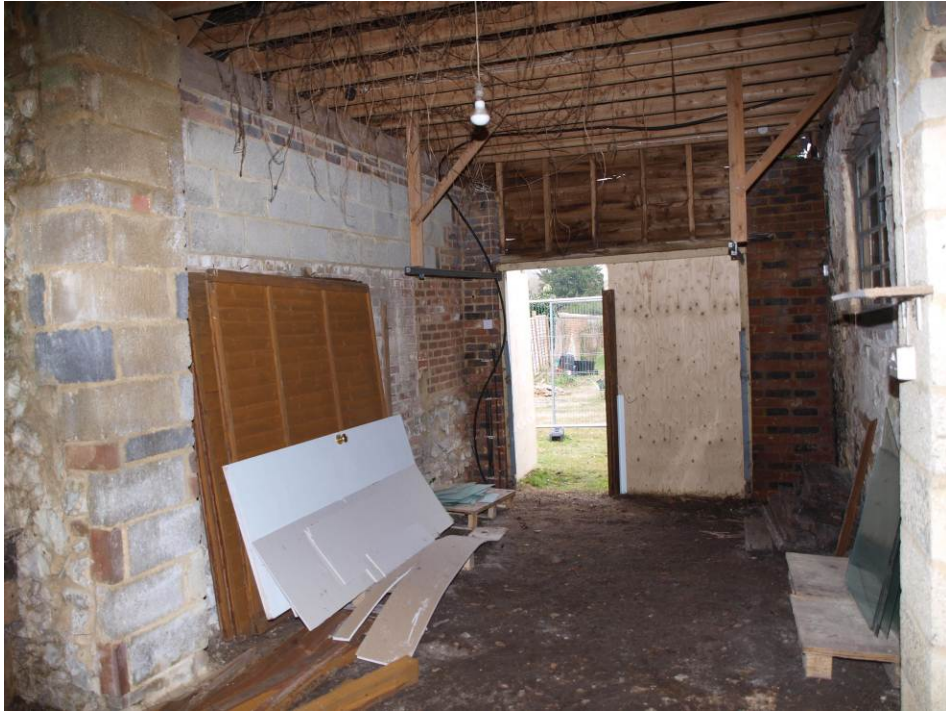
Plate 9

- 5.13 On the interior (Plate 9) the wall has been faced in more modern materials, suggesting that it was quite flimsy in its initial construction. The 20th-century brickwork at the top of the wall is faced with breeze-blocks. The upper part of the southern stonework is faced with modern bricks set into buff-coloured cementitious mortar.

Interior of Block 2 facing south

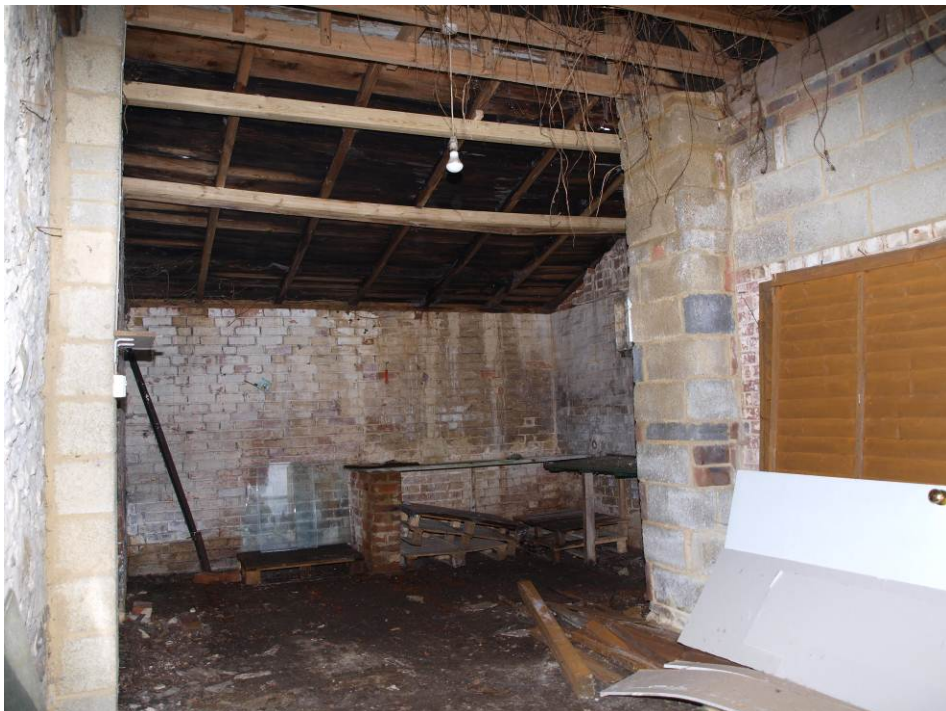
Plate 10

- 5.16 Block 3 is formed as a lean-to structure at the end of Block 2 (Plates 10 and 11). As Block 2 is open-ended, there is only a short section of masonry forming the south wall of Block 3 where it overlaps the east wall of Block 2.

Interior of Blocks 2 and 3 facing north-east

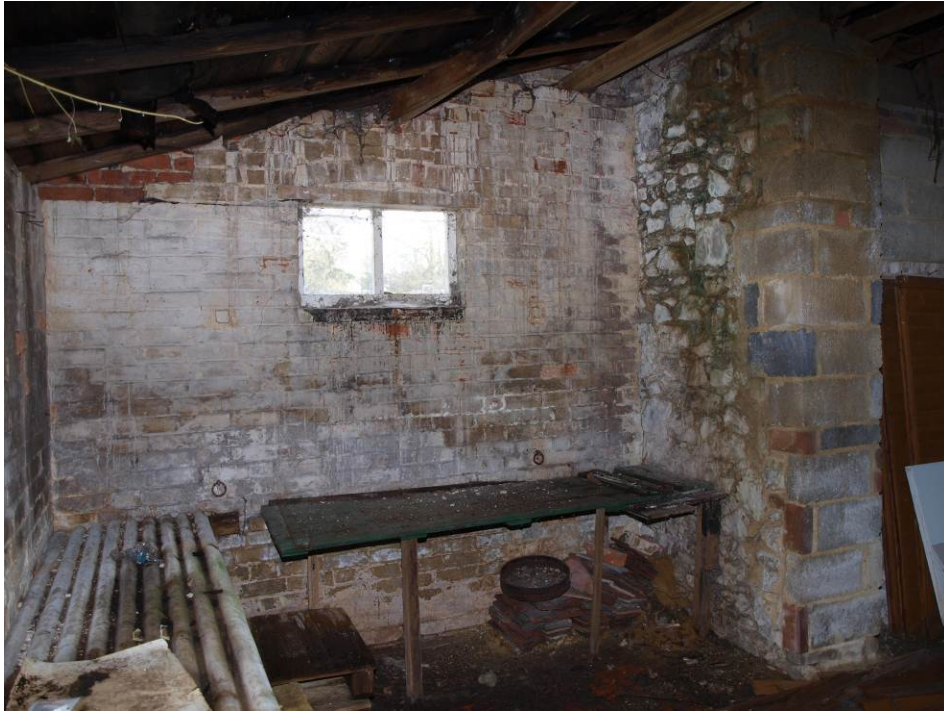
Plate 11

Interior of Block 3 facing east
