**Archaeological Evaluation Report
Former Seaview Avenue Garage
Seaview Avenue, Peacehaven
East Sussex**

**NGR: 542191 101014
(TQ 42191 01014)**

**ASE Project No: 5428
Site Code: SVA12**

**ASE Report No. 2012096
OASIS ID: archaeol6-123889**

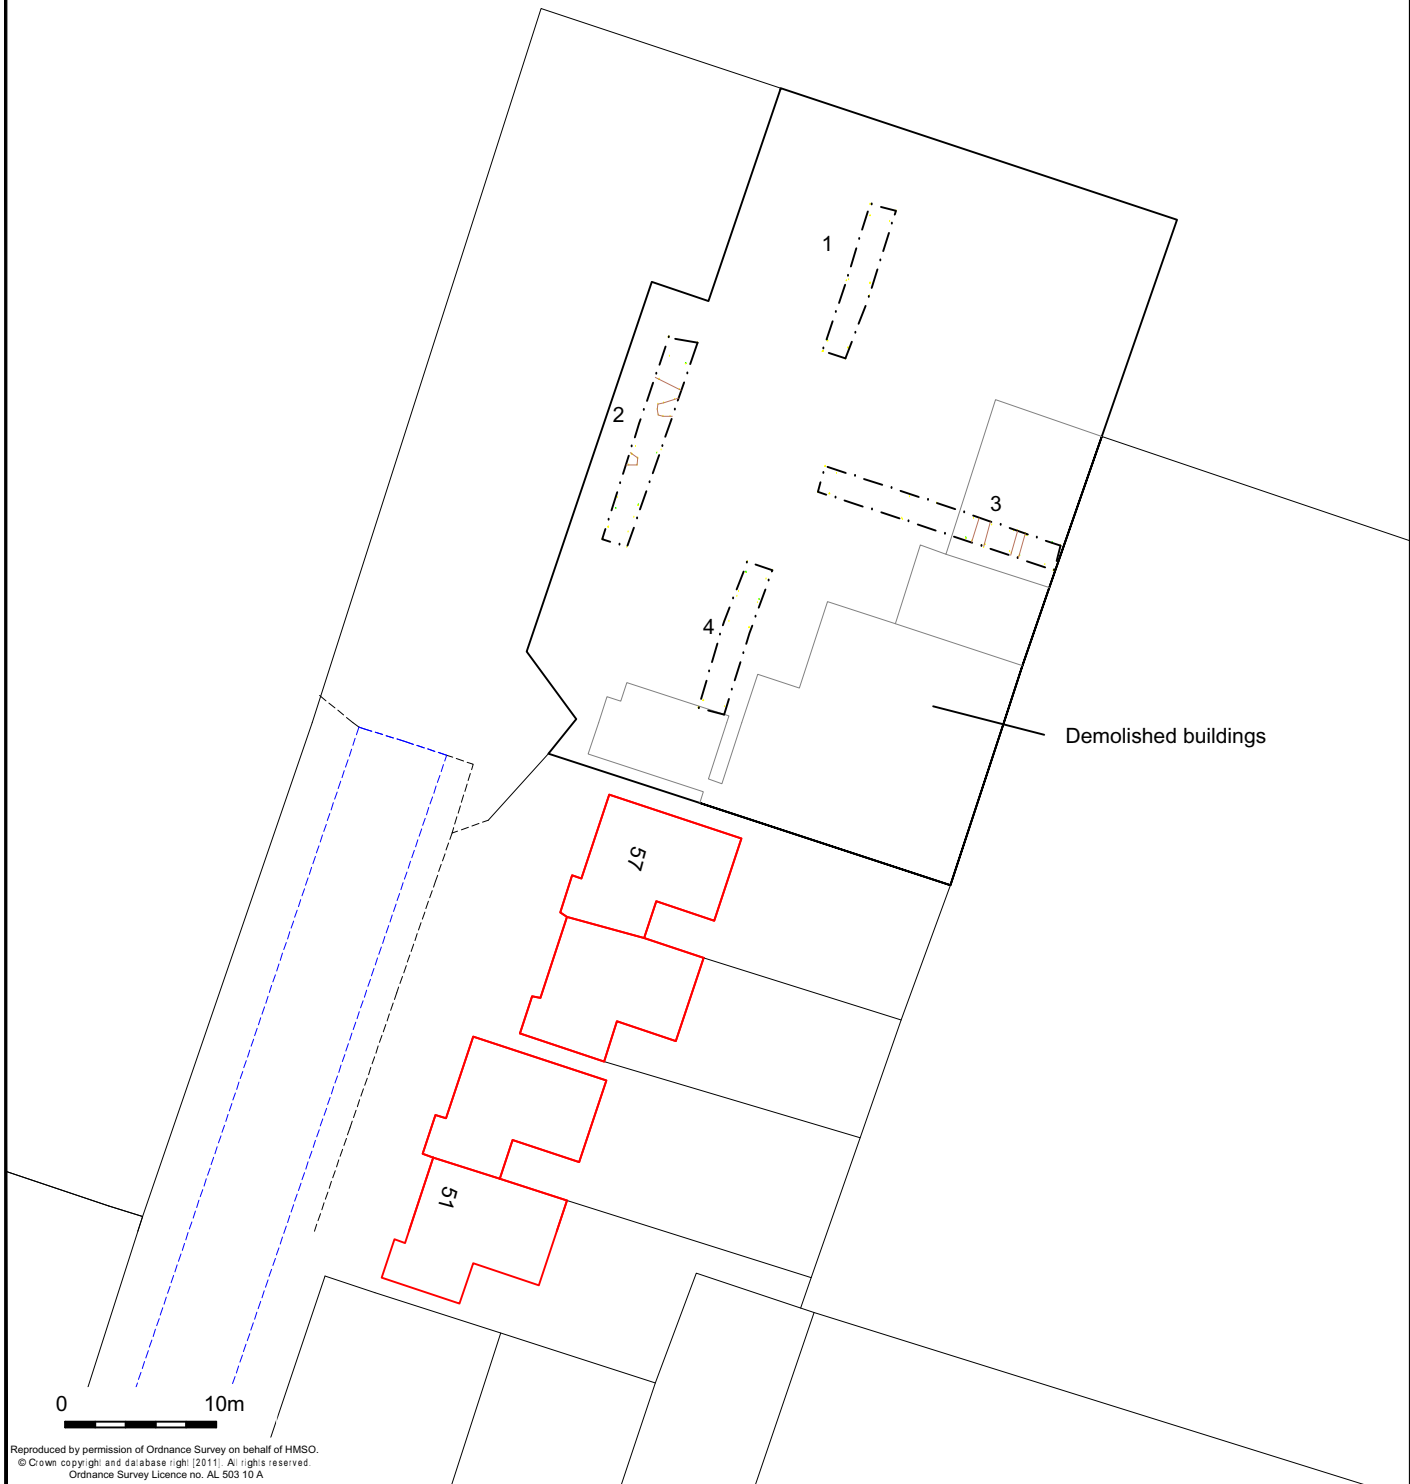
© Archaeology South-East		Former Seaview Avenue Garage, Peacehaven	Fig. 3
Project Ref: 5428	April 2012	Trench Location	
Report Ref: 2012096	Drawn by: JC

- 3.1 Four trenches, two measuring 10m x 1.8m and two measuring 15m x 1.8m, were machine excavated across the area of proposed development under archaeological supervision (Figure 2). These were as per the locations specified in the WSI (ASE 2012).

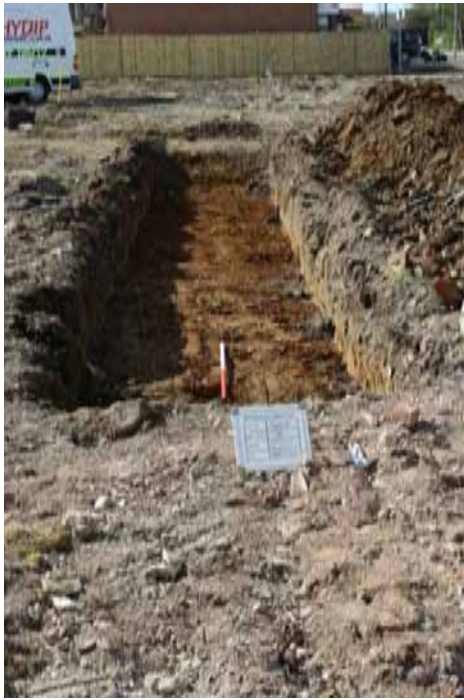
Fig. 4a: Trench 1, facing south

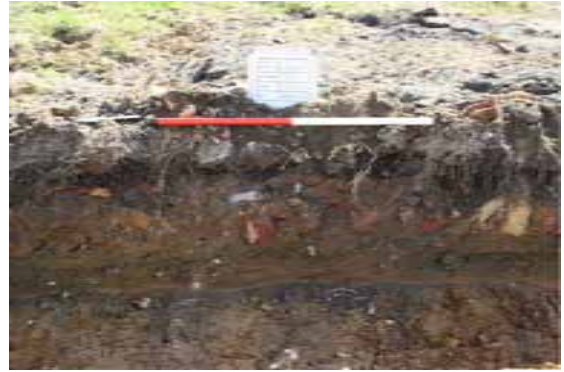
4.1.2 The natural [1/004], a mid orangey brown sandy clay with moderate sub-angular flint inclusions, was observed between 37.95 m OD in the north of the trench and 38.03 m OD in the south of the trench. A subsoil layer, [1/003], a mid yellowish brown sandy clay with infrequent modern ceramic building material and small flint inclusions, lay over the natural and underneath a layer of made ground [1/002] underlying asphalt.

Fig. 4b: Trench 1, example section, facing east

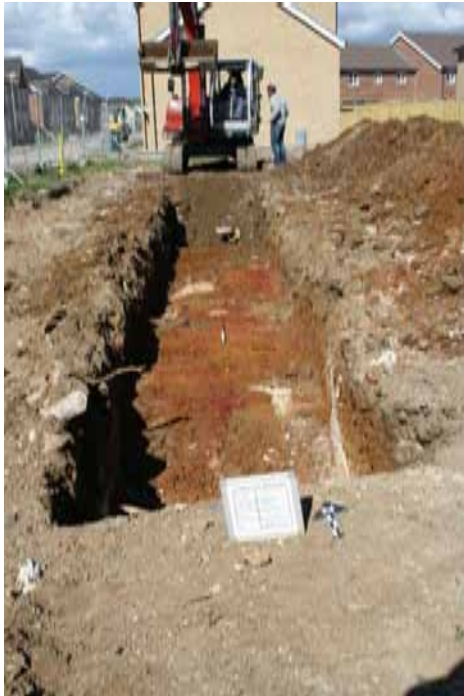
4.2.1 Trench 2 measured 15m in length and 1.8m in width and was orientated on a north-south alignment. The trench was excavated to the natural horizon with a sondage at the southern end. No archaeological features were observed within this trench. Three areas of modern truncation were recorded.

Fig. 4c: Trench 2, facing north

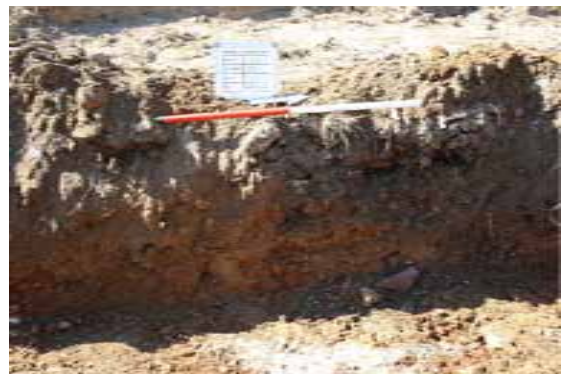
4.2.2 The natural [2/003], a mid orangey reddish brown sandy clay with moderate sub-angular flint inclusions, was observed between 37.45 m OD in the north of the trench and 37.66 m OD in the south of the trench. A subsoil layer, [2/002], a mid yellowish brown sandy clay with infrequent small flint inclusions, lay over the natural and underneath a layer of made ground

Fig. 4d: Trench 2, example section, facing west

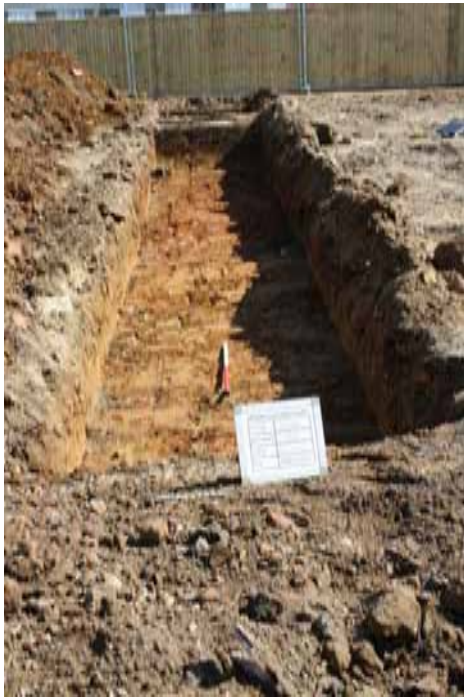
4.3.1 Trench 3 measured 15m in length and 1.8m in width and was orientated on a east-west alignment. The trench was excavated to the natural horizon with a sondage at the southern end. No archaeological features were observed within this trench. Modern truncation and concrete footings recorded.

Fig. 5a: Trench 3, facing east

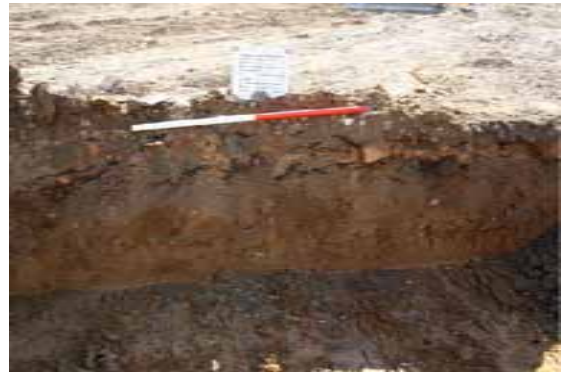
4.3.2 The natural [3/003], a mid reddish brown sandy clay, was observed at 38.54 m OD. A subsoil layer, [3/002], a mid yellowish brown sandy clay with infrequent small flint inclusions, lay over the natural and underneath a layer of made ground [3/001]. Modern steel reinforced concrete footings and associated truncation, from the former garage buildings, were observed in the eastern end of the trench.

Fig. 5b: Trench 3, example section, facing south

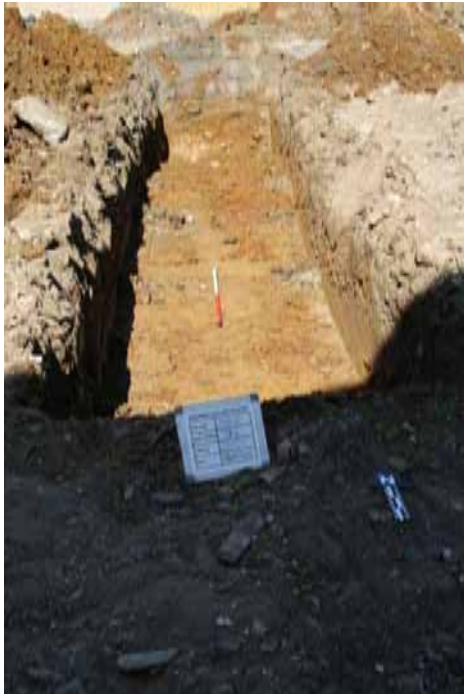
4.4.1 Trench 4 measured 10m in length and 1.8m in width and was orientated on a north-south alignment. The trench was excavated to the natural horizon with a sondage excavated at the northern end. No archaeological features were observed within this trench.

Fig. 5c: Trench 4, facing north

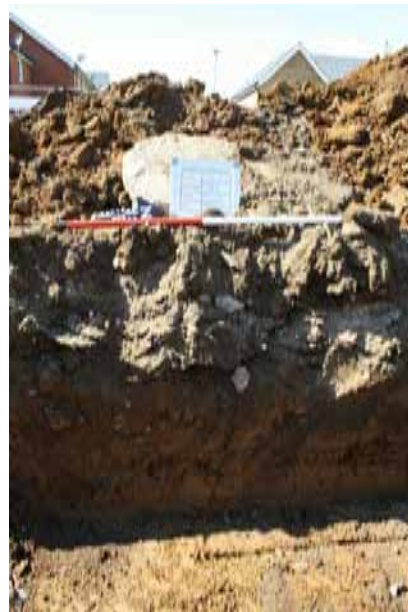
4.4.2 The natural [4/003], a mid orangey brown sandy clay with moderate flint inclusions, was observed between 38.16 m OD in the north of the trench and 38.19 m OD in the south of the trench. A subsoil layer, [4/002], a mid yellowish brown sandy clay with infrequent small flint inclusions, lay over the natural and underneath a layer of made ground [4/001]. No archaeological features were observed within this trench.

Fig. 5d: Trench 4, example section, facing west

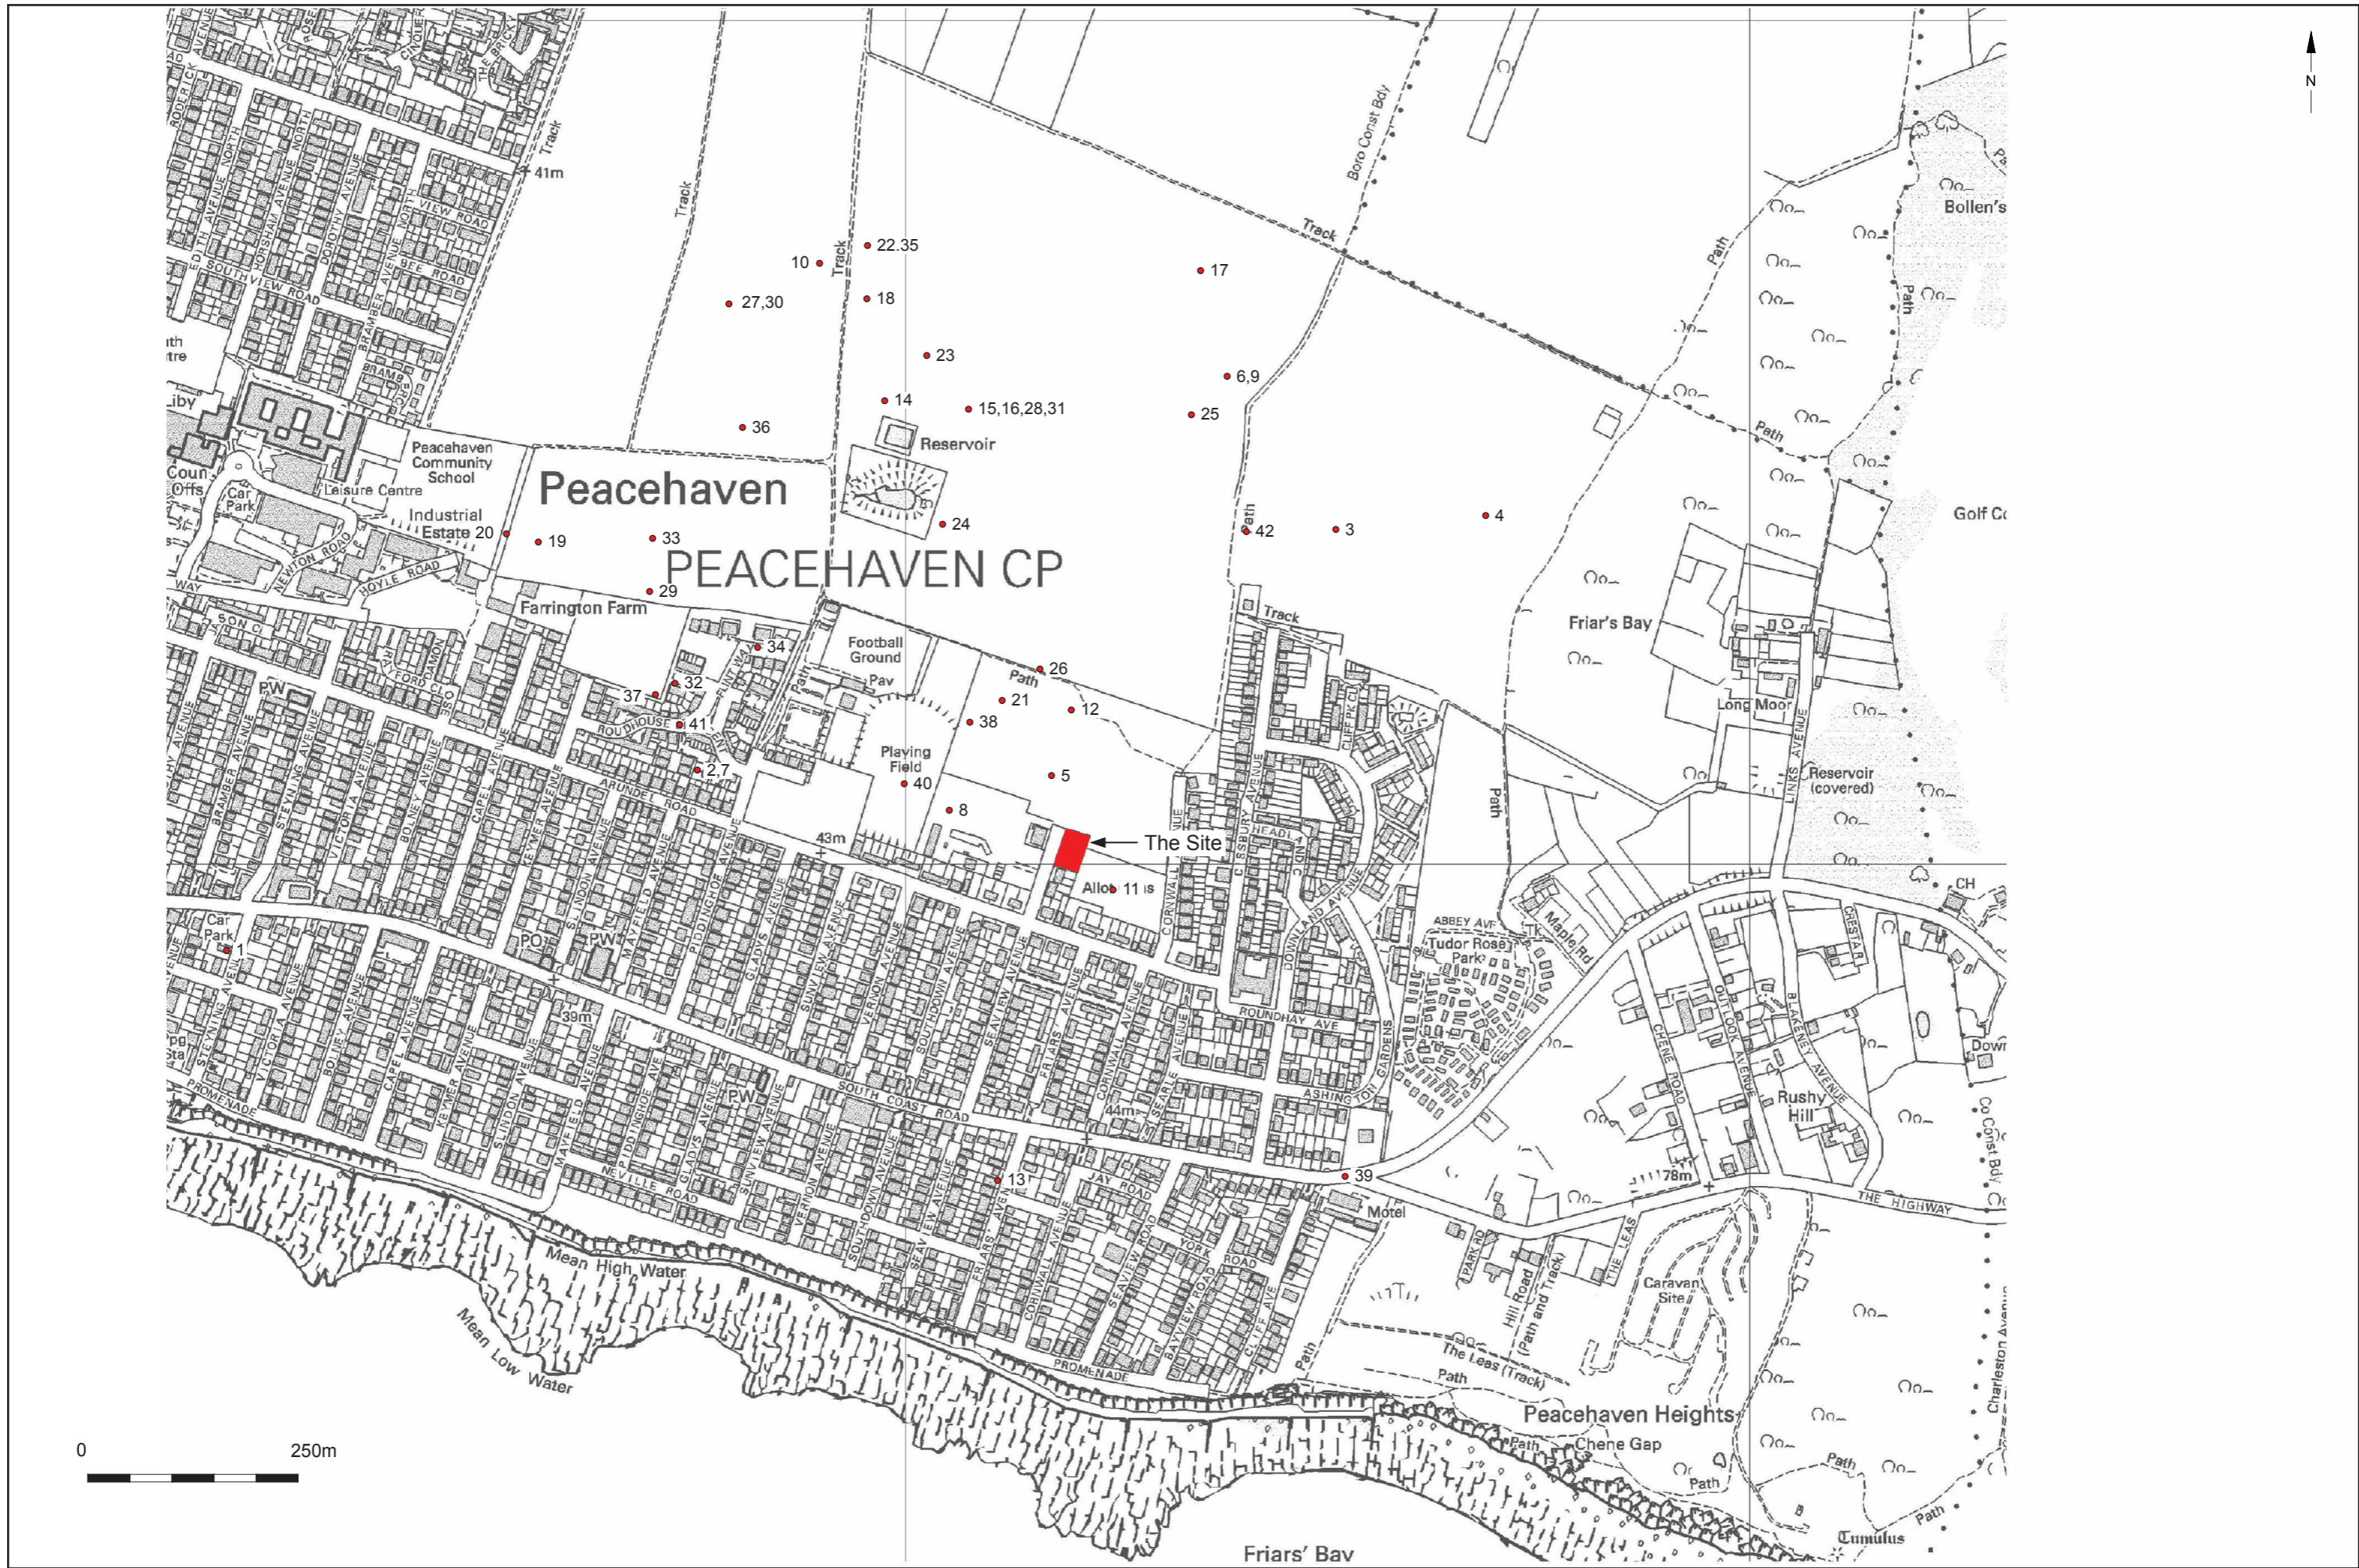
© Archaeology South-East		Former Seaview Avenue Garage, Peacehaven	Fig. 6
Project Ref: 5428	April 2012	Archaeological data	
Report Ref: 2012096	Drawn by: JLR

The site numbers correspond to their position on Figure 6 (ESHER reference numbers in brackets)

2.6.1 The East Sussex HER records 42 archaeological sites within the area, none of which are recorded within the site. These are listed as an Appendix and shown of Figure 6.
