41 HIGH STREET, HARPENDEN, HERTFORDSHIRE, AL5 2SD

**HISTORIC BUILDING RECORD
(ENGLISH HERITAGE LEVEL 3)**

Site Code: HSH 12
Project No. 5449
Report No. 2012098

April 2012

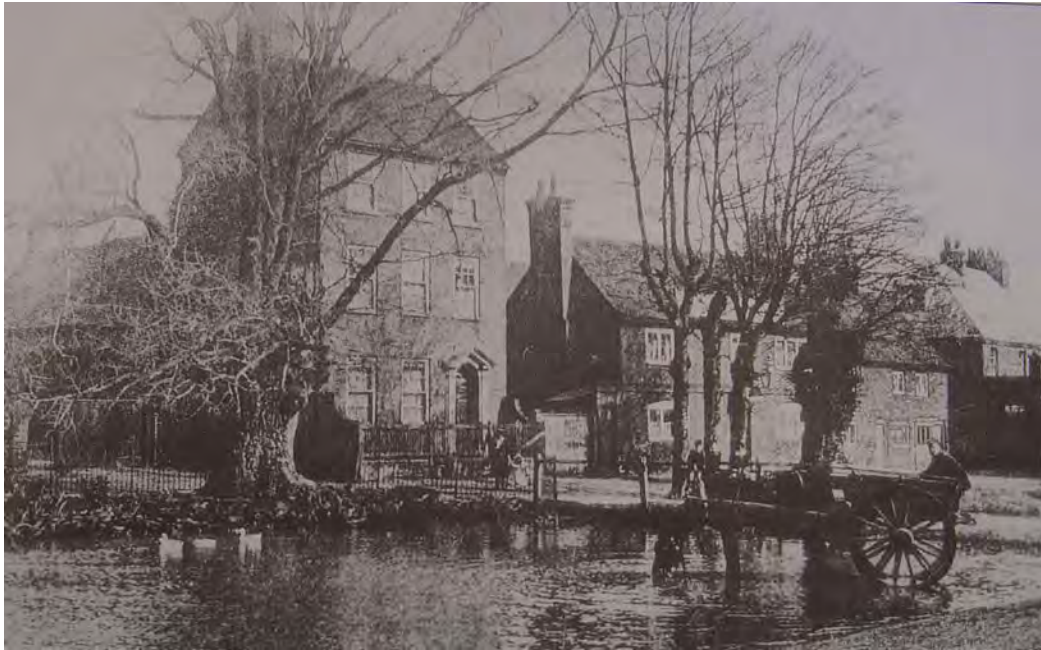
Plate 1: Late-19th century photograph showing original ground floor arrangement
(Source: Brandreth 1996)

- 4.5 A photograph dating to the late-19th century (Brandreth, 1996; Plate 1) shows the front of the property as it was originally built, before the ground-floor door and windows were replaced by a shop-front. The historic street directories record some of the occupants of the building from this time and onwards. In 1890 a Sydney Ollard is listed, and in 1900, the house, which was then identified as The Pollards, was occupied by an Alfred Charles Osman Ashton.

- 5.2 The late-19th century photograph (Plate 1) shows the building prior to the addition of the shop-front. There were two windows on the ground floor, with the main entrance located on the right-hand side. The original door-case incorporated a fan-light and had a broken pedimented head. A later photograph which dates to the mid-20th century (held at HALS; not reproduced) shows the building had another shop-front prior to the existing one.

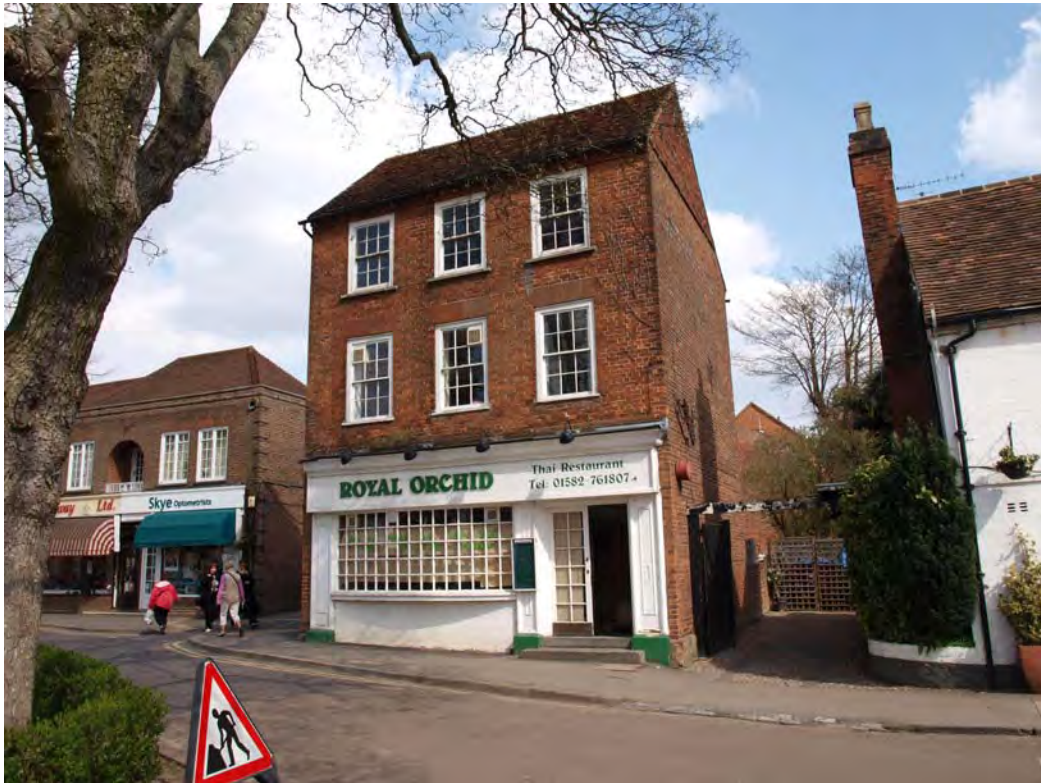
Plate 2: South-west elevation with modern shop-front, looking north-east

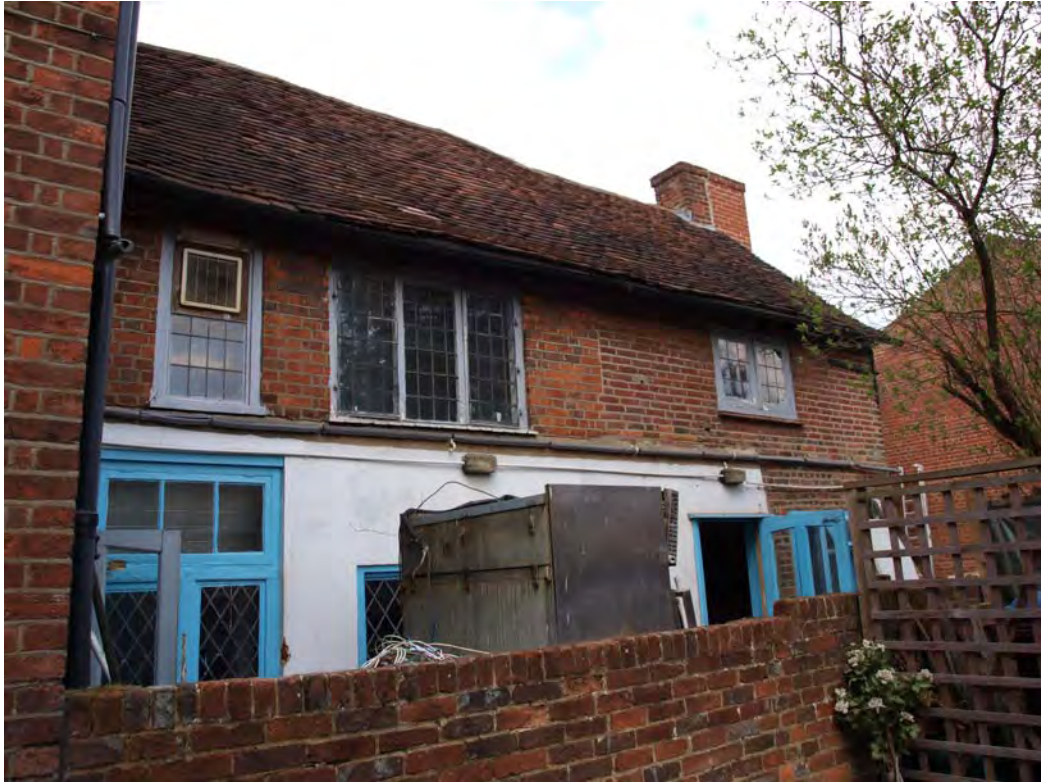
Plate 3: South-east elevation of rear range, looking north

- 5.4 The exterior of the adjoining rear range has been extensively modified with the result that it is now impossible to ascertain the original location of doors and windows (Plate 3). It is of two storeys, constructed in brick, and has an uneven plain clay tile roof which is gabled at the north-east end. Roughly three-quarters of the ground-floor level of the south-east elevation is

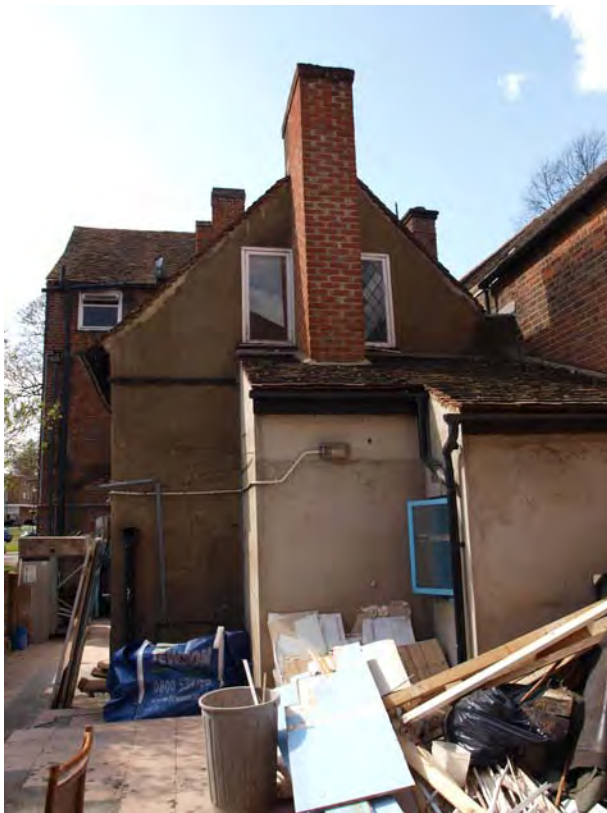
Plate 4: Lean-to (Unit 4) adjoining the north-east gable-end of Unit 3, looking south-west

- 5.6 The gable-end is adjoined by the single-storey lean-to addition (Plate 4). The visible part is rendered and has a central chimney stack either side of which is a single-light casement; the north-west one with diamond leaded panes, the other plain-glazed. The chimney stack is of two phases: the earliest part, which rises internally, pierces the apex of the roof, while a modern added flue projects forwards from the elevation.

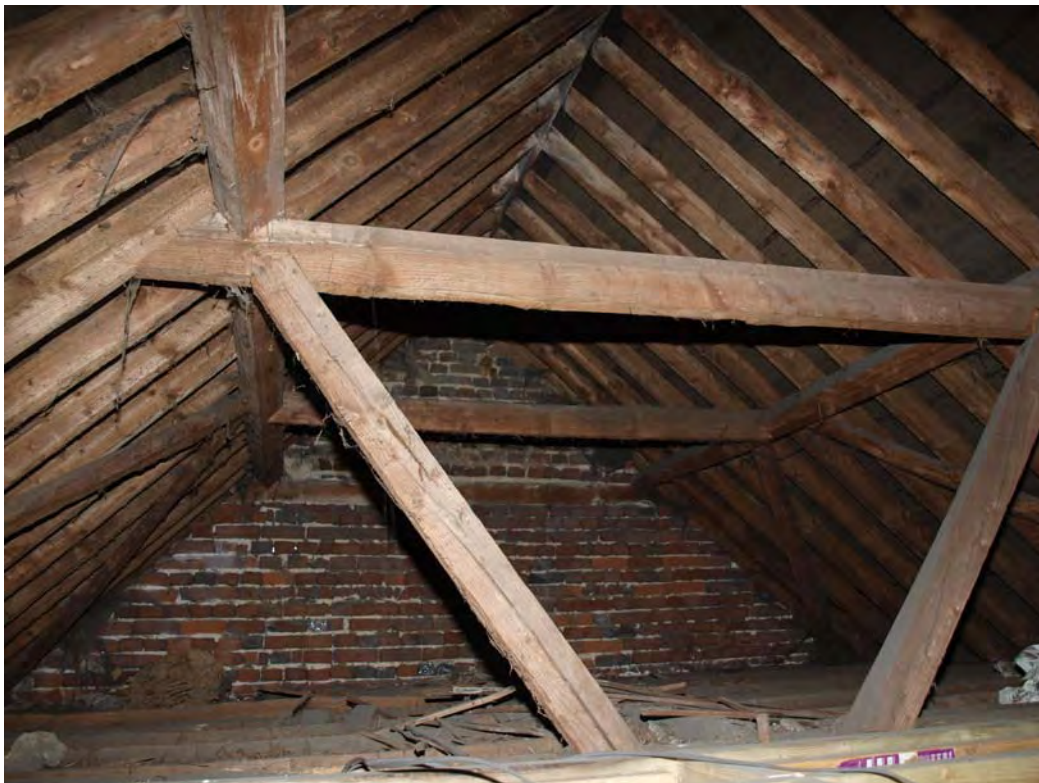
Plate 10: Roof above Unit 1, looking south-east

- 5.14 The roof was viewed through a missing section of the modern plasterboard ceiling above Room 2.02. It is of softwood construction, comprising a single principal roof truss consisting of principal rafters and a pegged collar claspings a single purlin in each roof pitch (Plate 10). Further support is offered by a pair of raking queen-struts on the truss, and on either side by intermediate collars bird's-mouthed to the purlins. The rafters meet at a ridge board at the apex, and there are also nailed rafter braces in each roof pitch.

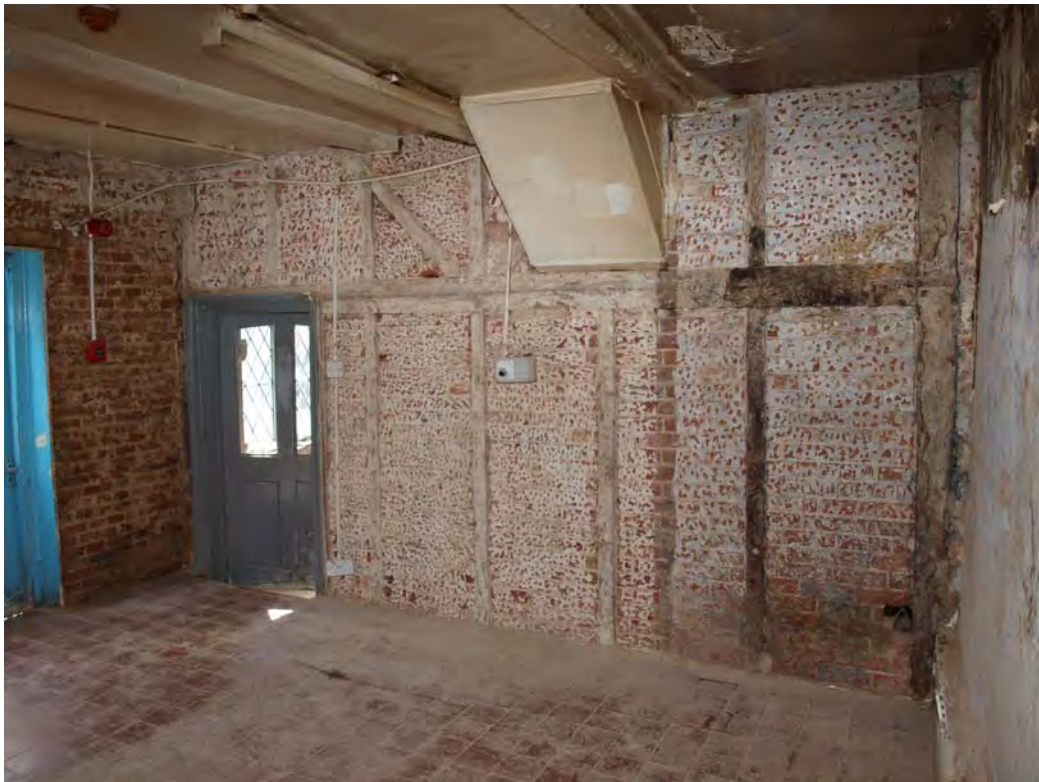
Plate 12: Unit 2 wall-framing, viewed from Room G.05, looking south-west

- 5.18 The partition walls, of which there are two, are located at the bay divisions (see Cross-Section, Fig. 9; Plates 12 & 13). Each comprises a pair of principal posts, which are inset from the outer walls, and jointed and pegged to a tie-beam. At ground-floor level, slender studs rise from a fragmentary sole-plate to the cross-beam, to which alternate studs are pegged. Above, the first-floor framing also incorporates a single primary-brace extending downwards from each of the posts to the cross-beam. At this level only the central stud and the primary braces are pegged. The roof is of clasped side-purlin type, consisting of two collars (located over the bay divisions) and common-rafter couples clasping a single purlin in each roof pitch (Plate 14). Above the tie-beams, each truss has six studs, four of which are pegged to the collar and tie-beam, plus another two studs above the collar. A single rafter-brace is located in each pitch at the north-east end of the roof.

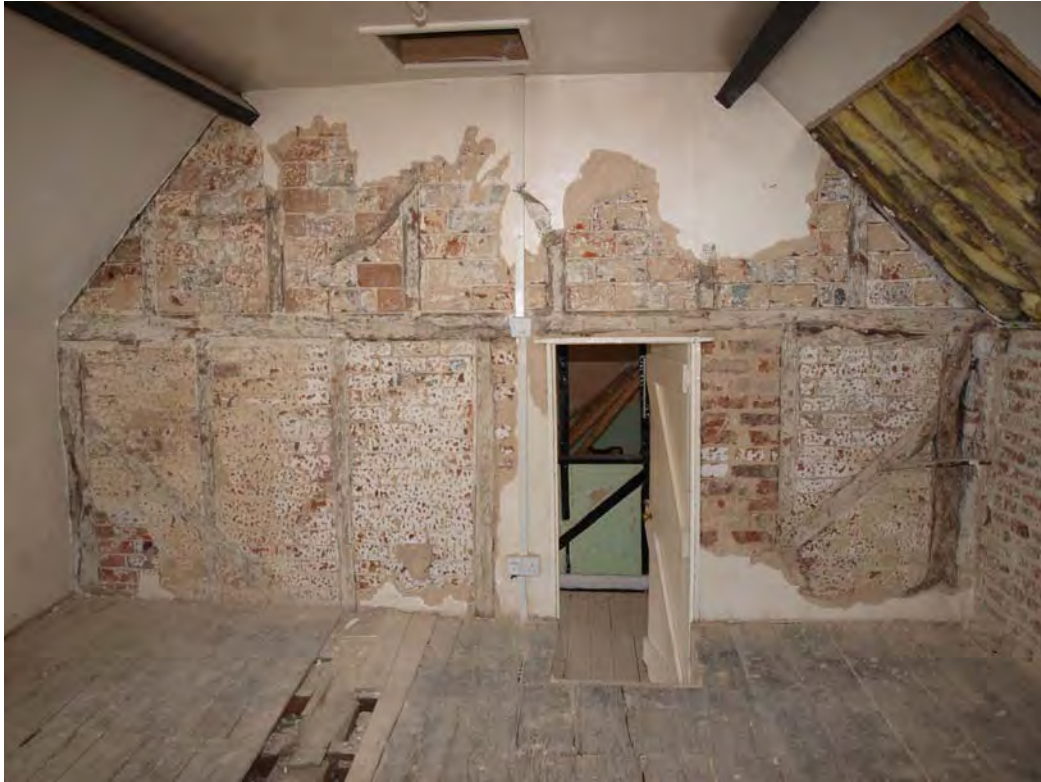
Plate 13: Unit 2 wall-framing, viewed from Room 1.05, looking south-west

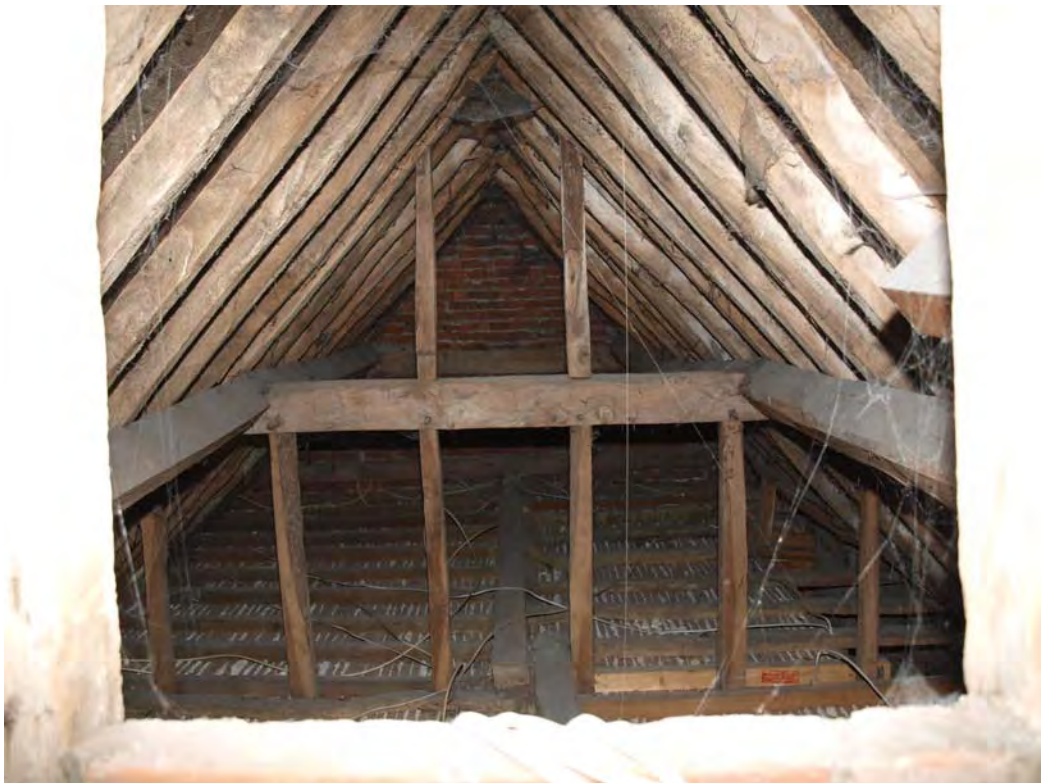
Plate 14: Roof over Unit 2, looking south-west

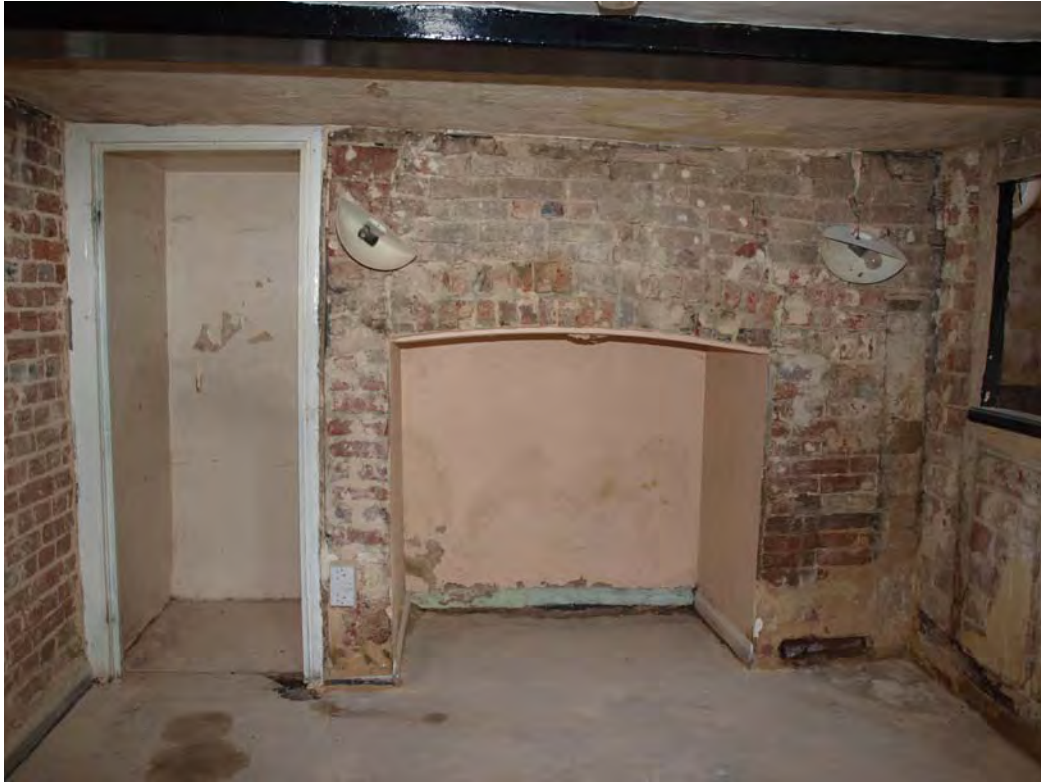
Plate 15: Fireproof safe on north-west wall of Room 1.03, looking north-west

- 5.19 Room G.03 on the ground floor is entered directly from the street range, through a modern fire-door. The north-west wall of this room contains a chimney-stack with large fireplace (Plate 15), on the left-hand side of which is a full-height cupboard (door missing). The south-west wall, which is formed by the rear wall of the street range, contains the blocked inserted opening noted within Room G.02 (Plate 16). The south-west wall contains the modified two-light window with over-light, while the north-east partition wall contains an

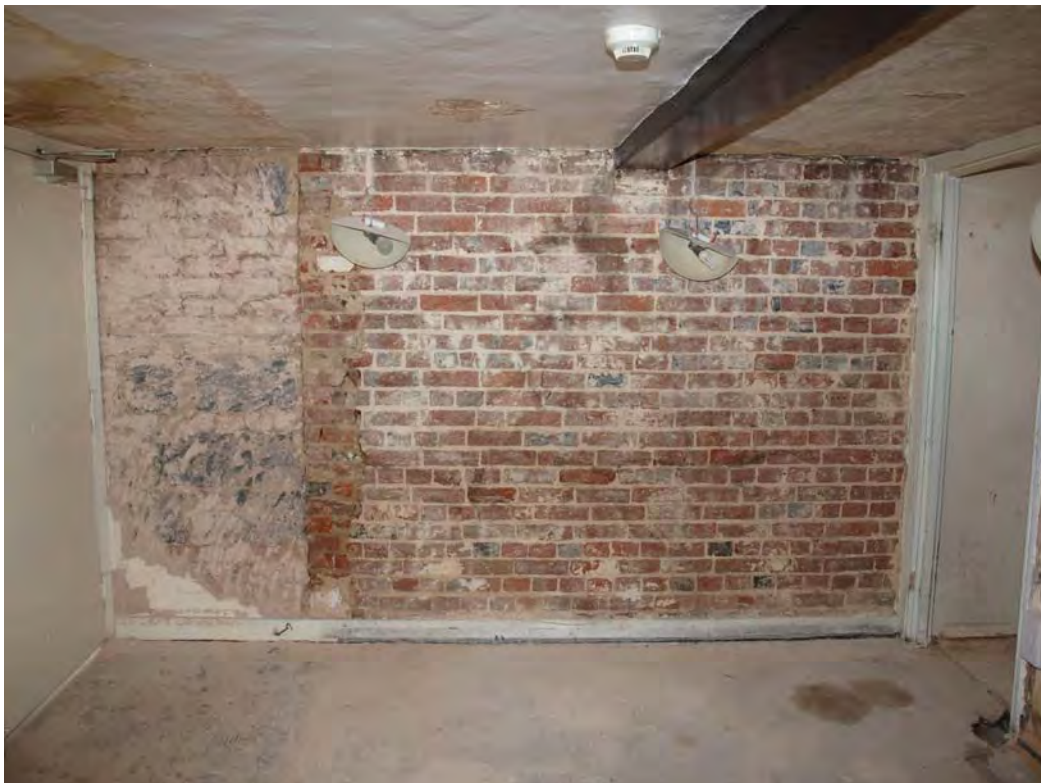
Plate 16: Rear wall of Unit 1 showing blocked inserted doorway, viewed from Room G.03, looking south-west

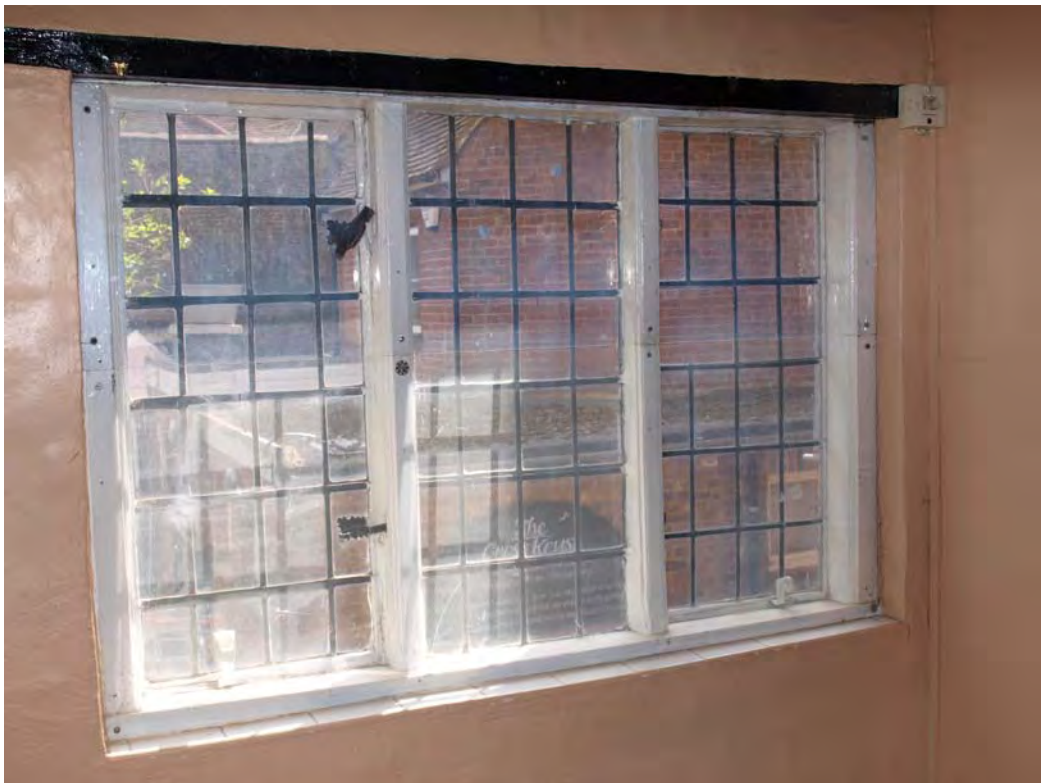
Plate 20: Window on south-east wall of Room 1.04

- 5.22 The most notable feature within Room 1.04 is the three-light window on the south-east wall (Plate 20). It has stout mullions, with a simple moulding to the arrises and rectangular leaded glazing (retaining some old glass). The opening lights have turnbuckle catches and tulip-leaf handles. From the exterior it is clear that this window is not in its original location, the brickwork having been cut to accommodate it, nevertheless its form is consistent with the c. 1700 date suggested by the timber-framing and it is possible that it has been reused from another location within the building. Inserted within the north-east wall is a 20th century door, through which a series of steps lead up into Room 1.05.

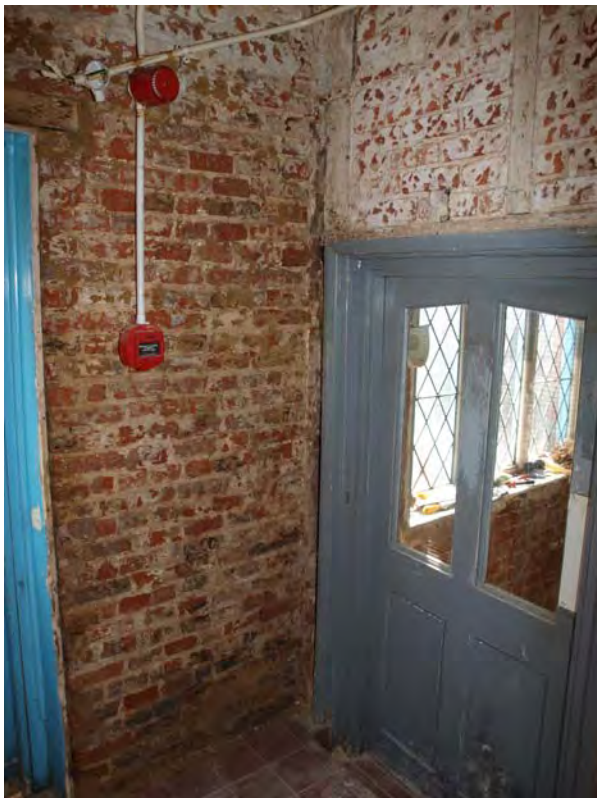
Plate 22: Straight joint within the brickwork at the junction of Units 2 and 3, view from Room G.05, looking south

- 5.23 Unit 3, which comprises a single room on each floor, is more accurately described as being of one-and-a-half storeys; the first-floor level being accommodated partly within the roof-space. With the exception of the section of original, probably 17th-century brickwork visible on the exterior, the wall construction is most readily visible on the interior, as at ground-floor level the south-east and north-east walls have been stripped of their plaster finish, as have the north-west, north-east and part of the south-east walls on the first floor. The brickwork, which is orange, is laid in lime mortar in a haphazard bonding pattern (Plate 21). There is much variability in the dimensions of the bricks, although they are on average thinner than the bricks of the later units, with most measuring between 40 and 50mm. As with Unit 2, the apparent offset at the base of the north-west wall (presently tiled over) suggests that a pre-existing wall was utilised within its construction, and at both levels the north-east wall, which itself is probably of two phases, appears to abut the brickwork of the north-west wall. Further phasing is clear on the ground floor, where a straight joint in the brickwork is clearly visible in the south corner of the room, at the junction with Unit 2 (Plate 22).

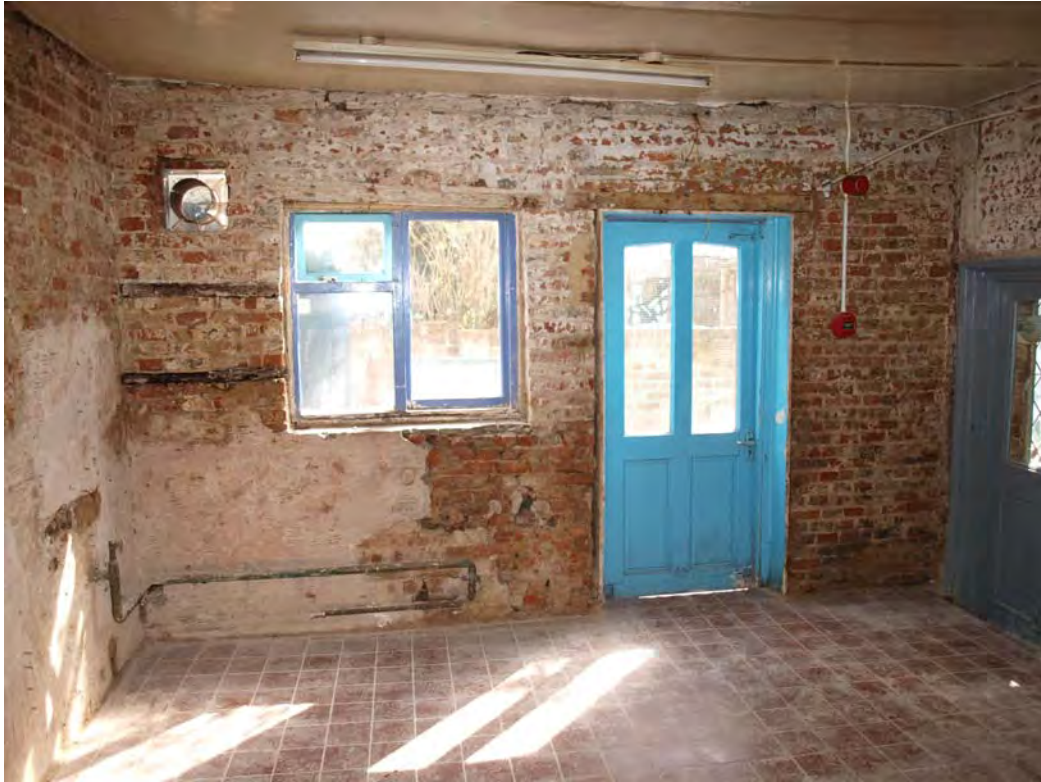
Plate 23: South-east wall of Room G.05, looking south-east

- 5.24 The ground floor room (G.05) is accessible internally, through a doorway inserted in the north-east wall of G.04, and through an external doorway on the south-east (Plate 23). Each doorway contains a 20th-century four-panel door, of which the upper two panels within each are glazed. North-east of the external door is the two-light casement window with top-hung opening section. The north-east wall contains an inserted doorway into Unit 4 (Room G.06). The floor within this room is set c. 0.25m higher than that of the adjacent range and is finished with red quarry-tiles. The ceiling contains two principal axial joists supported within the brickwork of the south-west and north-east walls (Plate 12). Each is chamfered and stopped at either end. The south-east wall contains a horizontal timber, possibly originally a wall-plate, at ceiling level (Plate 23).

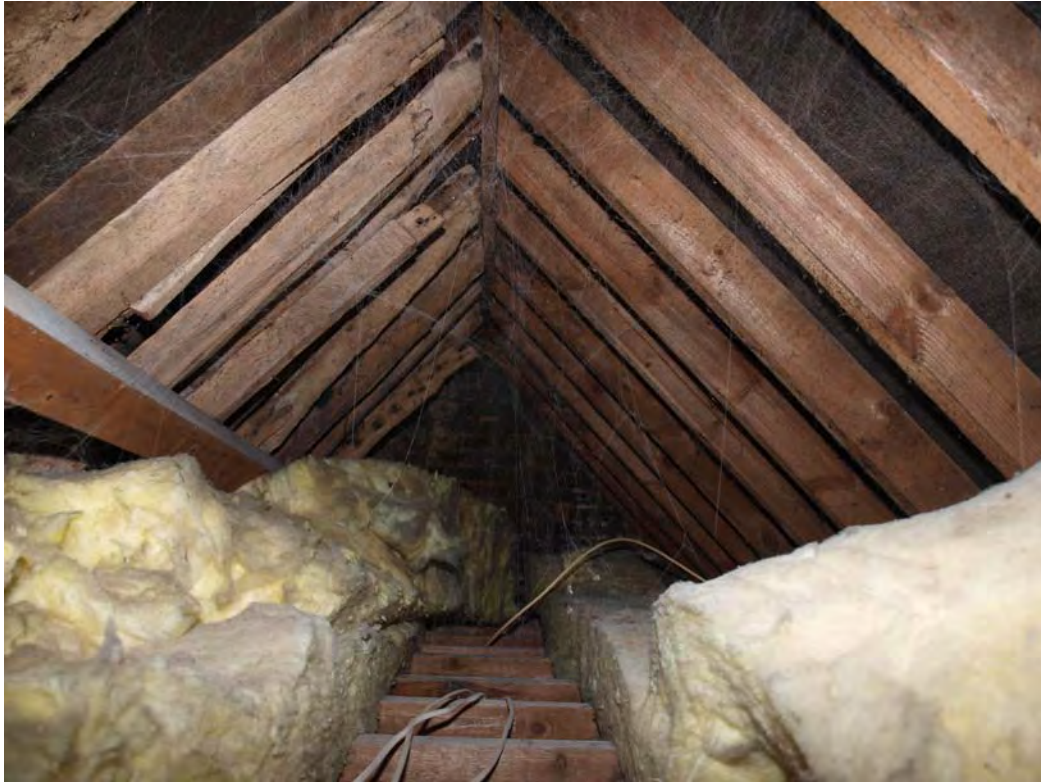
Plate 25: Early rafters within roof over Unit 3, looking north-east

- 5.26 The room is ceiled beneath the level of the collars, at which point two in-pitch purlins are visible. A hatch on the south-west side of the room gives access to the roof-space, including that above Unit 2. The roof is of 20th-century construction in precisely-sawn softwood, consisting of paired common rafters, which meet at a ridge board. Within the north-west pitch of this roof, there is the fragmentary survival of an earlier roof, consisting of a series of earlier rafters, now supported by a secondary purlin (Plate 25). The rafters appear to be set at a very slightly shallower pitch than the present roof, and are slightly shorter, the ends of the rafters preserving mortices and tenons for their now-lost couples from the opposing pitch.

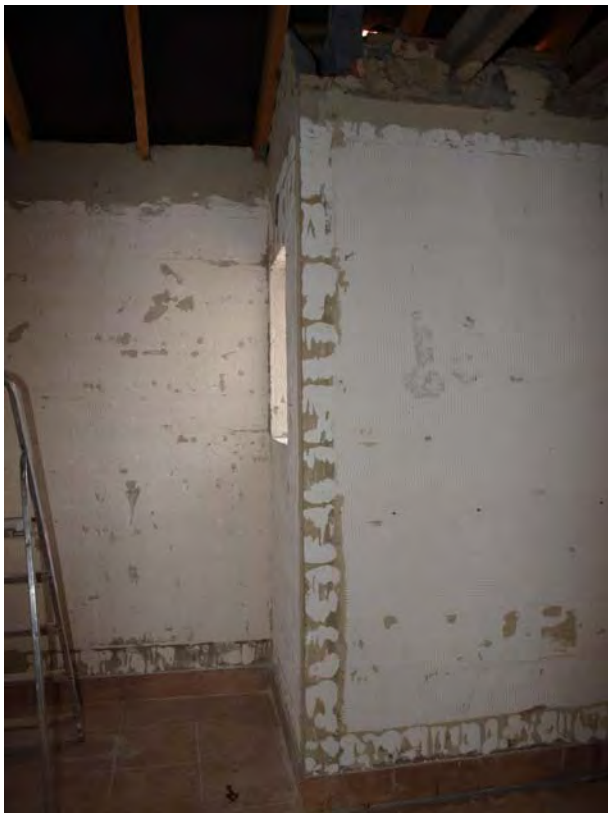
Plate 26: Room G.06, looking north-east

- 5.27 The interior of Unit 4 is open as a single L-plan room (G.06), which is presently open to the roof (Plate 26). All visible fabric is modern; the floor which is set c. 0.1m higher than the adjacent room (G.05) being covered in modern tiles, whilst the walls are fully plastered. The roof is of simple lean-to form, comprising precisely-sawn softwood rafters. The south-east wall contains a single casement window with obscured glass.
