**LOUSE HOUSE CULVERT ON THE ROYAL MILITARY CANAL,
NEAR BILSINGTON, KENT**

ARCHAEOLOGICAL WATCHING BRIEF

Report No. 2012114

Project No. 5334
Report No. 2012114
Site Code: LHC12

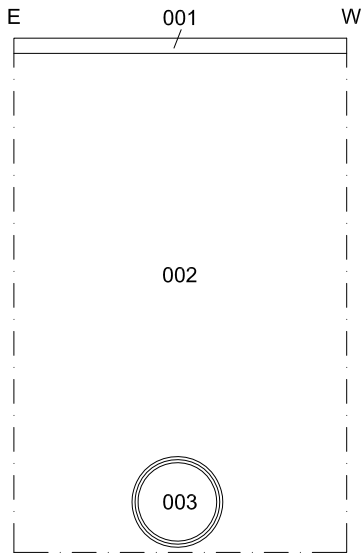
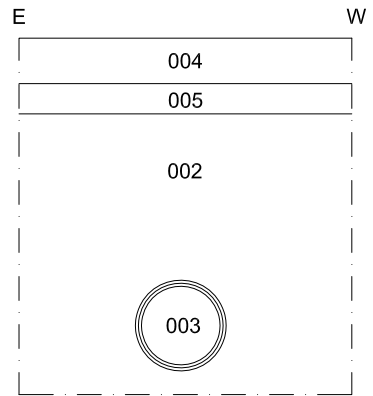
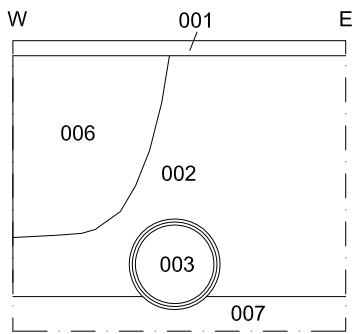
Section 1

- 5.2 Except where noted to the contrary, the excavations revealed a basic stratigraphy consisting of a thin layer (c. 0.1m) of topsoil (001) over a mid-brown silty-clay (002) back-fill or up-cast deposit (Fig. 4; Plate 3). The depth of this deposit varied between c. 1.5m towards the north end of the culvert and c. 3.5m towards the south end. Towards the northern end of the excavated area, in the south-facing section at Stage 5 a layer of blue-grey clay, possibly natural alluvial clay was encountered at a depth of c. 1.7m beneath the ground surface.

- 5.5 Within Stage 5 of the excavations, it was observed that at some point in time part of the culvert had collapsed and a resulting void above had been in-filled with brick rubble (006) (Fig. 4; Plate 6).

- 5.6 Roughly half-way along the length of the culvert, within the north-facing section of Stage 4, a layer of disturbed clay (004) c. 300mm in depth was seen overlying a layer of crushed brick (005) which was c. 200mm in depth (Fig. 4; Plate 7). This has been interpreted as a possible road/track surface, related to the Royal Military Road.

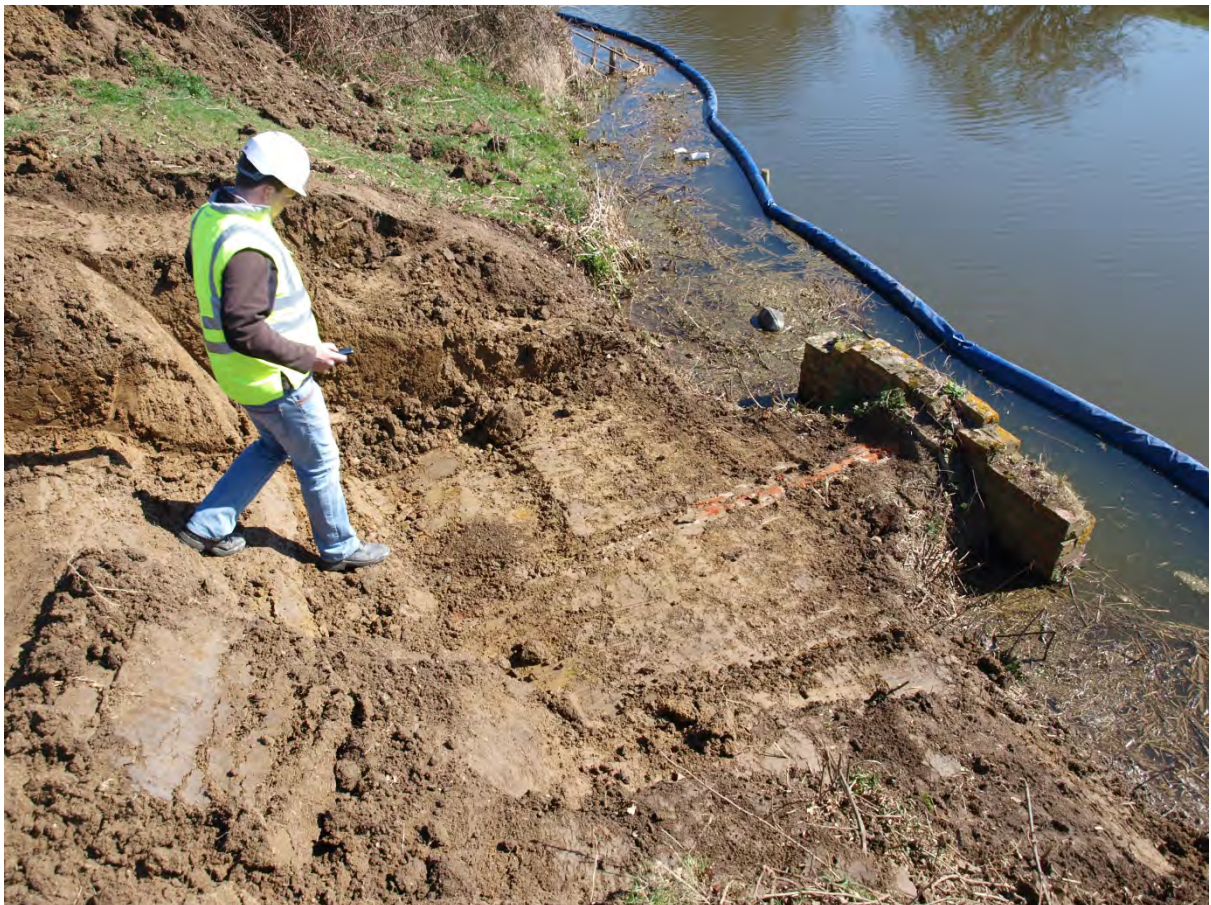
- 5.1 The culvert, which extended for 25m north – south was excavated in six stages, with each section being sealed with clay and backfilled prior to the excavation of the ensuing section (Fig. 3). The maximum width of the excavations was 2.2m. Work commenced (Stage 1; Plate 2) at the south end with the removal of the head-wall (referred to as Structure 3 in Briscoe 2012), and continued north, concluding (Stage 6) with the removal of the north head-wall (Structure 2, Briscoe 2012). Each stage of excavation provided the opportunity to view the structure of the culvert in section.

Plate 2: Stage 1 of the excavations which included the removal of the head-wall, looking east

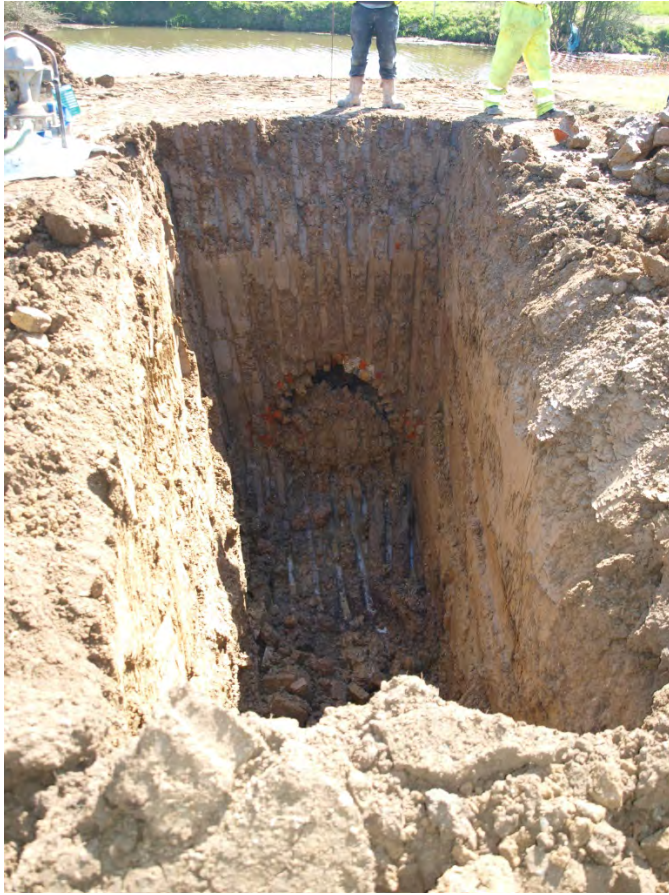
Plate 3: Stage 3 of the excavations (north-facing section)

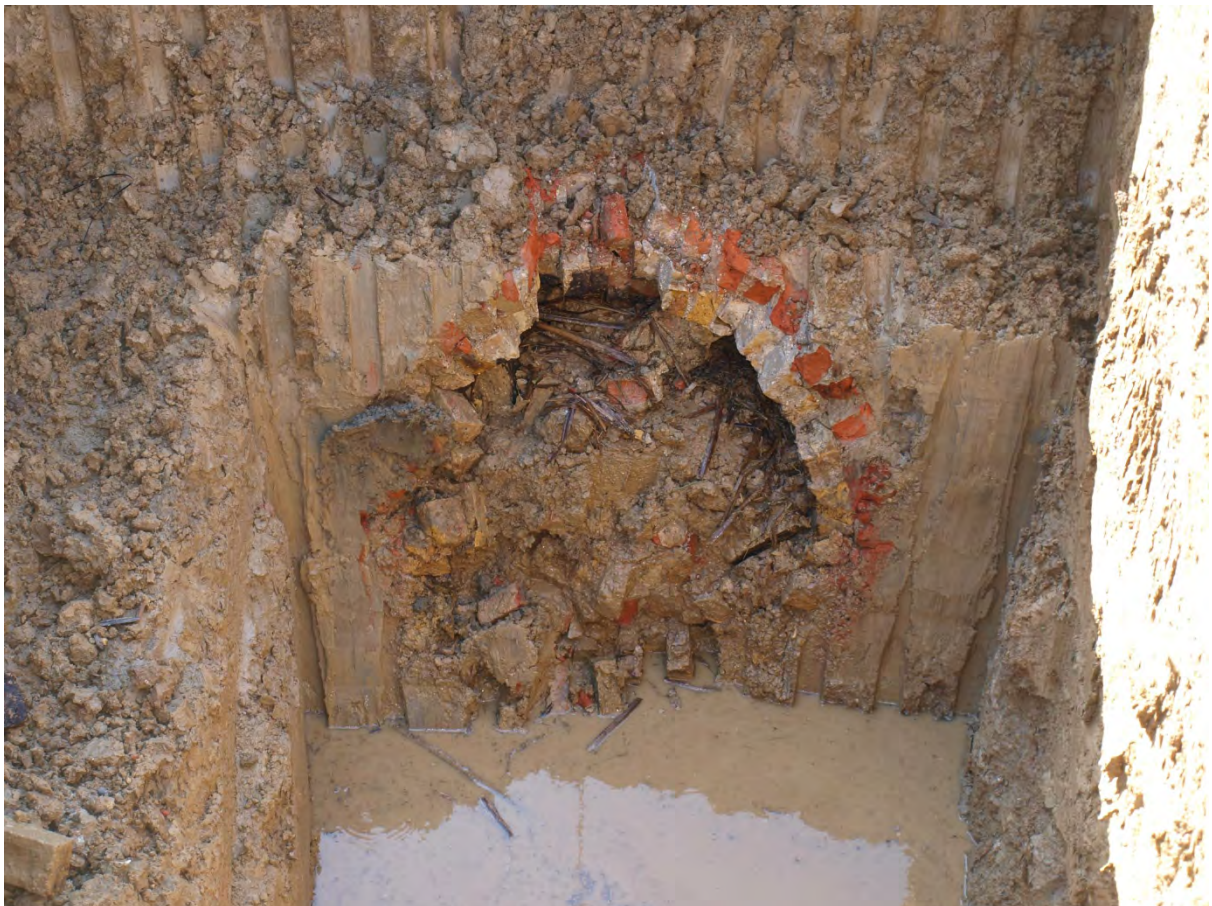
- 5.3 The culvert (003) measured c. 600mm in diameter and was circular in section (Plate 4). Its construction comprised two skins or brickwork laid on edge. The inner skin was of yellow Kentish stock bricks (museum of London fabric code

MOL3035), which have a very slight, indistinct frog. These bricks were in production from 1770 until 1940, although the general warped appearance of the bricks suggests they are probably early examples, from the very end of the 18th to early-19th century (Sarah Porteus pers. comm.). The outer skin of the culvert was of orange bricks, which are unfroged and of a slightly under-fired orange sandy fabric. Dating for such bricks is less accurate, broadly 17th to 19th century, although they may be reused as one of the bricks within the sample has two layers of mortar visible (Sarah Porteus pers. comm.). In places gravel ballast was visible beneath the culvert structure. No construction cut was visible. The culvert sloped downwards (north – south) along its length, the top of it lay c. 1.2m beneath the ground surface at the northern end, while at the southern end the top lay c. 2.8m beneath ground level.

Plate 4: Detail of culvert as seen in north-facing section of Stage 2

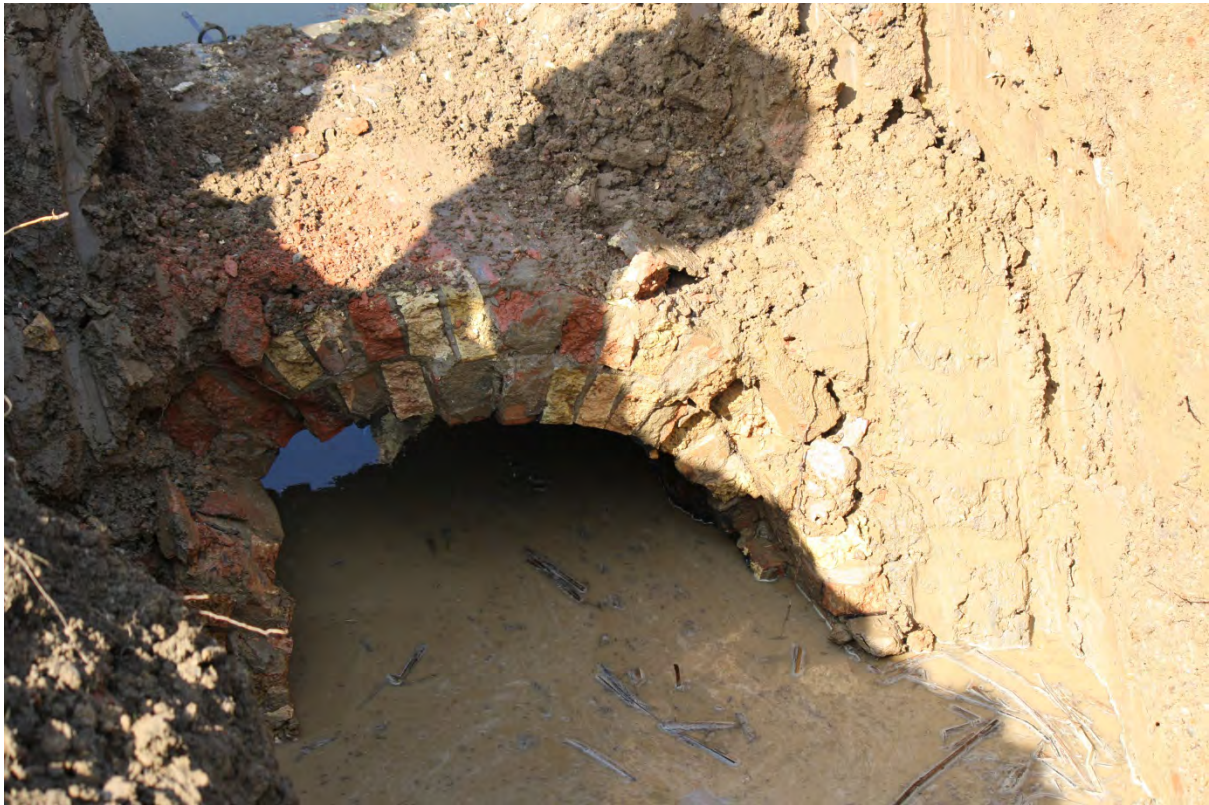
- 5.4 Towards the north end, within Stage 6 of the excavations, it was apparent that the workmanship involved in its construction was less-accomplished, with yellow and orange bricks being used in both skins, possibly indicating that the culvert at that end had been re-built, reusing original bricks (Plate 5).

- 6.2 The mixed nature of the brickwork at the northern end of the culvert suggests that it had been repaired at some point, possibly in connection with the construction of the head-wall (Structure 2, Briscoe 2012) in the late-19th or 20th century. Certainly there is evidence that the structure has failed in the past, as exposed in Stage 5 of the excavations, where an area of collapse was visible, together with some rubble back-filling of a void which had resulted above.

Plate 5: Mixed brickwork at north end of culvert (Stage 6), looking north

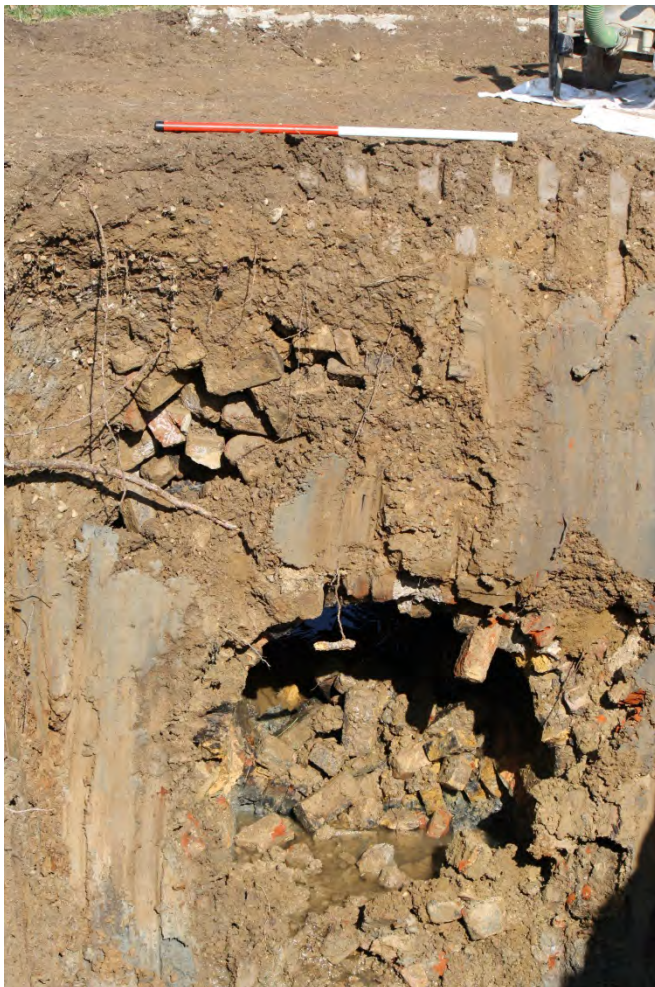
Plate 6: Area of collapse and rubble-filled void (006) visible at Stage 5 of the excavations, looking north

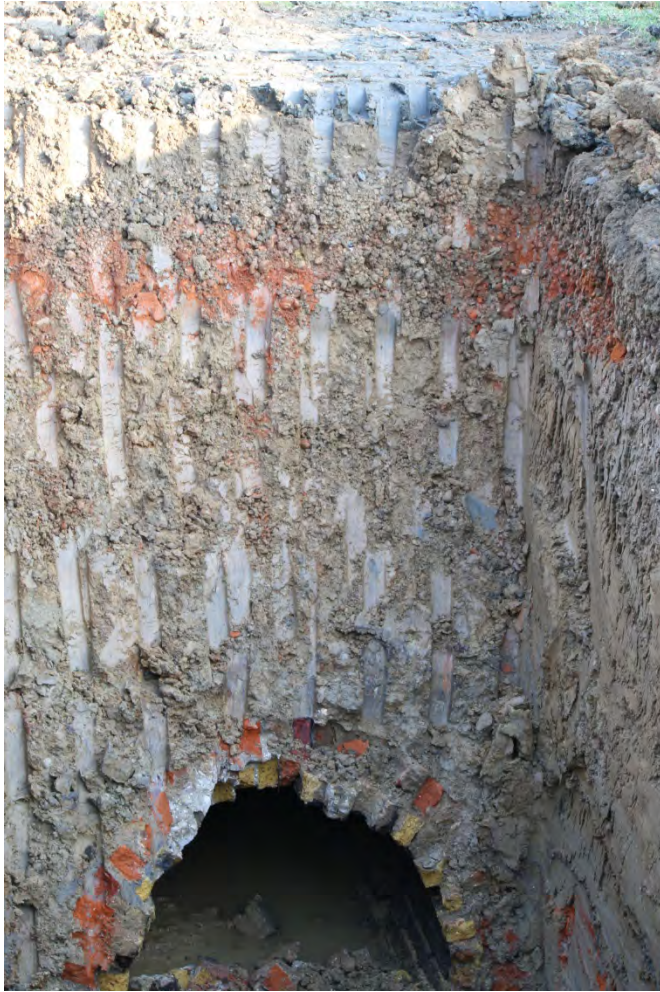
Plate 7: Layer of crushed brick (005) visible in north-facing section of Stage 4
