**An Archaeological Watching Brief Report  
The Holy Cross, Bignor Road, Bignor  
Pulborough, West Sussex**

**Planning Application Reference: BG/10/01433/FUL**

**ASE Project No: 4715  
Site Code: HCB 11**

**ASE Report No: 2012120  
OASIS ID: archaeol6-127158**

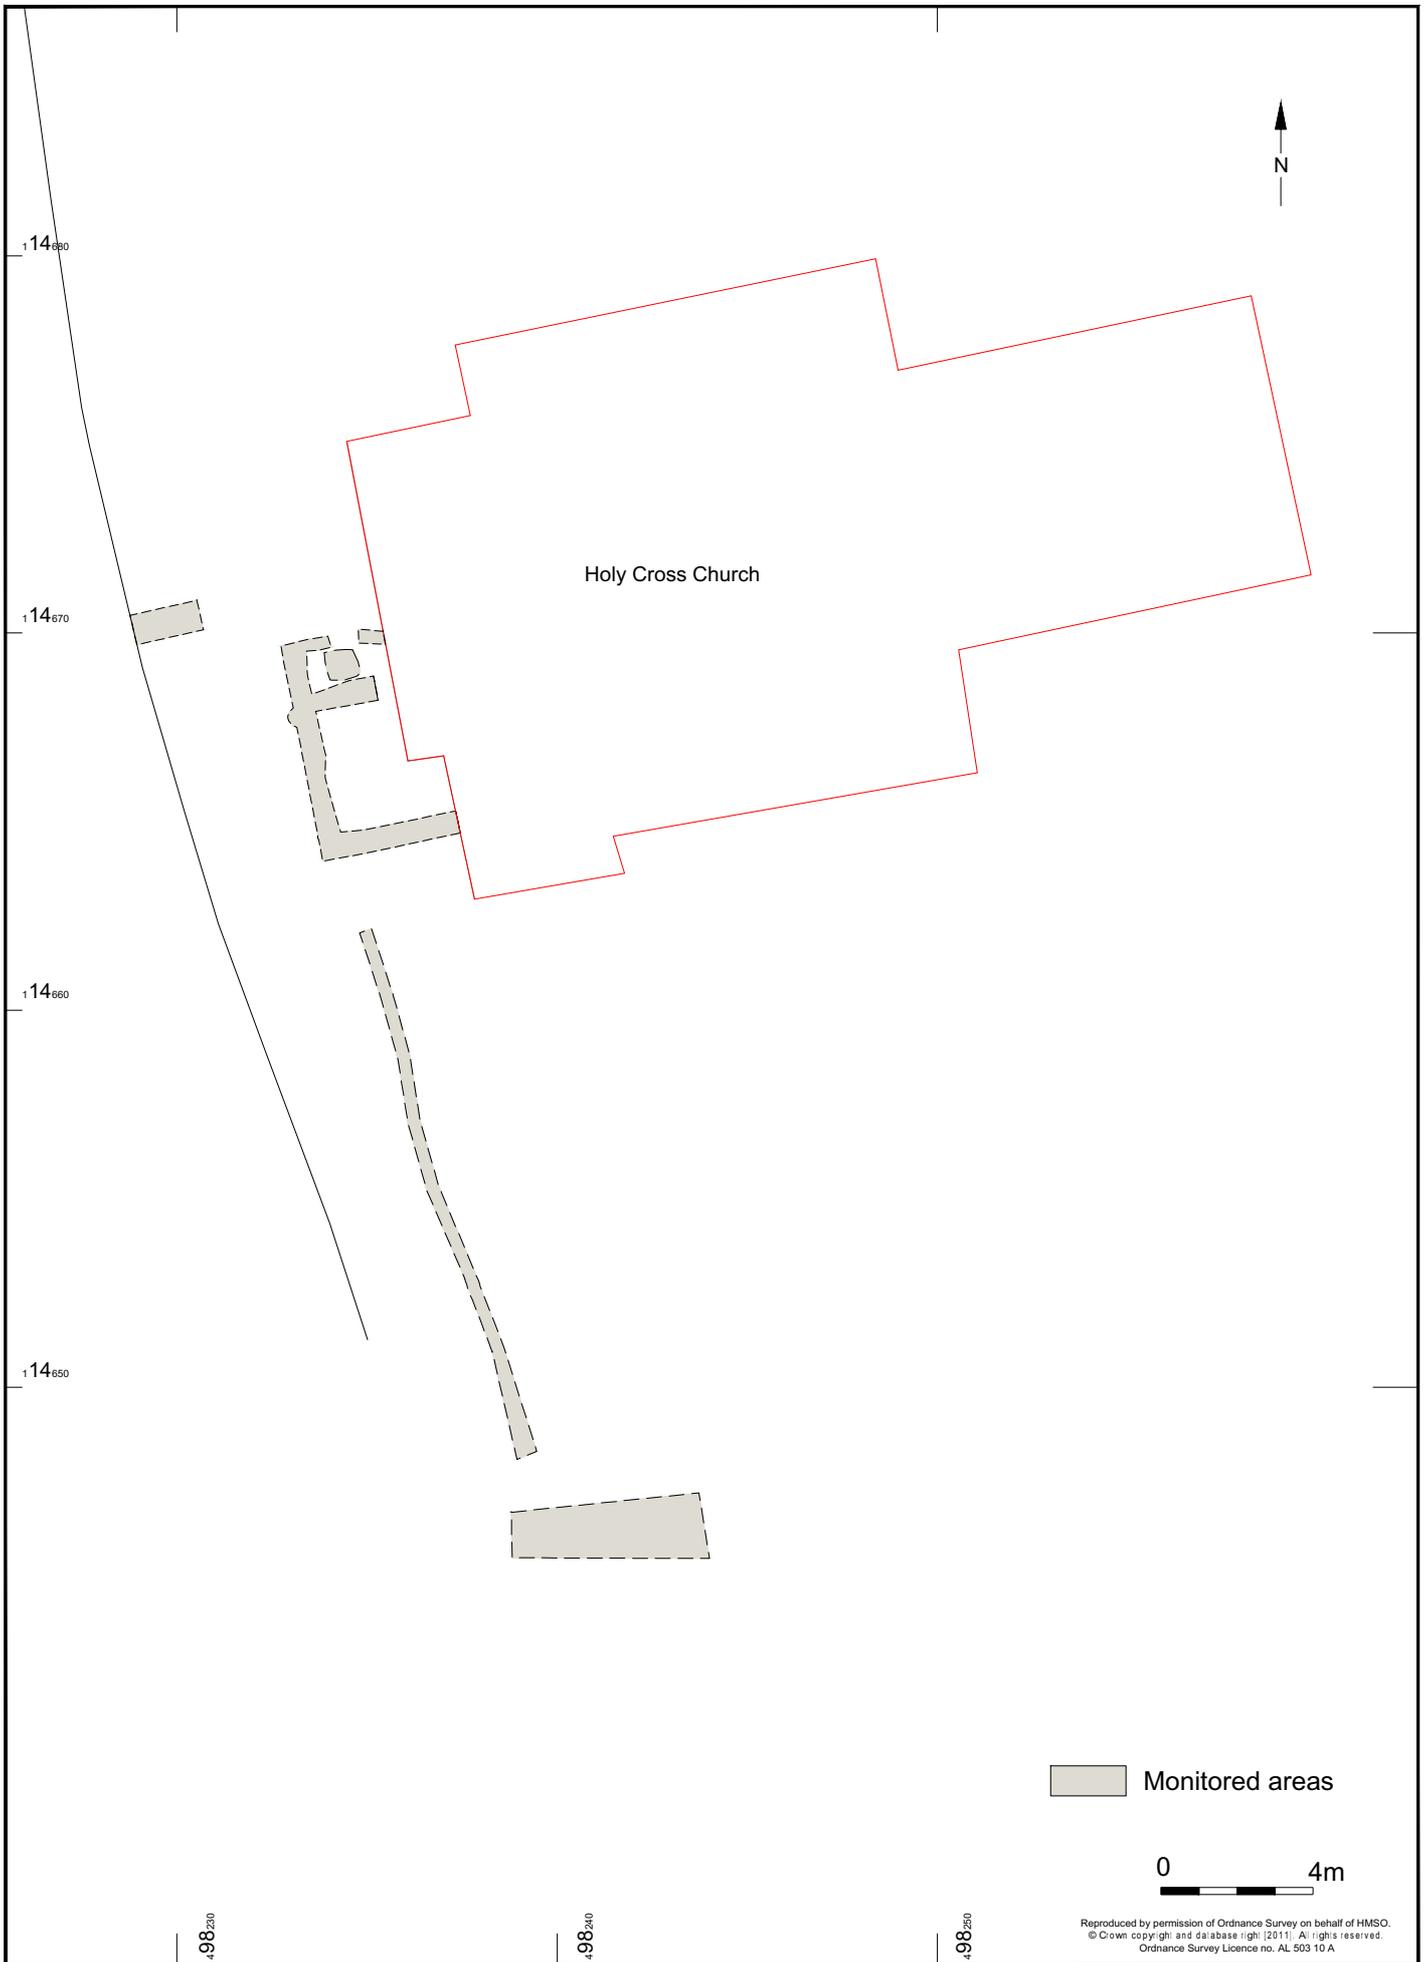
© Archaeology South-East		The Holy Cross, Bignor	Fig. 2
Project Ref: 4715	2012	Location of monitored areas	
Report Ref: 2012120	Drawn by: AR

3.1.1 The groundwork consisted of the excavation of trenches for the extension to the church building, the excavation of service trenches and soakaway as well as a pit which was excavated for the reburial of all the recovered skeletons. The original drainage layout was adapted to minimise the risk of disturbing more graves.

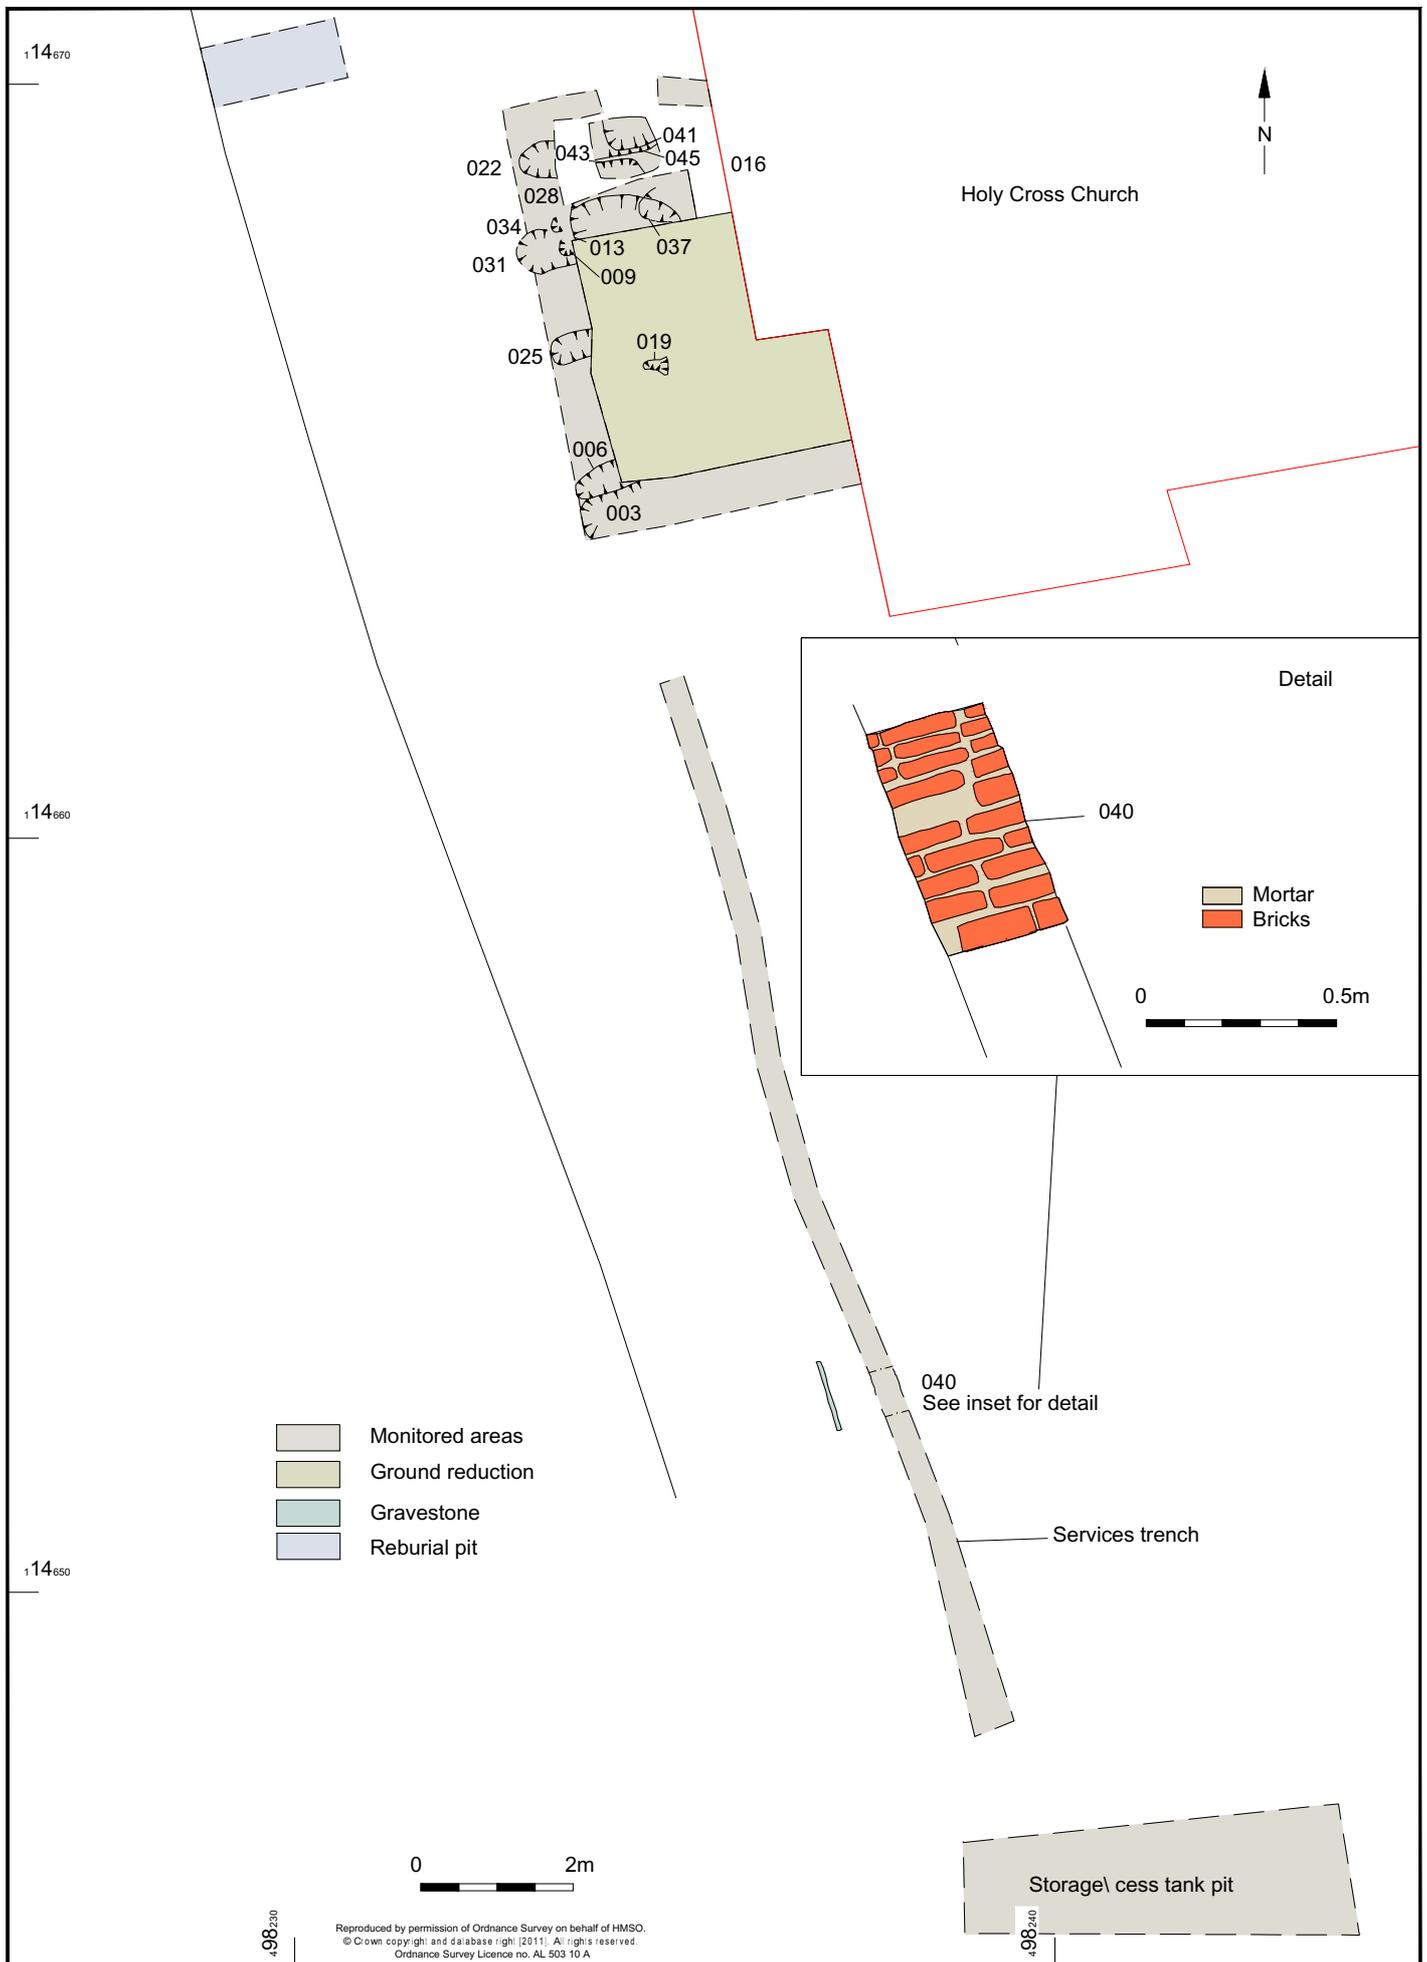
© Archaeology South-East		The Holy Cross, Bignor	Fig. 3
Project Ref: 4715	May 2012	Plan of monitored ground work and archaeological features	
Report Ref: 2012120	Drawn by: AR

- 4.4.1 Fifteen grave cuts were recorded during the monitored works within the foundation trenches, the reduced area and the small pit excavated for a water pipe [003, 006, 009, 013, 016, 019, 022, 025, 028, 031, 034, 037, 041, 043 and 045]. Thirteen of these graves contained partially articulated skeletons at the monitored levels [003, 006, 009, 013, 016, 019, 022, 025, 028, 031, 034, 037 and 045]. Graves [003, 006, 009, 013, 016, 022, 025, 028, 031, 034 and 037] were revealed within the foundation trenches for the extension to the church. Grave [019] was encountered during ground reduction in the area of the new foundations at a depth of 300mm BGL. Graves [041, 043 and 045] were observed within a small pit excavated for a water pump.

- 4.4.4 All burials were aligned roughly east-west with the body in a supine position and the head at the west in traditional Christian manner. Many of the burials were inter-cutting and truncated each other which suggest that this part of the graveyard was used over a long period of time. The result of this continuous grave-digging, in addition to the limited area of excavation for the development, was that only partial skeletons (e.g. one arm or an articulated foot/spinal column) were uncovered during the watching brief. It was also clear that some skeletal elements had been deliberately relocated as a result of disturbance during grave-digging. The level of this intercutting meant that phasing the burials was impracticable; however some ordering of the burials into rows is discernible from the plans.

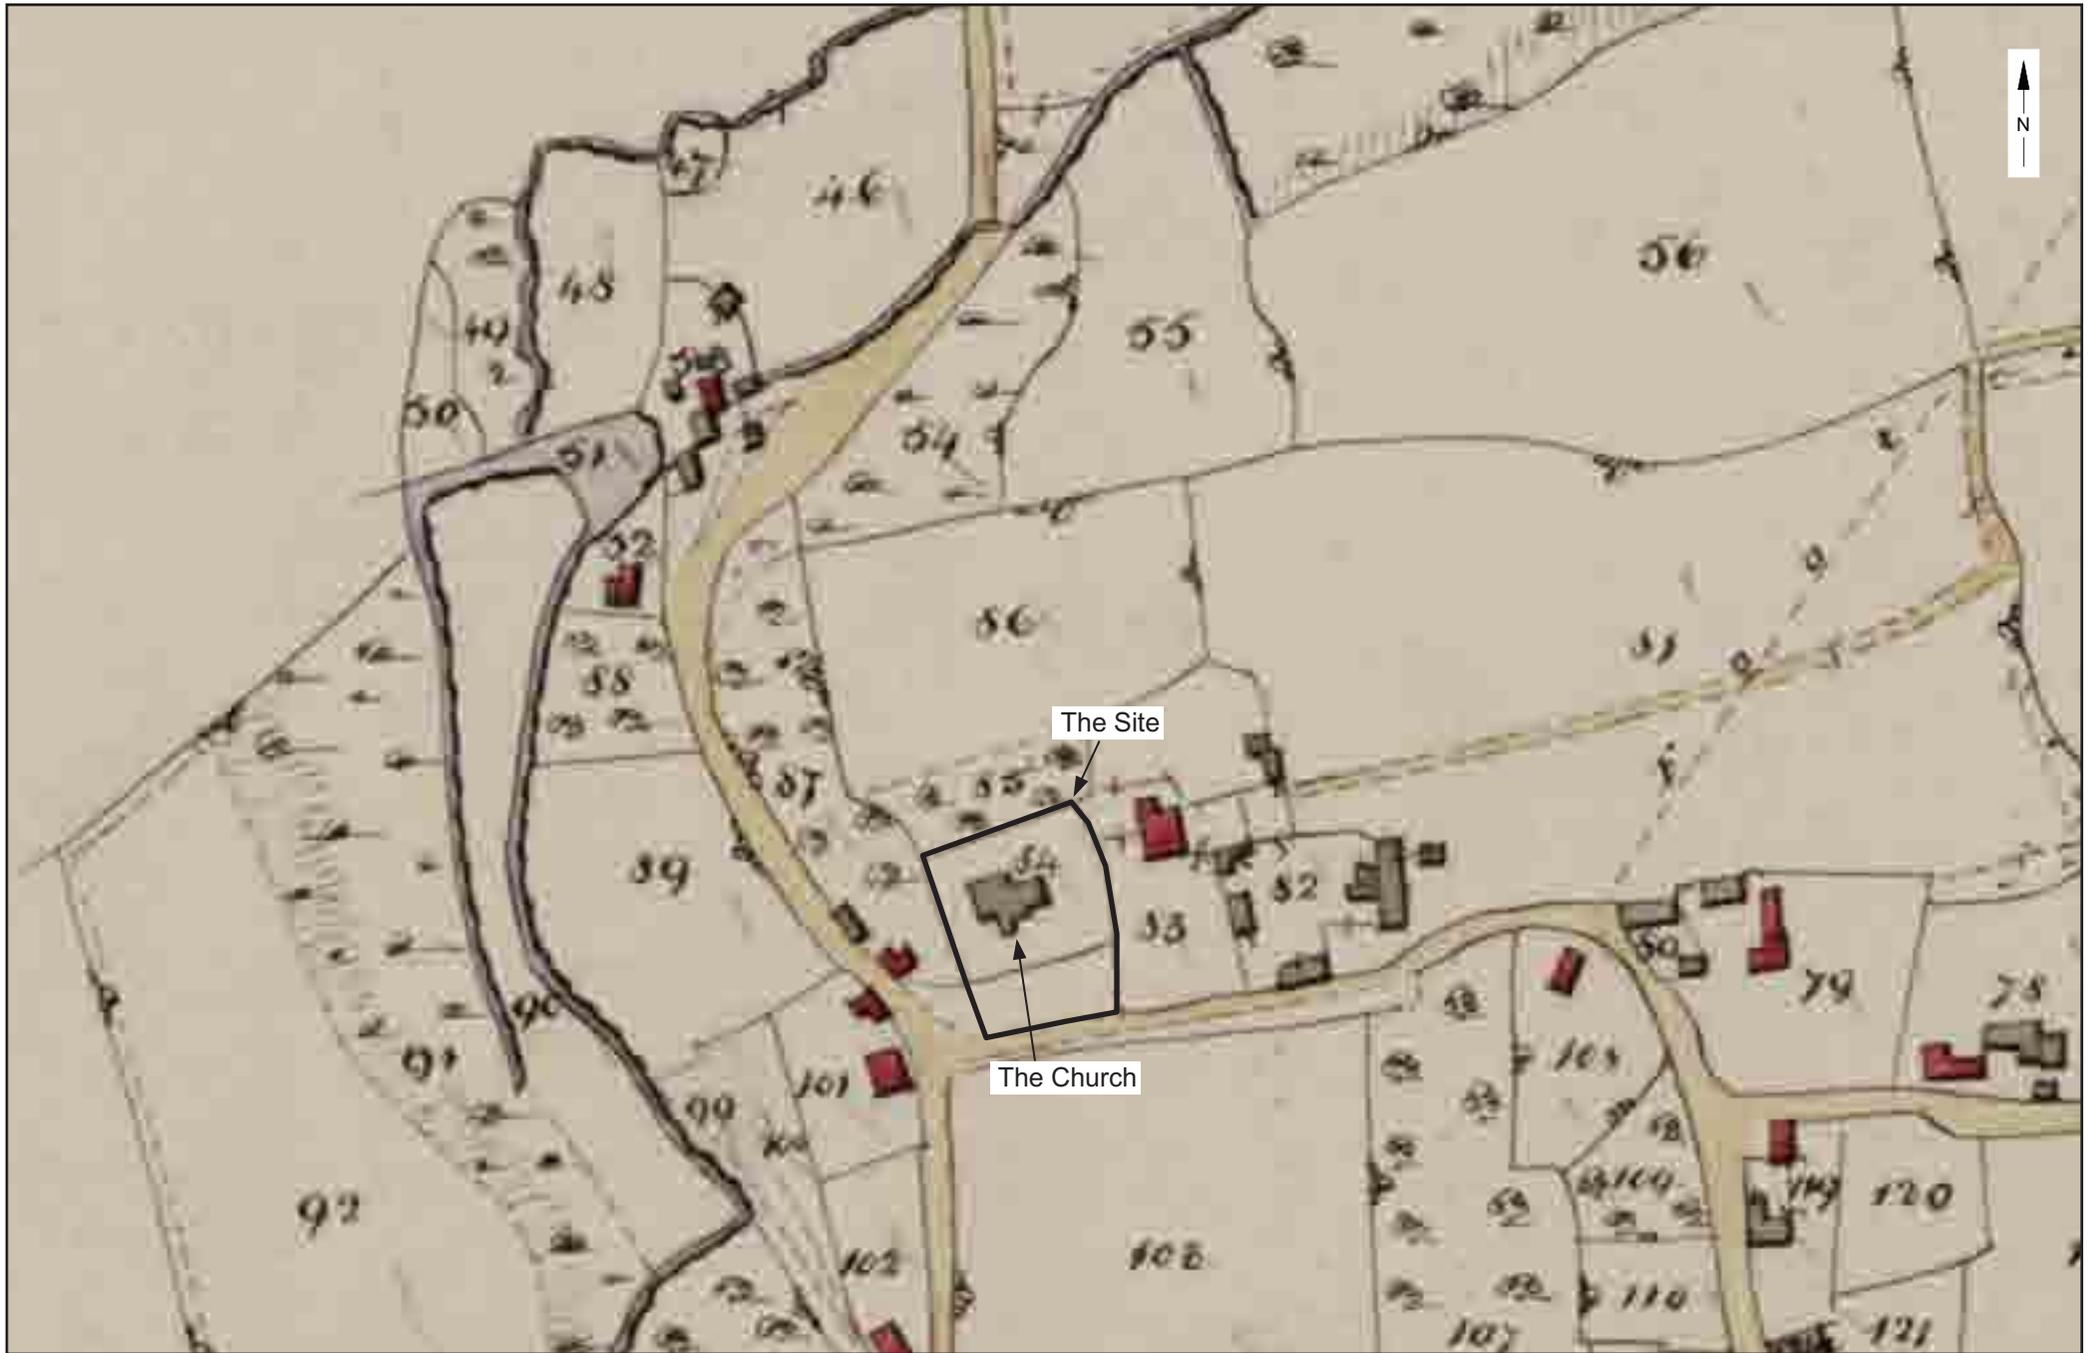
© Archaeology South-East		The Holy Cross, Bignor	Fig. 4
Project Ref: 4715	May 2012	1843 Bignor Tithe Map	
Report Ref: 2012120	Drawn by: AR

- 2.3.4 The current church is Listed Grade I (LBS Number: 300339). Little evidence of a Saxon church is evident in the current building since it was rebuilt in the 13<sup>th</sup> century. However, the chancel arch and perhaps the north and south doorways and font may be of Saxon origin (Fisher 1970, 40). Surviving Norman features are restricted to the chamfers of the jambs of the north and south doorways (*ibid.*). A restrained restoration was undertaken between 1876 and 1878 under the guidance of the eminent architect George Edmund Street (Symes 2010). The mid-19<sup>th</sup> century plan of the church is shown on the 1843 Bignor Tithe map (Figure 4).

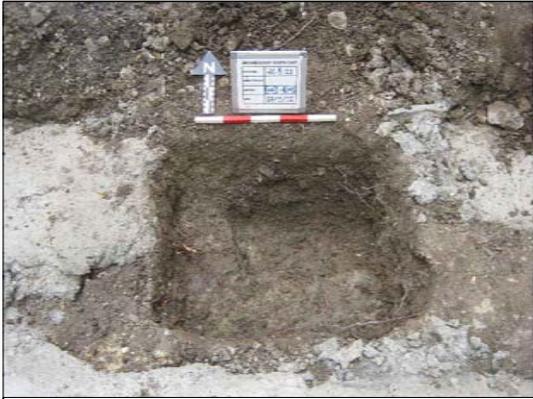
Fig. 5.1: Water pump pit

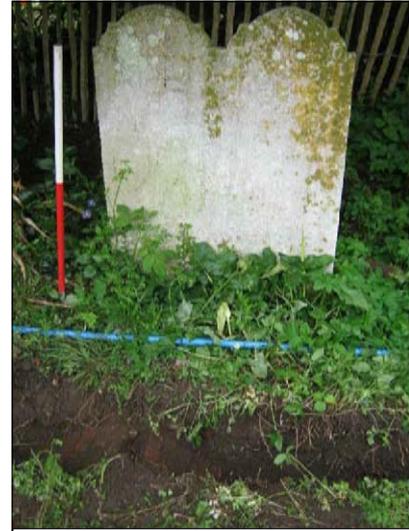
4.2.2 A brick vault [040] was partially revealed during the excavation of a service trench (Figures 5.2 and 5.3). Both the head and foot stones were observed for this, but no grave cut was observed at the level of excavation. The head stone suggests a double burial which could indicate that the vault contained stacked burials as no adjacent burial was revealed. The vault consisted of fired-red bricks, which were mortar bonded. It was preserved *in-situ* within the service trench so although this was revealed it was not directly impacted by the groundwork.

Fig. 5.2: Brick vault facing west

- 6.6 The red brick-built vault was largely preserved *in-situ* within the service trench. This was the only grave with a marker in the form of a gravestone. The fourteen other graves identified during the groundwork were all unmarked.

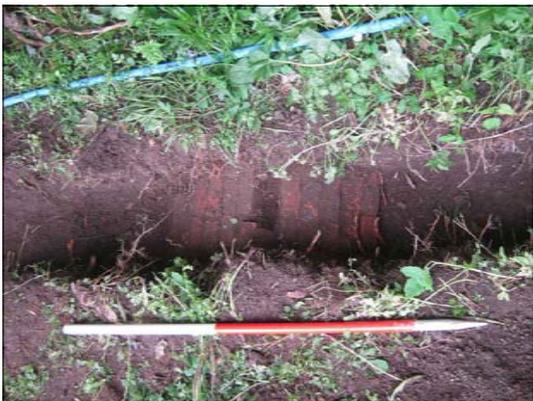
5.1.1 A single un-frogged brick of probable 17<sup>th</sup> to mid-18<sup>th</sup> century date was recovered from brick vault [040]. The brick is well-fired and uniform and measures 55mm thick x 210mm long x 113mm wide and weighs 2208g. Attached was some grey-cream coloured lime mortar which contained fine sand.

Fig. 5.3: Brick vault

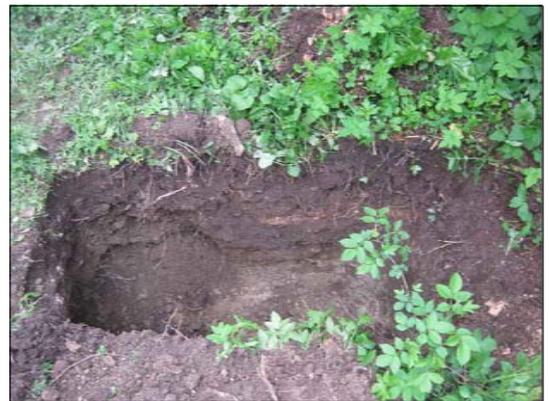
4.2.1 The foundation trenches for the extension to the church building measured c.600mm wide with a maximum depth of 1m and were excavated by ground workers using hand-tools. The ground covering the main foundation area within the footing trenches was reduced by 300mm by mini-digger fitted with a flat-bladed bucket. Service trenches were hand-excavated to a depth of 500mm with a width of 300-400mm. A single storage/cess tank (Figure 5.5), measuring 4.7m by 1.2m, was also hand-excavated down to the natural horizon (c.350mm deep). A small pit (c.700m<sup>2</sup>) intended for a water pump was hand-excavated along the route of the northernmost foundation wall for the extension (Figure 5.1). The pit intended for the reburial of recovered human remains was excavated by mini-digger (Figures 5.4 and 5.6).

Fig. 5.4: Machine excavated grave for reburial of human remains

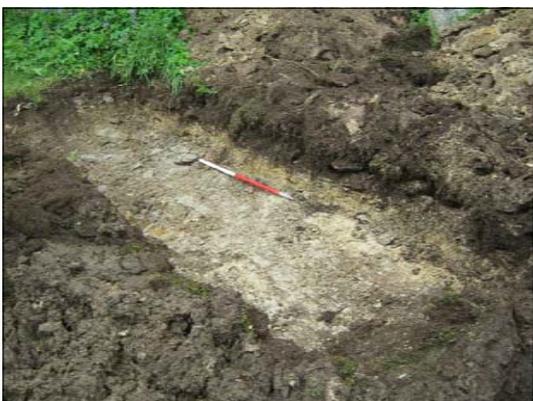
4.3.1 Natural Greensand geology [012] was encountered at 53.99m AOD in the north of the site (foundation trenches for new build), sloping gradually downhill to 53.34m AOD in the south (storage/cess tank pit). In the northern part of the site (where the new-build was located), the natural horizon was revealed beneath cemetery soil at a depth of c.1.2m. No evidence of burial activity was uncovered in the south of the site where the natural horizon was recorded directly beneath 300mm thick layer of topsoil.

- 6.4 No burials were uncovered during the excavation of the storage/cess tank or the reburial pit. The lack of a cemetery deposit within this area and the presence of the natural horizon 300mm below ground level suggest that this part of the churchyard is unlikely to have been used for burial.

Fig. 5.5: Storage/cess tank pit

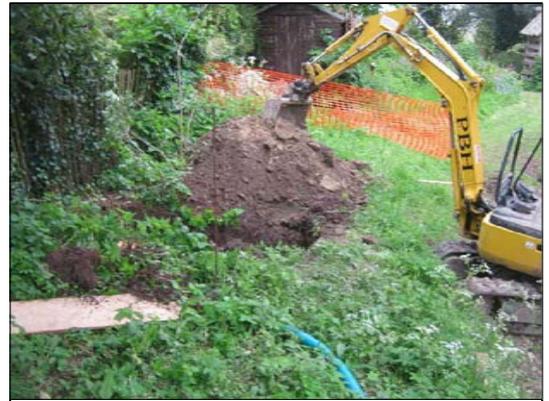
Fig. 5.6: Machine excavated grave for reburial of human remains
