**Archaeological Watching Brief and
Historic Building Recording Report
Old House, Chailey Heritage School
Haywards Heath Road
North Chailey, East Sussex**

**ASE Project No: 5136
Site Code: OLD11**

**ASE Report No: 2012172
OASIS ID: archaeol6-132078**

August 2012

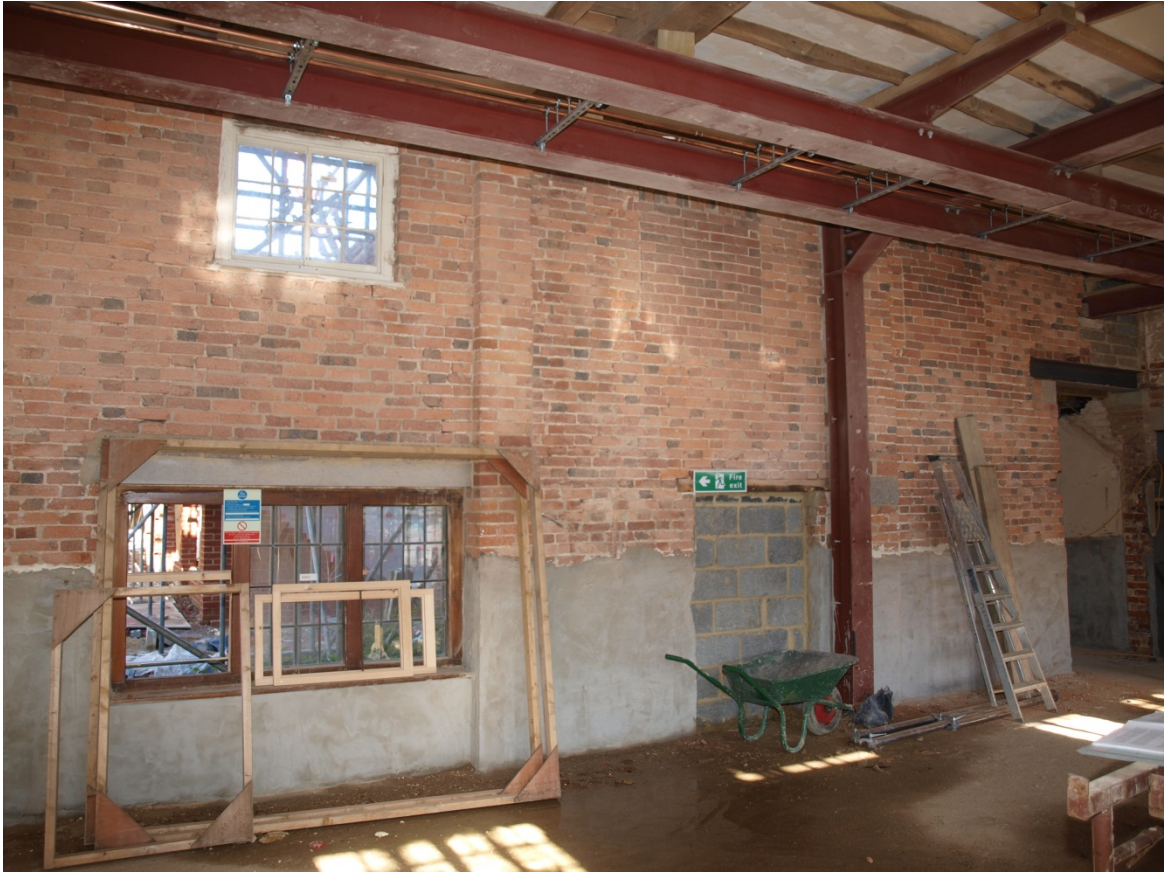
Wall Design, Windows and Doorways: Two blocked window apertures visible at first floor level on the west wall of the Period-B range appear original (Fig. 6; Plate 1). These would have become redundant with the addition of the adjacent Period-D range c. 1836.

Plate 1: Two blocked window apertures at first floor level in Period B range, looking north-west

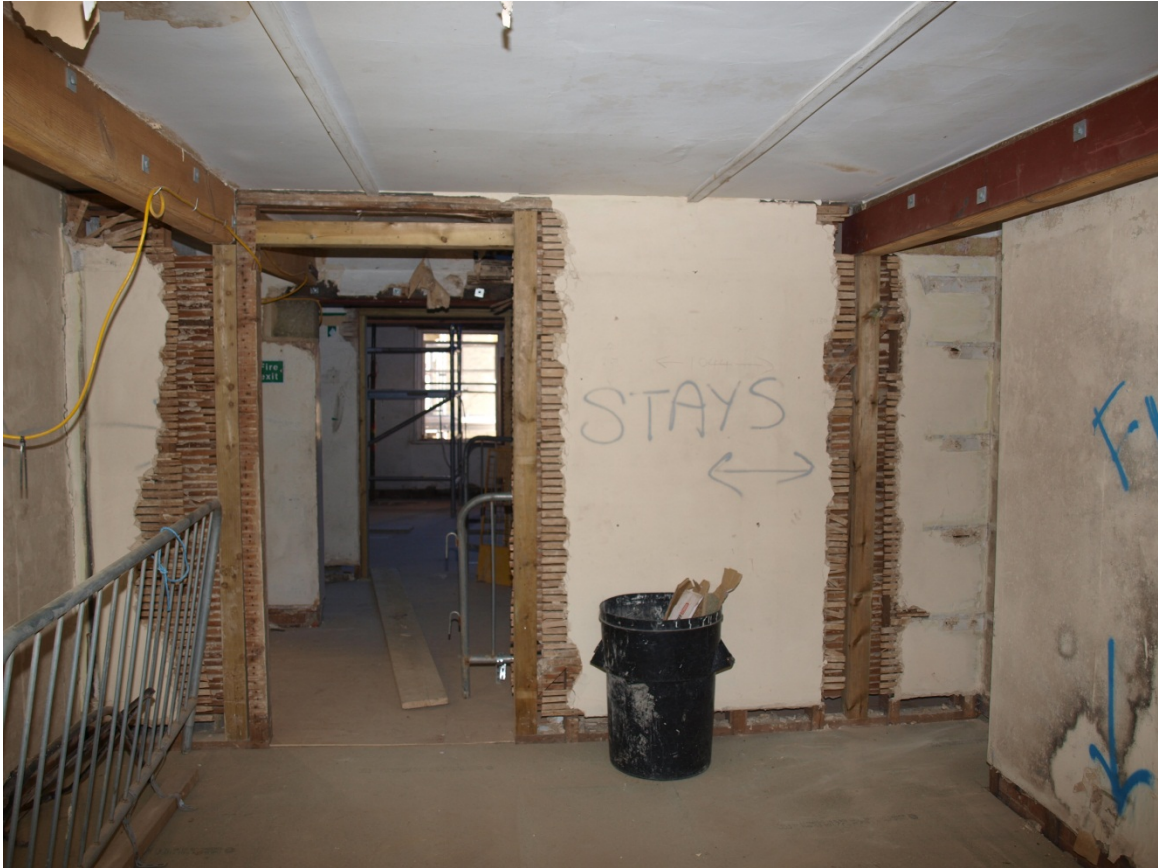
Wall Design, Windows and Doorways: Internal partition wall within eastern end of western range is of primary-braced studwork in softwood; with lath and plaster finish (Fig. 6; Plate 2).

Plate 2: Internal studwork partition wall in Period D western range, looking south

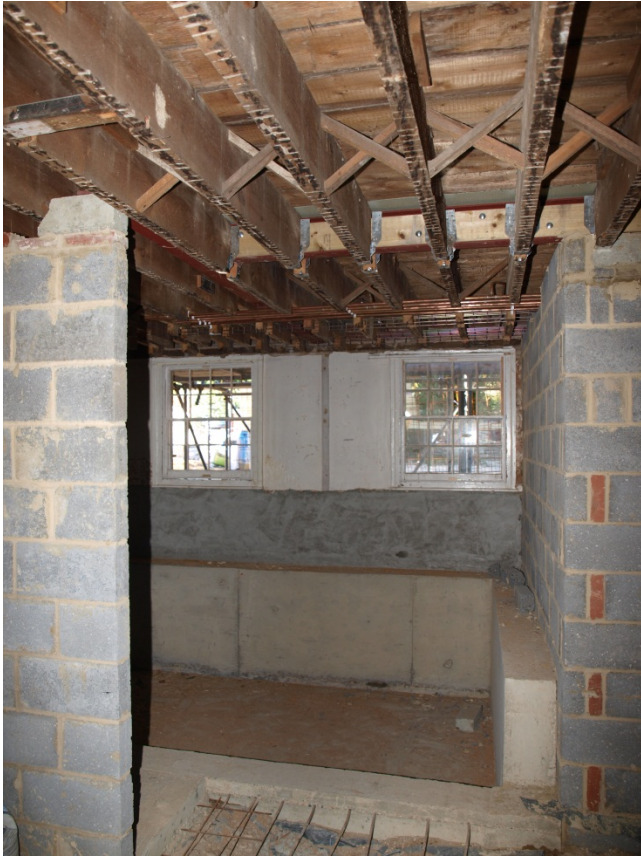
Floors and Ceilings: Ground floor ceilings - deep-section softwood joists with cross-strutting (Fig. 5; Plate 3).

Plate 3: Cross-strutted ceiling over ground floor of Period D western range, looking north

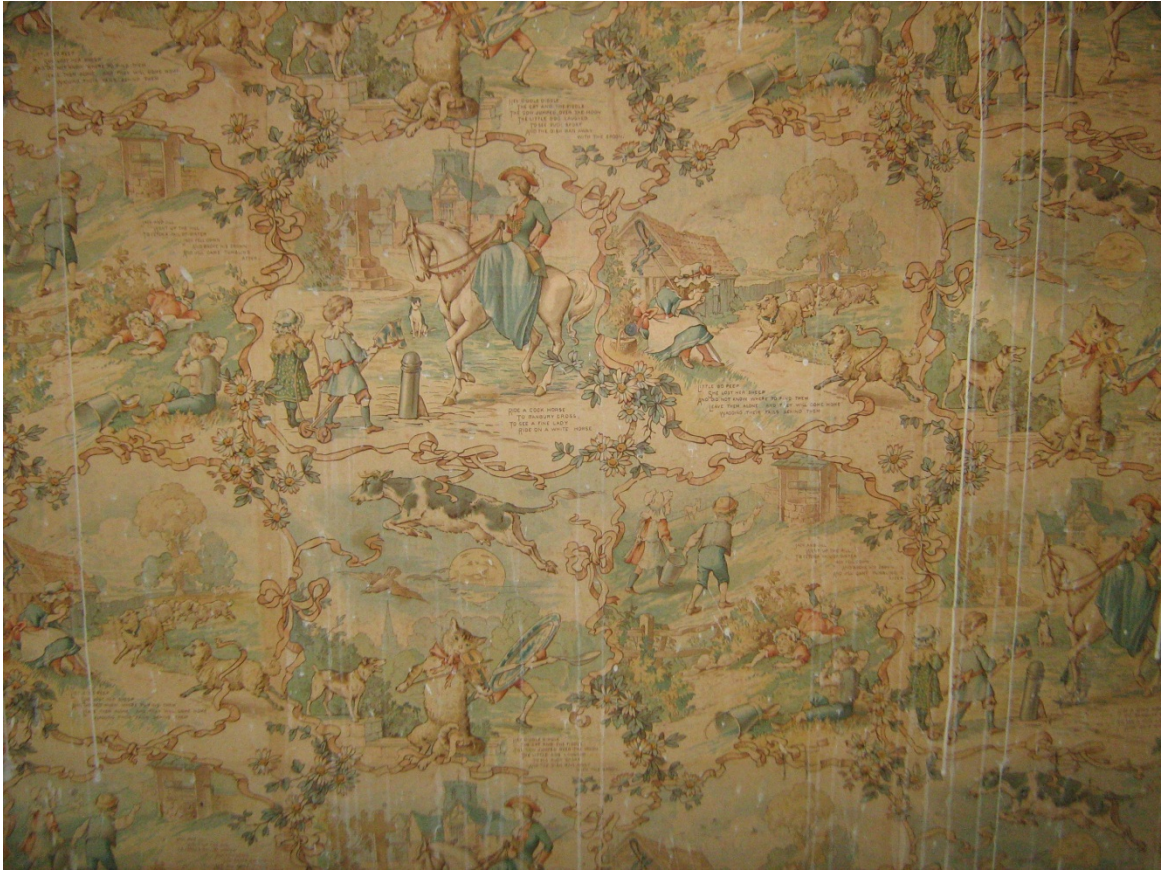
Late-19th/20th century wallpaper with nursery rhyme design revealed behind match-boarding on north face of first floor E-W partition wall of Period C range (Fig. 6; Plate 4).

Plate 4: Nursery rhyme wallpaper on first floor of Period C range, looking south
