**FARM BUILDINGS AT HEATH BARN FARM,
BROADBRIDGE HEATH, WEST SUSSEX, RH12 3LN**

**HISTORIC BUILDINGS RECORD
(ENGLISH HERITAGE LEVEL 2)**

Report No. 2012173

August 2012

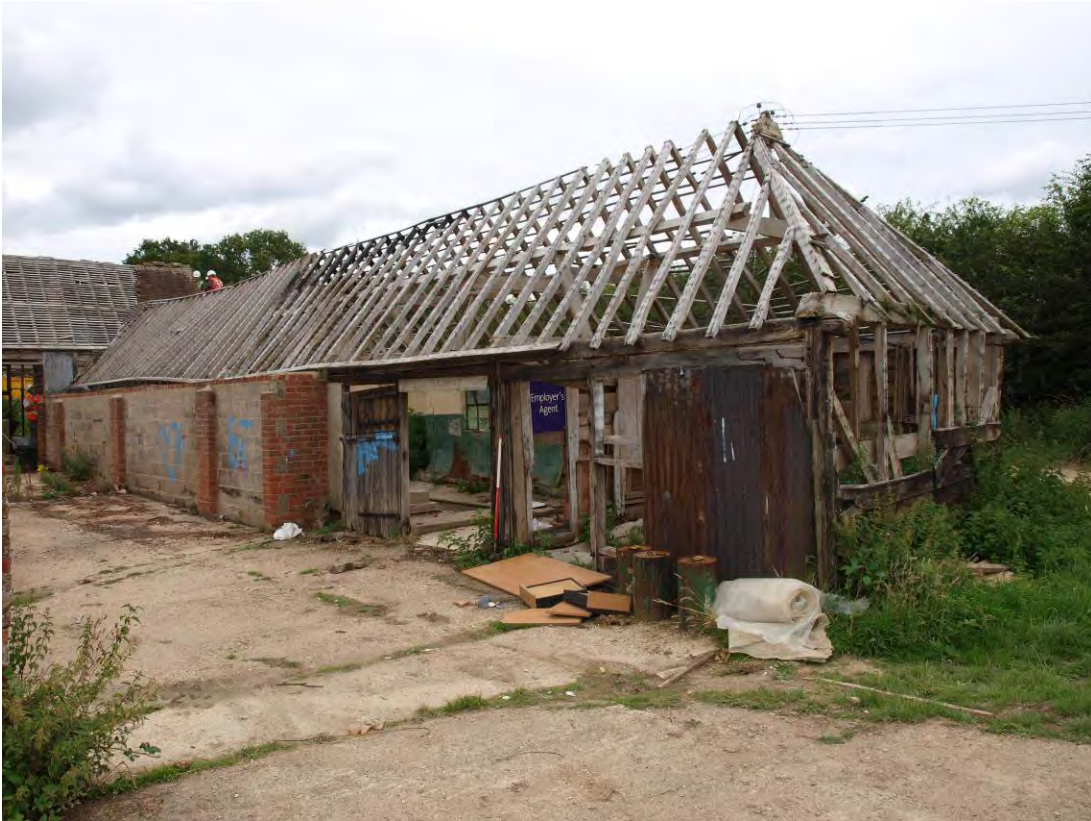
- 4.1.2 Aligned north – south, the building originally had an open front onto the yard which lies to the west (Plate 1). This side is no longer open, the two southernmost bays each retaining remnants of a rudimentary infill and a doorway, the doorway to Bay 2 retaining a boarded, ledged and braced half-door, while the remainder of the elevation has been extended outwards by c. 0.6m in 20th century brick and blockwork to accommodate feeding troughs.

Plate 1: West elevation of Building 1, looking north-east

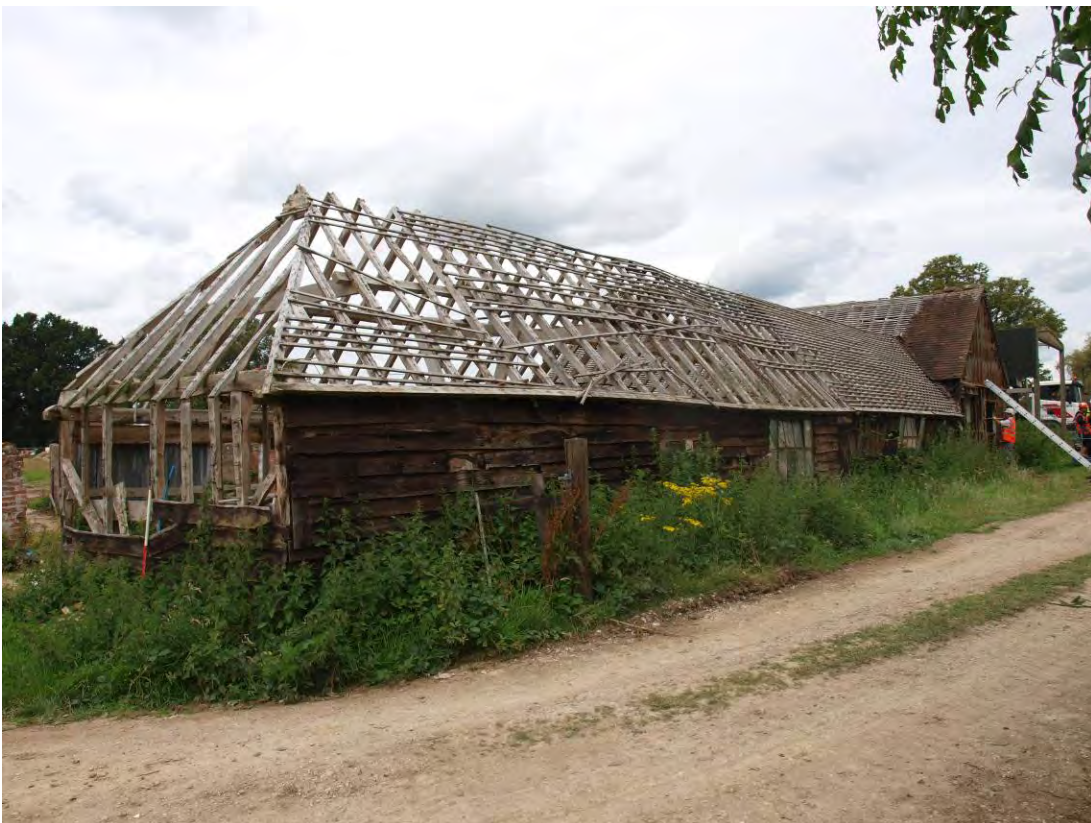
- 4.1.3 The east elevation (Plate 2) contains two boarded, ledged and braced doors (Bays 2 and 3) and two inserted iron-framed windows (Bays 3 and 4). The south elevation is plain. The building abuts Building 2 at its north end.

Plate 2: South and east elevations of Building 1, looking north-west

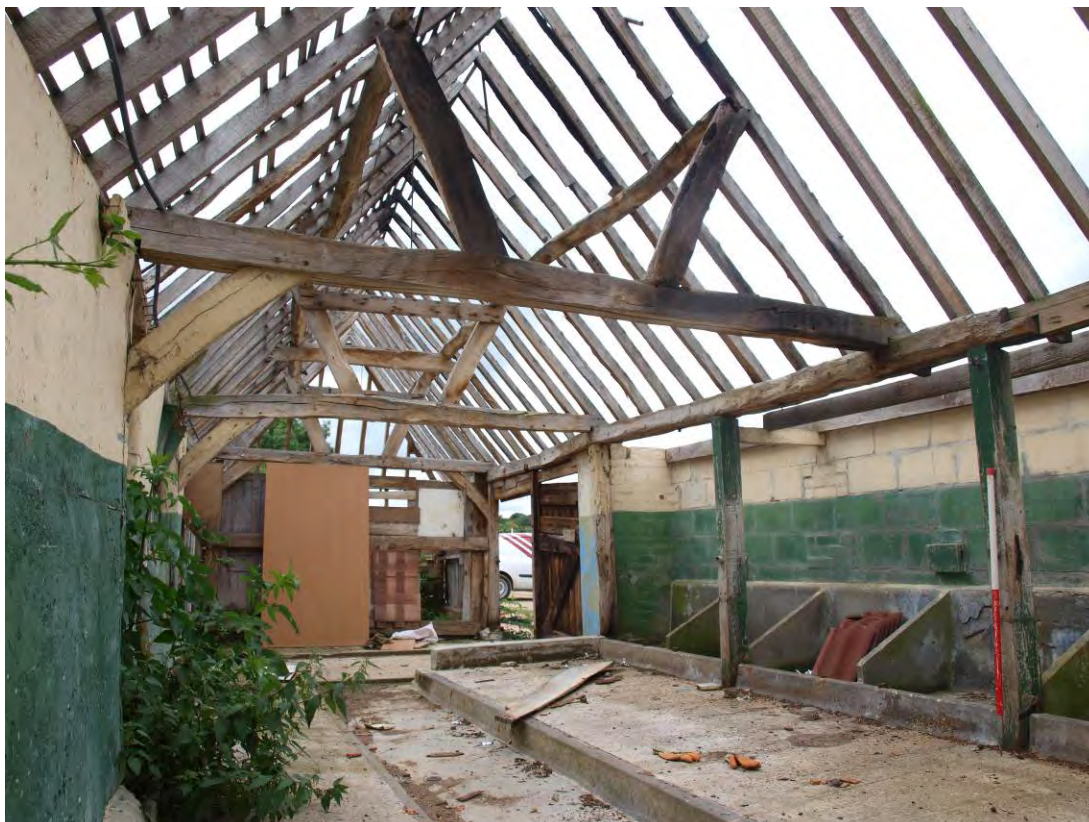
- 4.1.4 The surviving part of the original (c. 1700) structure measures 12.40 m by 3.70 m overall, the three surviving bays each being 3.50 m in length (Plate 3). The main frame is constructed in relatively-waney hardwood and the studs are mainly of waney 'hedgerow' timber, although some contain evidence (in the form of redundant mortices) for having been reused from an earlier structure. The frame bears neatly-chiselled carpentry assembly marks (Plate 4), although it is worth noting that these did not form a discernible sequence up the length of the building, so could not be used to determine its original length (i.e. original number of bays). The brickwork of the dwarf wall was only visible in discrete locations, but appears to be consistent with a c. 1700 date. It is essentially orange, laid in English bond, with average brick dimensions being 235mm x 110mm x 65mm; the bricks have a shallow frog.

Plate 3: Three surviving bays of original c. 1700 structure (Building 1), looking south

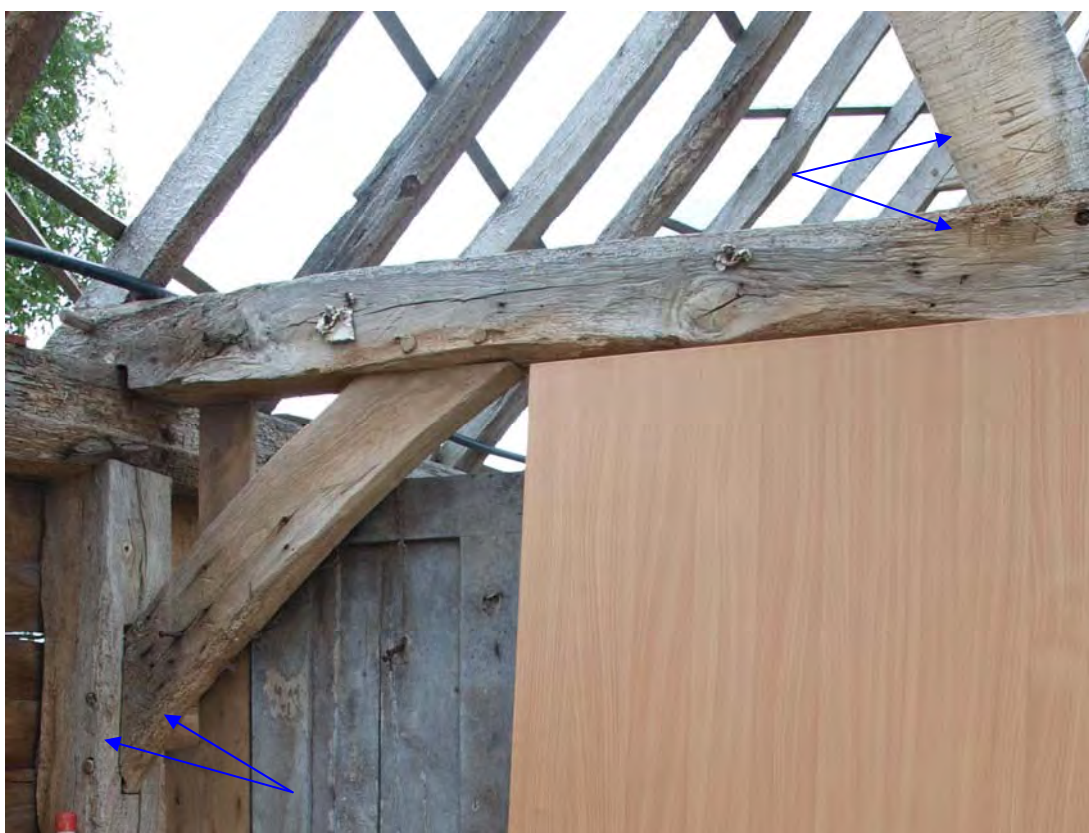
Plate 4: Chiselled carpentry assembly marks (highlighted), upon c. 1700 frame of Building 1

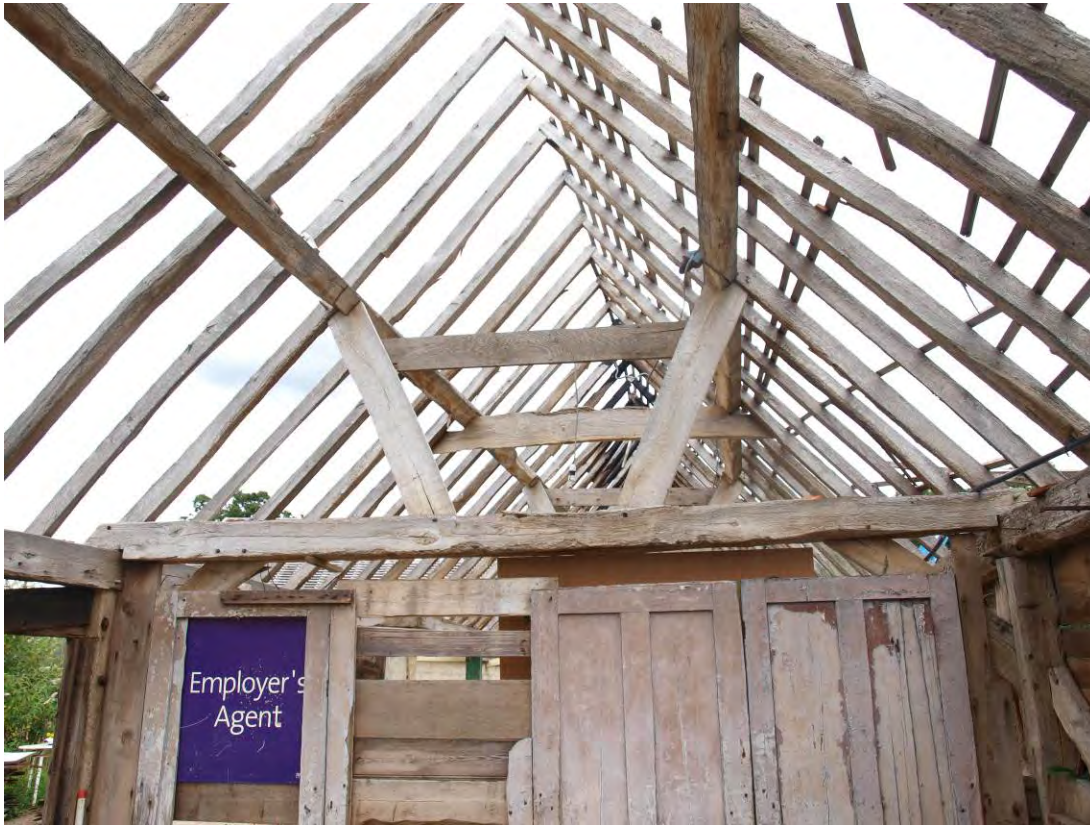
- 4.1.5 Each principal truss originally comprised a pair of un-jowled posts, supporting wall/arcade plates and tie-beam in normal assembly (Plate 5). Slightly curved arch-braces triangulate posts and tie-beam. From each tie-beam, a pair of essentially straight, board-like raking queen-struts extends to support the principal rafters, where they clasp a single purlin in each roof pitch. The principal rafters are of only slightly greater scantling than the common rafters, and have a shallow, elongated notch to accommodate the purlins, which are scarfed at the bay intervals. The rafters are jointed and pegged at the apex. The south roof terminal, which is hipped, includes a central jack-rafter and high-set collar (Plate 6). There are intermediate nailed collars located at the half-bay intervals.

Plate 5: Truss between Bays 1 and 2 (Building 1), looking north

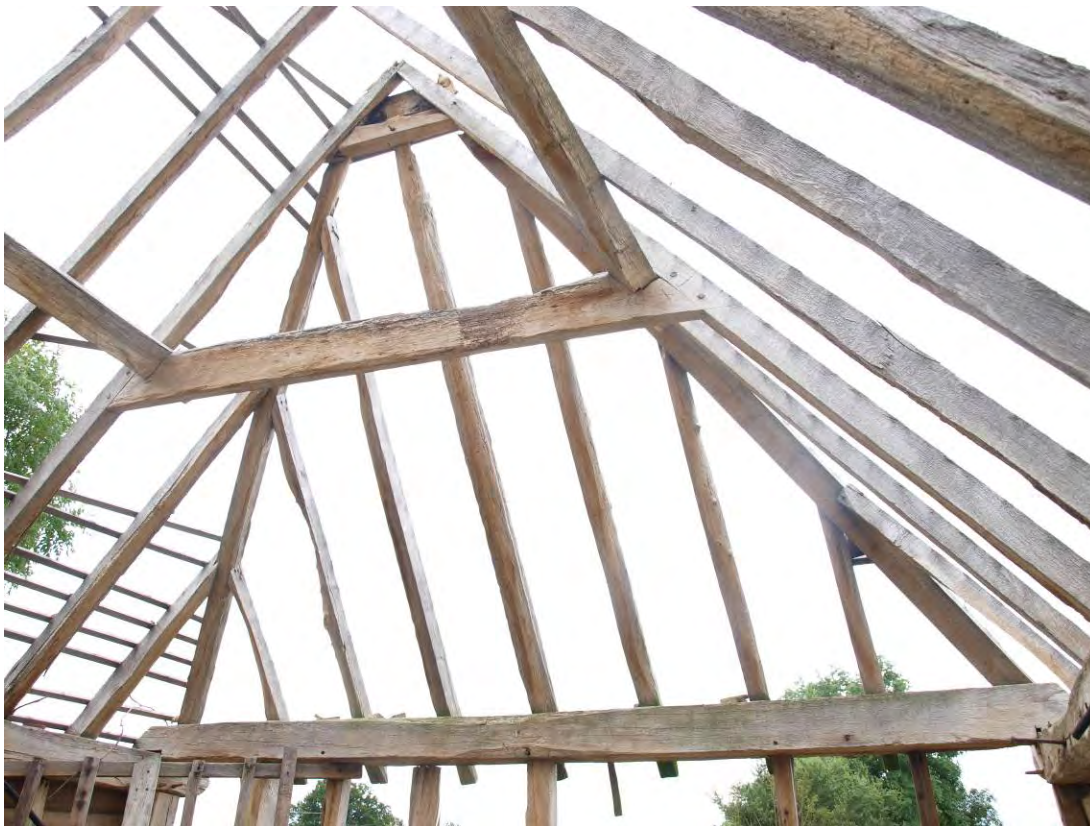
Plate 6: Hipped roof terminal to Building 1, looking south

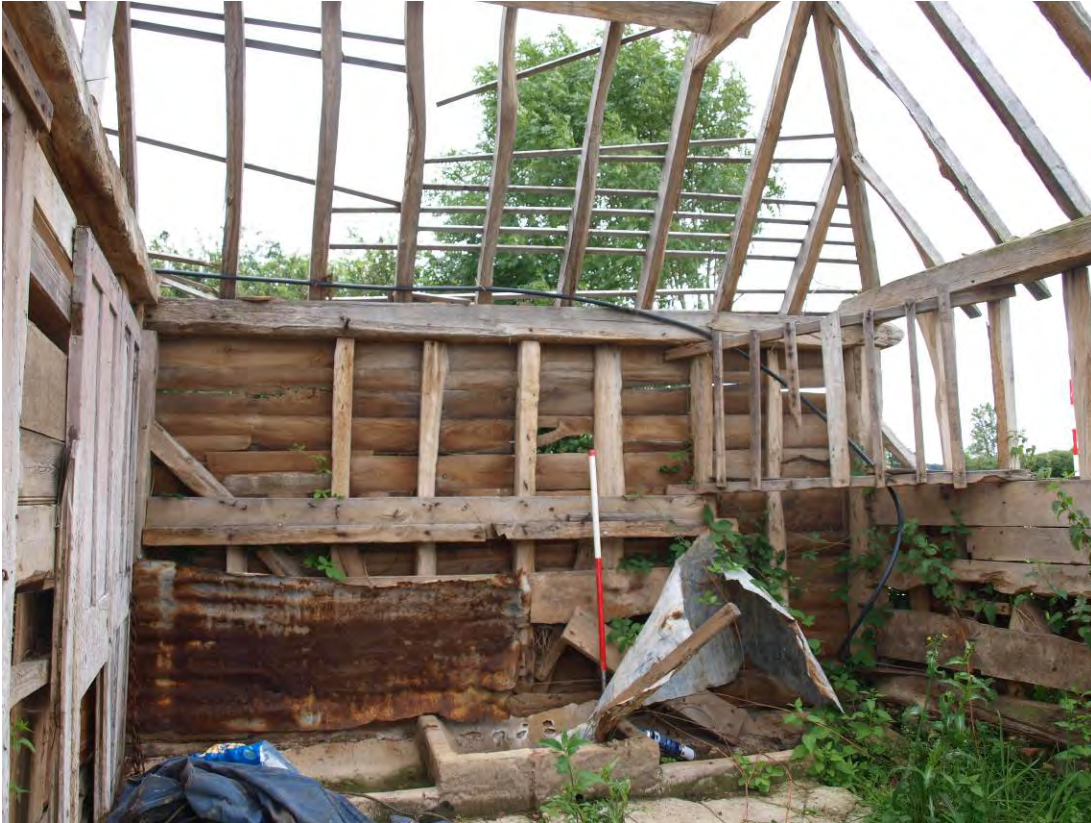
- 4.1.6 At the time of the survey, the wall-framing was much obscured by fixed metal sheets; however, where visible (principally in Bays 1 and 2), the wall panels comprise three pegged studs, alternated with a single nailed stud (Plate 7). The south end wall includes two jointed and pegged primary braces, extending from the corner posts down to the sill, and within the end bay, the east wall contains a further similar brace extending downwards from the bay division post. The exterior is clad with weatherboarding, while the interior retains some horizontal boarding at the lower level

indicating its former use to house animals. Fixed in the south-east corner of Bay 1 is a rudimentary, nailed-together feeding rack.

Plate 7: East wall of Bay 1 (Building 1), looking east

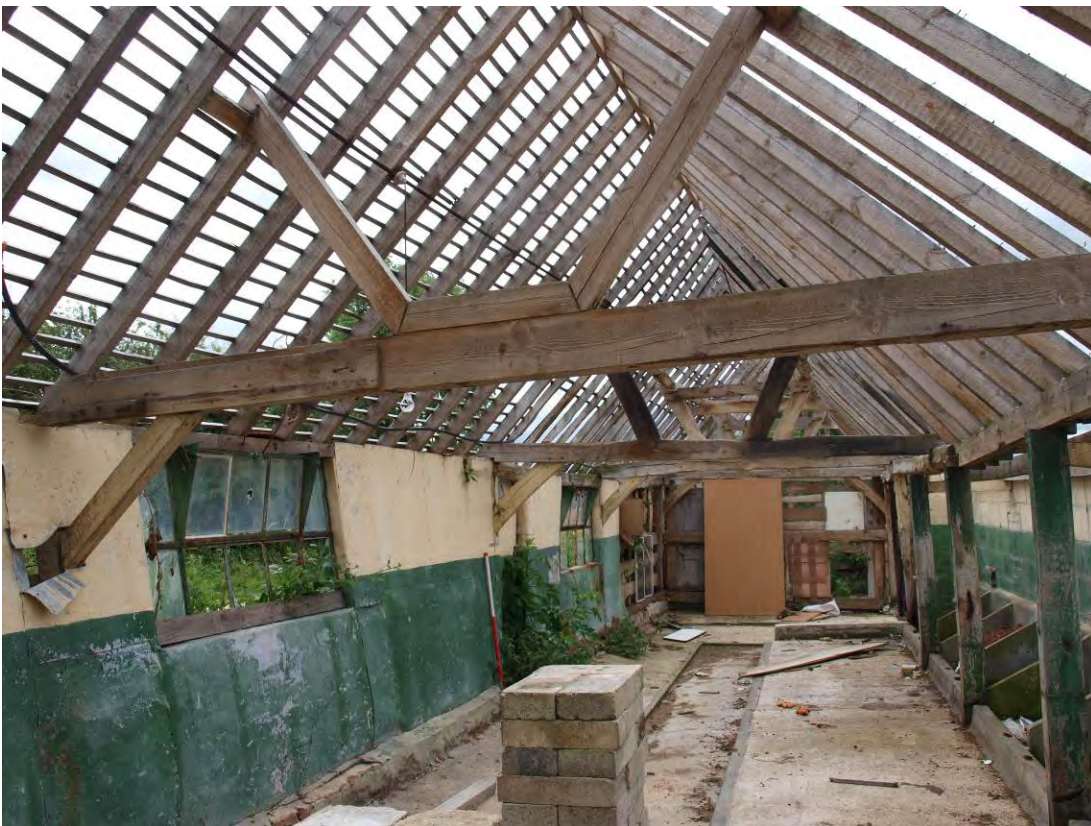
- 4.1.8 The two later (northernmost) bays are easily distinguished from the earlier work by their construction in precisely-sawn, nailed softwood. The division between Bays 4 and 5 is marked by a single roof truss (Plate 8), which on the east side of the building corresponds with a supporting post, but on the west side is carried directly on the arcade plate; the posts on this side being spaced more frequently in order to support the roof structure above. The truss consists of a straight tie-beam, from which raking queen-struts extend to a short length of timber located between two of the common rafters (in place of a purlin). A further short 'spacer' timber is located between the bases of the struts. The west side of the building (three northernmost bays) has been extended outwards by c. 0.6m to accommodate feeding troughs, while the floor, which is concrete, includes a gully for mucking-out. A door at the north end leads into Building 2.

Plate 8: c. 1900 truss to northern section of Building 1, looking south

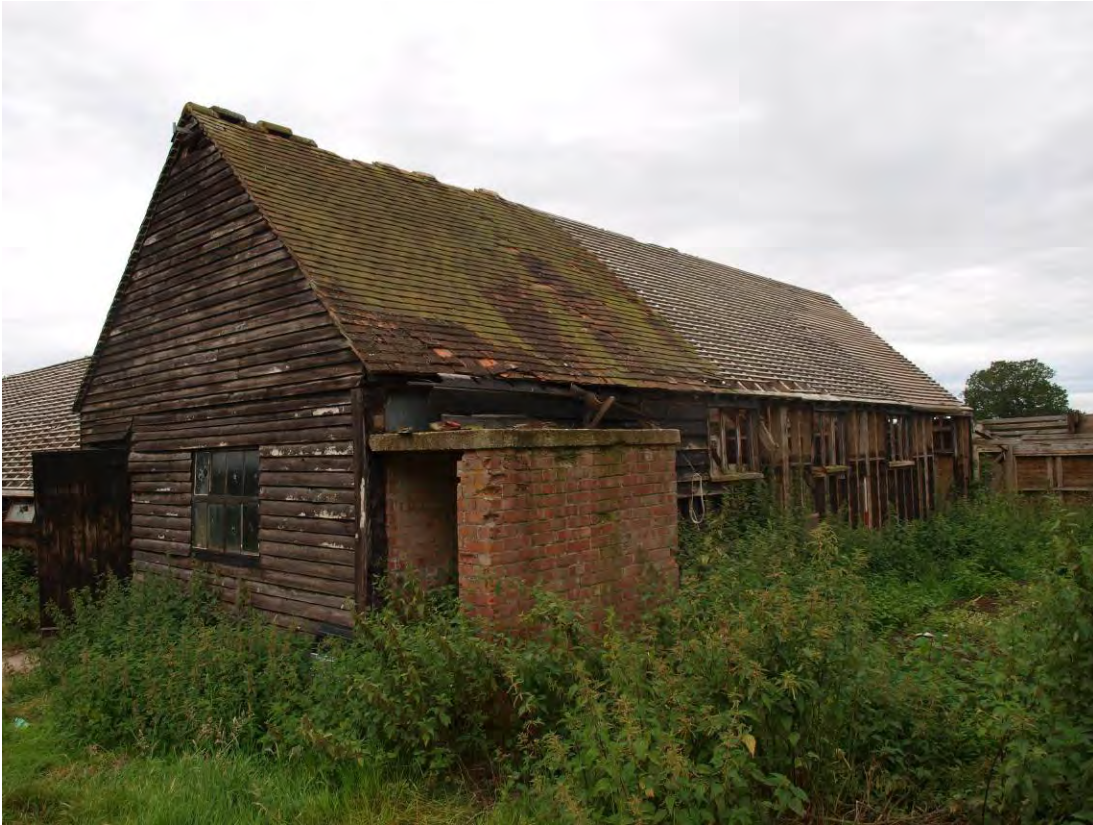
- 4.2.1 At the time of the survey, the building had been stripped of most of its weatherboarding and plain clay tile roof covering, except for at the eastern end (Bay 5) where stripping work was continuing – consequently only a cursory inspection was made of this end of the building (Plate 9). It is of bolted-and-nailed timber-frame construction in precisely-sawn softwood, over a dwarf brick wall. The exposed exterior face of the studwork reveals neatly-chiselled carpentry marks. The roof is gabled.

Plate 9: North and east elevations of Building 2, looking south-west

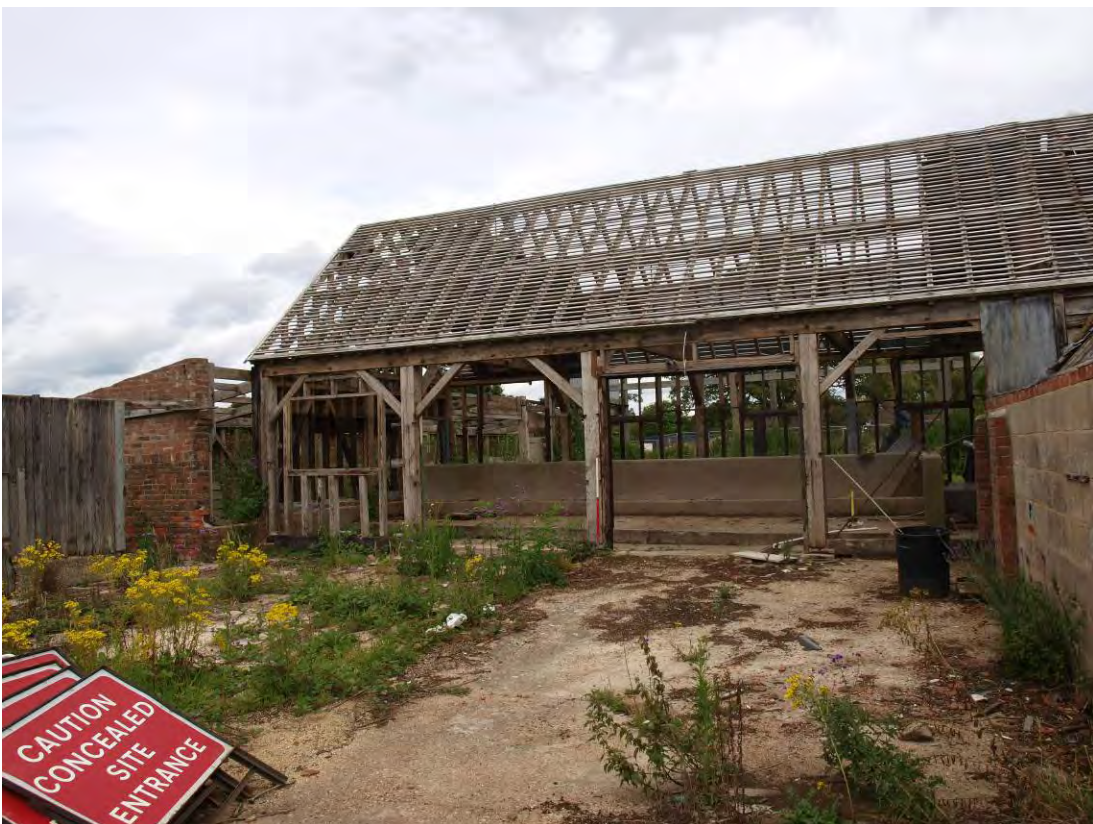
- 4.2.3 The open-fronted south side of the building faces onto the yard (Plate 10). Bays 1 and 4 have subsequently been infilled and Bay 3, which no longer retains its arcade-bracing, contains a frame for a door. The north side of the building features a single, relatively high-set window aperture to each of the four open bays, while Bay 5 is lit by a window on the east elevation. Adjacent to the south of this window is a doorway with boarded door, leading into the passage. The west end of the building is enclosed within a dilapidated lean-to structure (not entered). A doorway, with framed, boarded, ledged and braced door is located at the north end (Plate 11). The gable retains an aperture for a ventilation louvre.

Plate 10: South elevation of Building 2, looking north

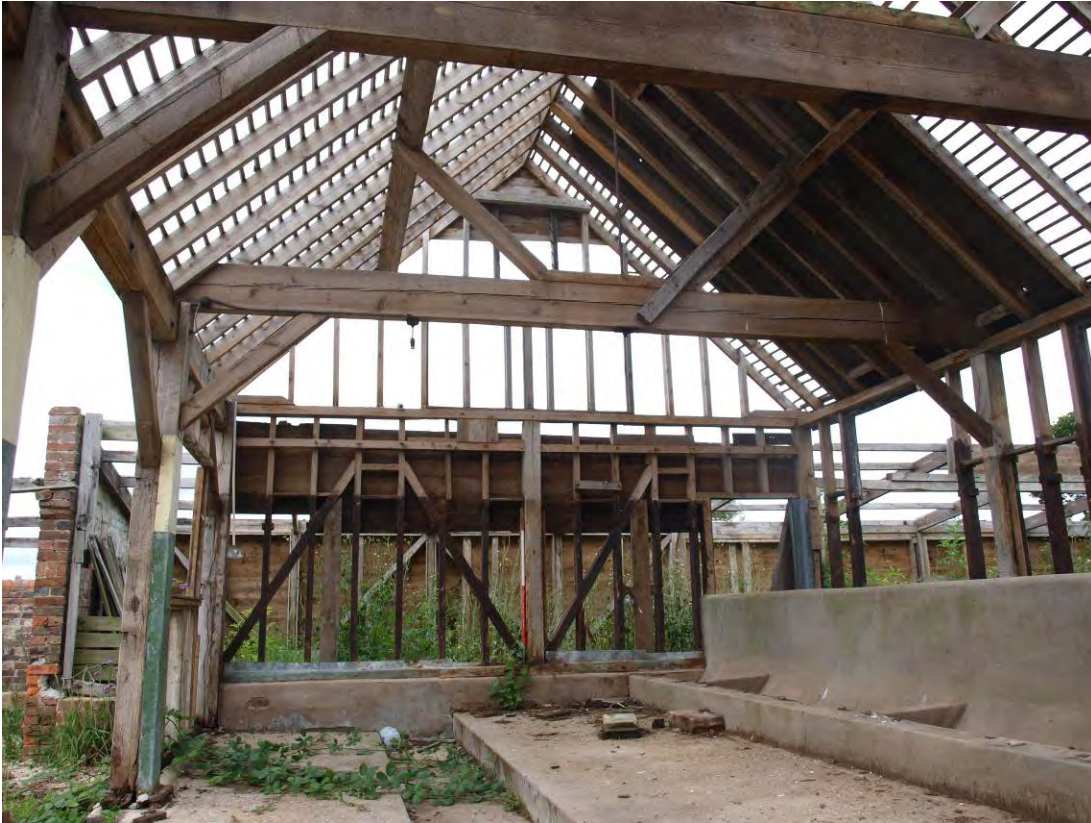
- 4.2.4 The principal trusses each consist of a pair of posts; on the north side the posts are un-jowled, while those on the south side are slightly deeper and have a 'jowl' or tongue overlapping the arcade-plate (Plate 11). The tie-beams are strapped to the wall/arcade plates. From each tie-beam, a pair of raking queen-struts, with 'spacer'

(as on the truss within the later section of Building 1), extends to clasp a single purlin in each roof pitch. Common rafters ride over the backs of the purlins and meet at a ridge-board at the apex. The walls are of regular studwork; the end walls, together with a partition wall between Bays 4 and 5 also incorporating primary braces.

Plate 11: Interior of Building 2, showing west end wall and roof construction, looking west

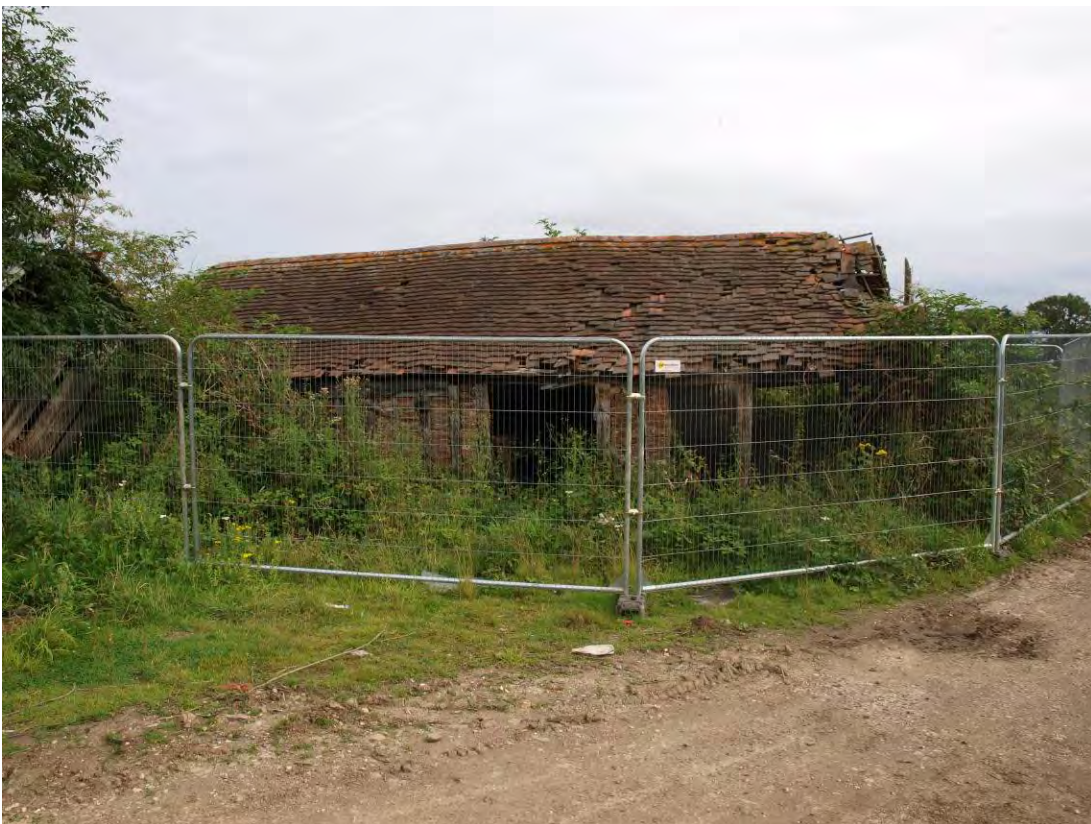
- 6.2 The larger of the two buildings is oriented on a west-north-west to east-south-east axis (hereafter simplified west – east) and appears to have served as a shelter shed (Plate 12). It is known from historic mapping (James 2007) that it was located on the south side of a yard, with its east end adjoining a larger building, no doubt a barn, which has since gone. It essentially comprises three timber-framed bays with a plain clay tile roof. The building utilises much reused timber within its construction. The south wall retains its posts and some studs, together with a jointed and pegged primary-brace which extends downwards from one of the bay-interval posts. The surviving studwork has a rudimentary brick infill of a later date. The north wall does not preserve any studwork, and probably therefore was open-fronted onto the yard (Plate 13). The east end retains no visible walling, and it is unclear whether any material within the western end wall is of the original construction. The roof, which is of relatively shallow pitch, is of clasped-side-purlin form; a single purlin in each roof pitch being clasped by board-like raking queen-struts. There is no ridge-board, the rafters being secured by a peg at the apex. There is a timber feeding-trough located against the south wall of the building. Within the building is a piece of historic farm machinery which appears to be related to harvesting – possibly for winnowing.

Plate 12: The larger of the two buildings at Hares Hill Farm, looking north

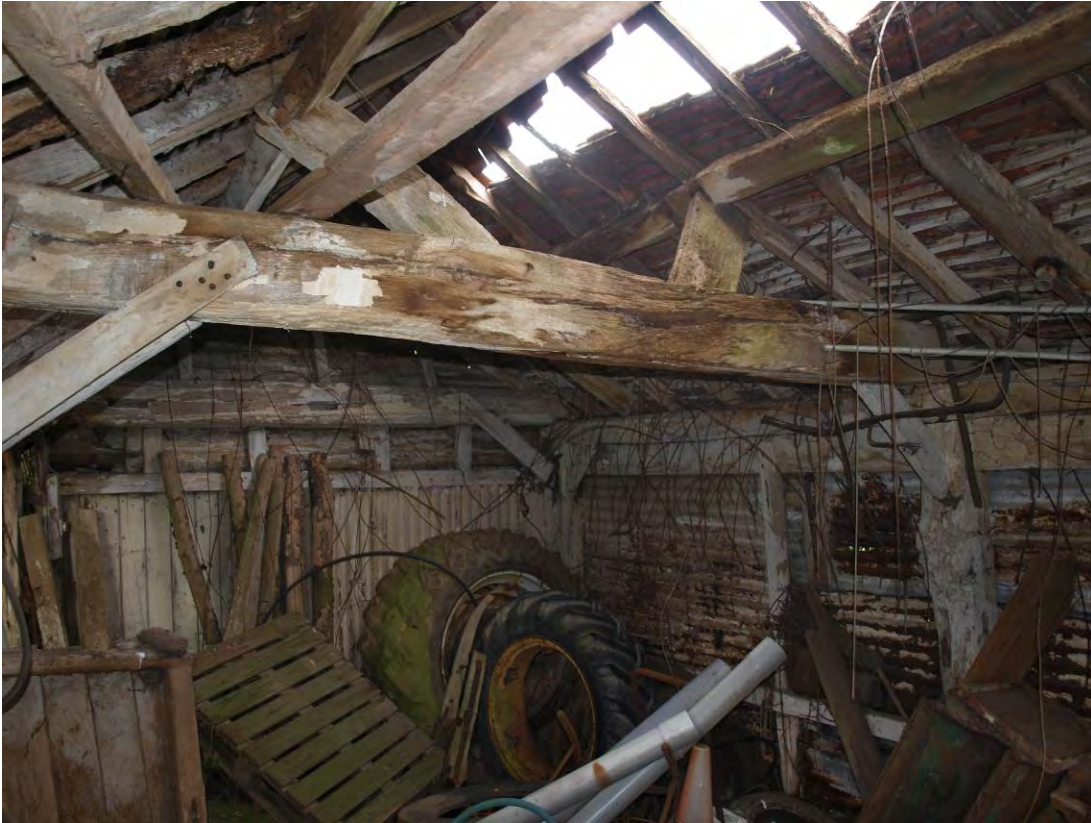
Plate 13: Interior of the larger of the two buildings at Hares Hill Farm, looking west

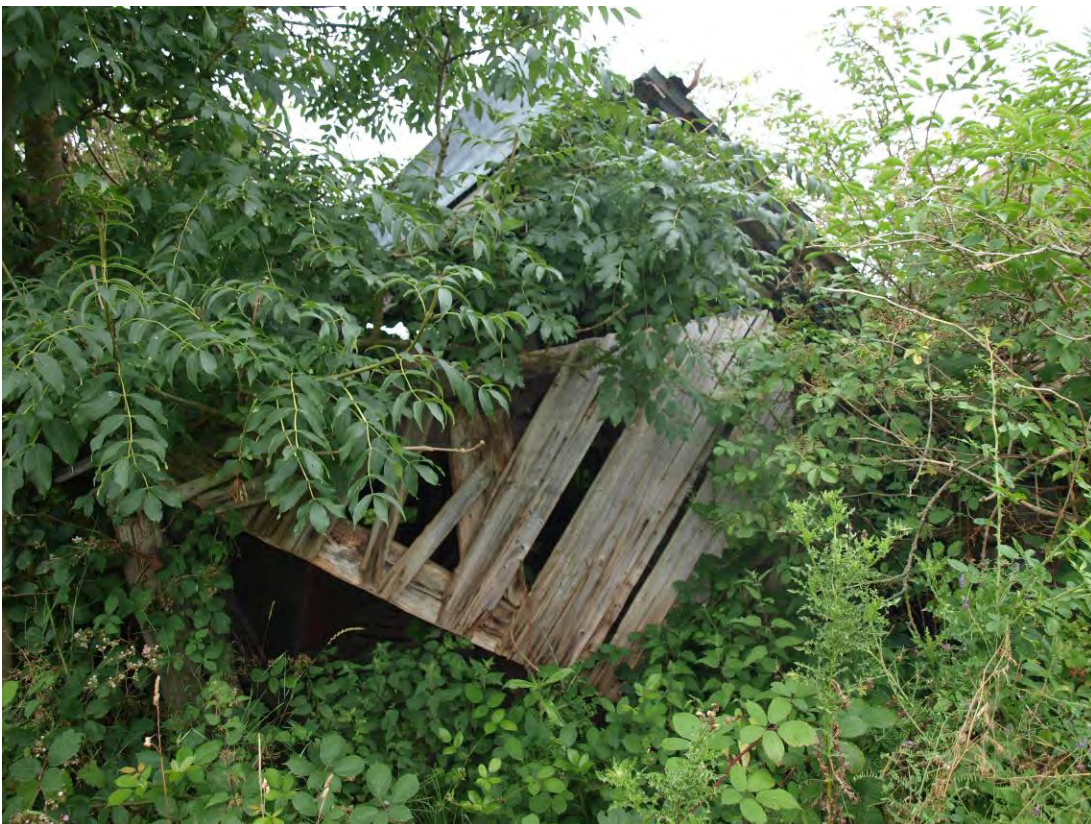
- 6.3 Located immediately adjacent to the south-west corner of the building is a smaller two-bay timber-framed structure, seemingly also an animal shelter (Plates 14 & 15). The stud walls incorporate primary-braces within their construction and the roof is of similar clasped side-purlin form to the adjacent structure, also without a ridge-board.

Plate 14: The smaller of the two buildings at Hares Hill Farm, looking west

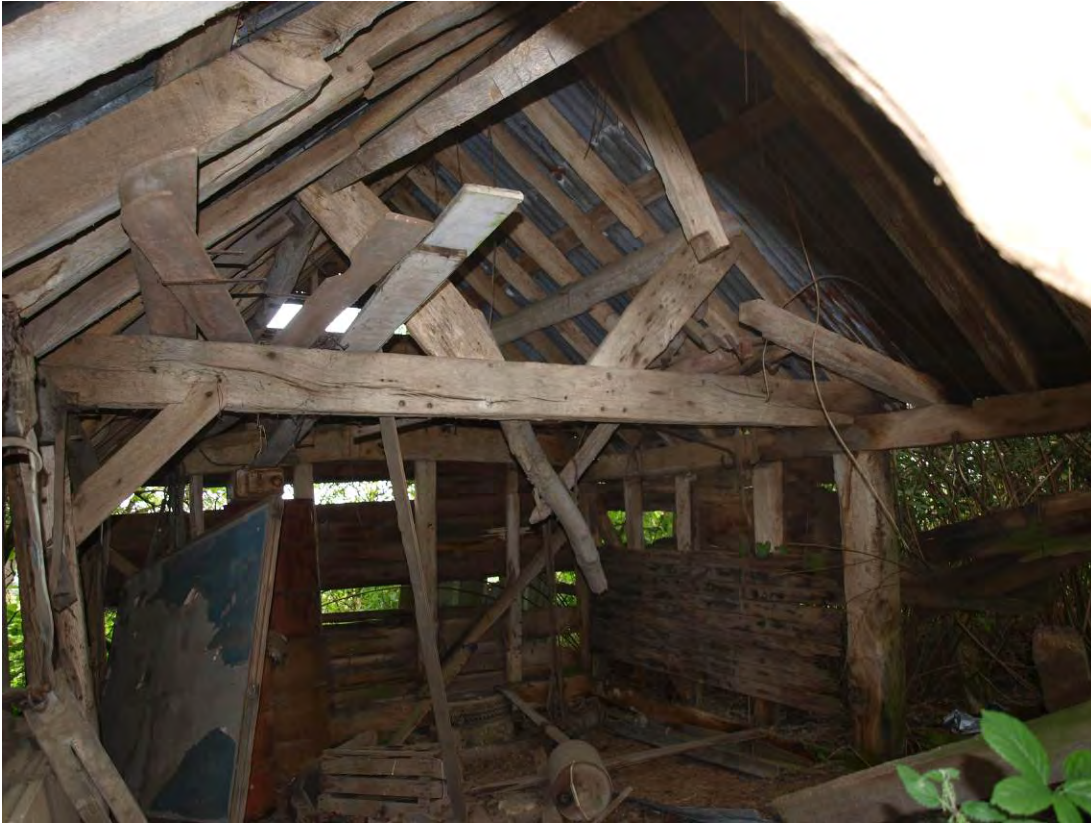
Plate 15: Interior of the smaller of the two buildings at Hares Hill Farm, looking west
