**Archaeological Evaluation of
Land at Oaklands Hospital, Chaldon Road,
Caterham, Surrey**

**Project No: 5666
Site Code: OHC12**

**ASE Report No: 2012175
OASIS ID: archaeol6-132707**

August 2012

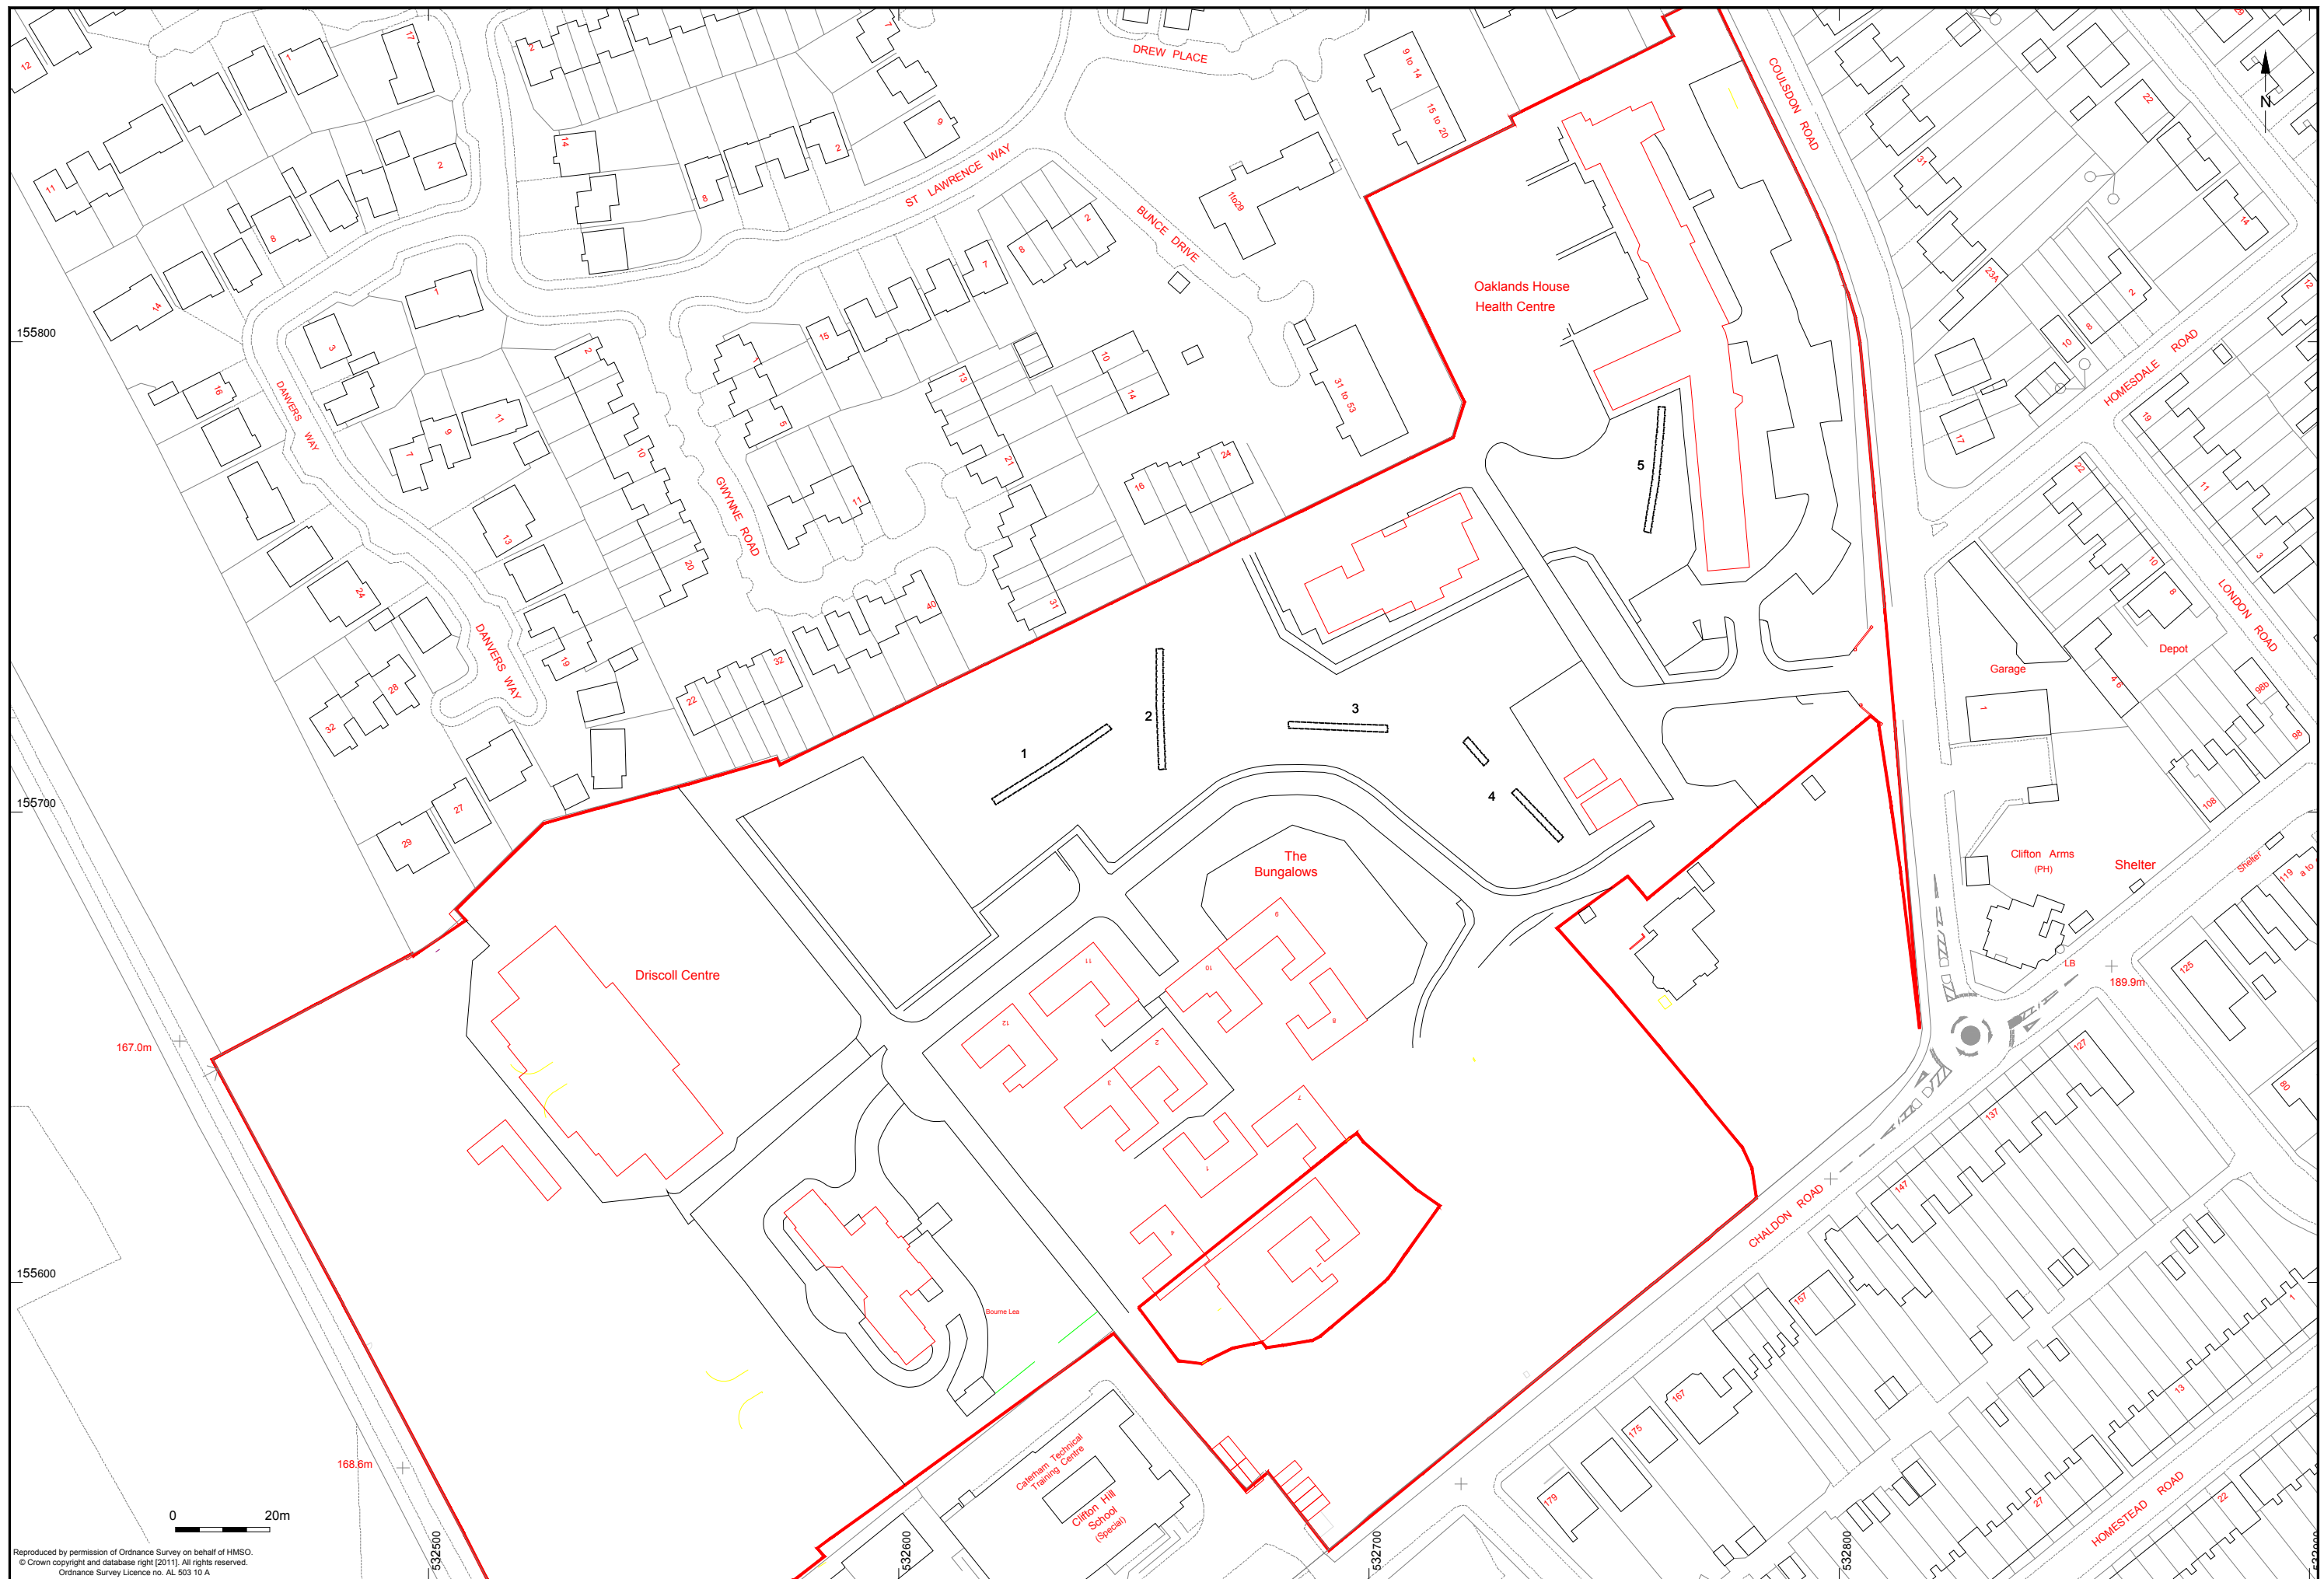
© Archaeology South-East		Oaklands Hospital, Caterham		Fig. 2
Project Ref: 5666	Aug 2012	Trench location		
Report Ref: 2012175	Drawn by: JLR

4.0 RESULTS (Fig. 2)

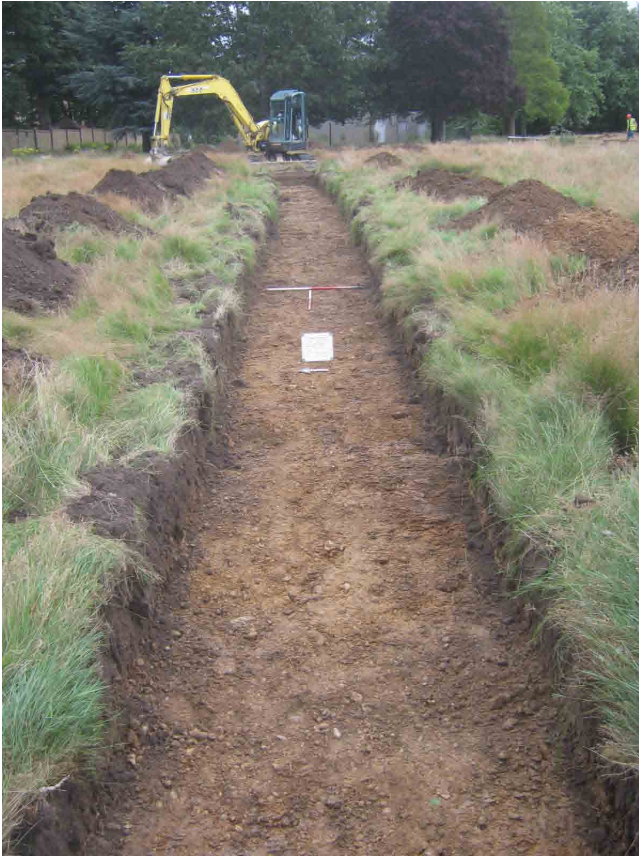
Fig. 3.1: Trench 1 looking east

4.2.1 Trench 1 was located in open grass close to the northern perimeter wall of the site. It was excavated to a length of 30m and to a depth of 390mm (186.85mAOD) at the south-western end and to 330mm (187.60mAOD) at the eastern end, at which point the 'natural' was encountered and mechanical excavation ceased.

4.2.2 The overburden consisted of a layer of mid-brown humic topsoil, context [1/001]. It directly overlay the brownish orange gravelly silty clay 'natural', context [1/002]. No archaeological features or deposits were encountered, and no artefacts were recovered from the overburden.

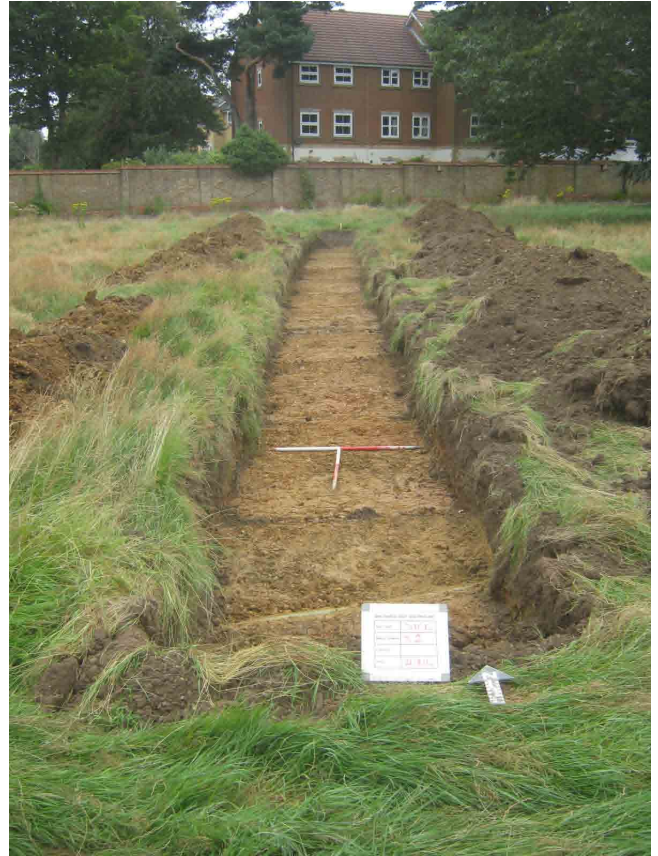
Fig. 3.2: Trench 2 looking north

4.3.1 Trench 2 was located to the east of Trench 1. It was excavated to a length of 30m and to a depth of 440mm (187.68mAOD) at the northern end and to 460mm (also 187.68mAOD) at the southern end, at which point the 'natural' was encountered and mechanical excavation ceased.

4.3.2 The topsoil and underlying 'natural' were similar in character to those found in Trench 1. No archaeological features or deposits were encountered, and no artefacts were recovered from the overburden.

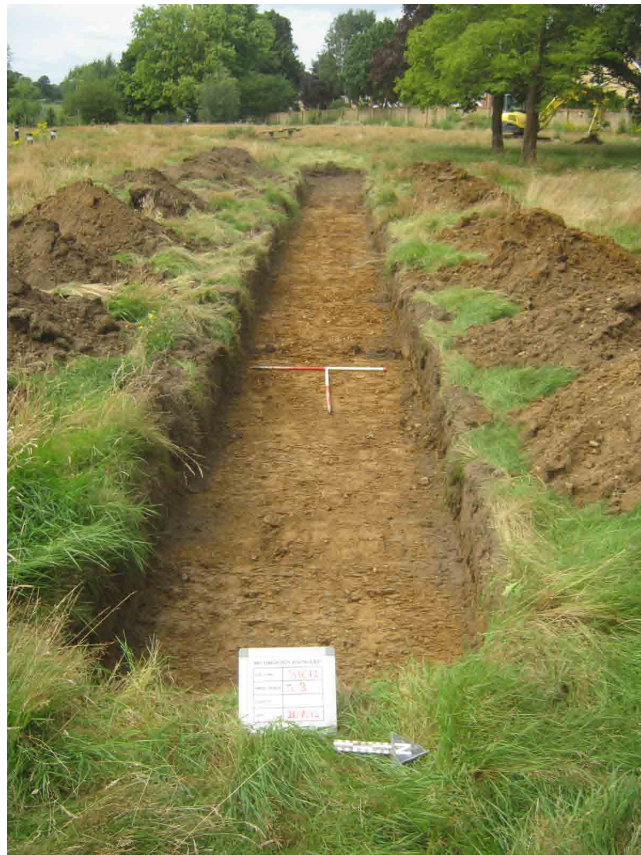
Fig. 3.3: Trench 3 looking west

4.4.1 Trench 3 was located to the west of Trench 3 and was shortened from its planned length owing to the presence of buried services. It was excavated to a depth of 400mm (188.55mAOD) at the western and to 470mm (188.45mAOD) at the eastern end, at which point the 'natural' was encountered and mechanical excavation ceased.

4.4.2 The layers of topsoil and underlying 'natural' were similar in character to those found in Trench 1, but there was a discernible layer of orangey brown silty clay subsoil, context [3/002] between them. No archaeological deposits or features were encountered but a single struck flint flake was recovered from the topsoil.

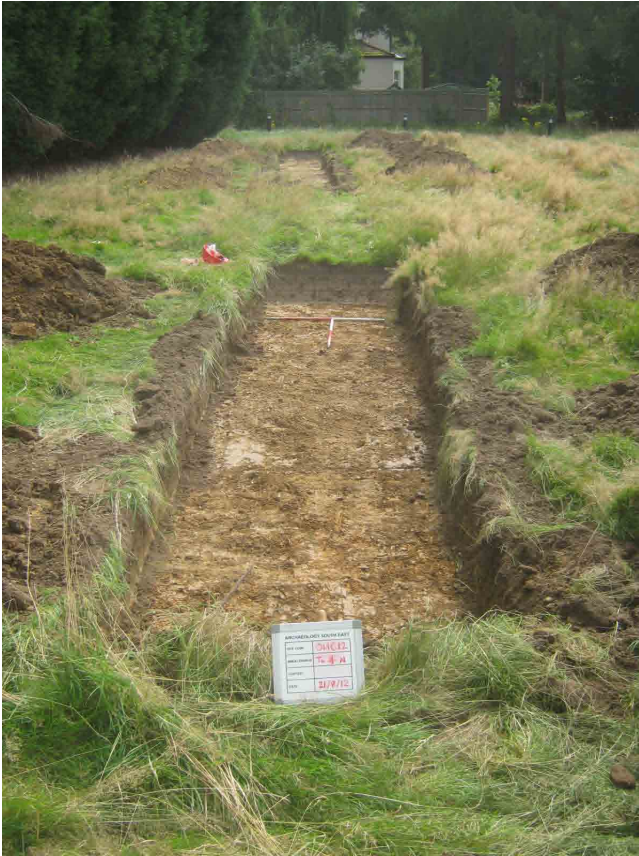
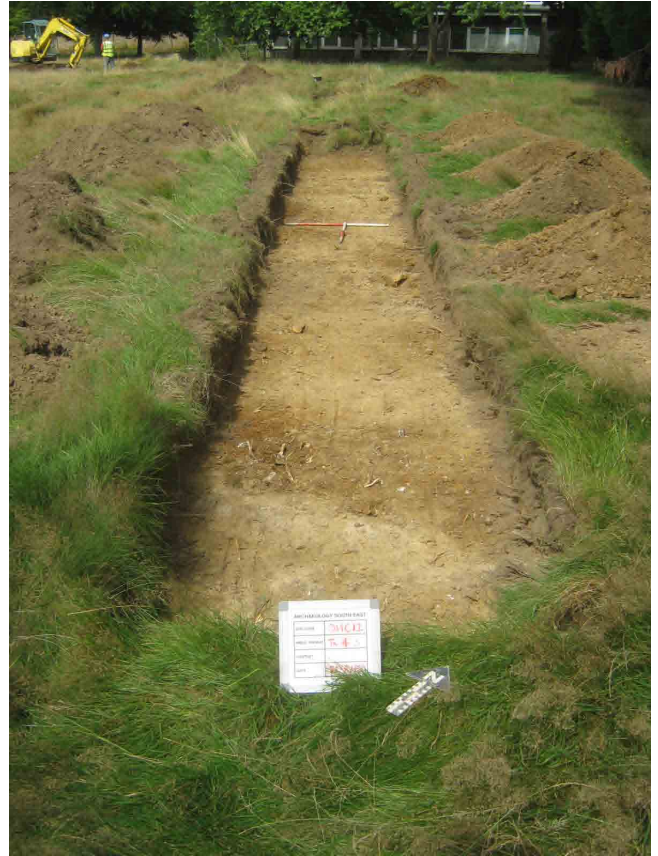
4.5.1 Trench 4 was located close to a line of trees, to the west of Trench 4. It was excavated to a depth of 370mm (188.82mAOD) at the north-western end and to 290mm (189.44mAOD) at the south-eastern end, at which point the 'natural' was encountered and mechanical excavation ceased. The trench was split into two lengths to avoid a detected buried service.

4.5.2 The two layers of overburden and underlying 'natural' were similar in character to those found in Trench 4. No archaeological features or deposits were encountered, and no artefacts were recovered from the overburden.

Fig. 4.1: Trench 4 north looking north-west

Fig. 4.2: Trench 4 south looking north-west

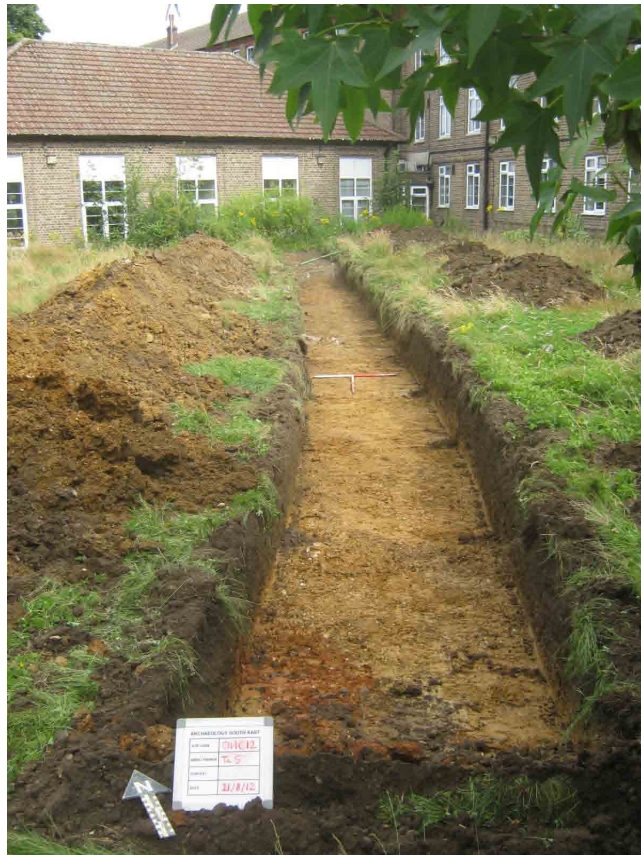
Fig. 4.3: Trench 5 looking north

4.6.1 Trench 5 was located adjacent to one of the existing buildings at the site. It was excavated to a length of 30m and to a depth of 630mm (189.82mAOD) at the northern end and also to 590mm (189.53mAOD) at the southern end, at which the 'natural' was encountered and mechanical excavation ceased. The topsoil and underlying 'natural' were similar in character to those found in the other trenches at the site, but there was a layer of made ground between them consisting of a mixture of topsoil, building sand and brick rubble, context [002], presumably resulting from the construction of the nearby building.

4.6.2 The area of the trench had been heavily disturbed during the laying of services in the recent past. No archaeological features, deposits or finds were encountered.
