An Archaeological Watching Brief at St. John the Baptist Church, Findon, West Sussex

Planning Application No: FN/10/11

ASE Project No: 5032 Site Code: SJP 11

ASE Report No: 2012235 OASIS ID: archaeol6-137969

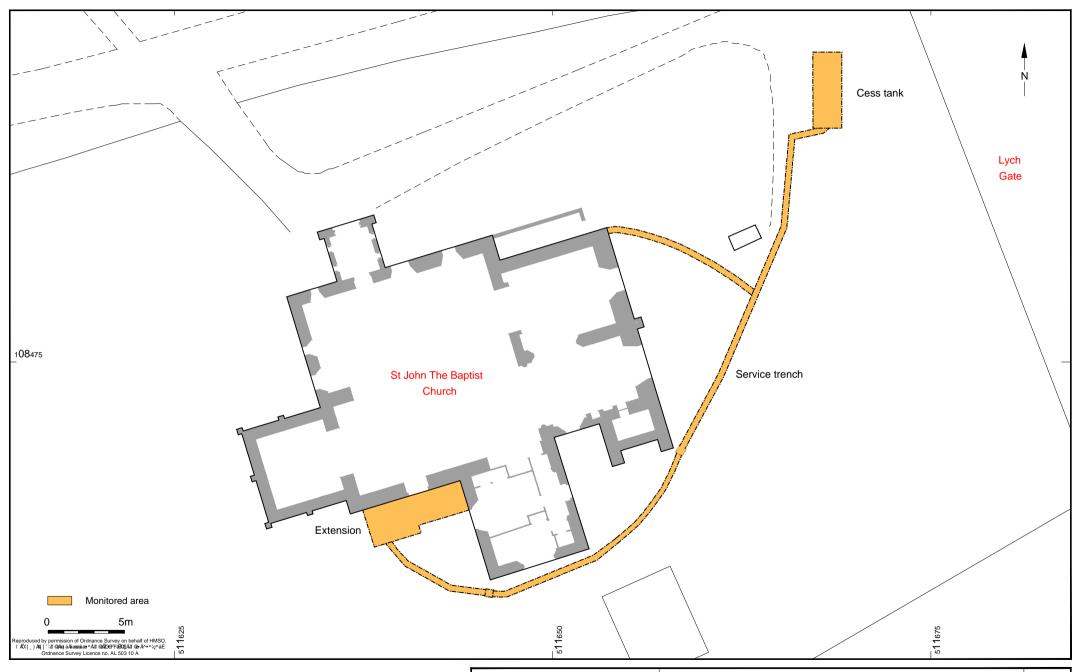
î Ærchaeology South-East		St. John the Baptist Church, Findon	Fig. 2
Project Ref: 5032	Nov 2012	Plan of monitored groundworks	1 1g. Z
Report Ref: 2012235	Drawn by: JLR	Tian of monitored groundworks

- The groundwork programme involved the construction of a new extension for kitchen and toilet facilities in addition to associated drainage services and cess tank excavations (Figure 2).
- 3.1.2 A combination of machine and hand excavation was used during the excavation of each area. A breaker was also used to get through the steps and concrete covering the area of the extension directly outside the door.

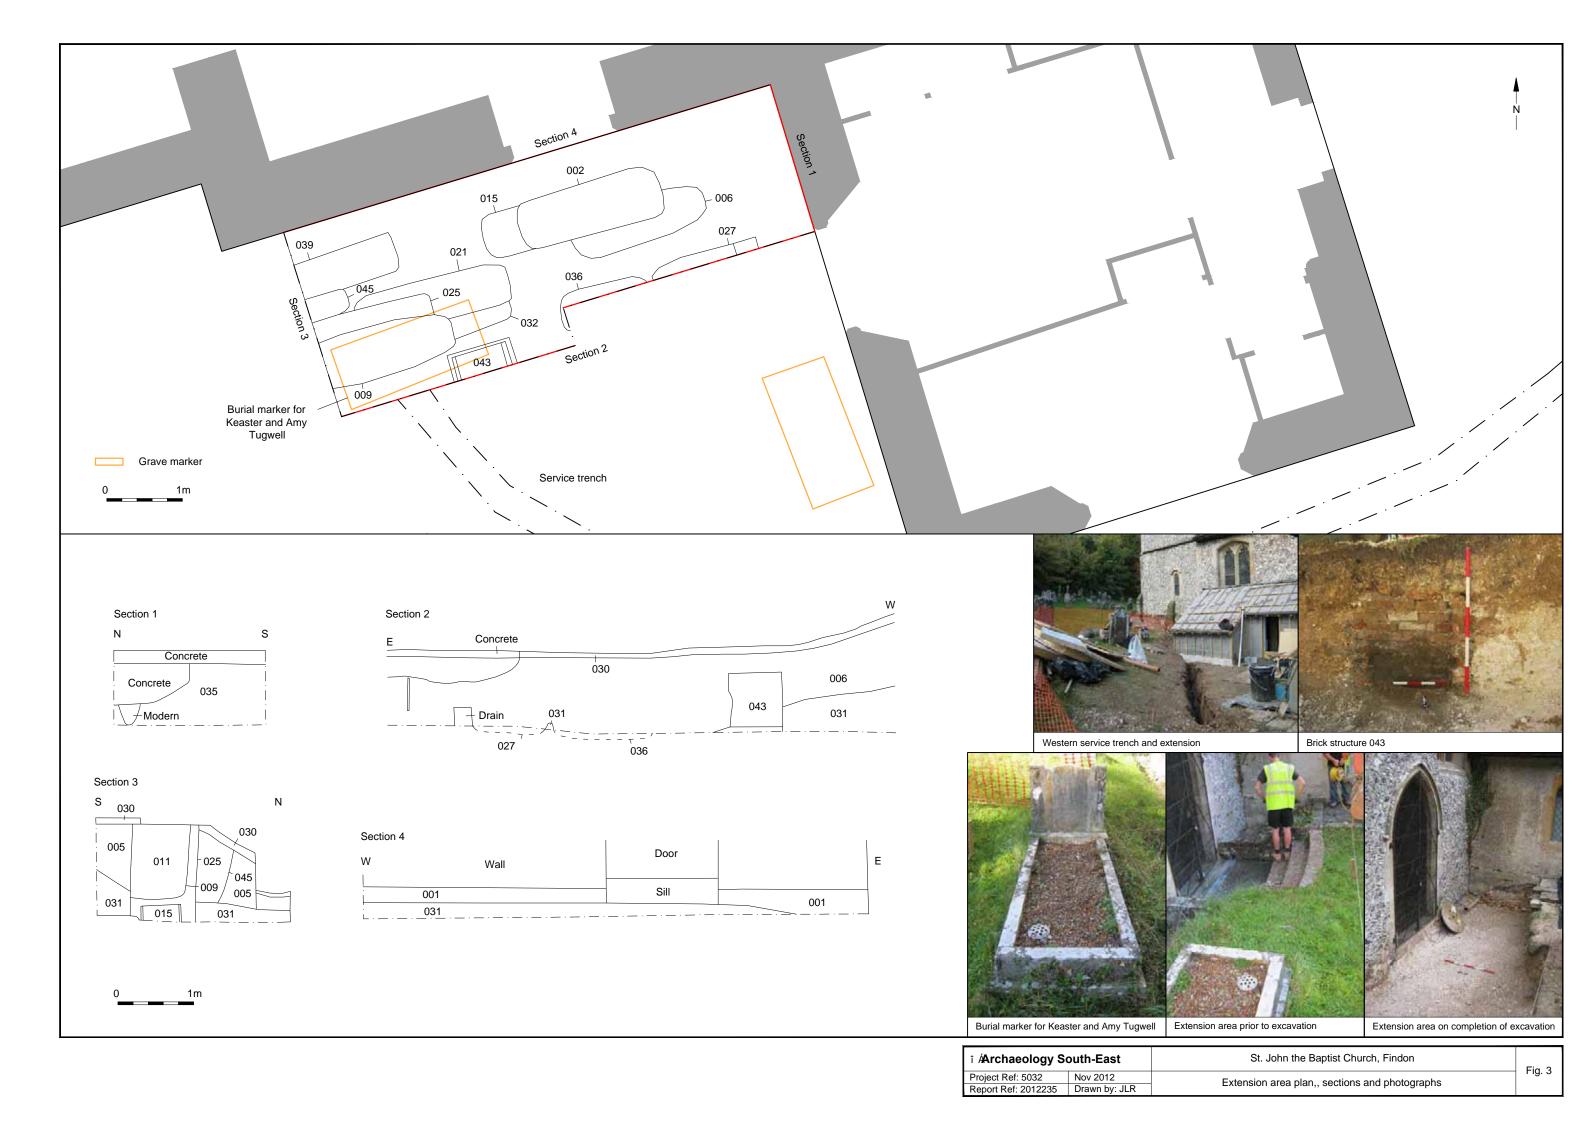
# **4.2** The Extension (Figure 3)

- 4.2.1 The extension area measured *c*.6.75m east-west by 2.50m north-south. Excavations began on the main extension area on 11<sup>th</sup> September and were monitored through to the required depth which was completed on 14<sup>th</sup> September. The ground level in this area was between 75.12m AOD and 75.65m AOD. A total of 47 contexts including contexts for 12 burials were recorded within the extension area.

- 4.2.2 Natural chalk bedrock [031] was recorded between 0.7m and 1.2m below ground level at a maximum height of 74.75 in the southwest corner. A moderately compacted mixed cemetery soil [005] was revealed overlying natural chalk with a thickness of 0.7-1.2m. It comprised light brownish grey silty loam with occasional inclusions of flint nodules, chalk flecks, ceramic building materials (CBM) and disarticulated human bone. The cemetery deposit was sealed by topsoil and turf [030] covering the church grounds. Several disarticulated bones were recovered from the cemetery soil and bagged for reburial. Many of the artefacts encountered during the archaeological investigations were typical of those found in a repeatedly used burial ground, with the digging of graves over a lengthy period resulting in the disarticulation of human bone and the scattering of coffin fittings (in this case only evidenced infrequently by nails) and sporadic CBM (usually related to reconstruction work associated with the church building) within the graveyard soil.

- 4.2.3 A total of 12 articulated burials were observed and recorded within the area of the new extension [010, 014, 015, 016, 019, 020, 021, 022 and 023] at heights of between 74.15m AOD and 74.55m AOD. The burials were at depths of between 0.4m (below doorsill) and 1.4m below current ground level this area depending on the location of the grave. The slope of this area is reflected in these depths, therefore the depth below ground level can be misleading. The ordnance levels demonstrate that there was only 400mm

- 4.2.6 A poorly built small square brick structure [043] (0.85m² and 0.75m tall/deep) was recorded in the southern section 0.35m below ground level. The function of this feature is unclear although it is too small for a tomb or funerary structure and may have been, more likely, a drainage structure/manhole. The structure was covered with a stone slab (70cm by 65cm with a thickness of 7cm).

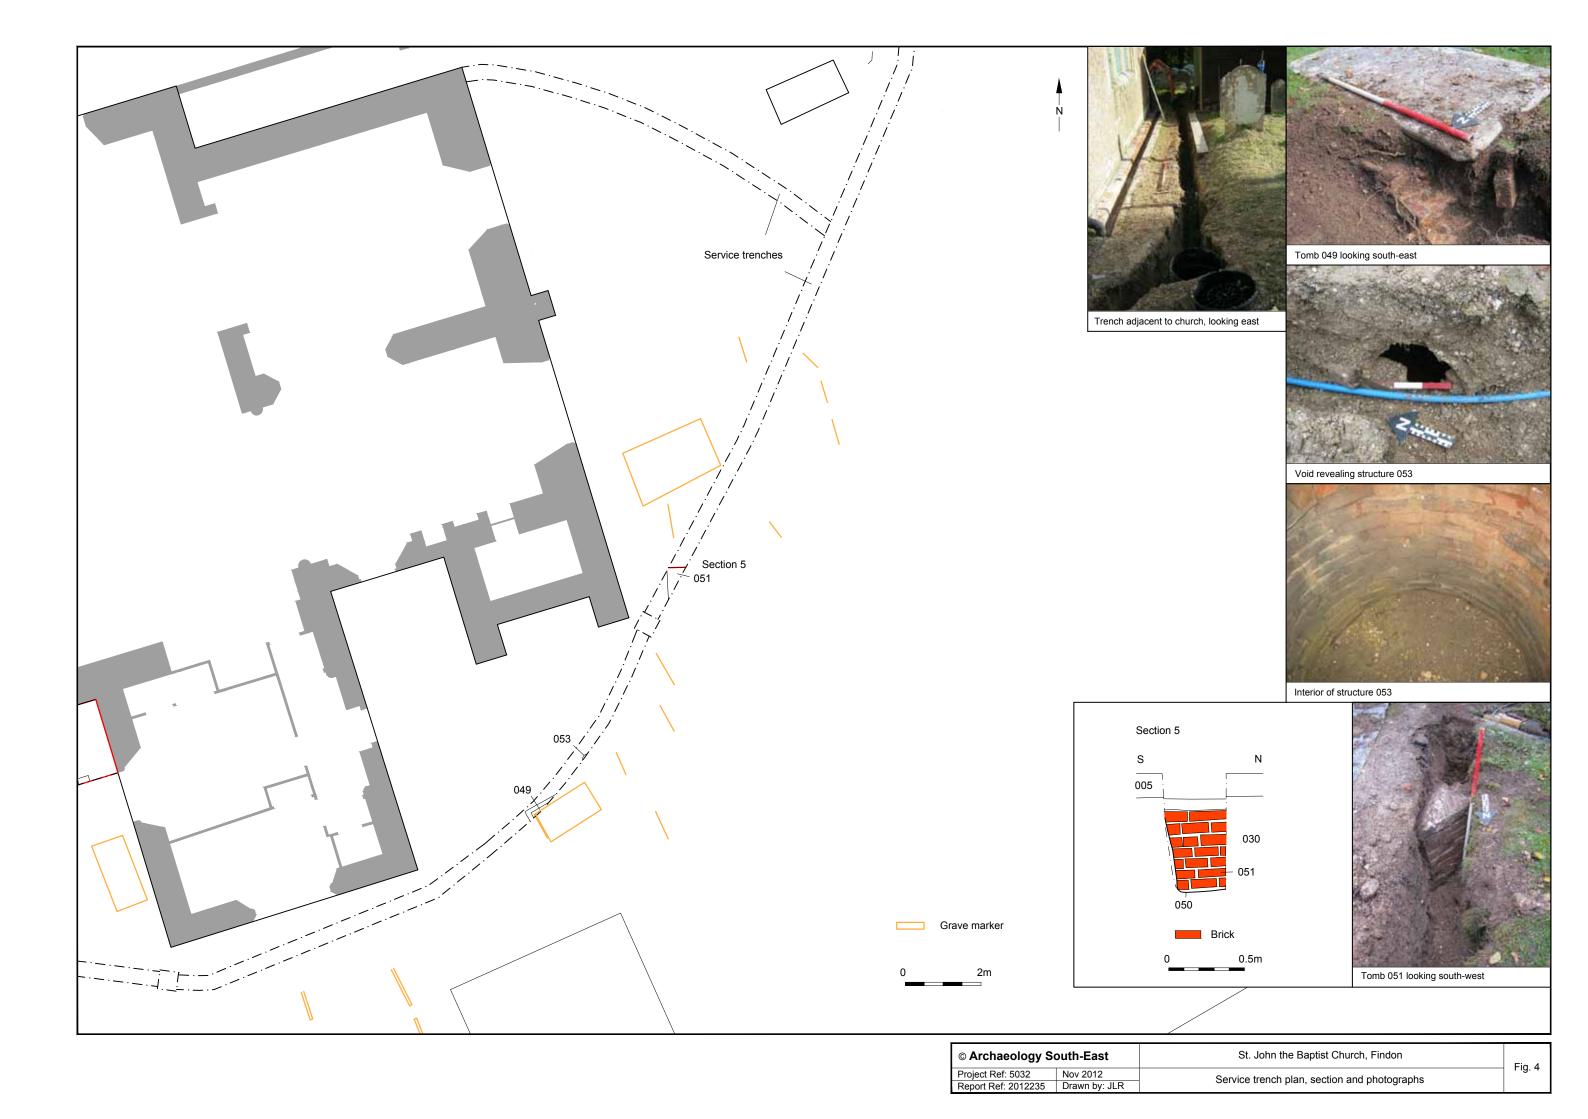
- **4.3** The Service Trenches (Figure 4)
- 4.3.1 The drainage trench excavations began in the south-western corner of the extension (at 75.65m AOD) and extended around the corner of the church building to the east and down the natural slope of the cemetery to the

location of the cess tank east of the church (at 71.00m AOD). These excavations began on 15<sup>th</sup> October and were monitored until 17<sup>th</sup> October when excavation ceased. A total of 6 contexts were recorded within this area, one of which one was later discarded.

- 4.3.2 The trench measured 0.45m wide with a depth of 1.35m in the west and it became gradually shallower (to a depth of c.0.7m) as it extended to the east. In the westernmost extent of the trench the excavations cut 450mm into the natural chalk bedrock [031].

- 4.3.3 The excavations for the service trench revealed occasional disarticulated human bone fragments which were bagged for reburial, but no articulated burials were encountered during these excavations. However, the north-western corner of a brick-lined tomb [049] and a separate brick-lined tomb wall [051] were revealed during these excavations.

- 4.3.4 A second service trench (measuring 12m in length, 0.4m wide and 0.6m deep) was excavated on a roughly north-south alignment to the east of the church. This trench met the original service trench approximately 15m southwest of the cess tank.

- 4.3.5 A round brick structure [053] was observed through a void in the side of the service trench. The size and shape of this structure suggests it is unlikely to be a funerary structure and is perhaps more likely to be a soakaway or well.

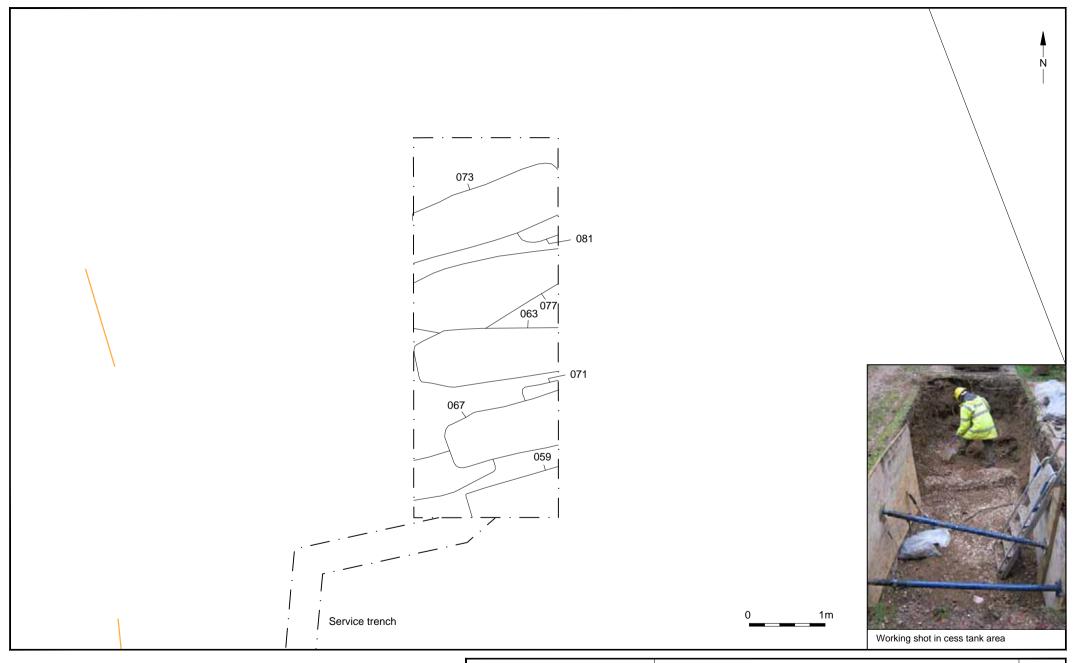
î AArchaeology So	outh-East	St. John the Baptist Church, Findon	Fig. 5	
Project Ref: 5032	Nov 2012	Cess tank plan and photograph	1 ig. 5	ĺ
Report Ref: 2012235	Drawn by: JLR			ĺ

- 4.4.1 Excavations were carried out to the east of the church for the installation of a 9000 litre cess tank. The area measured 5.8m by 1.8m with a depth of 2.5m. The ground level in this area was *c*.71.00m AOD. Excavations began on the cess tank area on Tuesday 19<sup>th</sup> October and were monitored through to the required depth which was completed on 26<sup>th</sup> October. A total of 29 contexts including contexts for 6 burials were recorded within the extension area.

- 4.4.2 Natural chalk geology [031] was revealed at a depth of 1.2m below ground level (c.69.9m AOD) in the cess tank area. This was overlain by cemetery soil [058] (same as [031]) consisting of light brownish grey silty loam with occasional inclusions of flint nodules, chalk flecks, ceramic building materials (CBM) and disarticulated human bone. The cemetery deposit was sealed by topsoil and turf [030] covering the church grounds.

- 4.4.3 A total of 6 articulated burials [056, 061, 065, 069, 075 and 079] were recorded during the excavations for the cess tank at heights of between 69.74m AOD and 70.31m AOD. Only 2 of these [056 and 069] burials were intercutting which suggests that this part of the graveyard was not utilised to the same extent as the area of the new extension. The cess tank excavations revealed a north-south aligned row of burials with no evidence of stacked burials. With the exception of [056] all of the burials were cut into natural chalk.

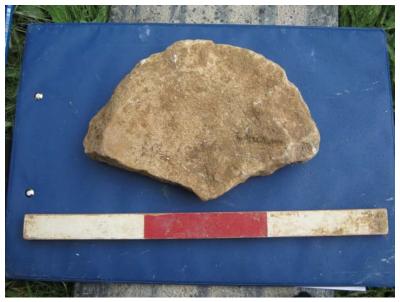
Fig. 6.1: 13th-14th c. grinding mortar reused as pillow stone - found in grave 027 with skeleton 028

- 4.2.5 A pillow stone (Figure 6.1) (underlying the skull of skeleton 028) was retained from one grave [027], which is indicative of an earlier burial. The recovered stone is an abraded base fragment from a well-used grinding mortar in Caen stone of 13<sup>th</sup>-14<sup>th</sup> century date. The individual in this grave was male with extensive tooth wear indicative of a pipe smoker. This find indicates the potential for medieval and possibly even earlier graves to have survived within the cemetery in spite of the considerable post-medieval burial activity. In addition, a small (silver?) cross pendent was also found around the neck area of this skeleton (Figure 6.2). This artefact was reburied with the skeletal remains with which it was found.

5.2.1 A single piece of stone (Figure 6.1) was recovered from the site during the archaeological monitoring (context [029]). This is the pillow stone mentioned above in 4.2.5. This consists of a somewhat abraded base fragment from a well-used grinding mortar in Caen stone. The vessel is likely to be of 13<sup>th</sup>- to 14<sup>th</sup>- century date.

- Burials in cemeteries are often hard to date accurately in the absence of headstones and burial records, but one burial did contain a pillow stone comprising a reused 13th-14th century grinding mortar in Caen stone which demonstrates the potential for medieval burials to survive on the site in spite of post-medieval burial activity. The burials at this site did provide some

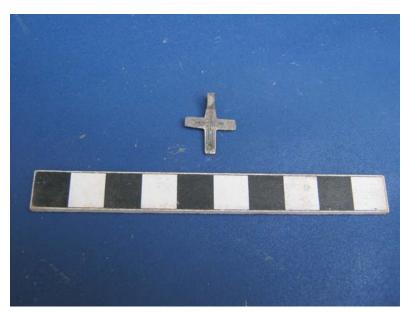
Fig. 6.2: Cross pendant found in grave 027 with skeleton 028
