**AN ARCHAEOLOGICAL WATCHING-BRIEF AND
TARGETED HISTORIC BUILDING RECORD AT
THE OLD TOWN HALL, MARKET SQUARE, HORSHAM,
WEST SUSSEX, RH12 1EU**

Report No. 2012202

October 2012

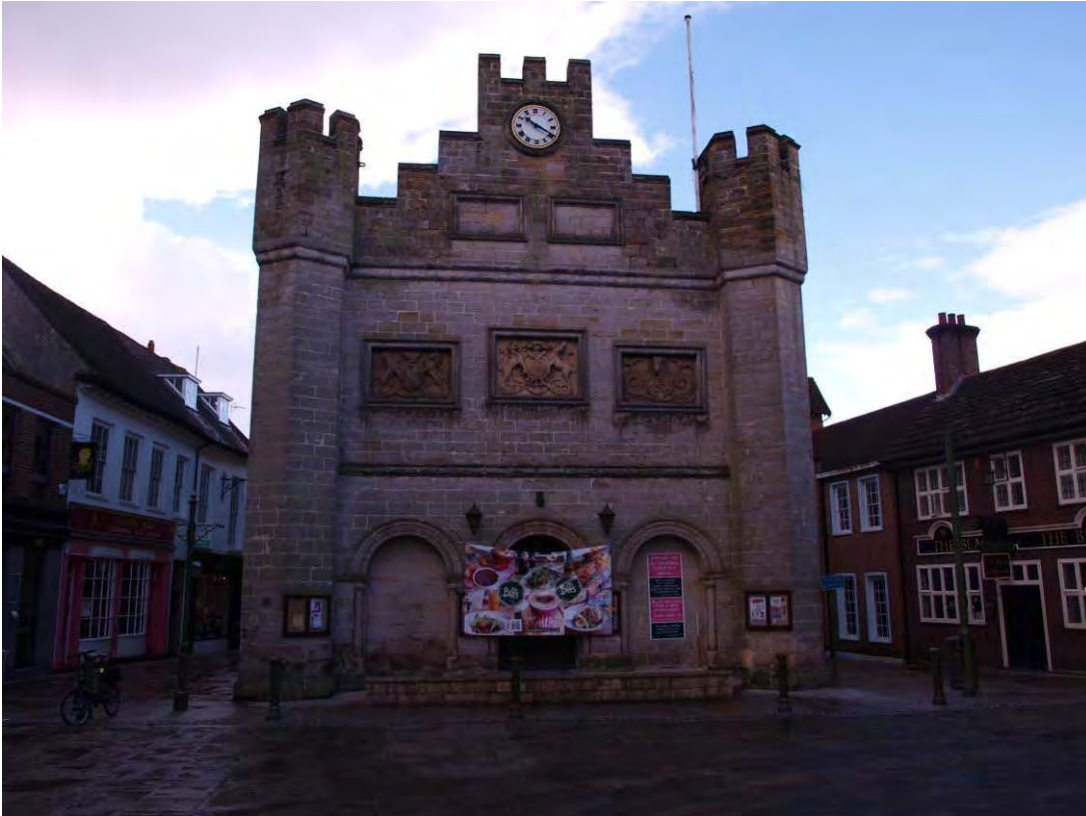
- 5.1.1 The north elevation comprises three Romanesque arches at ground floor level (Plate 1). Originally, all three were designed as architectural blinds, although for some time, the central arch has formed the main entrance to the building. The façade is constructed in ashlar blocks of sandstone, with later repointing in cement mortar. The infill of the blind arches was of the same sandstone. The outer two arches were drawn (Fig. 4) and photographed (Plates 2 and 3) prior to their opening-up as part of the alteration works.

Plate 1: North elevation prior to alteration (21)

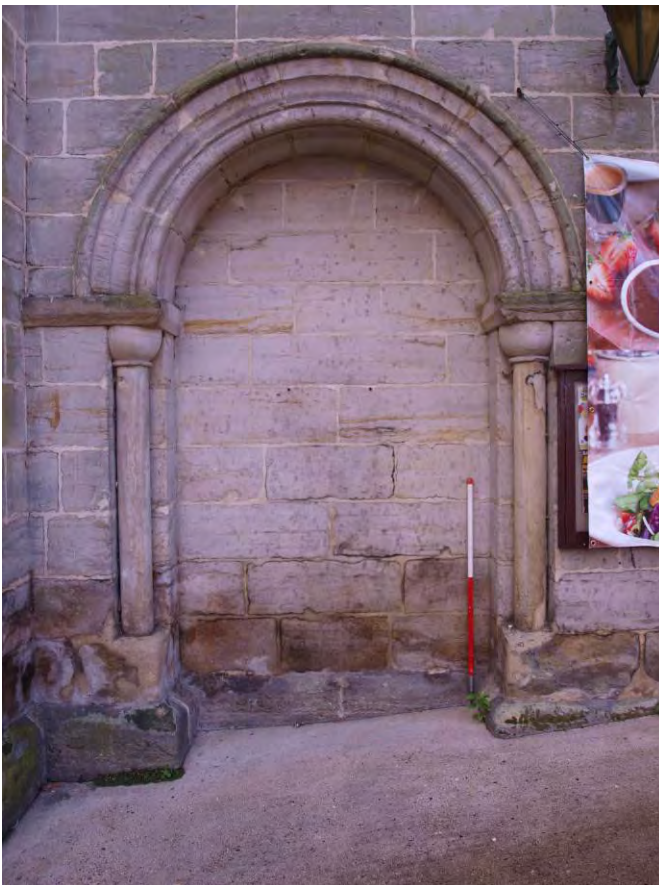
Plate 2: Left-hand blind arch prior to alteration (23)

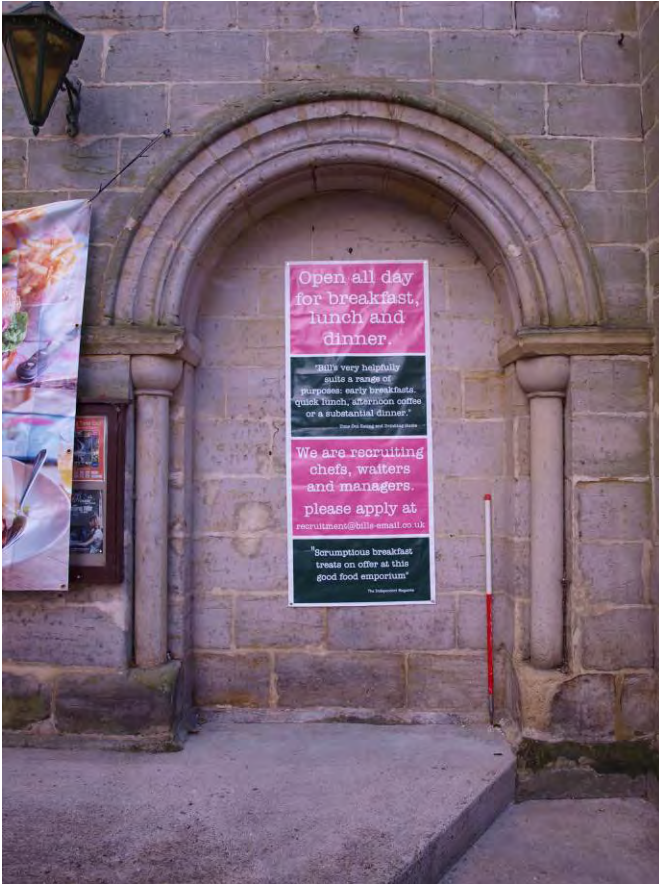
Plate 3: Right-hand blind arch prior to alteration (22)

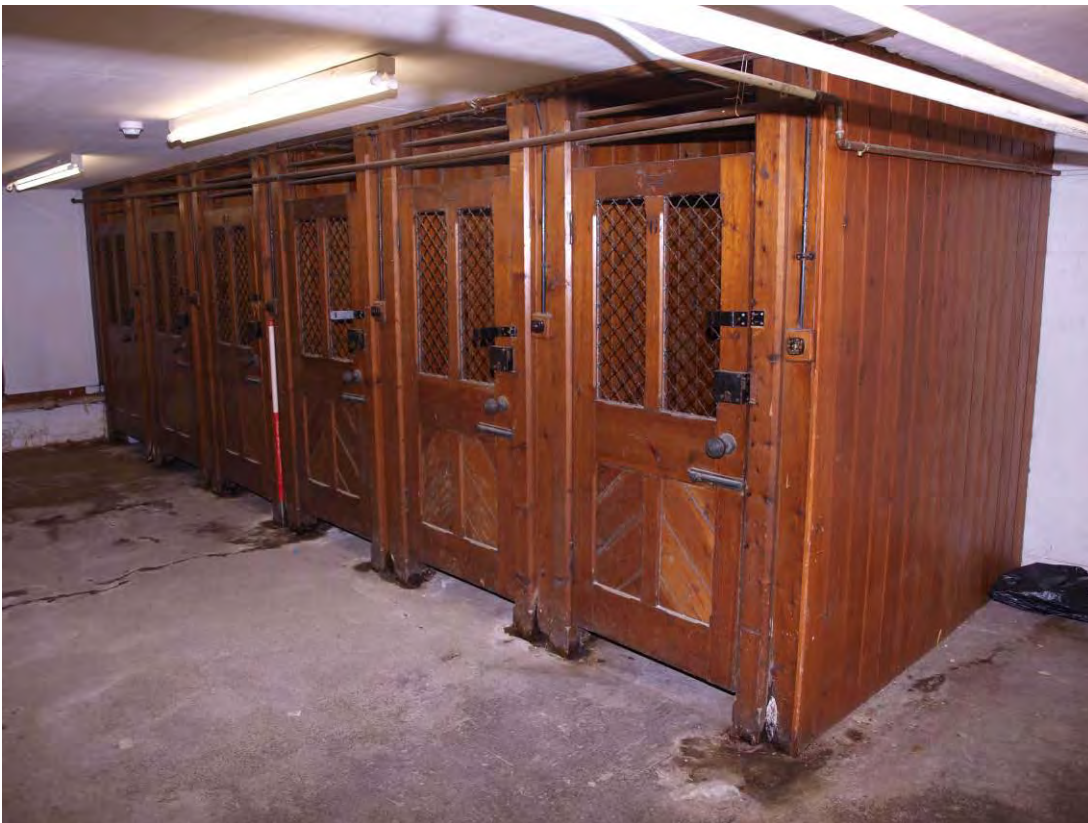
- 5.1.2 The main, northern part of the basement is divided into two length-ways (north – south) by a brick wall (Fig. 6). The resulting two areas each contain a series of six wooden holding cells backing onto the dividing wall (Plates 4 and 5). Stylistically they appear c. 1900 in date. The cells were recorded prior to their refurbishment.

Plate 4: Cells in western portion of basement, looking north-east (11)

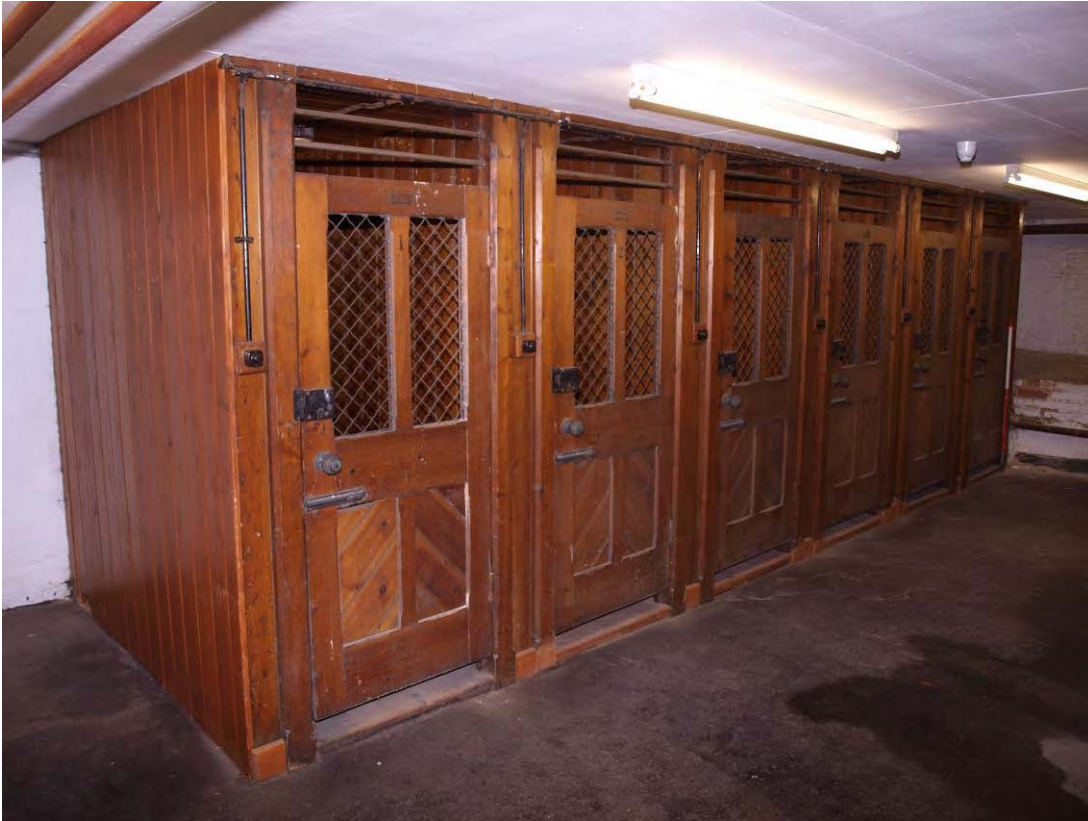
Plate 5: Cells in eastern portion of basement, looking north-west (18)

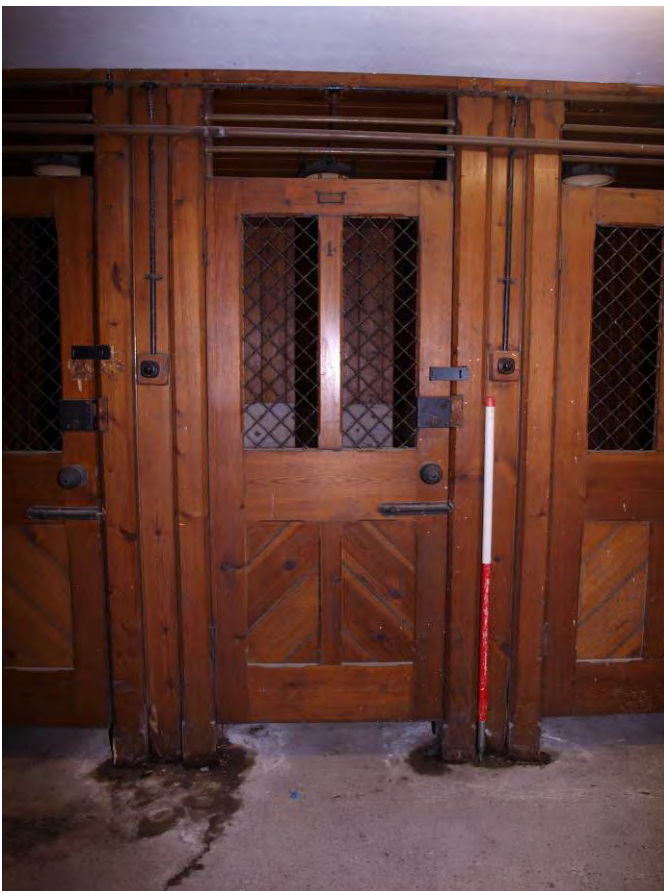
- 5.1.3 The cells are notable for their virtual completeness. They are constructed in softwood tongue-and-groove boards, with the timber uprights of the cell partitions and the doors being enriched by chamfer detailing. Each cell measures 1.9m x 0.95m and is closed by a four-panel timber door, the two upper panels of which contain a wire lattice-work grille (Plate 6). The doors retain their original furniture including handle, rim-lock and bolt. The space above each door is spanned by two iron bars to prevent prisoner escape. The reverse side of each door is fixed with a folding ledge (Plate 7), while fitted benches at the back of each cell have formerly been removed. Each cell retains an original light fitting (Plate 8). The walls of the cells retain some 20th century graffiti written by individuals awaiting trial.

Plate 6: Cell door detail (13)

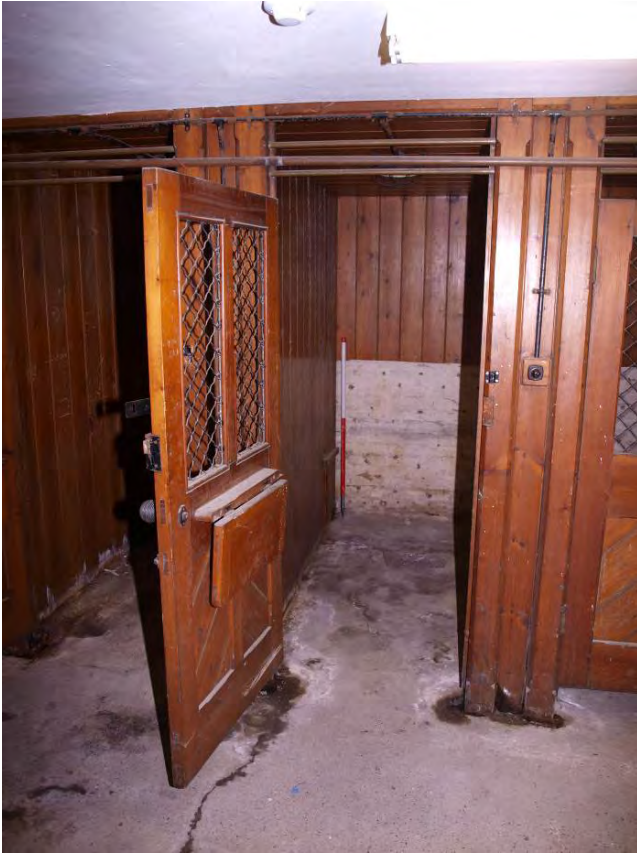
Plate 7: Cell interior detail (15)

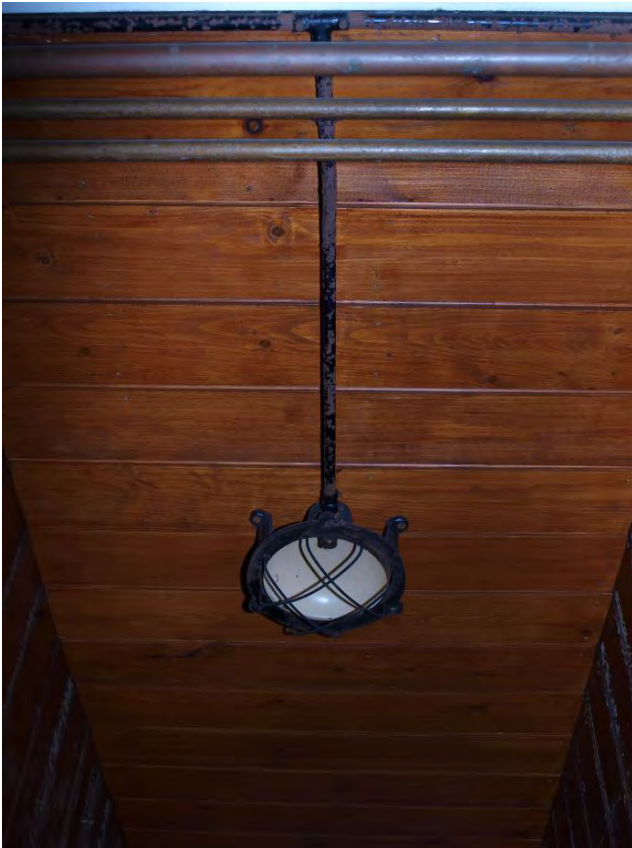
Plate 8: Cell light-fitting (16)

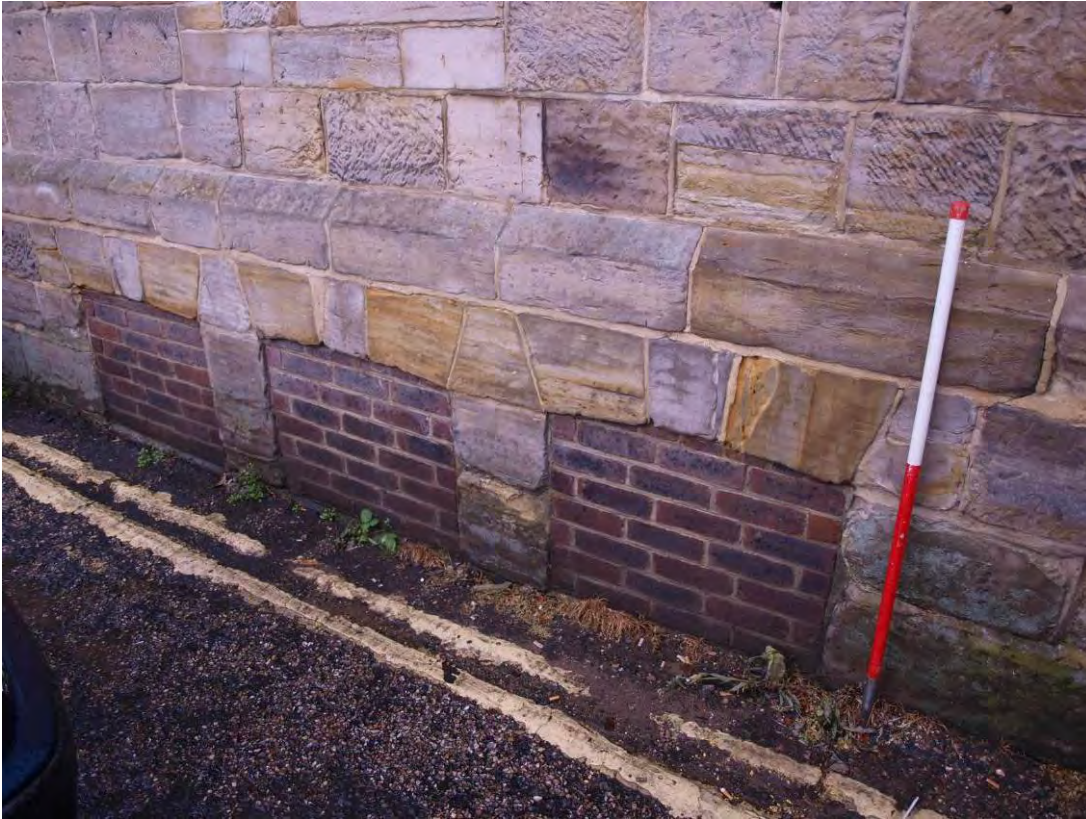
- 5.1.4 The south elevation contains three basement window apertures (Plate 9) which presumably belong to the 1888-9 phase of construction. They are blocked with 20th century brickwork laid in a cement-based mortar.

Plate 9: Blocked basement window apertures within south wall, looking north-west (24)

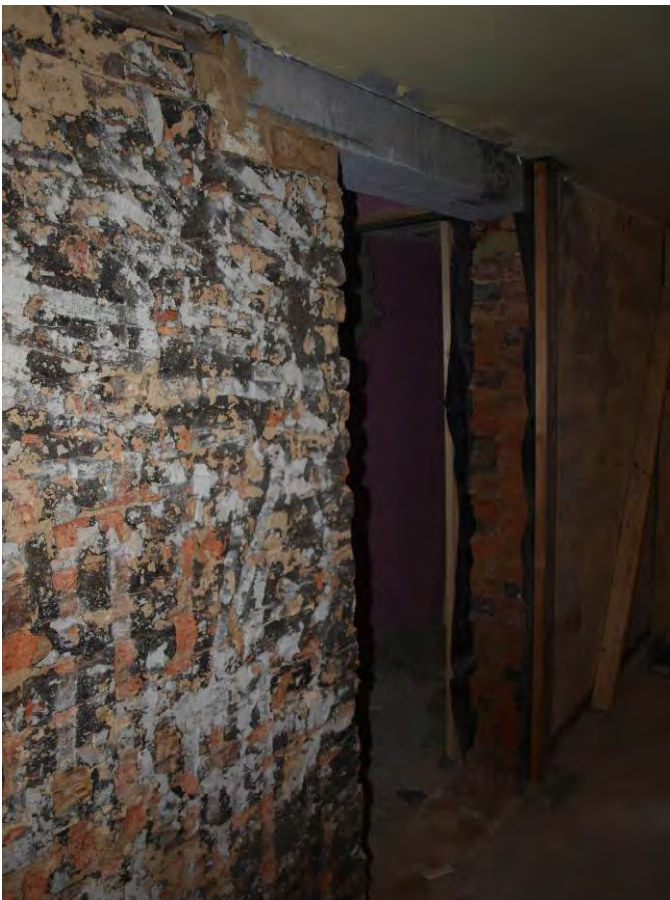
- 5.2.1 A doorway was created within the partition wall between the two southern rooms of the basement (Plate 10). The removal of a modern tiled surface revealed underlying, probably 19th century brickwork of a mottled pale orange colour, laid in a lime-based mortar.

Plate 10: Doorway inserted within basement wall, looking south-east (51)

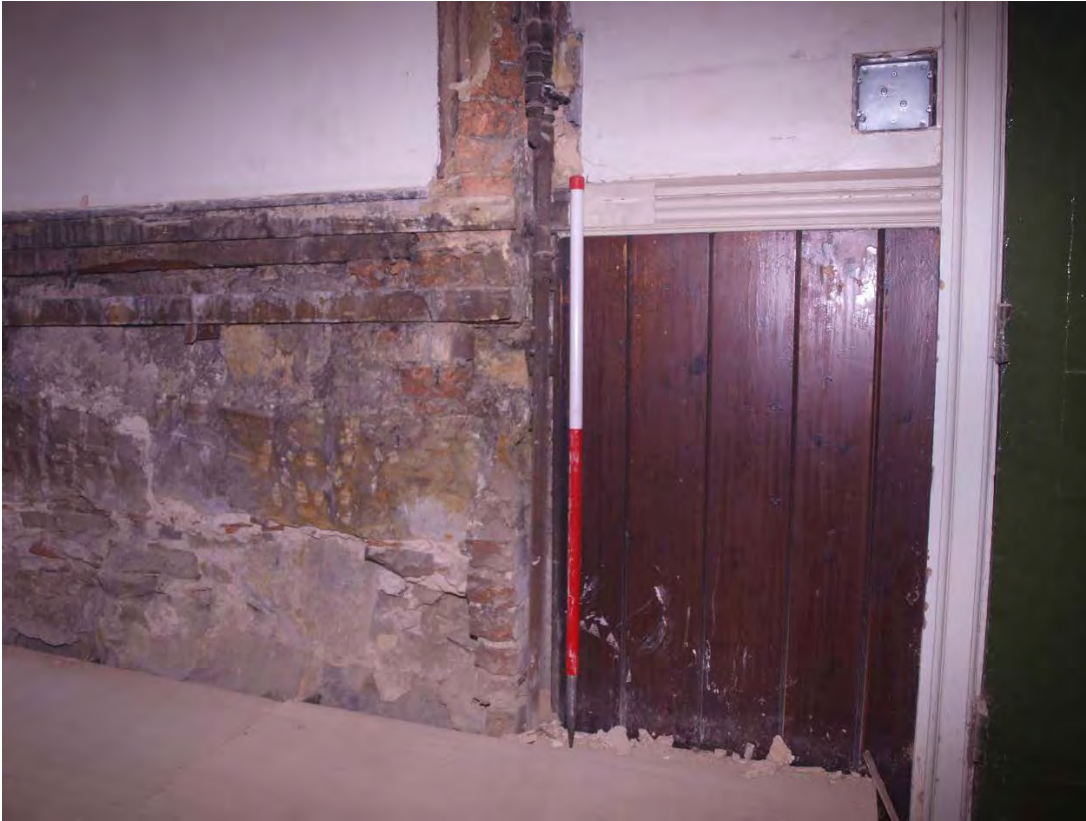
Plate 11: Tongue and groove boarded dado revealed on north wall, looking north (35)

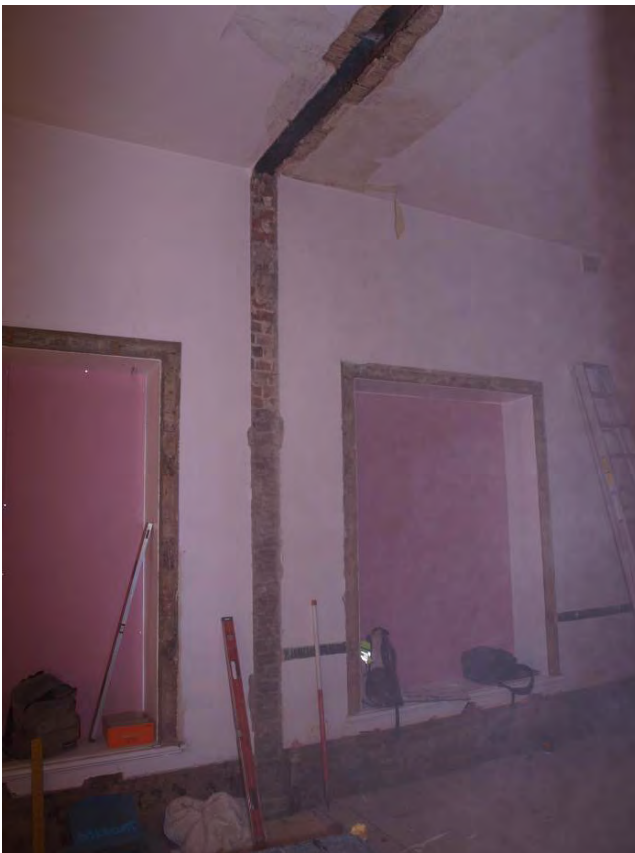
- 5.2.7 The removal of the partition wall between the two southern rooms exposed a narrow strip of the brickwork between floor and ceiling level (Plate 12). This appeared to be of two phases, the lower brickwork, to c. 2m from floor level being the earlier of the two (i.e. of 1888-9), with later, 20th century brickwork, seemingly representing a repair, above. Above this, on the line of the partition, the ceiling contained a length of I-girder (not continuing to the opposite wall) supporting the projecting first floor window above, and possibly associated with a later repair.

Plate 12: Rear ground floor room following removal of partition wall, looking south (46)

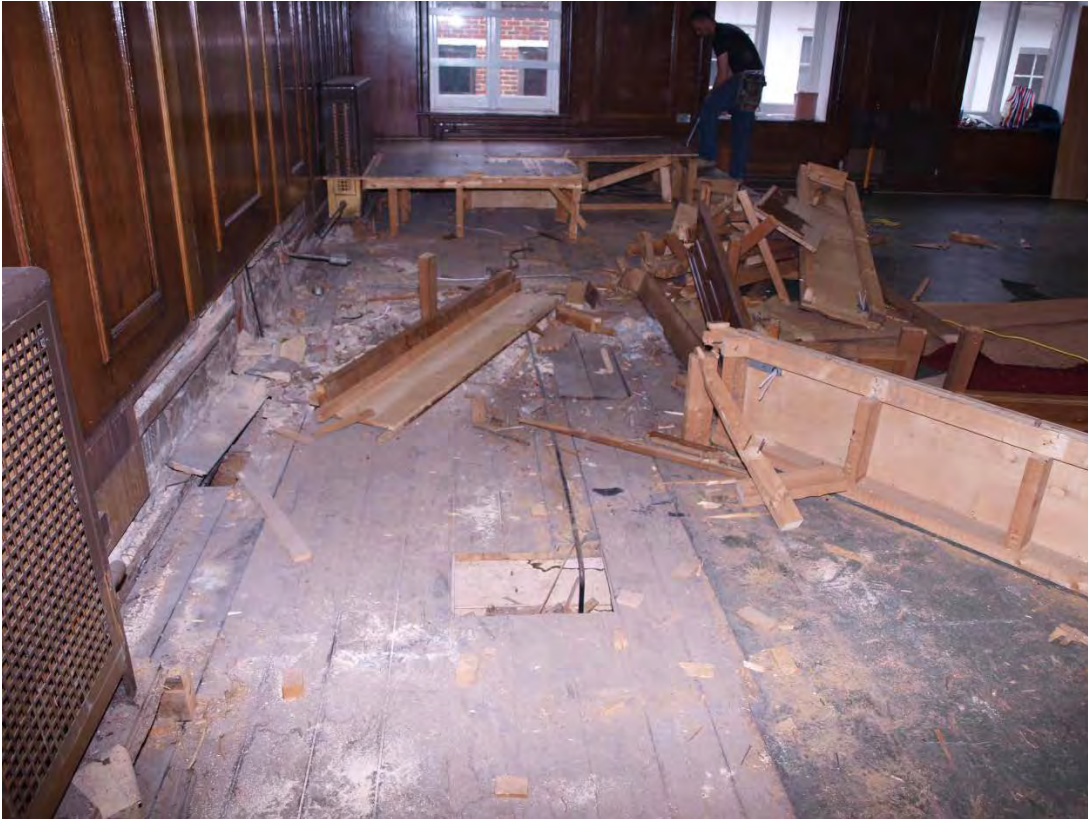
- 5.2.9 The creation of the void between the ground and first floor first involved the removal of a raised dais area within the former council chamber. A newspaper of March 19th 1974 was found beneath the dais indicating that it was constructed on or after this date. The dais was constructed over a surface of vinyl floor tiles, beneath which were fairly narrow softwood timber boards (Plate 13). These were laid over deep-section softwood joists (275mm x 63mm/10½" x 2½") aligned north-south supported over riveted I-girders, and at the north wall directly upon the stone masonry, with bricks between for added rigidity (Plate 14).

Plate 13: Removal of 1970s dais (first floor), looking east (26)

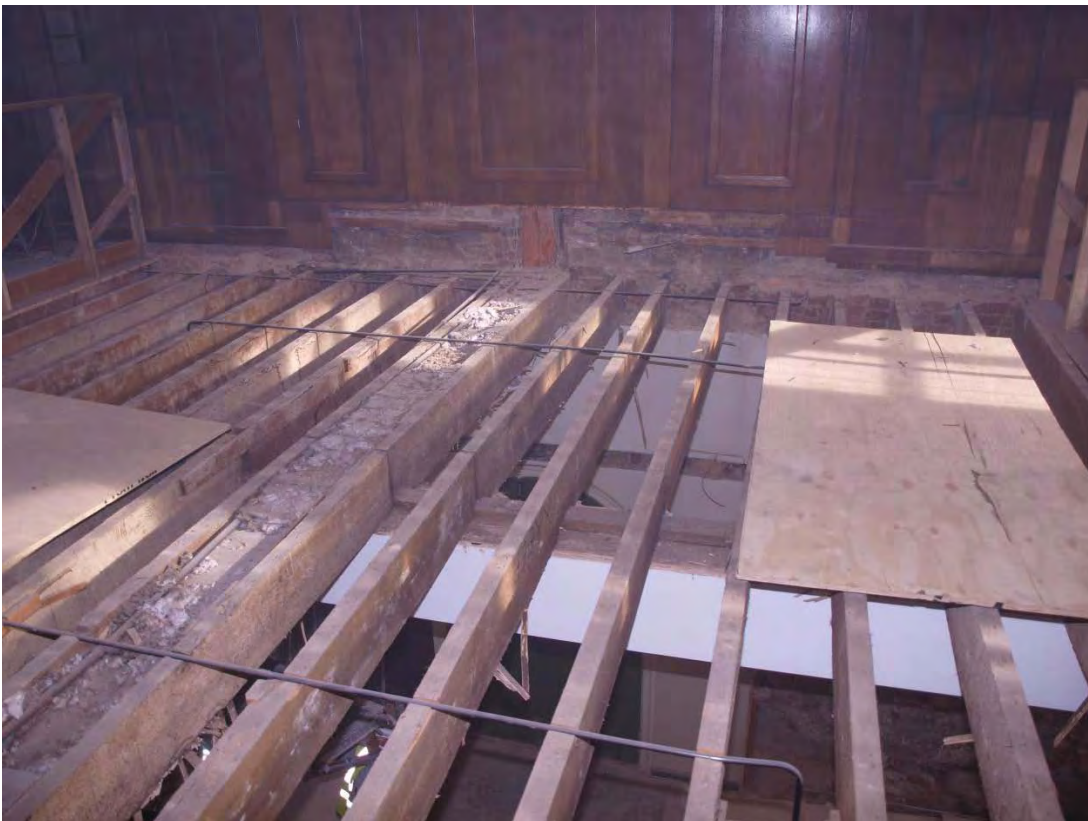
Plate 14: View during creation of first floor void, looking north (43)

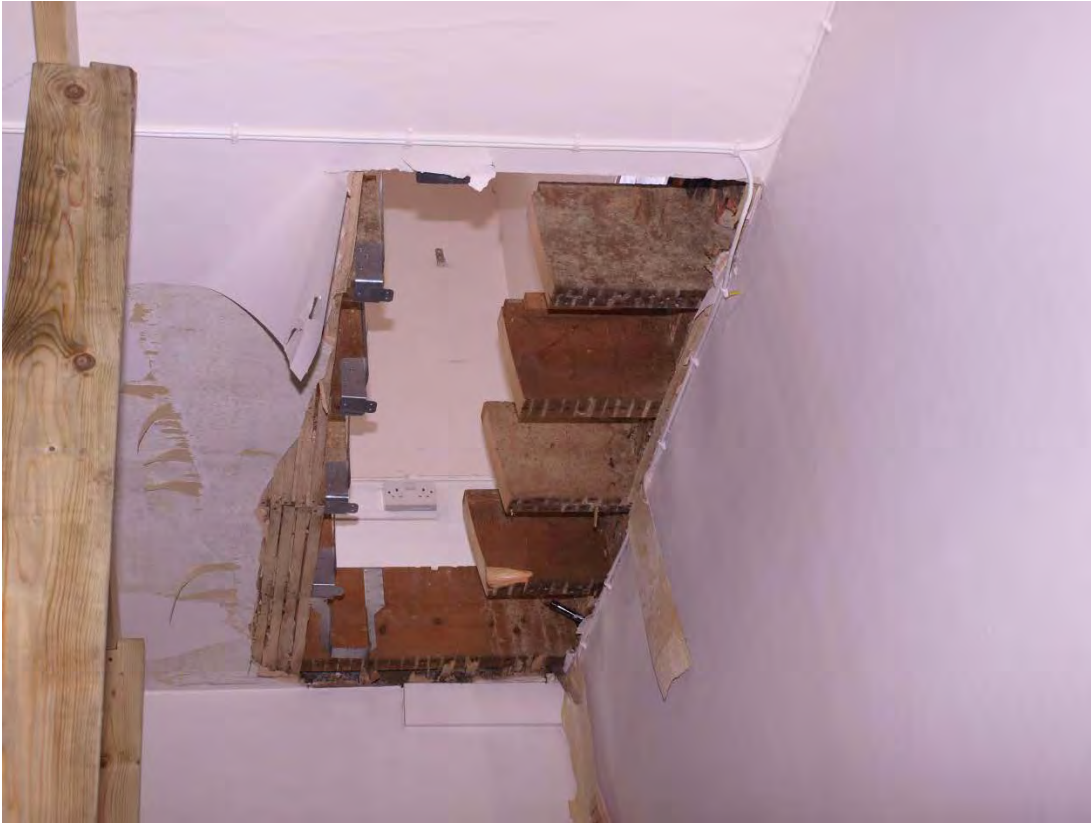
- 5.2.10 Within the rear room, the removal of the small sections of flooring in association with the hoist and ducting revealed no significant features or fabric (Plate 15).

Plate 15: Creation of void in first floor for ducting, looking west (49)

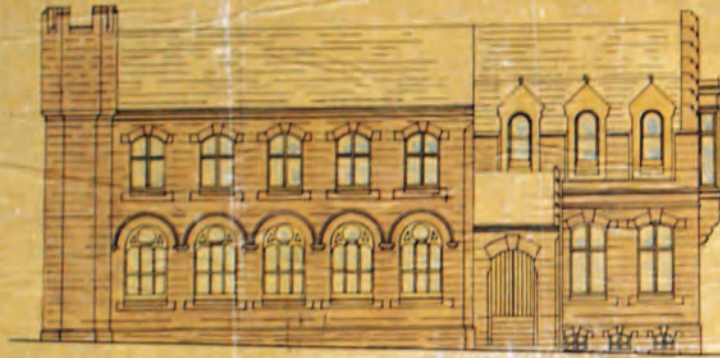
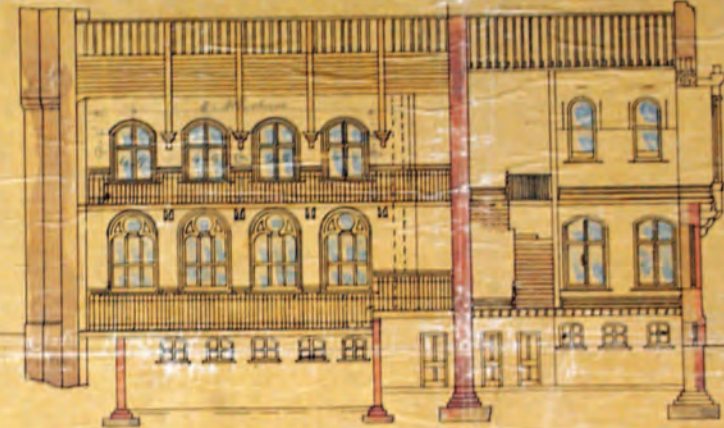
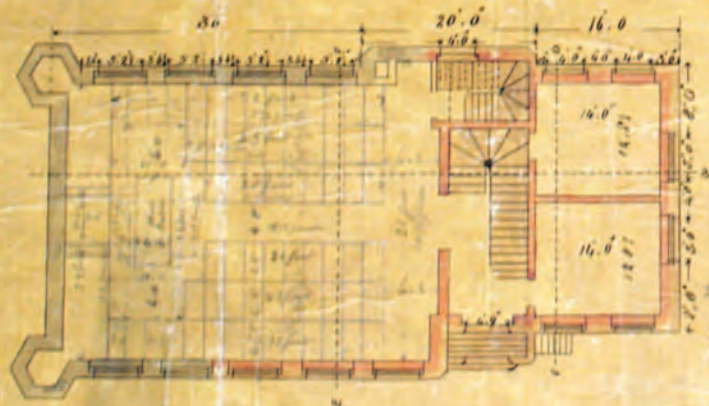
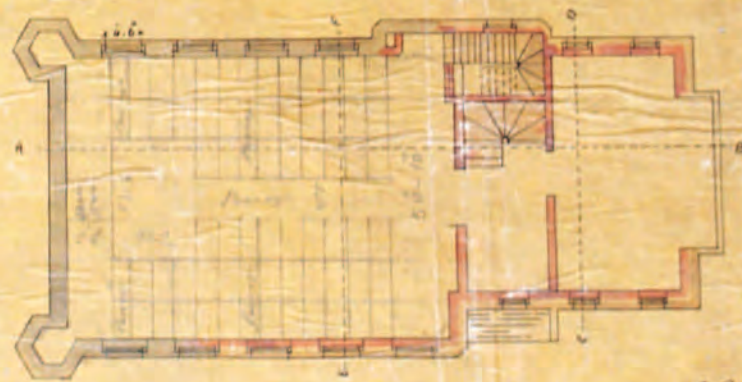
DRAWING N^o1

- 4.4 Architectural drawings by J. Percy Gates, dated 29.9.1888 (Fig. 3), show the alterations proposed for the Town Hall, which are reflected in the building's current layout. The plans indicate that the north façade and the east façade as far as, and including part of, the east stair tower were retained, together with the return wall of the west elevation, the remainder of which was extended outwards on the same line. At this point within the basement, the west wall contains a visible break in the construction of the building comprising earlier stonework to the north, and later brickwork to the south. The new southern end of the building provided two rooms on the ground floor plus a single room on the first floor.

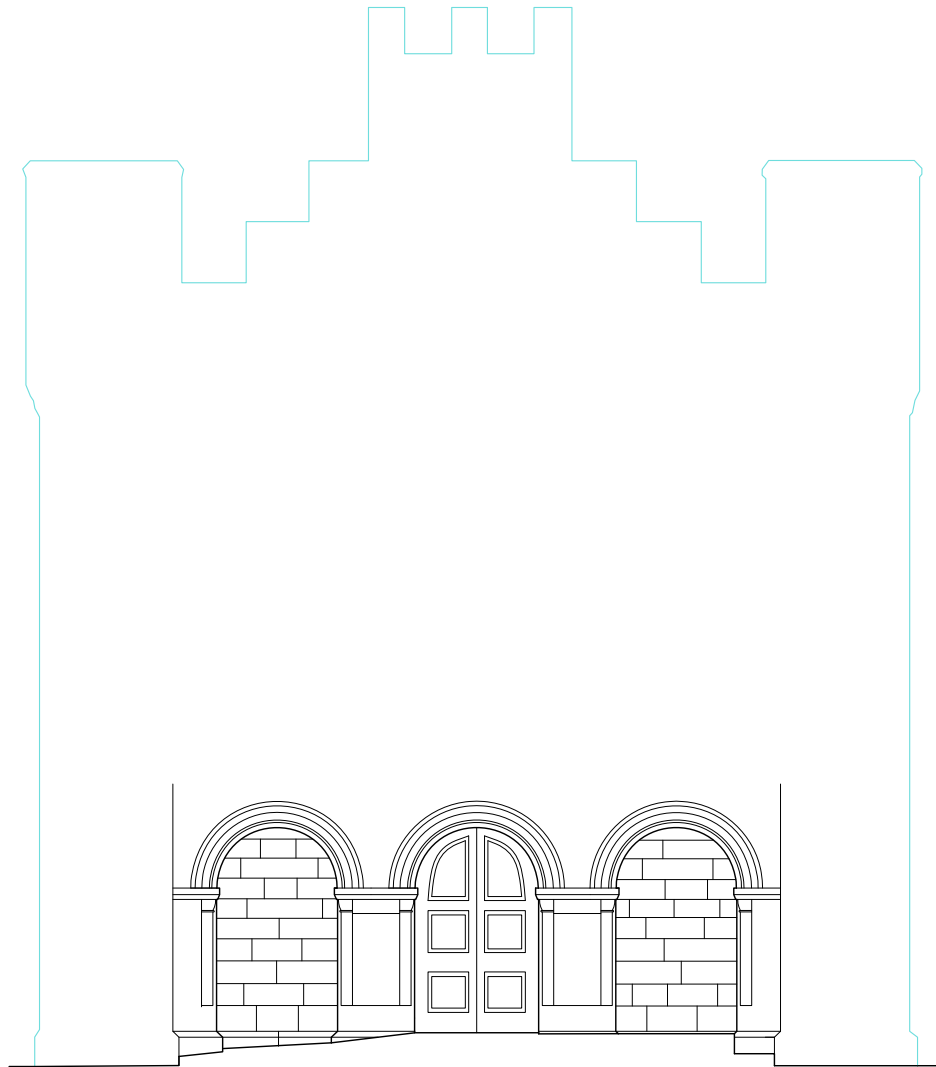
© Archaeology South-East		The Old Town Hall, Market Square, Horsham	Fig. 4
Project Ref: 5652	Nov 2012	Blind arches on north elevation	
Report Ref: 2012202	Drawn by: AW

- 5.2.4 The arches are formed in ashlar sandstone blocks, with ashlar sandstone blocks (externally), and brickwork (internally) infilling the arch, with a half-brick skin of brickwork containing timber-bearers to the internal face. Above the arches, the interior face of the wall is formed of orange English-bonded brickwork laid in a lime-based mortar. At its lower level, to c. 1m in height, the wall is formed essentially of stone blocks, although differentiation in the composition of the walling, which is more rubbly to the lower c. 0.35m, whereas formed of generally larger, more regular stone blocks above, might suggest that the wall is of more than one construction phase. The two are separated by a tile levelling course.

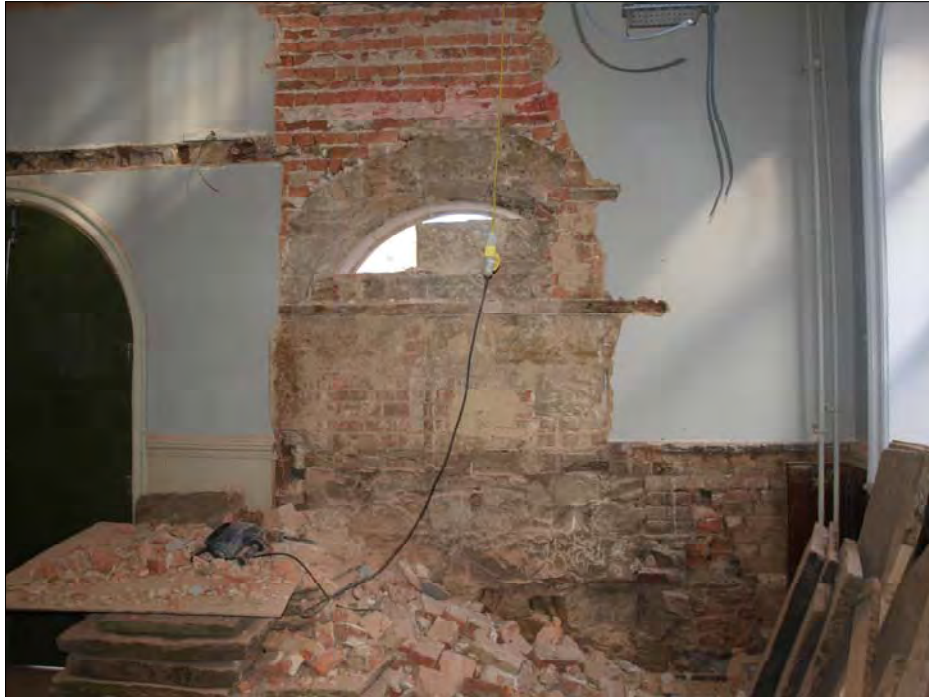
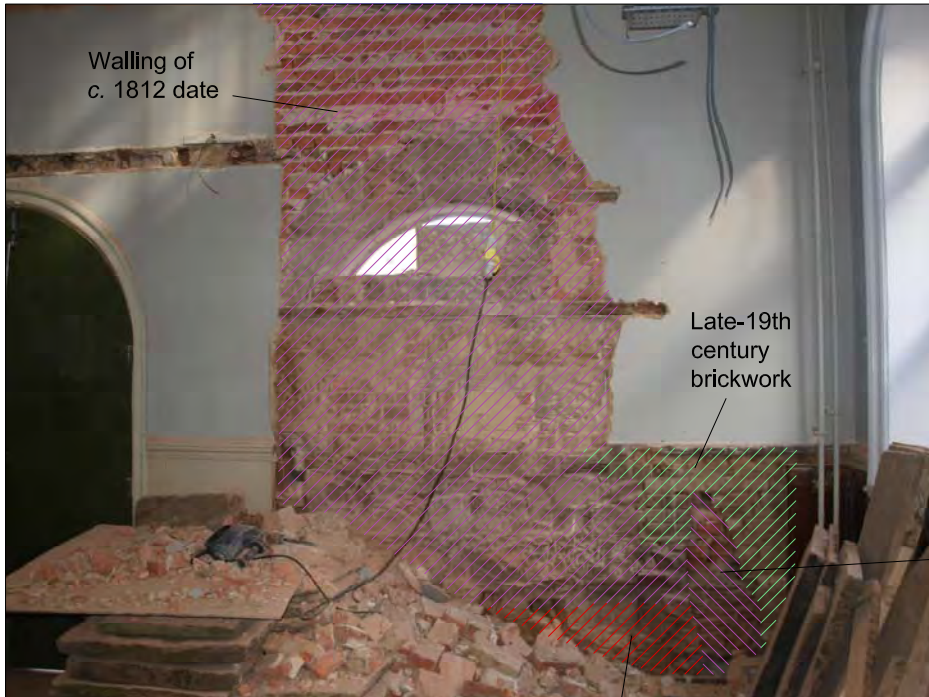
© Archaeology South-East		The Old Town Hall, Market Square, Horsham	Fig. 8
Project Ref: 5652	Nov 2012	Photograph of exposed area of north wall (east end), showing phasing	
Report Ref: 2012202	Drawn by: AW

- 5.2.3 Prior to the opening-up of the arches, the inner face of the north wall was partially stripped of its finishes. Initially this involved the removal of the modern hardboard dado, beneath which was revealed an earlier softwood tongue-and-groove boarded dado with moulded rail, presumably of the 1888-9 phase of alterations (Plate 11). The subsequent removal of this revealed the underlying construction of the wall which comprised a mixture of stone and brickwork, of probably three main phases (Figs. 8 & 9).

Walling of
c. 1812 date

Late-19th
century
brickwork

Brickwork,
probably of
c. 1812 date

Stonework,
probably of
pre- c. 1812
date

mainly to the basement. The recent partial surface stripping of the interior of the north wall, and the removal of the infill of the arches, revealed evidence to suggest that within the north elevation, the lowest c. 350mm of stonework surviving there might be retained from a previous building phase. Whilst it is possible that the wall is essentially of a single phase (c. 1812); the ragged edge of the walling at the junction with the orange brickwork at each end, would appear to indicate that the stonework has been cut back to allow the brickwork of the corner turrets to be tied-in to the wall, thereby suggesting that the lower part of the wall pre-existed.

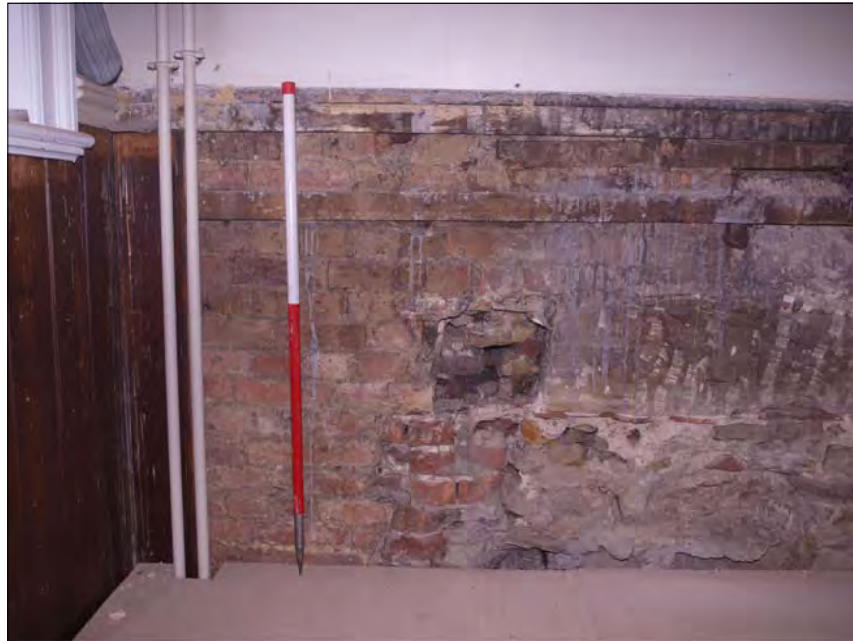
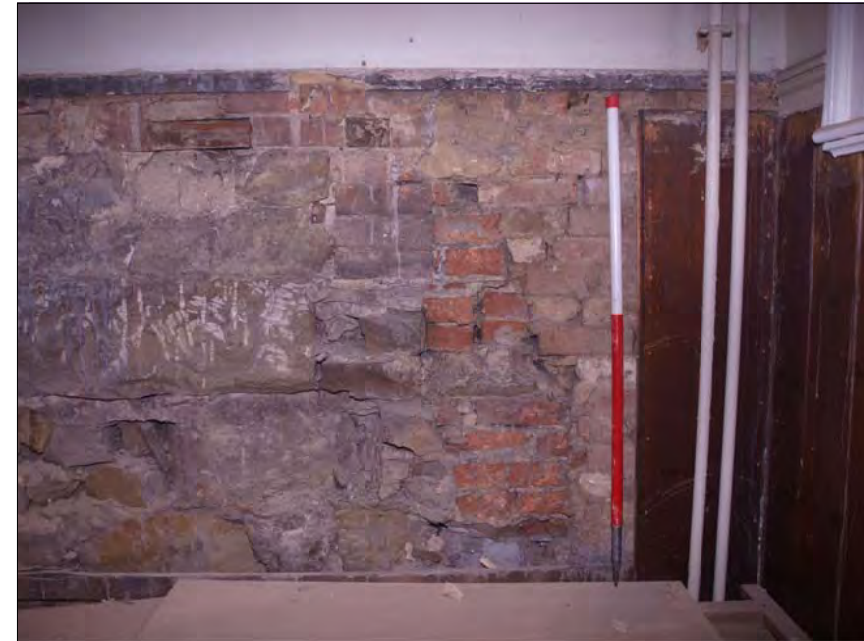
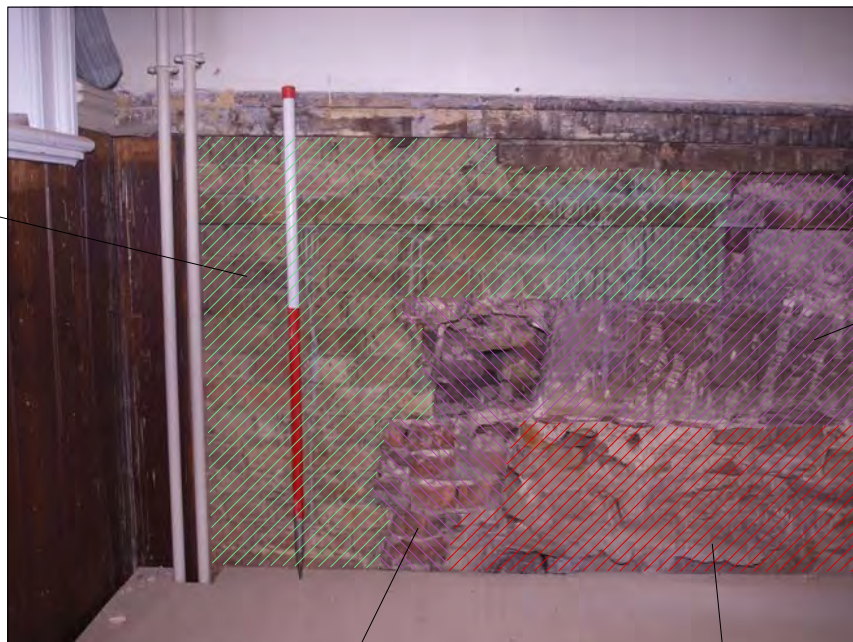
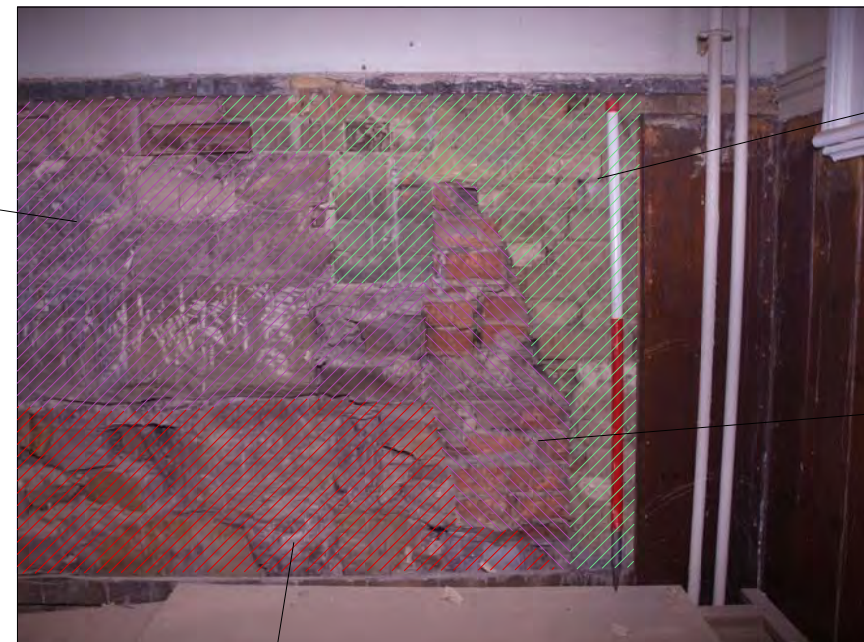
- 5.2.5 Towards either end of the wall, there is a discrete area of orange brickwork which probably relates to the turrets located at each corner. The brickwork, which appears to be similar to that surrounding the arches (i.e. of early 19th century date) appears to truncate the lower stonework, corroborating the suggestion that the lower stonework survives from an earlier building phase. The orange brickwork, at the east end at least, continues above the tile levelling course to c. 0.8m in height, above which it is concealed/truncated by later brickwork.
- 5.2.6 At the east and west corners there is an area of later (probably late-19th century) salmon pink-orange brickwork laid in a cement mortar, no doubt relating to the later-19th century (1888-9) phase of reworking/rebuilding.

Late-19th century brickwork

Walling of c. 1812 date

Brickwork, probably of c. 1812 date

Stonework, probably of pre- c. 1812 date
