KING'S HEAD HOTEL, CARFAX, HORSHAM, WEST SUSSEX, RH12 1EE

AN ARCHAEOLOGICAL WATCHING BRIEF

Report No. 2011260

Project No. 5404

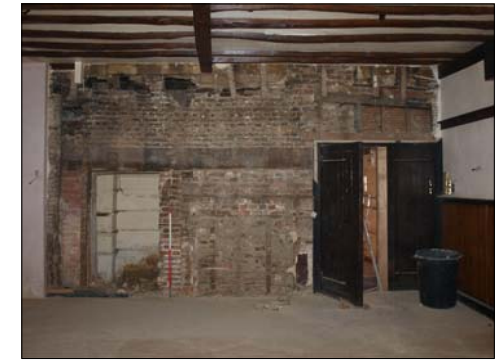
Plate 1: Elevation 1

- 5.1 The ground-floor part of the stack has a considerable footprint, measuring approximately 3.50 metres roughly east-west and 3.05 metres roughly north-south. There are fireplaces facing north and south. The south face bears evidence for two phases of fireplaces. A large fireplace, measuring 1.65 metres high and at least 3.00 metres wide, has a timber lintel. This lintel is chamfered on the lower leading edge, with a stepped-and-hollowed stop at the western end, respecting the brick jamb formed in brick (B2 – see Table 1 below for all brick descriptions). The lintel has a shaped rear face to allow for the brick tumbling on the interior of the stack. As there is no chamfer-stop at the eastern end of the present lintel, it is assumed that the lintel has been truncated at this end. Above the lintel there are narrow bricks (B1) extending up to ceiling level. These bricks appear to be of 16th-century date and have experienced some damage: there are various holes in the brickwork below the timber cross-beam. Above the ceiling, this brickwork is truncated, and does not form part of the first-floor stack.

- 5.2 This large fireplace has been blocked leaving an open area below the earlier lintel which forms the doorway into a small cupboard. This space has been fully plastered. There is a blocked doorway to the west which has pintels on the southern timber jamb on which a door has formerly hung. After this doorway was blocked (at an unknown date), the whole cupboard was fitted with shelves which reached to each side wall and across the former doorway. These shelves have since been removed.

- 5.3 To the east of the opening into the cupboard there is a pier of brickwork (B3) laid in lime mortar. These bricks have been cut to form the western opening, suggesting that they were inserted into the earlier fireplace and later cut through to create the cupboard. The pier extends up to the timber lintel, which suggests that the earlier, larger fireplace was sized down, reusing the original lintel, before being made smaller a second time.

- 5.4 To the east of the brick pier is a smaller blocked opening. This has a roughly-made western jamb which has been butted up to the earlier brickwork and bricks (B4) have been inserted below the timber lintel to create a lower opening. Across this brickwork is a horizontal softwood timber bearer. The bricks are supported from beneath by an iron strap, suggesting that this fireplace is late 18th or 19th century in date. This opening too seems to have been truncated to the east; it presently measures 1.70 metres wide and 1.05 metres high. It has been blocked by rough brickwork laid in a cementitious mortar, with timber studs set into the brickwork to carry lath and plaster.

- 6.1 The earliest part of the stack is the large ground-floor fireplace, which has a long, chamfered lintel and narrow bricks forming the flue (Elevation 1). This was later sized-down in two stages, once probably during the late 17th or 18th century and again in the late 18th or 19th century. As no bricks of this date can be seen in the first-floor part of the stack, the larger flue was probably sized-down when the fireplace was modified, but probably only when the third-phase fireplace was created. This late-18th/19th-century flue was then also removed, probably later in that century, and the south-western corner of the stack shored-up with a brick buttress.

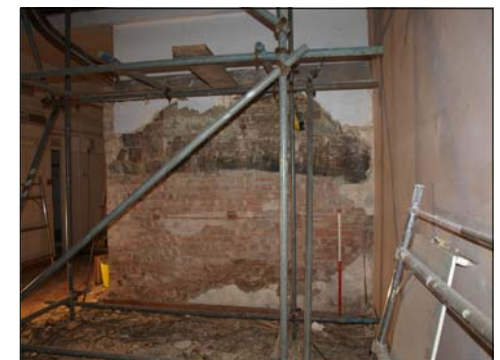
Plate 1: Elevation 3

- 5.6 The north face of the stack (Elevation 3) has a fireplace that has been completely blocked using varicoloured orange-yellow bricks. This fireplace has a lintel formed in a segmental arch, using three courses of header bricks laid on edge. At the eastern end the arch is covered by tiles set flat against the face of the brickwork. This type of arched fireplace is likely to date from the 18th or 19th century. It has been blocked by brickwork typical of the early 20th century. This arch too has been truncated, indicating that the sizing-down of the stack occurred after the creation of this wide fireplace. Above the fireplace is a wide offset in the stack with a sloping top. This offset is plastered.

- 6.2 At around the same time that the small southern ground-floor fireplace was created, the northern fireplace was remodelled to incorporate a wide segmental brick arch over what was probably, by this time, the main cooking hearth, superseding the original southern fireplace. This flue rises behind the northern tumbling visible in Elevations 4 and 6.

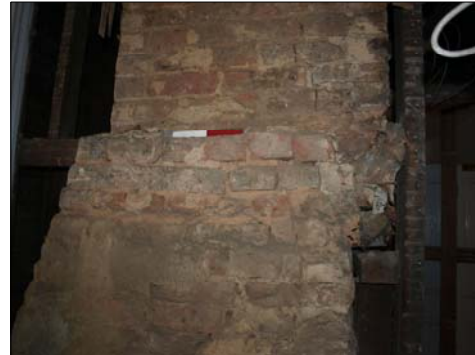
Plate 4: The offset in Elevation 4 showing Bricks B7 (top) and B8 (bottom)

- 5.10 The west elevation (Elevation 4) comprises an area of brickwork forming one side of a flue (brickwork B8). There is slight tumbling to the northern face, close to the wall of the building. A buttress has been built against this brickwork in later brick (B9) to the south. The buttress can be seen in profile on Elevation 5. It projects to the west and supports the corner of the stack, which has been cut back. The upper part of the stack has been rebuilt in brick B7 and is offset from the southern face by 90 mm. This upper brickwork has straight sides.

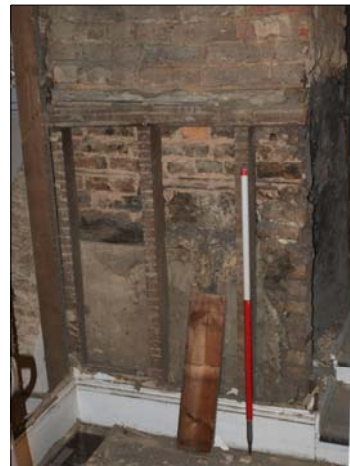
Plate 5: The lower part of Elevation 5 showing the plaster and soot-stained bricks B10

- 5.11 The south face of the stack (Elevation 5) shows some brick (B10) behind short vertical studs below a timber bearer which supports the overhanging upper brickwork. A flat piece of stone is positioned above the timber bearer giving extra support to this offset. The lower part of the brickwork behind the studs is obscured by plaster. There is some sooting on the bricks which indicates that this was previously the internal face of a flue that has later been removed. Below this is the large ground-floor fireplace, the flue for which has been truncated at first-floor level. The eastern end of this brickwork is broken off, suggesting that this side of the stack was originally wider than at present.

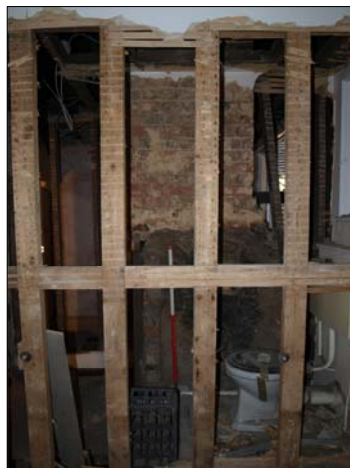
Plate 6: Elevation 6 from adjoining room

- 5.12 The eastern elevation (Elevation 6) is covered with heavily-sooted plaster, which suggests that it too was formerly an internal face of a flue which has since been removed. On either side of the sooting there are areas of modern filling material which may have been used to make good bricks broken when this flue was removed. In the centre of the sooted area is a small rectangle of brickwork. This comprises five stretcher bricks laid flat in a grey cementitious mortar. This has the appearance of

- 6.3 The heavy sooting on Elevation 6 suggests that there was formerly a first-floor fireplace in this location. It is possible that this was an original feature, but it is more likely a later addition, possibly tapping into the flue behind rather than adding a full-height flue to the stack. The jambs for this fireplace have been removed, probably during the late 20th century.

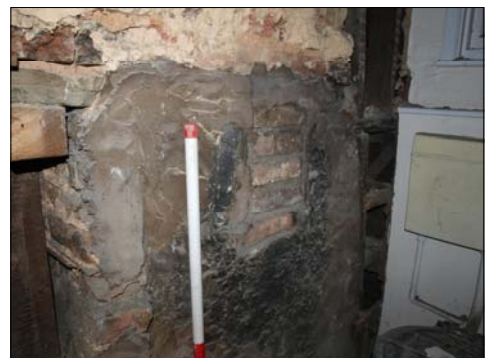
Plate 7: Detail of Elevation 6 showing sooting, filling material and brick-filled opening

an opening designed to tap into an existing flue when an additional fireplace was added. It may have been for ventilation or for a pipe chimney from a range cooker or wood-burning stove. The style of the blocking suggests that this was carried out in the late 20th century, certainly after the flue was in use, as it is not sooted.
