**Archaeological Watching Brief Report
At Rusper Nunnery
Horsham Road
Rusper, Horsham
West Sussex RH12 4QT**

**ASE Project No: 5716
Sitecode: HRN 12**

**ASE Report No: 2012262
OASIS ID: 139653**

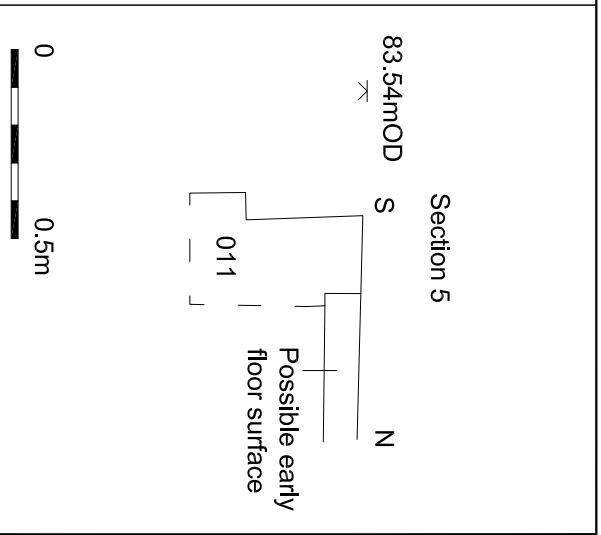
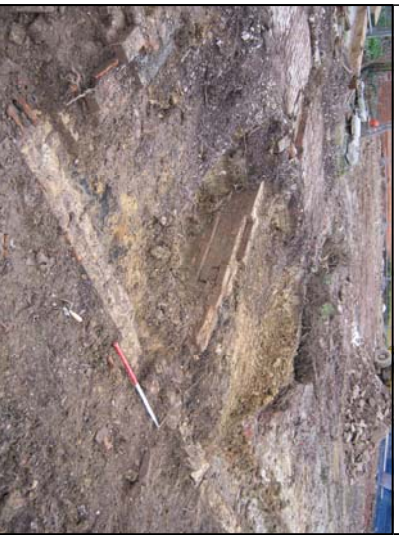
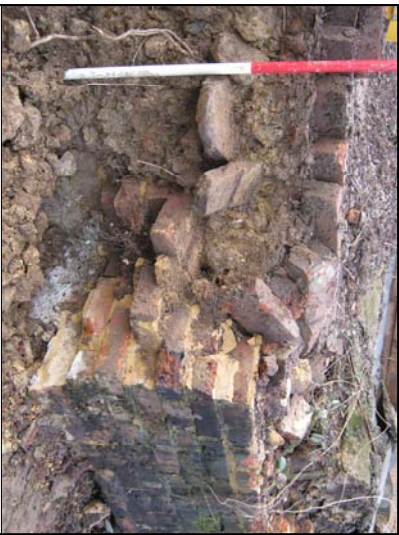
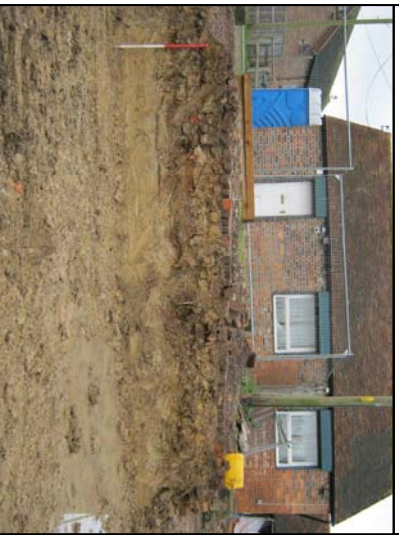
- 4.3.1 A brick building located immediately to the south of the “hovel” and known as the “pig-sty” was demolished prior to the watching brief. The original date of the construction was not known. A brick-paved courtyard and the wall footings of the building were preserved *in-situ* and recorded. Constructed of 18th to earlier 19th century un-frogged brick, its may have predated the second half of the nineteenth century and certainly pre-dated the construction of the “hovel” which abutted it to the north. At least two phases of building were observed, the original western wall [15] having been demolished to allow the construction of the courtyard [07]. Used as a pig sty in recent times, the building may have had an earlier function, but probably also as a farm out-building.

- 4.3.3 The surviving elements of the original building correspond to the eastern, and northern outer wall footings, [8] and [10] and the central partition wall footing [11]. These appeared to be identical in construction, although only [11] was fully exposed and observed to the base of the footing. Built of stretchers, two courses wide, it was 6 courses in depth (0.45m), the base of the footing stepped out 0.08m. The bricks were 0.21 x 0.11 x 0.07m, the bonding a soft yellow, coarse lime mortar. It extended over a distance of 4.0m, its junction with the eastern wall having been truncated. To the west, it was observed below the emplacement of a removed concrete wall-footing

- 4.3.4 The eastern footing [08] was extant along its full length (5.10m), the northern half showing evidence of collapse. The east wall of the hovel abutted its northern end.

- 4.3.7 The southern wall was of a different construction along the majority of its length. At the south-east corner of the building, a short segment (0.50m) of the original narrow construction survived. At the western end it was built of stretchers, 3 courses wide (0.30m) and five or six courses in depth (the base of the foundation was not clearly observed). This wider brick wall may belong to an intermediate building phase. A short segment of wall, 0.70m in length and 0.40m wide was situated towards the eastern end: it formed a junction between the narrow and wider wall elements and was constructed of both headers and stretchers. Abutting this segment, a narrow, irregular construction of single and half-bricks extended southwards [12], forming a yard wall.

- 4.3.9 The courtyard [07] was built of a single layer of stretchers set on edge without bonding. Preserved over a length of 5.80m, it extended 0.70m beyond the southern wall of the building. Observed over a width of 2.0m, it continued to the west below the current ground surface. The bricks were set into a foundation deposit of dark silty clay with crushed CBM overlying the levelling deposit [13]. The bricks were of the same date as those identified in the original walls, and may have been in a re-use context.

- 4.3.10 The original wall elevations had been replaced in the area of the courtyard by concrete plinths, 0.40m wide, broken out to reveal the top of the brick footings. A further concrete pillar or stanchion base, 0.50 x 0.40m wide was observed set into the east limit of the yard surface. It is probable that these replaced the earlier elevations of the northern southern and partition walls still functioning with the yard surface, the wall trenches being widened to receive the poured concrete plinths.
