**Archaeological Watching Brief Report
East Street, Spice Island
Portsmouth, Hampshire**

**ASE Project No: 5684
Sitecode: SIP 12**

**ASE Report No. 2012266
OASIS ID: 139832**

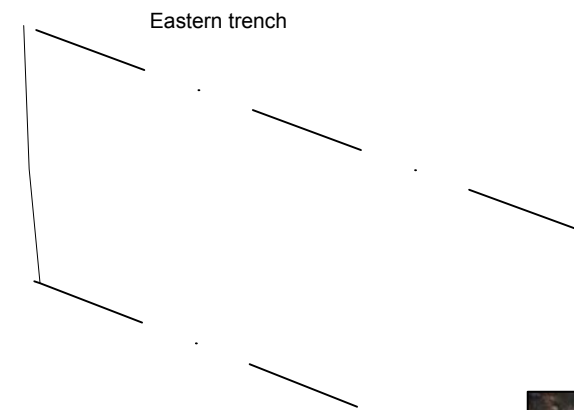
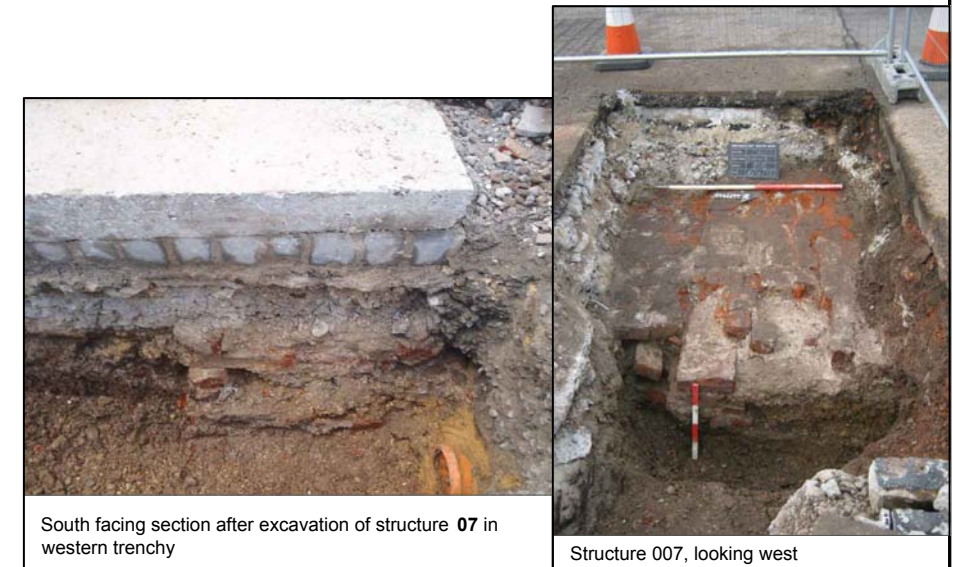
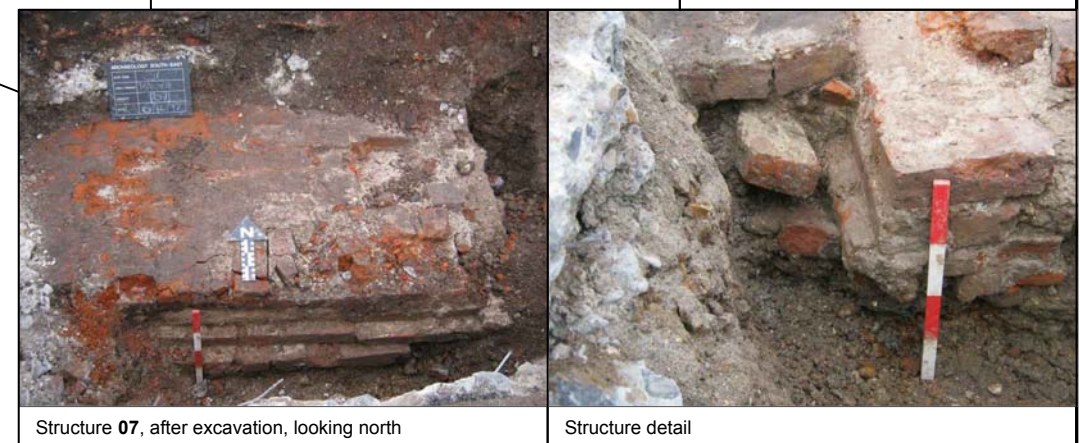
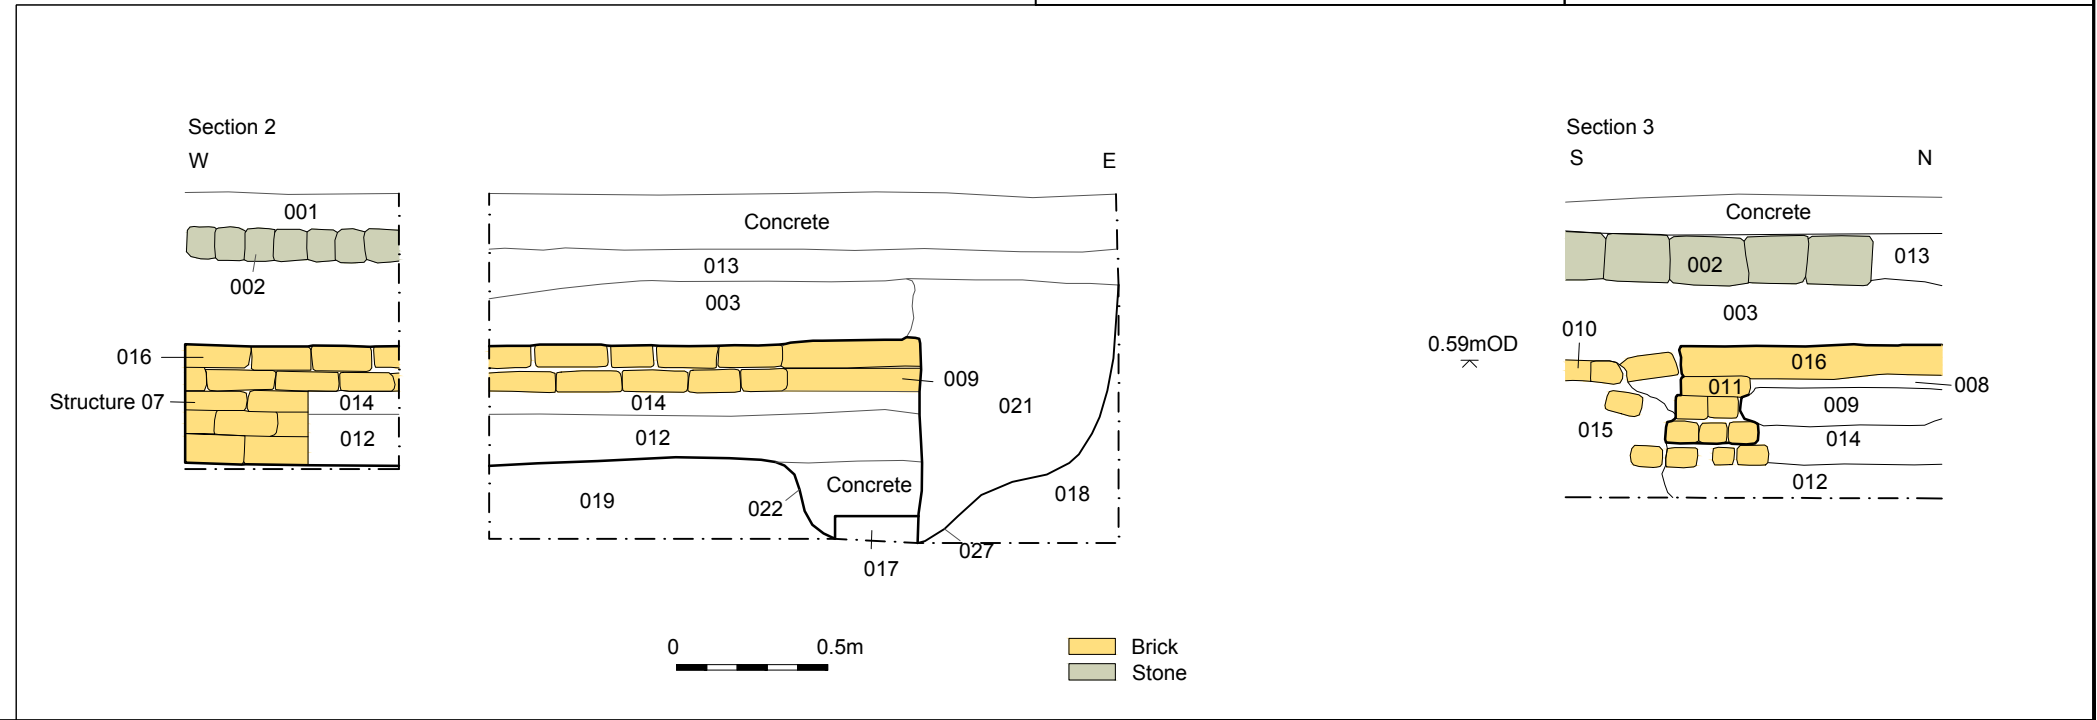
the eastern end descending to an unknown depth. The structure formed a low platform with a flat brick surface.

- 4.3.3 An upper brick surface [16] set into a thick white lime mortar [08], overlay two lower courses. The construction of this surface evidences some care, the southern limit having an edge revetment of headers, the bricks elsewhere organised into blocks of headers and stretchers. There was a localised concrete repair to the lower brick elevation course [09] at the eastern limit of the structure. The platform was supported along its southern limit by a brick-built stanchion [11], 0.40m wide and 0.30m deep, the lower courses of which are stepped. The western limit of the structure had a similar brick stanchion, with 5 courses descending to a depth of 0.37m. Within the body of the structure the brick platform was supported by a plinth of very compacted lightly bonded with cement [12], the upper horizon of which [14] was less compressed, together forming a layer 0.24m thick.

- 4.3.4 The structure was supported at the eastern end by a sunken foundation [17], 0.45m wide, constructed of brick fragments at the base overlain by a 0.20m thick deposit of concrete, within cut [22]. To the west, the foundation cut [22] truncated a loose underlying layer of hogging [19] to a depth of 0.26m.

- 4.3.5 To the east a deep cut [27] truncated the concrete plinth [03] forming a trench 0.87m deep and 0.68m wide against the eastern limit of the structure. Clearly out of phase with the construction of [07] this cut is a more recent intrusion, pre-dating only the modern concrete of Camber quay, and probably indicating the truncation of the structure at this end. No brick stanchion corresponding to those limiting the structure to the west and south was observed on this side of the structure.

- 4.3.6 A loose dark-grey sandy-silt with brick rubble and frequent inclusions of mortar [15] abutted the southern edge of the platform structure [07]. It was sealed by a single course brick surface [10], abutting the upper surface [16] of the structure [07]. Constructed of frogged brick and brick fragments, this forms an irregular, poorly-founded circulation surface showing evidence of subsidence into the loose underlying deposit [15]. Two fragments of pottery date this deposit to the later 19th-20th century, a date supported by a clay pipe stem and bowl, the latter dated between 1850-1910. An iron bolt with hexagonal nut falls within the same broad date range. Ceramic building material retrieved from this deposit include a late 18th-19th century peg tile which had been re-used in construction, its broken edges being covered in mortar, and small fragments of brick of types B1, B2 and B4.

- 6.2 A substantial brick platform [07] was recorded. This is of a reasonable construction quality and pre-dates the modern surface of Camber Quay, extending approximately 1.0m to the south of the present limit of this surface. The structure is bounded to the west and south by shallow brick footings or stanchions, the body of the structure being in-filled with compacted, lightly cemented hogging. The surface comprises two brick courses across the structure, the upper-most of which may evidence repairs. The eastern limit of the platform may have been subject to robbing. This side also appears to have been reinforced by a more deeply sunken foundation not observed to the west, but possibly not attained. The structure is dated to the late 19th-early 20th century, possibly incorporating some bricks slightly earlier in date in a re-use context.

- 6.2 A shallow brick surface, one course deep, abutted the southern limit of the platform. It is built of frogged brick bonded with hard concrete/mortar. It is without hard-core reinforcement being built directly onto a loose rubbly dump or make-up deposit, presumably in order to improve the quality of the circulation in this area and/or to raise the circulation level. It represents a relatively poor quality construction with poor load-bearing capacity; having suffered from subsidence, it has an irregular upper horizon.
