**Archaeological Watching Brief Report
The Lamb Inn, Wartling
East Sussex**

**Project No: 5901
Site Code: TLW 13**

**ASE Report No: 2013002
OASIS id: archaeol6-140645**

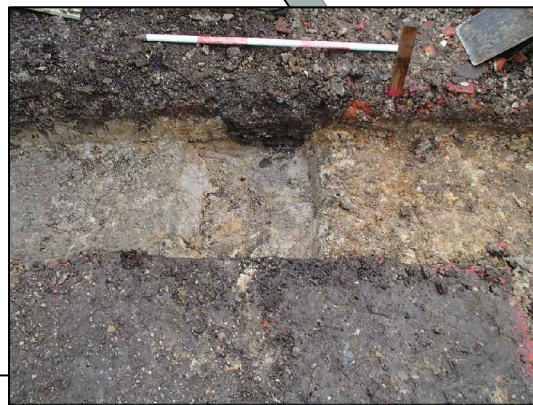
4.1.3 The made ground was cut by a single feature [04] in the south of the trenches. The feature appeared to be linear with steep sides and a curved base and measured 1.20m in length, 0.72m in width and 0.42m deep. The fill [03] consisted of soft dark grey clay with occasional inclusions of CBM and wood.

Ditch 004, facing south-east

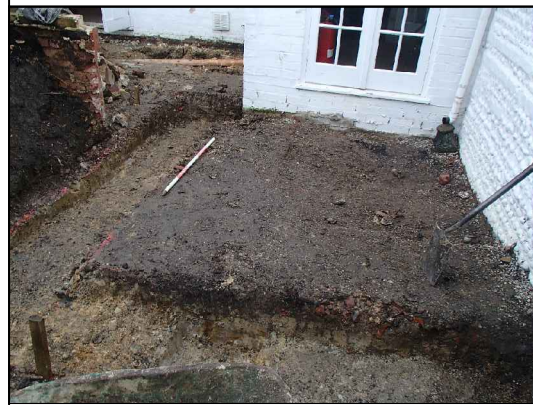
Monitored area, facing north-west

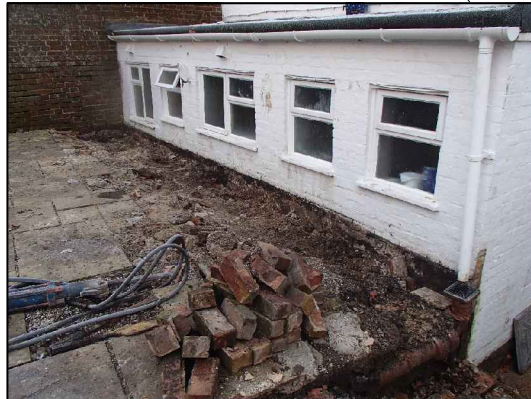
4.2.1 A trench 6.30m x 0.65m was excavated to a depth of 1.05m against the full length of the rear wall of the modern toilet block abutting the early 19th century rear range. A total of four contexts were recorded in this area and these are tabulated below.

4.2.2 Natural substrate, comprising stiff yellow silty-clay with blue mottling, was uncovered along the length of the trench at a depth of 0.85m below ground

Area 2, viewed towards the west

- 6.2 In Area 2, to the rear of the modern toilet block, a natural yellowish clay-silt substrate was reached at a depth of 0.85m below the present ground level. A structure consisting of two brick steps 1.32m wide was preserved to a height of 0.45m, at a depth of 0.60m below ground level. The base of this structure was founded in a shallow construction cut into the natural substrate. It is likely that the steps, built of unfrosted brick, provided access to raised ground or a garden to the rear of the main wing. The steps are not sited opposite any apparent doorway so cannot be attached with certainty to any of the identified phases, but they certainly predate the construction of the post 1849 toilet block by which they are truncated. The deposit that abuts them [06] has been dated to the early nineteenth century so it seems likely that they form part of the early nineteenth century additions to the property.

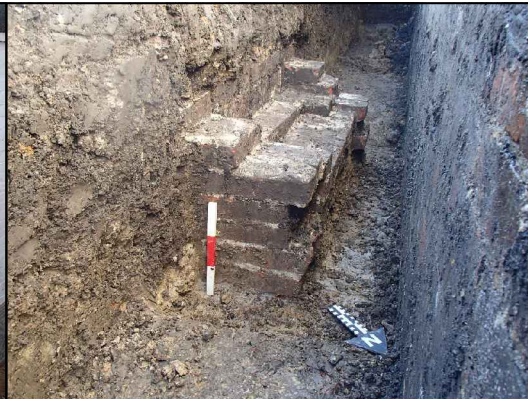
- 4.2.3 A block of brick steps [07] 1.32m wide and present to a depth of 0.45m were situated 0.90m from the SE angle of the toilet block. Their foundations lay in the natural substrate to a depth of 0.25m and were constructed of un-frogged brick (0.21m x 0.11m x 0.07m). Two end stanchions two courses wide enclosed two rises/steps, 0.96m wide. The lower step was built of stretchers, the upper step of a row of headers placed on their side, overlain by a row of headers placed flat. The structure was bonded by a hard white lime mortar.

- 4.2.4 Structure [07] was truncated to the north by the construction cut, 0.30m wide, for the installation of the toilet block. It was abutted to the east and west by a compact, light brownish-grey clay-silt deposit 0.25m thick with occasional inclusions of pot, clay pipe and CBM fragments [06], and was sealed to a depth of 0.60m by a modern loose dark-grey clay-silt deposit [05] containing frequent frogged brick fragments. The former deposit [06] probably corresponds to a garden soil contemporary to the use of the steps, the latter [05] being made-ground deposited prior to the installation of the toilet block. The construction trench for the toilet block is cut from just below present ground level and undisturbed natural was observed between the base of the step structure and the toilet block.

- 4.2.5 The steps, which are not situated opposite an obvious access to any phase of the building, ascend from the level of the natural substrate rather than serving an underground structure or cellar and are therefore presumed to provide access to a raised garden area to the rear of the house. The pottery retrieved from deposits [05] and [06] together suggest a deposition date between 1790 and 1820 for layer [06]. The clay pipe fragments date from 1750 to 1910. The upper deposit, layer [05] is more probably 20th century in origin. From this dating evidence it appears possible that the brick steps belong to the early 19th century additions to the property

Structure 07, viewed towards the south-west

- 4.2.6 As their destruction was not required, the steps [07] are preserved *in-situ* beneath the back-fill of the damp course trench.

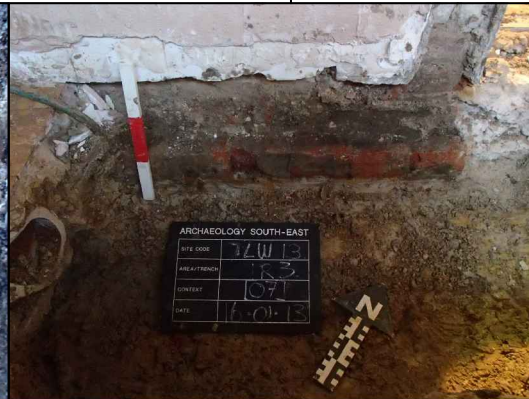
- 4.3.3 The brick footing of the rear wall of the building [11] was laid on the substrate at a depth of 0.20m but the foundation trench was not observed. A lower course was constructed of headers 0.12m wide and 0.07m deep, and was stepped out from the wall by 0.05m. The joints were narrow with little bonding material apparent. The upper foundation courses were constructed of stretchers, bonded with light grey lime mortar. The full brick dimensions were obscured by the residue of a mortar revetment.

Detail of wall foundation, section 3

- 6.3 The two small trenches (Areas 3 and 4) excavated within the modern toilet block permitted observation of the foundations of the rear wall of the early 19th century range to the rear of the original building. The foundations continued to between 0.20 and 0.25m below the floor level, the western end having a stepped-out lower course that was absent to the east. A natural stiff, blue clay-silt substrate was reached at a depth of 0.16-0.17m below the modern floor. No significant archaeological strata were present.

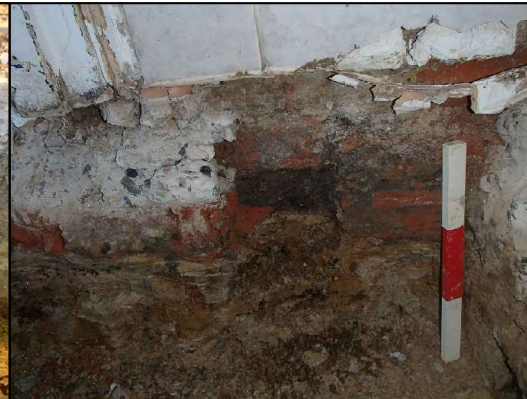
laid on the substrate at a maximum depth of 0.25m below the present floor surface. The wall footing [14] was built of headers bonded by dark grey lime mortar but was not stepped-out at the base. An irregularity in the coursing was observed in the construction of this foundation (photograph, Figure 5) but this is thought to represent a simple construction irregularity. No complete bricks were observed to establish full dimensions but they were 0.06-0.07m thick.

Detail of wall foundation, section 4

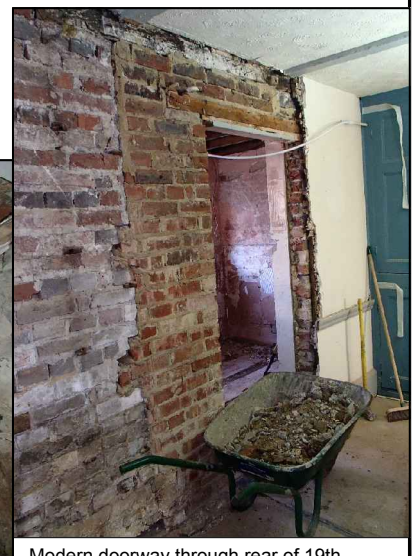
- 4.3.5 The door was a modern addition (see photograph, Figure 5) replacing an earlier phase window and the threshold was supported by a modern concrete plinth [13] where the original brickwork has been truncated.

Modern doorway through rear of 19th Century range

- 4.3.4 Like the west room of the toilet block, the modern door was broken through the original wall with the threshold underpinned by a modern concrete plinth [15] which appeared to have been laid on the lowest course of the original brick footing [14].
