THE LIMES, HOOK GREEN ROAD, SOUTHFLEET, KENT, DA13 9NQ

HISTORIC BUILDING RECORD

Report No. 2012257

Site Code: TLS12
Project No. 5825
Report No. 2012243

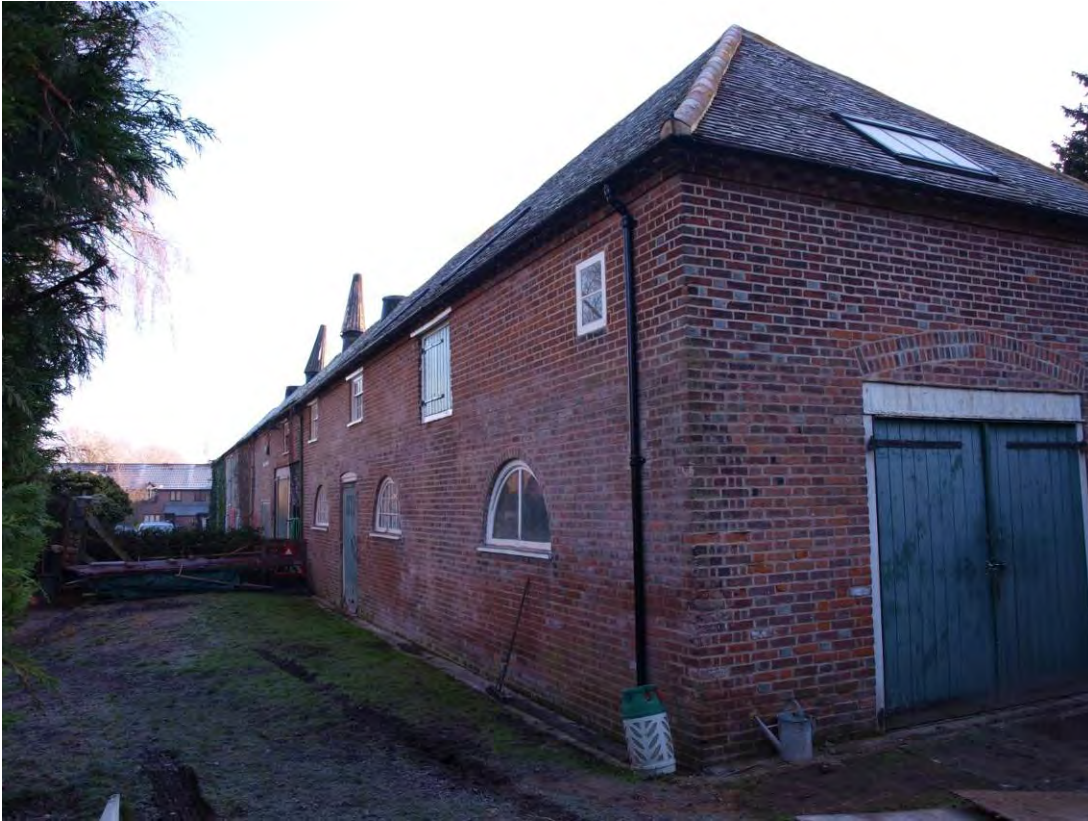
- 5.1 The building is oriented on an essentially west – east alignment, with its principal elevation facing north (Plate 1). It is constructed over one-and-a-half storeys and has a plain clay tile roof, hipped at the west end. The walls are constructed in brickwork which is orange-red with some over-fired headers, and laid in Flemish bond. The brickwork has recently been repointed, although on the adjoining eastern section of the building original lime mortar joints with traces of penny-striking are visible. There is a course of dentilated brickwork to the eaves.

Plate 1: North and west elevations, looking south-west (2)

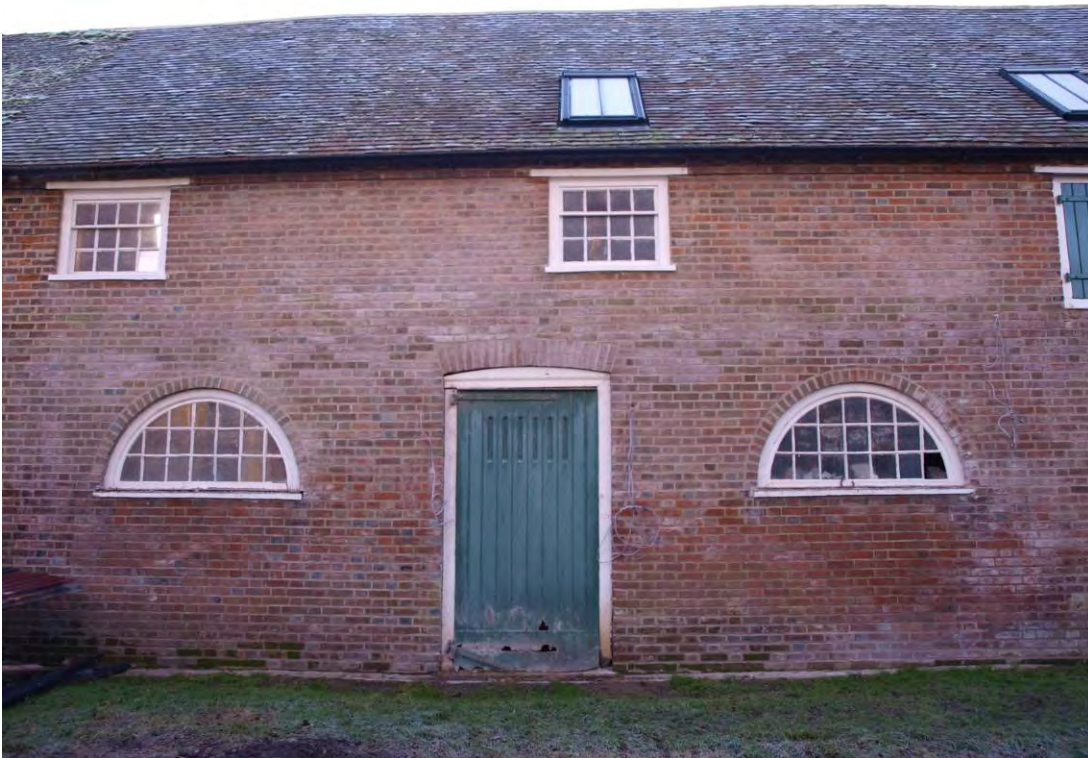
- 5.2 On the ground floor, the north elevation of the building contains three semi-circular windows each with a single cantilever-opening multi-pane light, except the westernmost whose glazing has been replaced by two large panes. Between the two easternmost windows is a doorway with segmental arched head containing a boarded door with ventilation slots and long-strap hinges (Plate 2). The upper floor has two small four-over-eight pane sash windows (east), a high-set loading doorway with boarded door on long strap hinges (Plate 3), and to the far west a small inserted window containing a single light of two-panes. The roof contains two newly-inserted roof-lights.

Plate 2: Principal doorway with flanking semi-circular windows on north elevation, looking south (4)

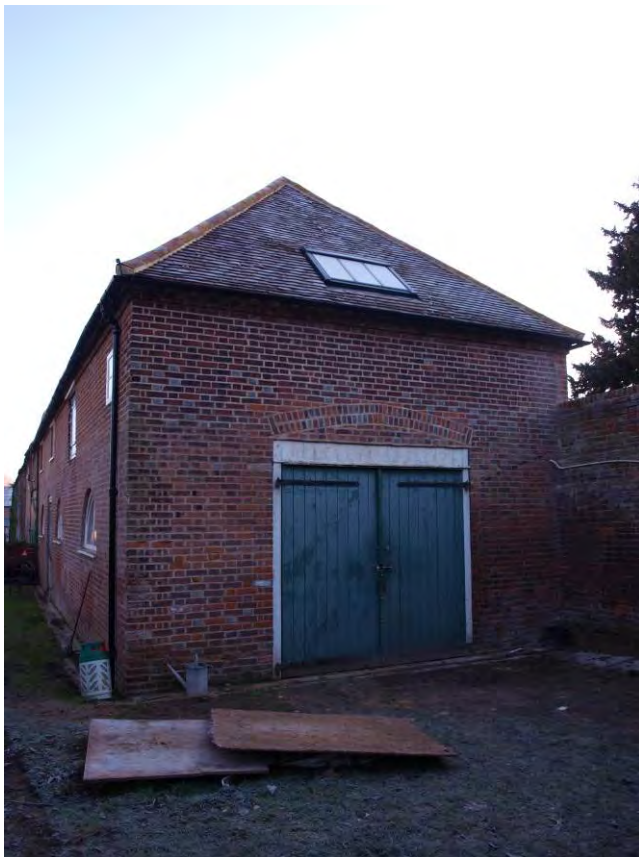
- 5.3 The west elevation contains a single wide doorway with two-leaf boarded door (Plate 4). The brickwork exhibits some degree of modification and it is probably the case that the doorway has been wholly inserted at a later date, or might possibly represent the enlargement of an earlier doorway. The brickwork to the northern door jamb, which is properly finished with a vertical line of queen-closers, might be original, but the southern jamb, which lacks queen-closer bricks is certainly not, nor is the arched head within the brickwork above. To the north of the doorway, a double line of queen-closers might relate to an earlier boundary wall in this location (see Fig. 4), while to the south of the doorway there is a line on the brickwork resulting from a former adjacent pitch-roofed structure, now removed. The hipped roof terminal above contains a newly-inserted wide roof-light.

Plate 4: Modified west elevation, looking east (1)

- 6.3 The western section of the building has historically undergone some modification to convert it to garage/storage use. This involved the insertion of a wide doorway within the west wall and the removal of the original north – south internal partition. On the basis of the existing doors, this would appear to have taken place in the earlier part of the 20th century. The map evidence suggests a date between 1909 and 1938 for this work (*c.f.* Figs. 6 & 7), the latter map showing an alteration to the boundary of the garden/driveway in this location, presumably to facilitate vehicular access to this end of the building.

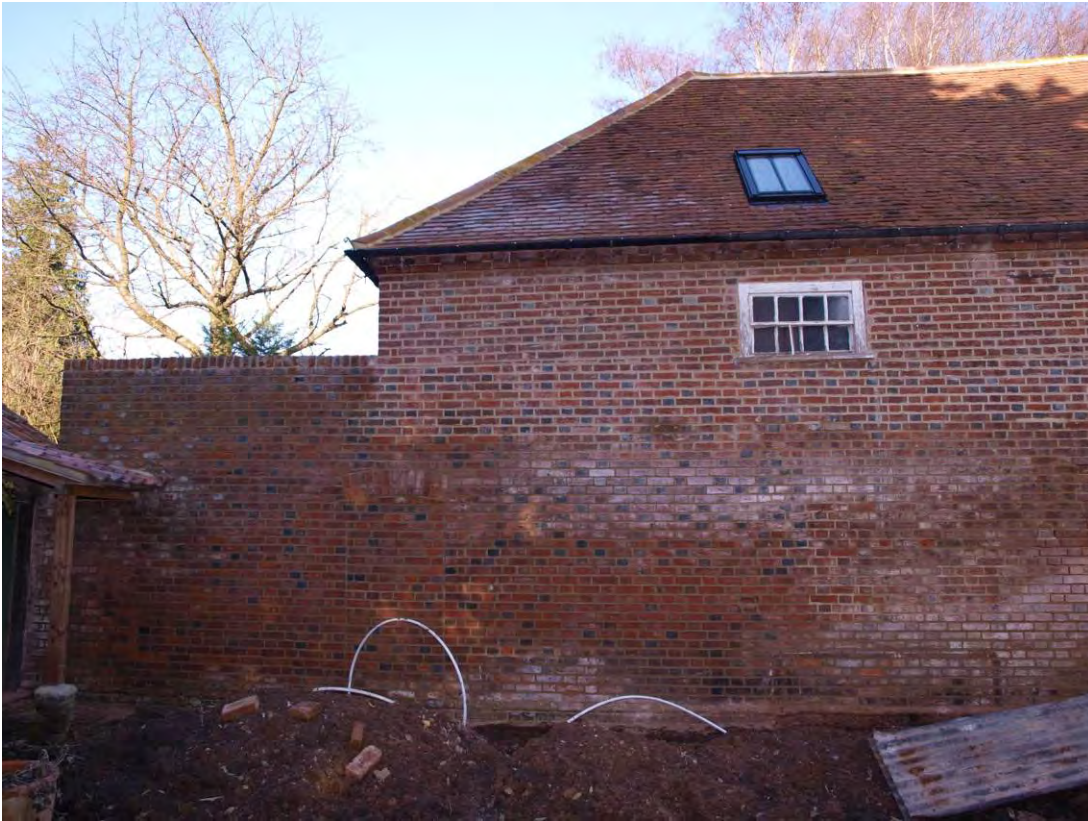
- 5.4 The south wall of the building has been constructed over the pre-existing 18th century garden wall (Plate 5). This section of the garden wall stands a little less than four metres in height, has a low chamfered off-set, and is constructed in Flemish-bonded orange-red brickwork with some over-fired headers incorporated. The brickwork towards the eastern end, where repointing has not yet been carried out, retains penny-struck lime mortar joints (Plate 6). The upper quarter of the garden wall contains a higher concentration of over-fired headers resulting in a chequered effect; this might represent a historic raising of the wall, or alternatively a change in brick stock. The brickwork above this relates to the construction of the stable block in the mid-19th century. The brickwork, which is the same as that on the north and west elevations is similar to that of the garden wall, and contains a levelling course of brick and tile at the junction with the garden wall (Plate 7).

- 5.5 Within the garden wall there is an original doorway, now blocked (Plate 5), which straddles the west end wall of the building, and therefore pre-dates it. At the east end is an inserted doorway (Plate 7) which has recently had its frame and door replaced. Above, the upper floor contains three small four-over-four pane sash windows. The easternmost window is contained within a lean-to greenhouse constructed against the south side of the building. Towards the eastern end of the building is a single-flue square chimney stack which pierces the roof close to the eaves. The south roof pitch contains four newly-inserted roof-lights.

Plate 5: South wall of the building, constructed over pre-existing garden wall, looking north (9)

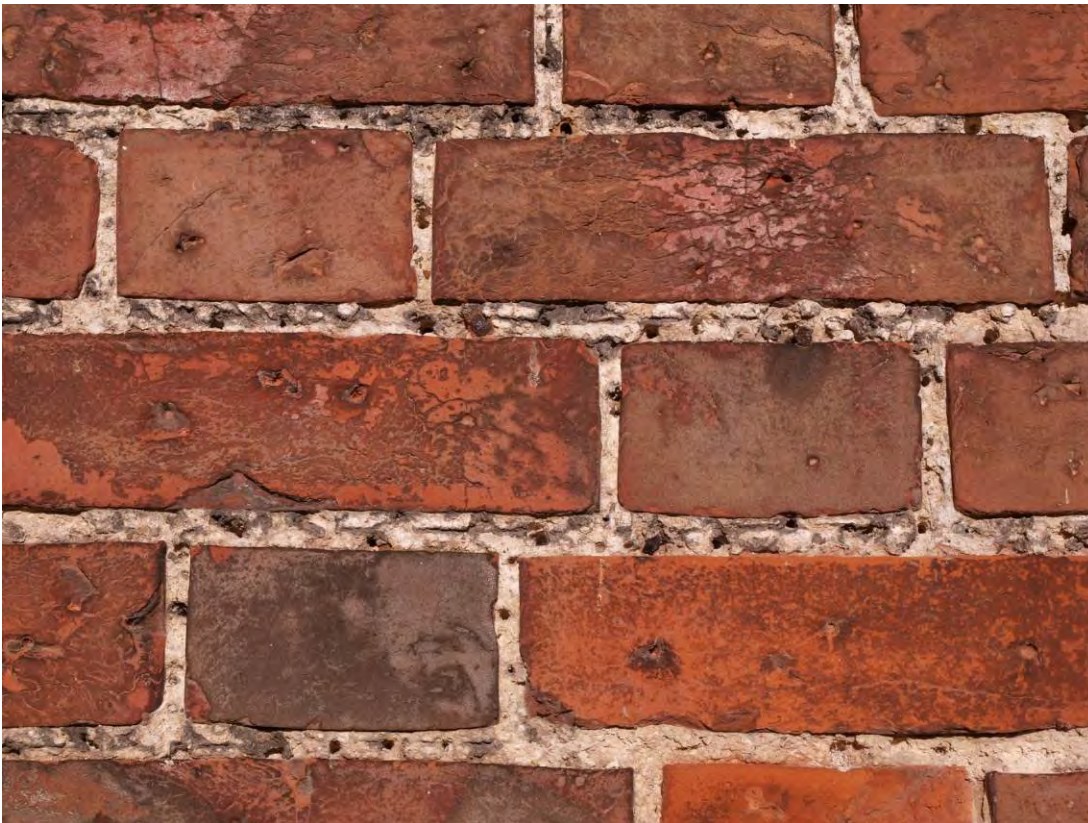
Plate 6: Penny-struck mortar joints to south face of garden wall, looking north (15)

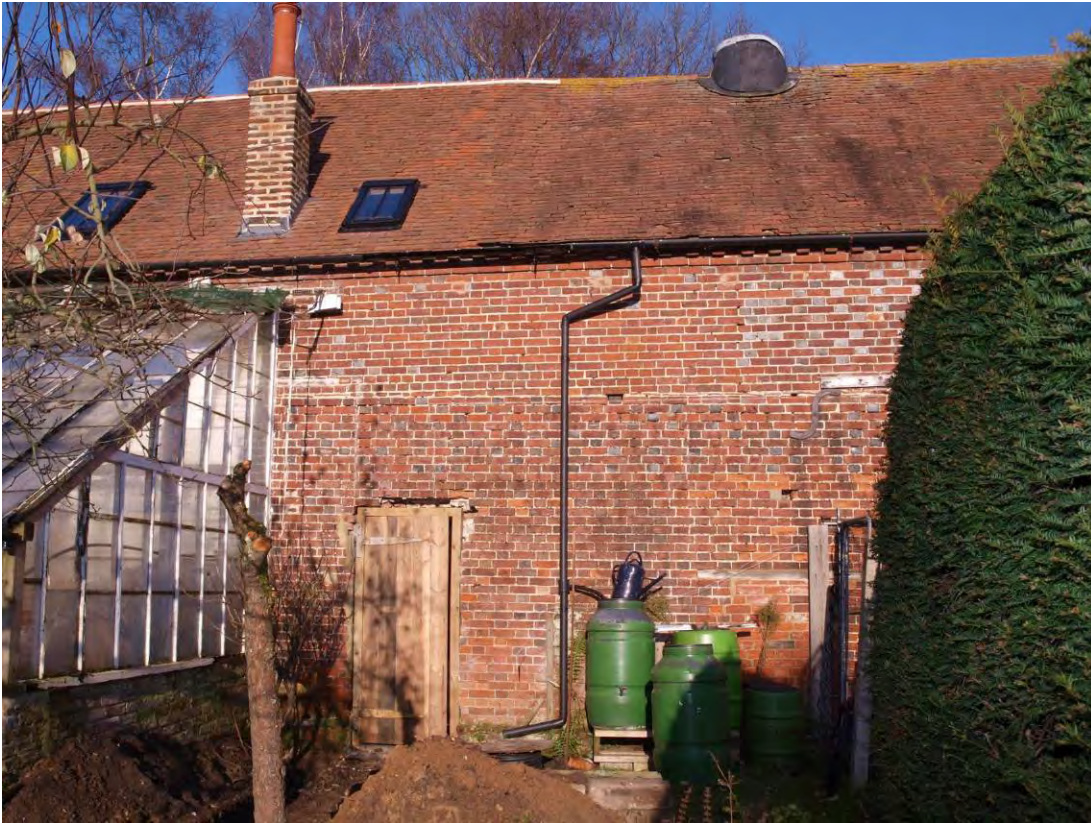
Plate 7: South elevation (eastern end of stable block) showing the two or possibly three phases of brickwork, looking north (12)

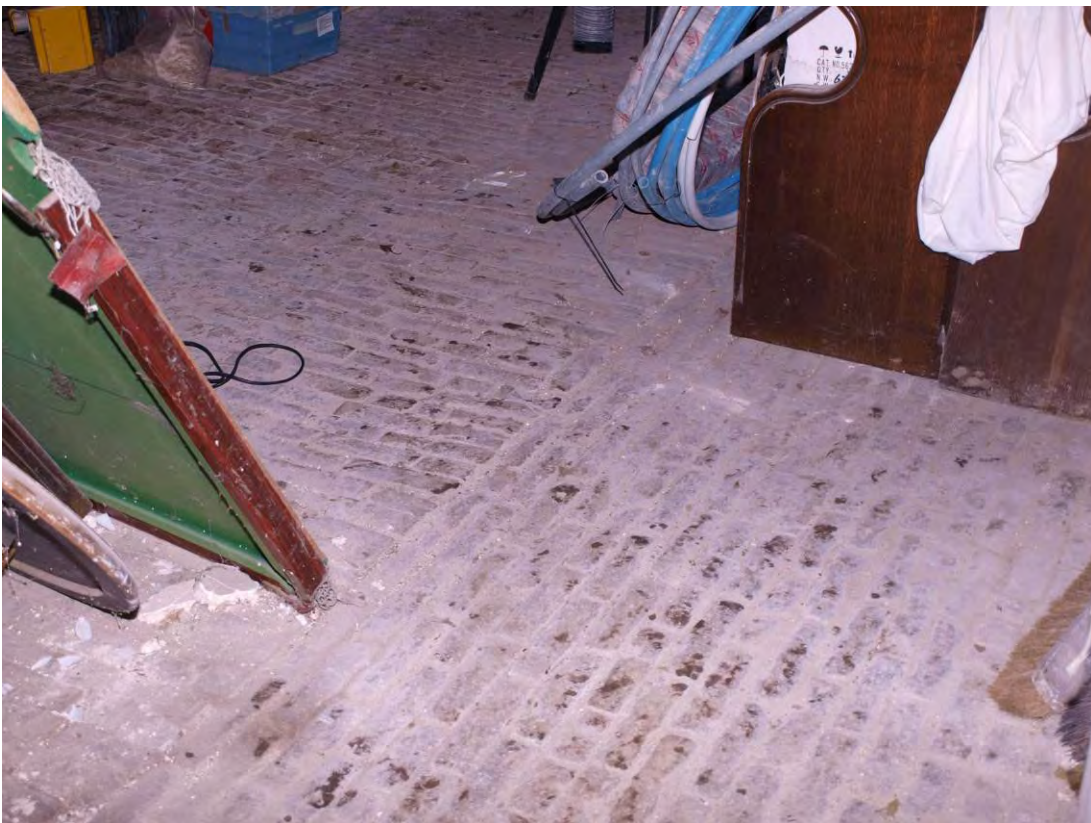
Plate 8:

Brick floor within Room 1, looking south-west (22)

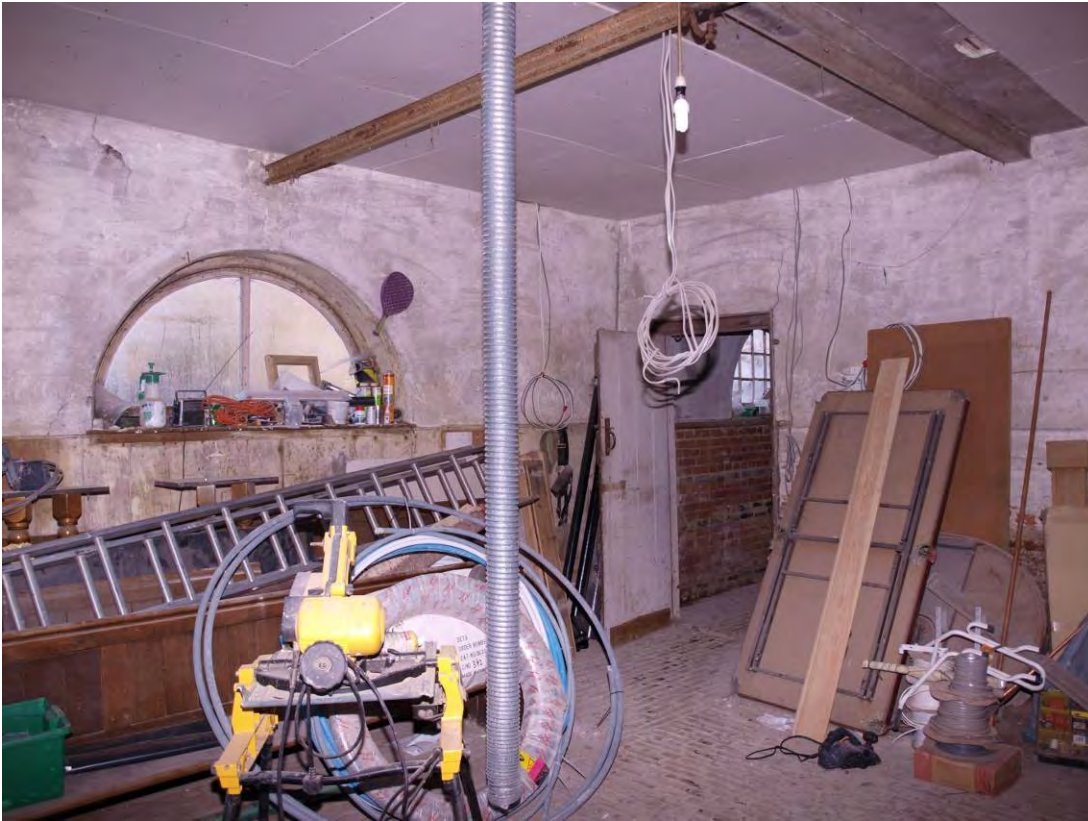
- 5.7 The walls in this area are of brickwork, the north and east with a plaster finish and the south and west painted. On the north wall there is also a vertically boarded dado with timber skirting and a single semi-circular window located above (Plates 9 & 10). The doorway on the west wall has a timber lintel, concrete threshold, and chamfered door-posts (Plate 11). The interior faces of the doors are ledged and braced. At the north end of the east wall is the doorway to Room 2 (Plate 12). The door is boarded and battened and retains an original thumb-latch and T-hinges. The south wall, towards the western end contains a straight joint within the brickwork relating to the blocked doorway within the garden wall. The ceiling contains a single axial joist, now supported half-way by a secondary iron I-girder (Plate 11). A small section of lath and plaster ceiling is visible above modern plaster-board.

Plate 9: North and east walls of Room 1, showing boarded dado and semi-circular window (N) and boarded door (E), looking north-east (17)

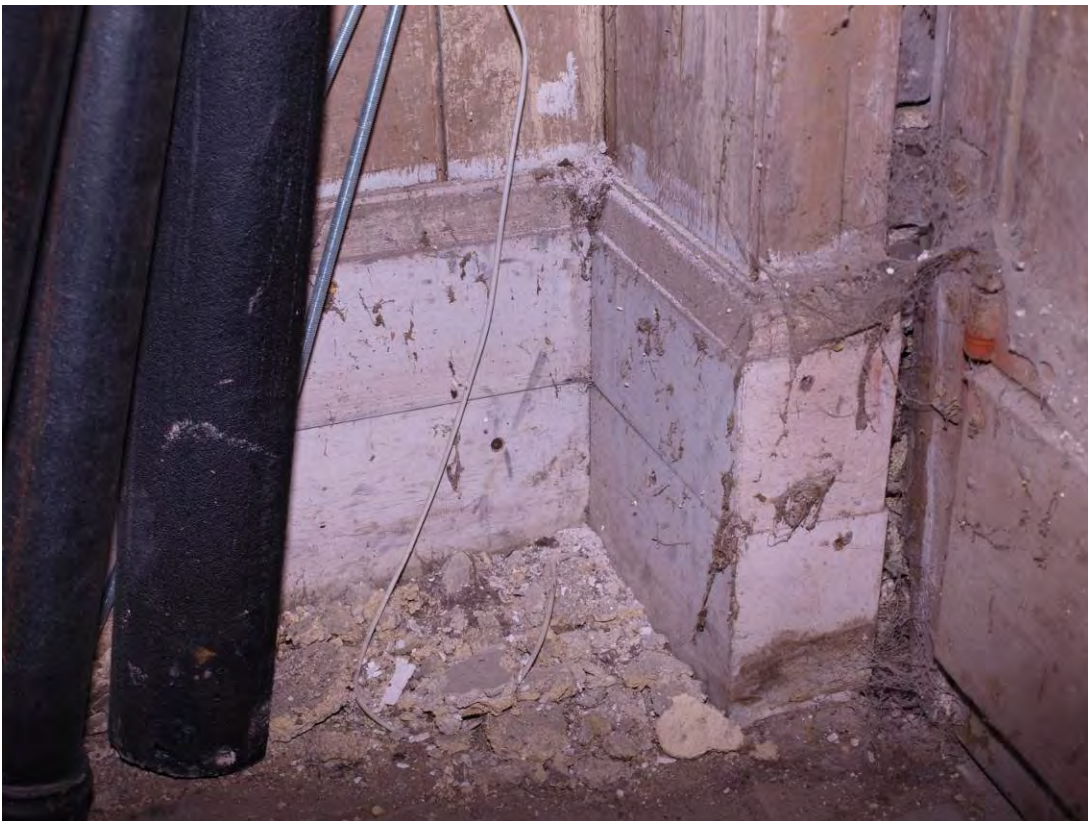
Plate 10: Skirting in north-east corner of Room 1, looking north-east (21)

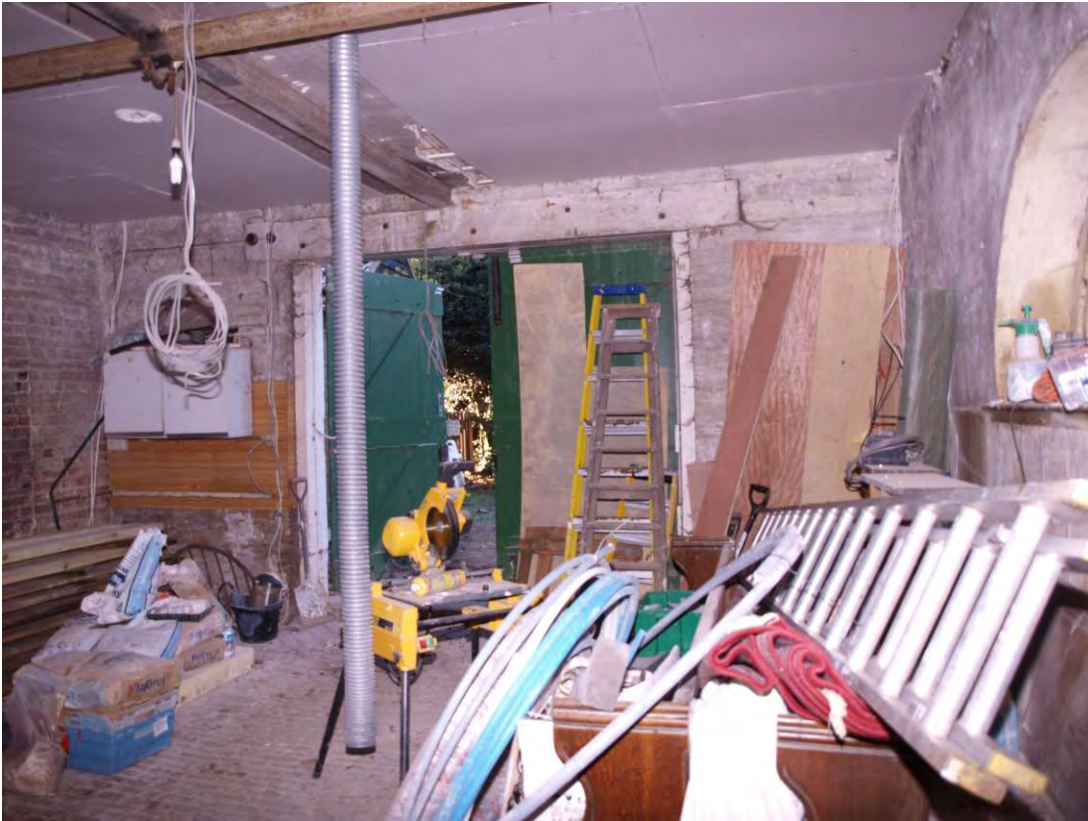
- 5.6 At ground floor level, the interior of the building is divided into three unequal-sized areas or rooms. Room 1, at the west end measures 5.75m x 5.4m. It is entered from the exterior by the wide doorway at the west end of the building, but also has an internal door leading into Room 2 to the east. The area has a worn brick floor, with most of the bricks laid on a north – south orientation, though on the northern side of the room the bricks are laid east – west (Plate 8). The larger southern area of brickwork appears to have been divided into two halves, north – south, as denoted by a line in the brickwork at this point. This might have been to provide two loose-boxes for horses in this area, though no further evidence for these is now visible.

Plate 11: West wall of Room 1, showing wide doorway, looking west (16)

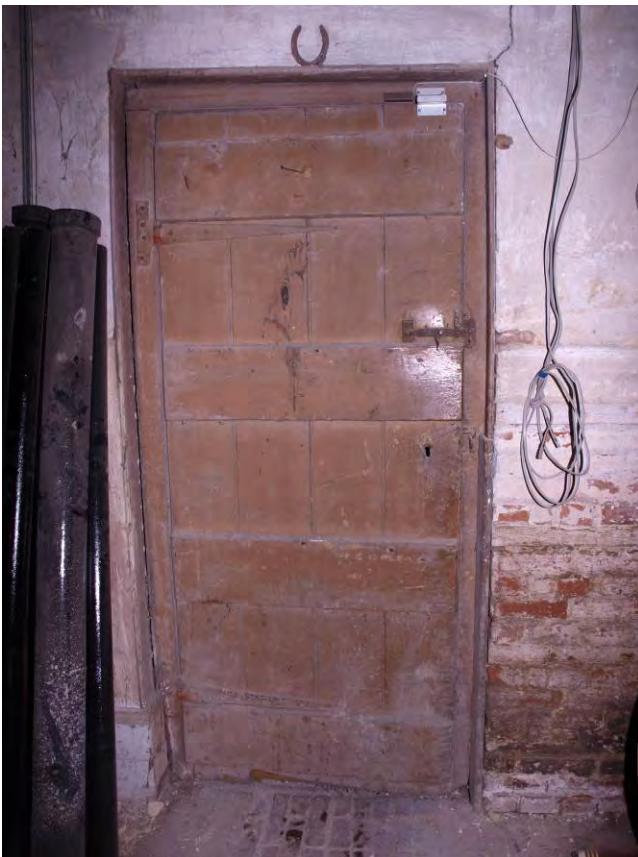
Plate 12: Door between Rooms 1 and 2, looking east (20)

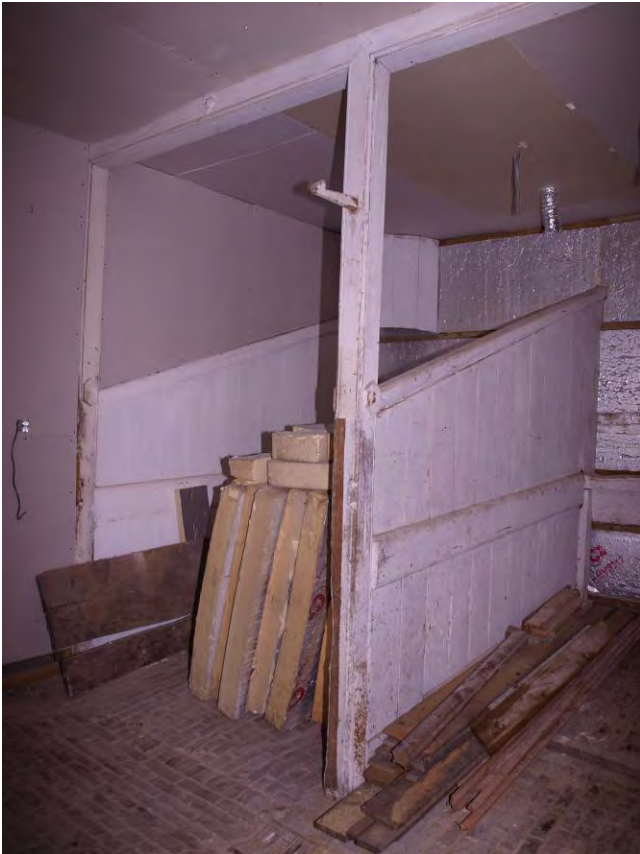
- 5.8 Room 2, located to the east measures 7.7m x 7.4m. On the south side are four stalls for horses, complete with timber stall partitions with wooden hooks for tack, wooden manger with tethering rings, and pitching holes within the ceiling (Plates 13-15). The floor is of brick, as in the adjacent area and laid according to the stall partitions, with a drainage gully extending along the northern ends of the stalls.

Plate 13: Stall partitions within Room 2, looking south-east (23)

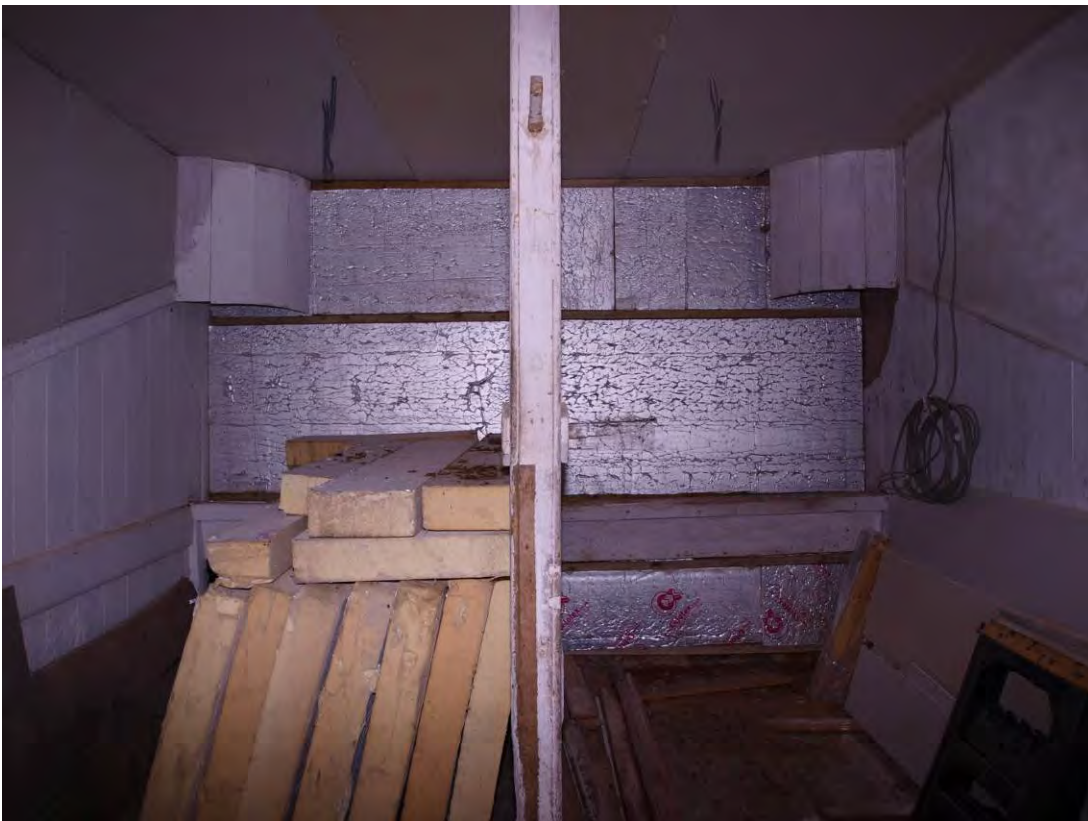
Plate 14: Stalls within Room 2, looking south (24)

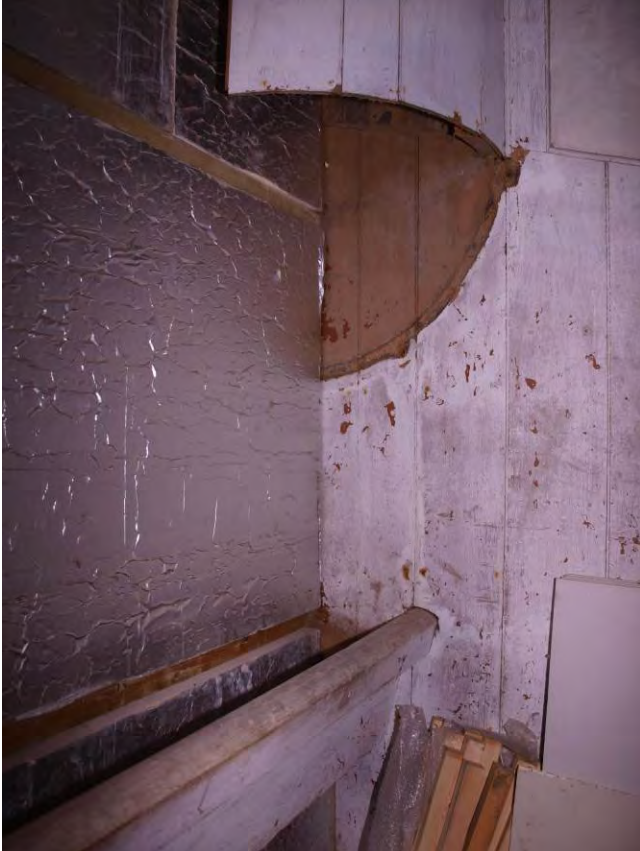
Plate 15: Manger and pitching hole in Room 2, looking south-west (25)

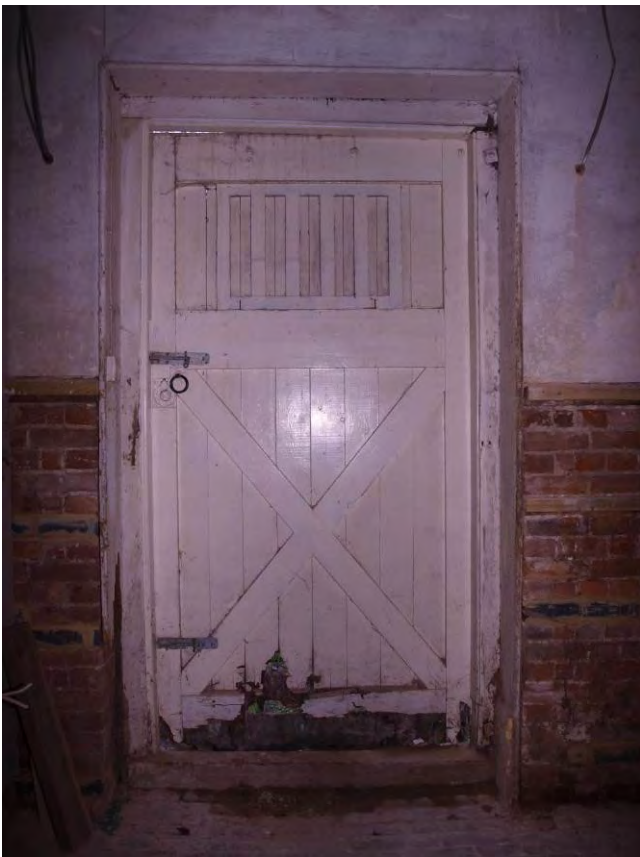
- 5.9 The north wall contains the principal entrance door, which is framed and cross-braced to the interior, and has a hit-and-miss ventilator (Plate 16). The door is flanked on either side by a semi-circular window. The north wall formerly had a boarded dado as in Room 1, though this has been removed. The east wall contains a doorway to Room 3, with boarded and battened door

Plate 16: Interior face of entrance door on north elevation, looking north (28)

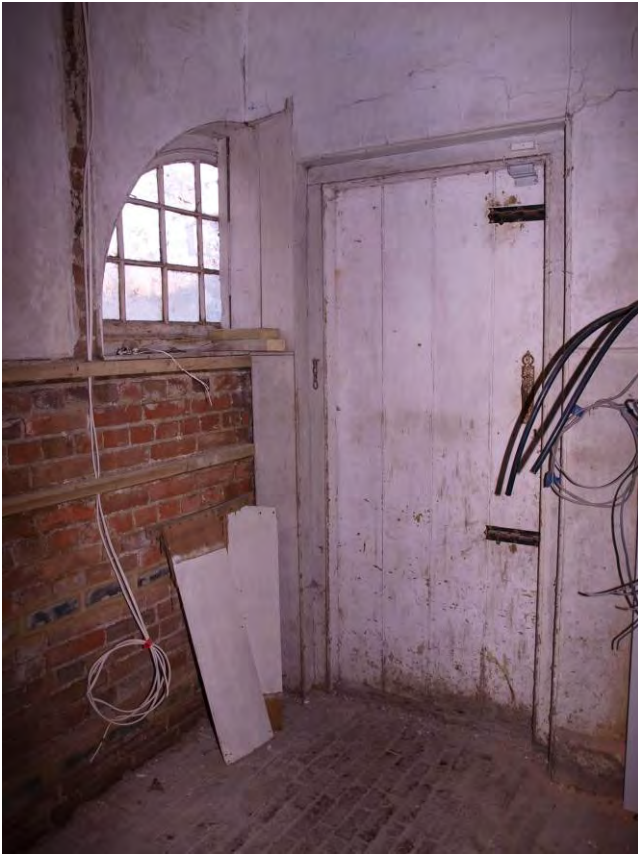
with thumb-latch and T-hinges (Plate 17). At this point, the east wall bisects the eastern window, which thereby serves to light both this, and adjacent Room 3.

Plate 17: Door between Rooms 2 & 3, looking north-east (29)

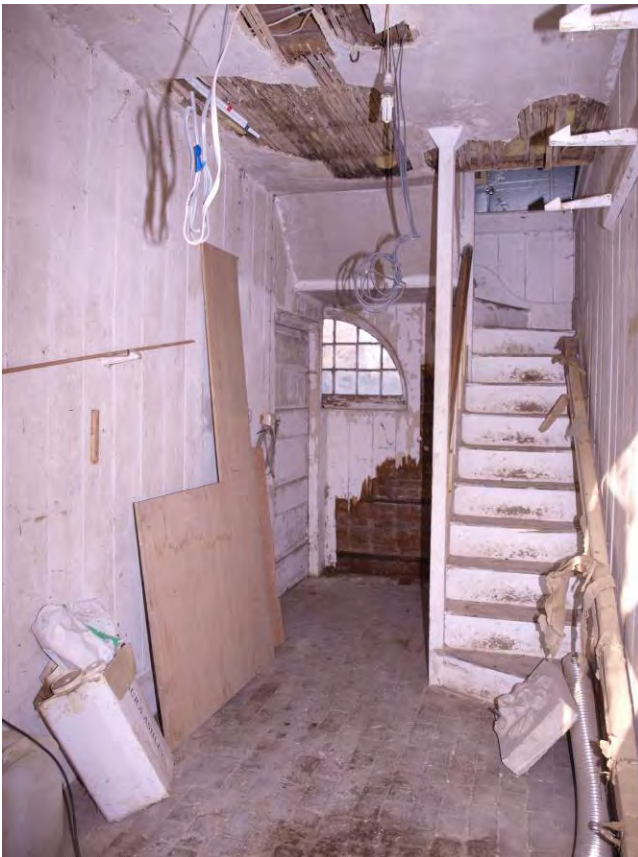
- 5.10 Room 3, which measures 2.1m x 5.4m, served as the tack room. It has a brick floor, full-height match-boarding to all except the south wall, and lath and plaster ceiling applied to deep-laid softwood joists. The north wall contains the other half of the semi-circular window seen in Room 2 (Plate 18), while the south wall contains the inserted doorway to the garden (Plate 19). Fixed to the east wall is a row of wooden hooks for tack; there is a further single hook on the west wall. The south-west corner of the room contains a corner fireplace with cast-iron hob grate. In the north-east corner of the room is a staircase to the upper floor. It is of dog-leg form with winders, comprises a closed string and has a simple toad's-back hand-rail; the balusters are modern (Plates 18 & 20). The under-stairs area is enclosed by match-boarding to form a cupboard. The cupboard doorway has a boarded and battened door (hung upside-down and back-to-front) and over-light.

Plate 18: Room 3 (tack room), looking north (34)

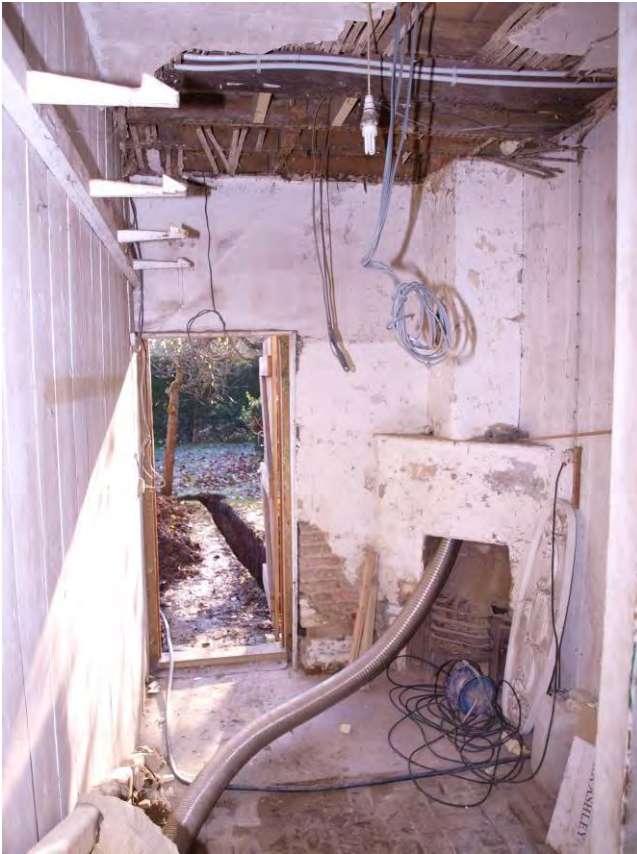
Plate 19: Tack room (Room 3), looking south (33)

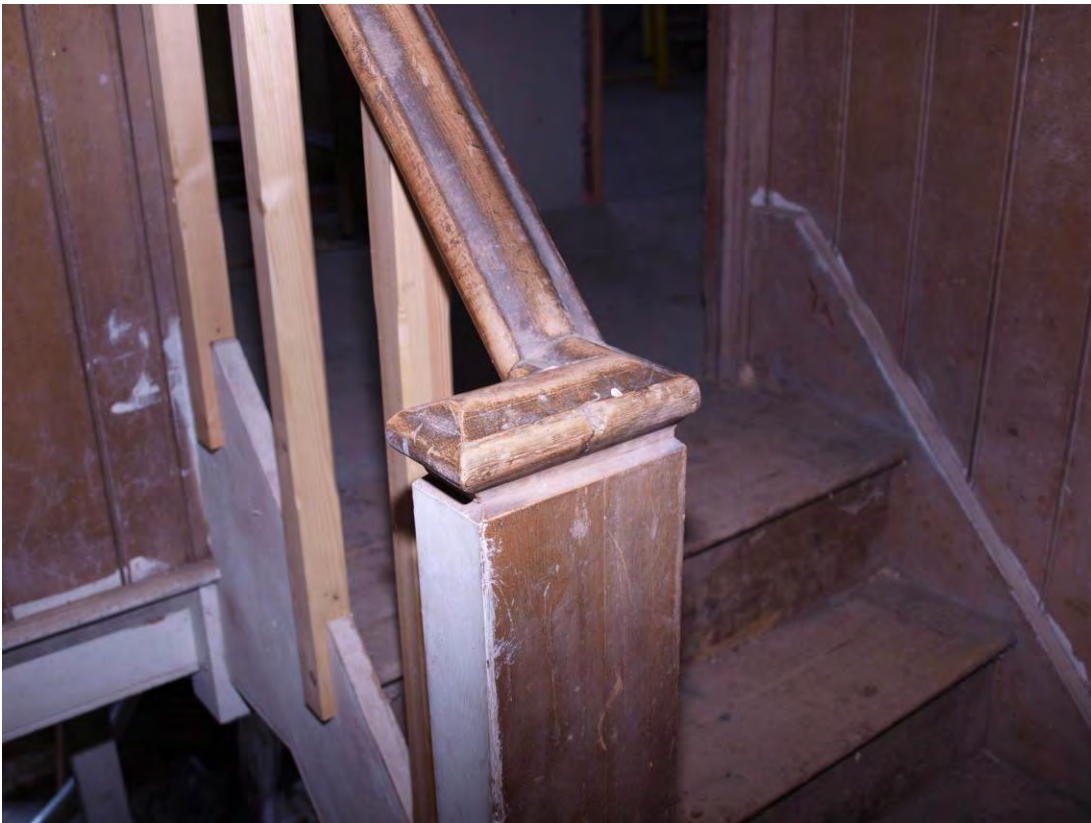
Plate 20: Staircase detail, looking south-west (52)

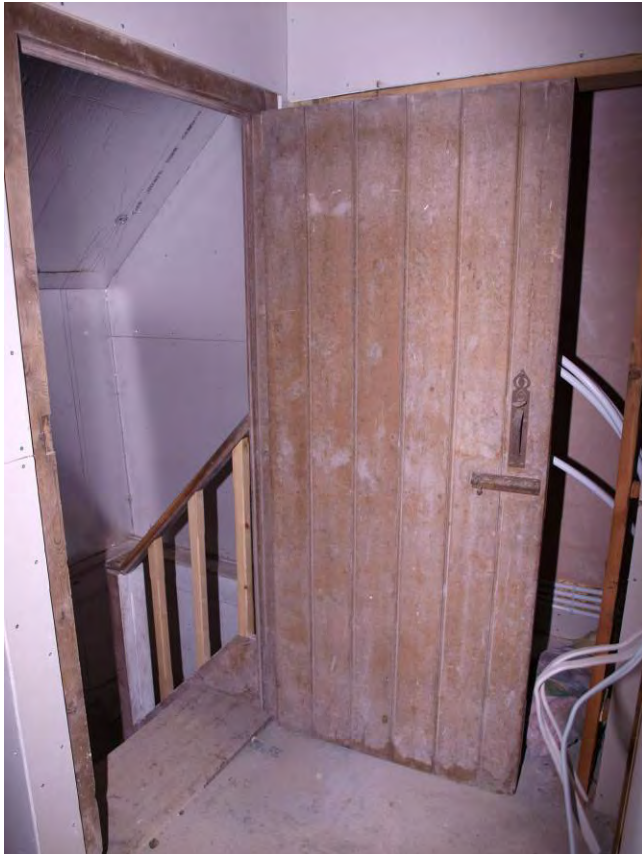
- 5.11 The stair landing is enclosed by match-boarding; there is a doorway on the south side, with a boarded and ledged door with thumb-latch as elsewhere (Plate 21). Original softwood floor-boards survive in this area, whereas the remainder of the upper floor has been recently been re-floored in chipboard. The area is lit by one of the four-over-eight pane sash windows on the north wall.

Plate 21: Door to staircase, looking north-east (45)

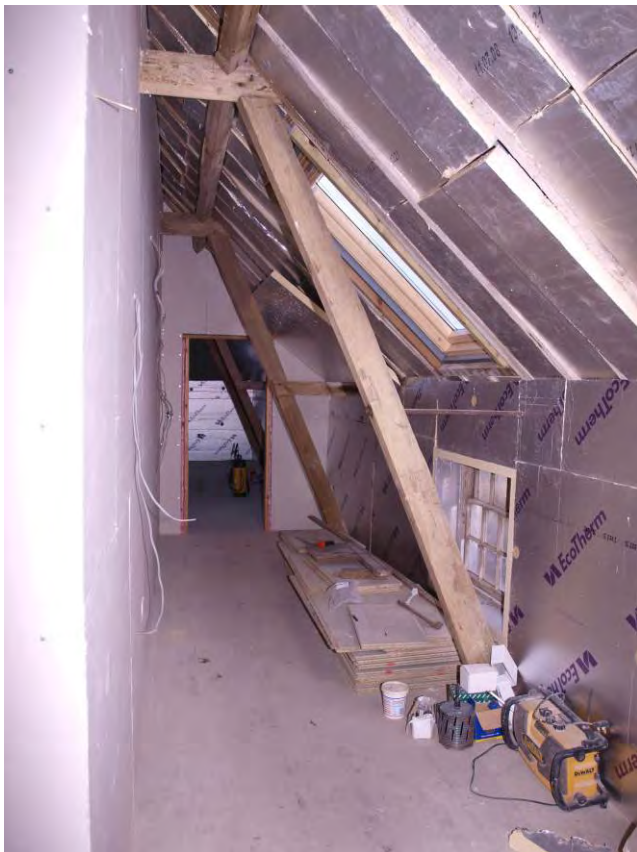
- 5.12 The upper floor was formerly open as a single space, but has recently been subdivided (Plate 22). The north wall contains the other four-over-eight pane sash window, high-set loading door with boarded, framed and cross-braced door, and small inserted window. The south wall contains the three four-over-four pane sash windows.

Plate 22: View of upper floor, looking west (48)

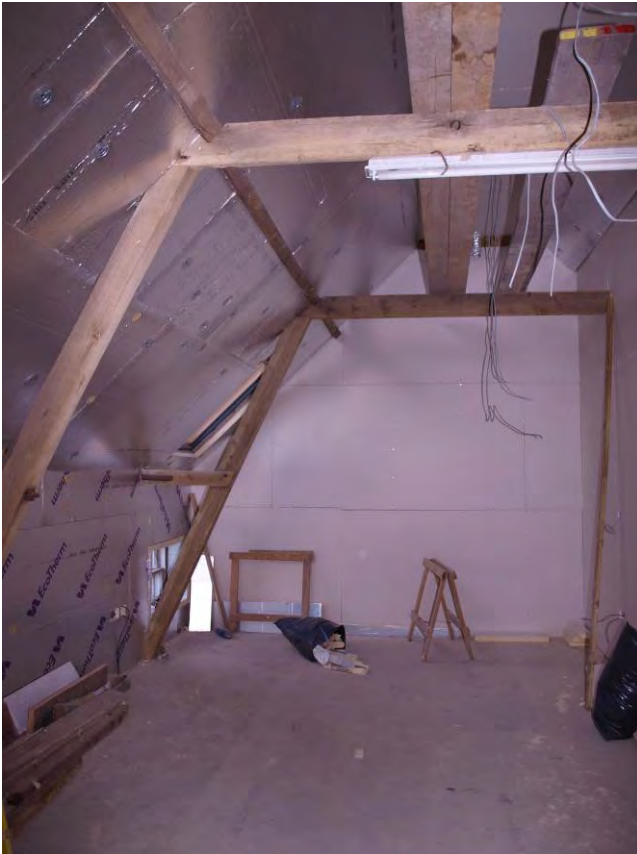
- 5.13 The roof is of clasped side-purlin type, supported by three original and two inserted interrupted tie-beam roof trusses (Plate 23). A single purlin in each roof pitch is secured by a collar at each of the principal trusses. At the original trusses, long struts, which are pegged to the collars, and to which the tie-beams are face-pegged extend down to floor level. The ties are stapled and strapped to the wall-plates. The inserted trusses are of similar form, though are secured by nails rather than any jointing or pegging; one of the trusses has iron tie rods in place of timber ties. Although not visible, the wall-plates are in level assembly as indicated by angle ties in north-west and south-west corners. There is a ridge-board at the apex.

Plate 23: Interrupted tie-beam roof truss (truss in foreground is a later insertion), looking west (49)

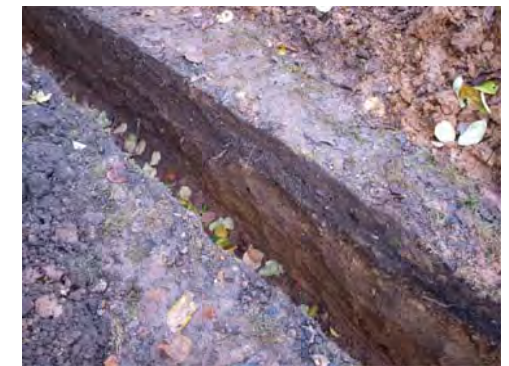
Section 1: showing garden feature/border [007] (left) and path [003/004], looking north-east.

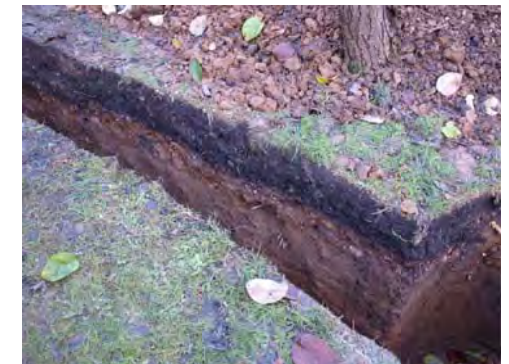
Section 1: showing garden path [003/004], looking north-east

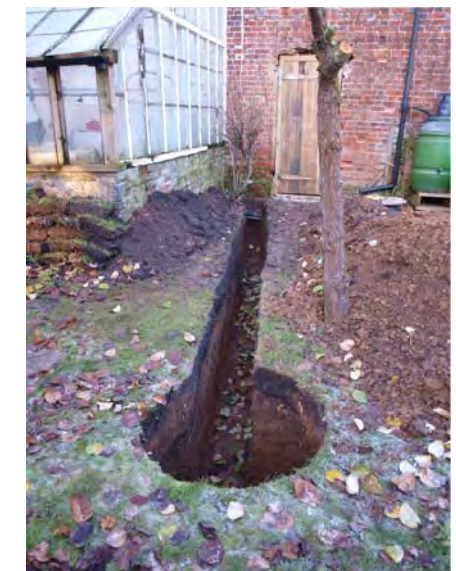
Service trench 1, looking north

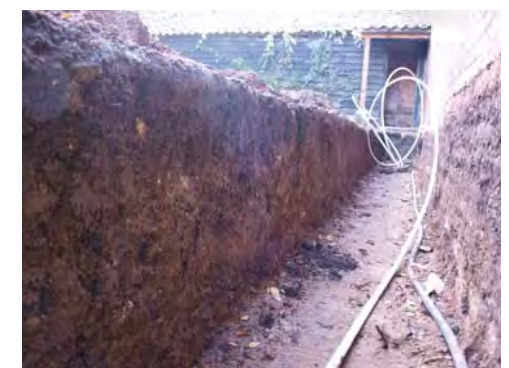
The trench sections revealed a stratigraphy similar to that observed in Service Trench 1, including a continuation of the garden path [003/004], thereby indicating it to be oriented on an approximately east – west alignment, and to the north a continuation of garden feature/flower border [007/008].

North-facing section of service trench 3, looking west
