**A Historic Building Record
of
Stanmer Stables, Stanmer Park, Brighton, East Sussex**
(appended with archaeological and standing building watching briefs)
(NGR TQ 3357 0951)

**Project No.: 5908
Site Code: SHS 11
Report No.: 2013016**

**January 2013
(updated August 2013 & April 2015)**

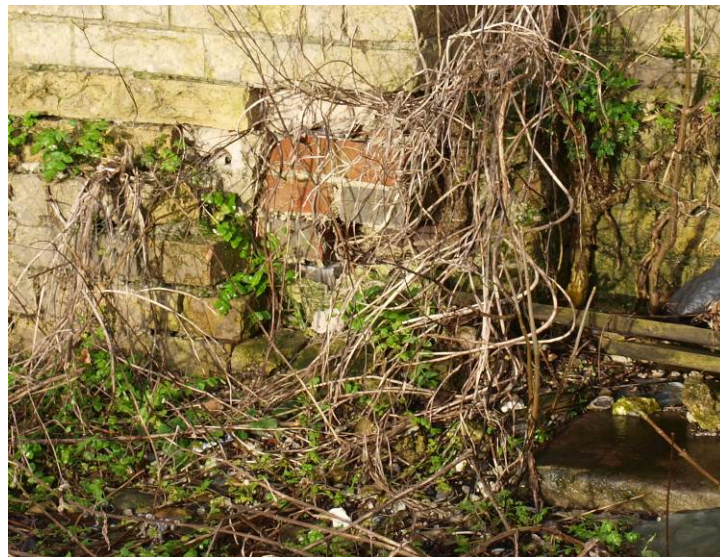
Plate 2

Damaged brickwork at the lower corner of the entrance block showing the red-brick wall behind the yellow-brick facing

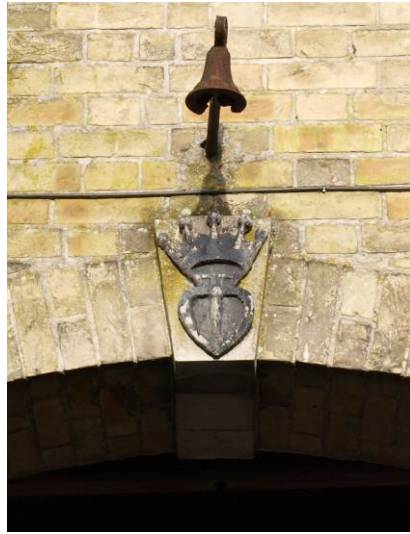
Plate 3

The Pelham buckle crest on the boss of the arch over the entrance way

- 7.2.2 In the centre of the entrance block there is a tall, semi-circular arched opening with the Pelham buckle crest on the projecting boss (Plate 3). Diocletian windows flank the opening. There are three square first-floor windows capped with splayed-brick flat heads weathered by lead drip-trays. The windows are much damaged, but the remains of a three-over-three double-hung sash window survives in one opening.

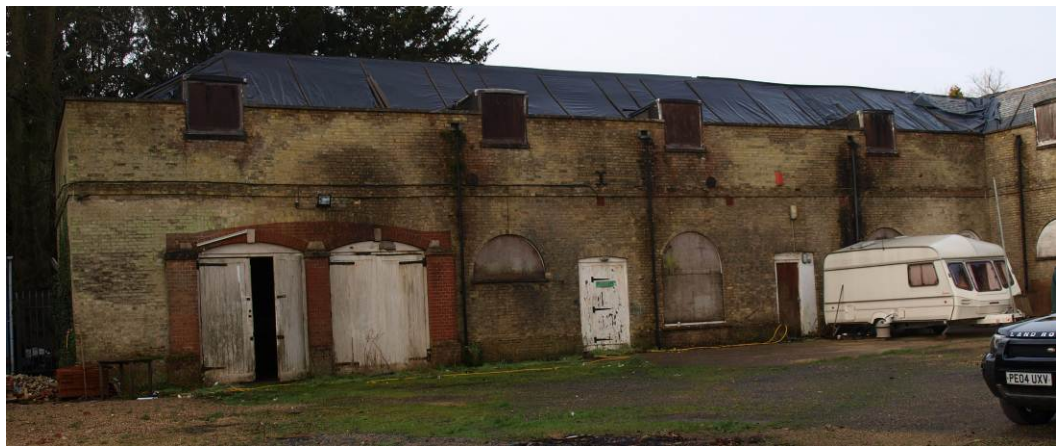
Plate 6

The inner (north-east) elevation of the south-west wing

- 7.2.5 The same wide, tall opening, infilled with two smaller, red-brick doorways, is positioned at the south-eastern end of the south-west wing (Plate 6). Unlike the feature opposite, doors have been retained in these openings. These are doors formed by narrow plank, ledges and diagonal struts fitted within a timber frame and hung on a variety of hinge types. Also mirroring the opposite wing is the door with semi-circular head adjacent to the central range. The semi-circular fanlight seems to have been an original Diocletian fanlight but the central pane has been replaced with a vent. The door is a plain board door within a plain architrave. Between this and the south-eastern openings are three windows alternating with two doorways. Each window has a lucarne positioned directly above it. The central and north-western windows were original Diocletian windows which have been lowered to form larger openings. The windows have a central mullion and high-level transom with narrower cruciform glazing bars dividing the panes. The south-eastern window is an original, unaltered Diocletian window. The two doorways both have segmental-arched heads, but the south-eastern window has been formed without the use of queen closers. These are wider than standard door openings, and both have been fitted with standard modern doors and a fixed narrow panel.

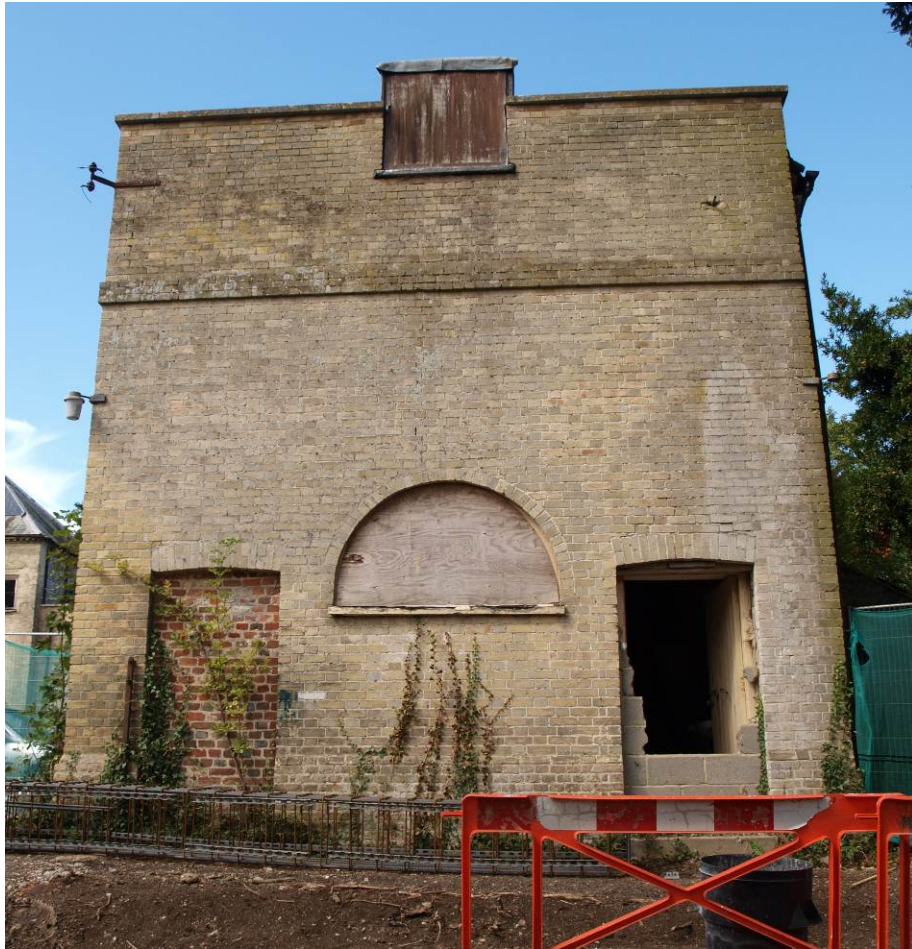
Plate 7

The end elevation of the north-west wing. The end elevation of the south-west wing differs in that it lacks a first-floor lucarne.

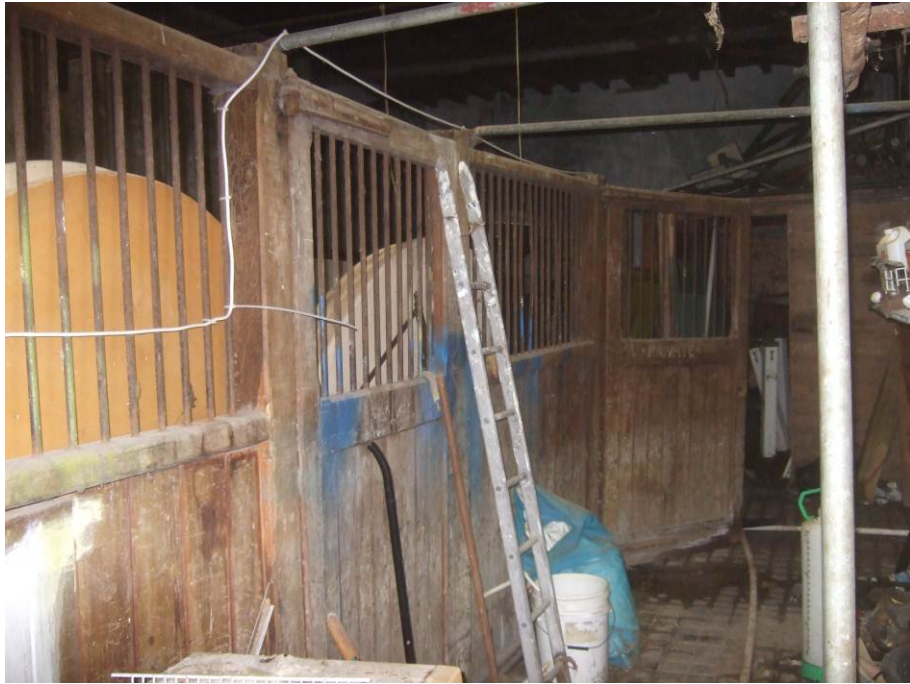
Plate 17

The stable partition in Room 1, viewed from the south-west

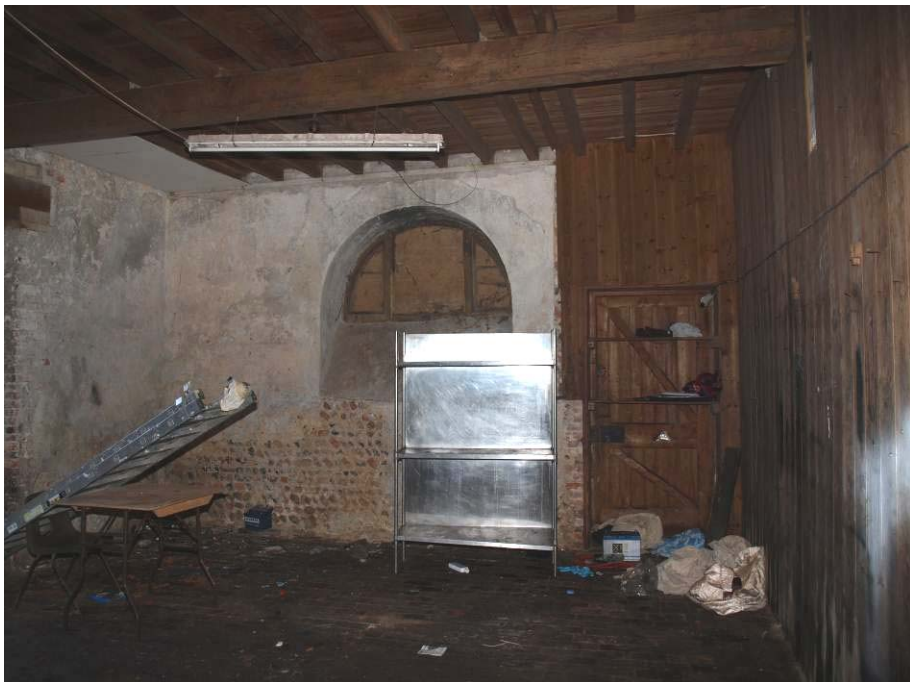
Plate 18

The south-east end of Room 7, viewed from the north-west, showing the partial panelling and grooved additional timber in the ceiling indicating the former corridor partition

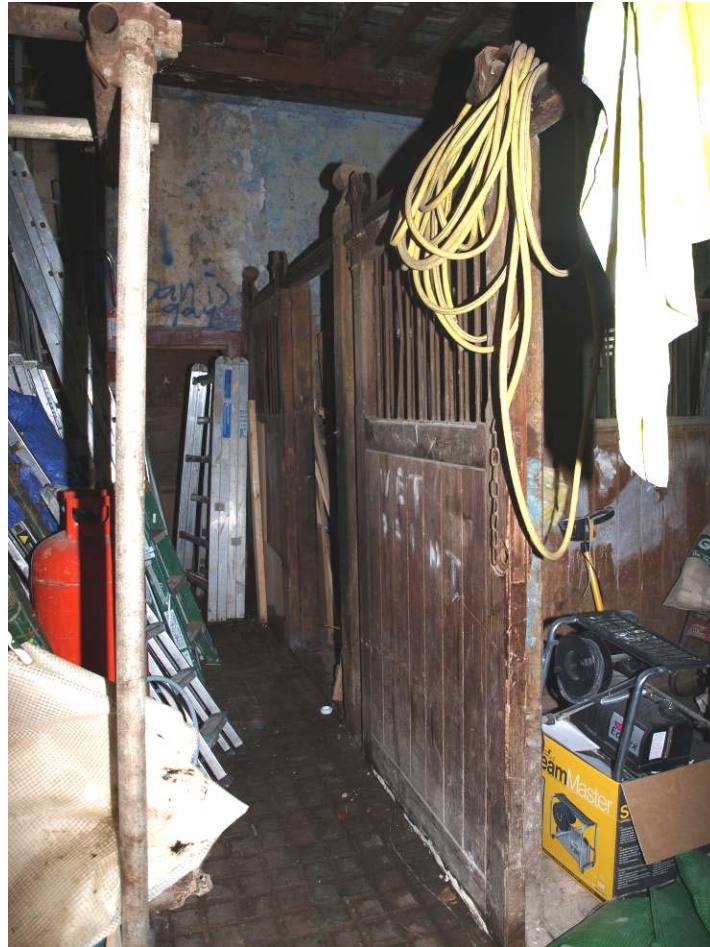
Plate 19

The stable partition in Room 8, viewed from the north-east

comprising sliding doors supported on runners within cast-iron housings (Plate 19). The housings were cast by A. Kenrick & Sons of West Bromwich (Plate 20), a family company founded in 1791. This date indicates that these stalls are not likely to be those fitted when the stables were originally built. The outer walls are not boarded. There was no evidence to suggest the size and form of any earlier stalls.

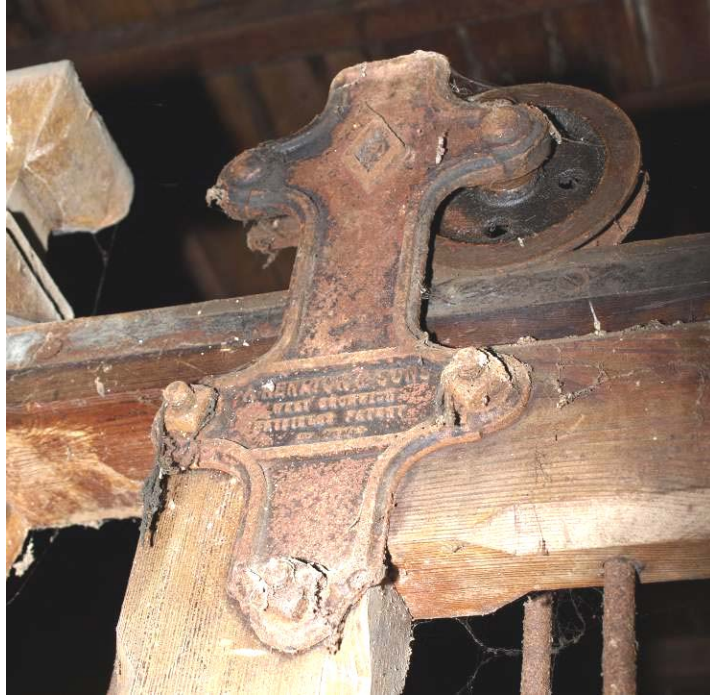
Plate 20

The cast-iron door runner housing in Room 8

- 8.8 The present stable fittings post-date 1791, when A. Kenrick & Sons was founded: their door runner housing survives in the north-eastern stables. This alteration is probably due to the changes in attitudes towards correct horse management and the consequent move towards the use of loose boxes rather than narrow stalls for stabling horses (Worsley 2004: 186). If these stable fittings are the same date as the six-panel doors, it indicates a widespread scheme of internal refitting in the early 19th century, which may correspond to the insertion of many additional windows and doors in the north-eastern wall, although these cannot be more closely dated.

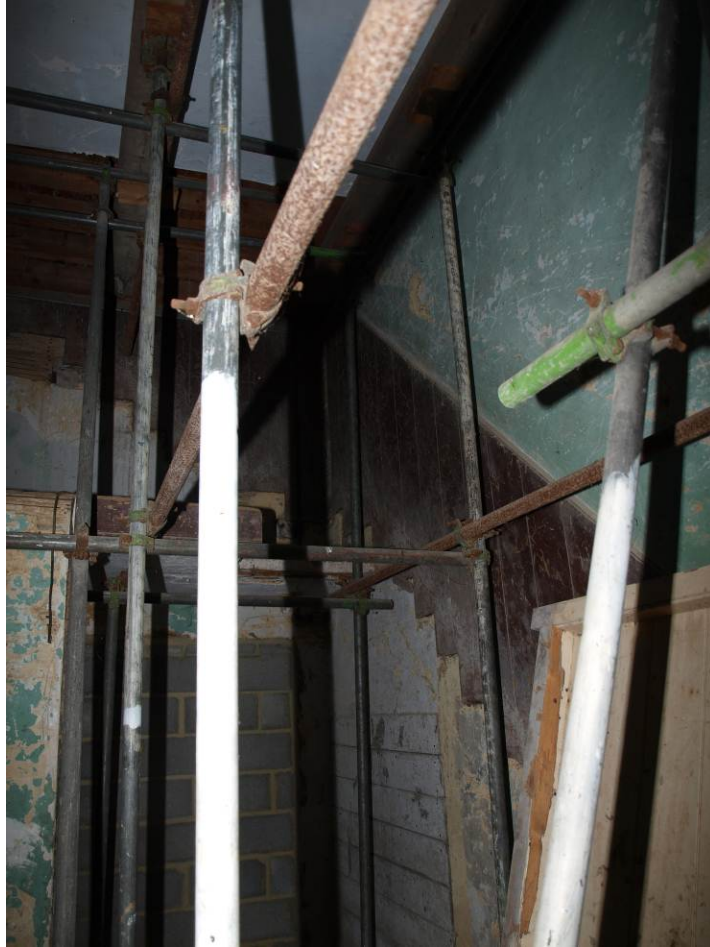
Plate 22

The evidence for the former stair in Room 15, viewed from the courtyard door

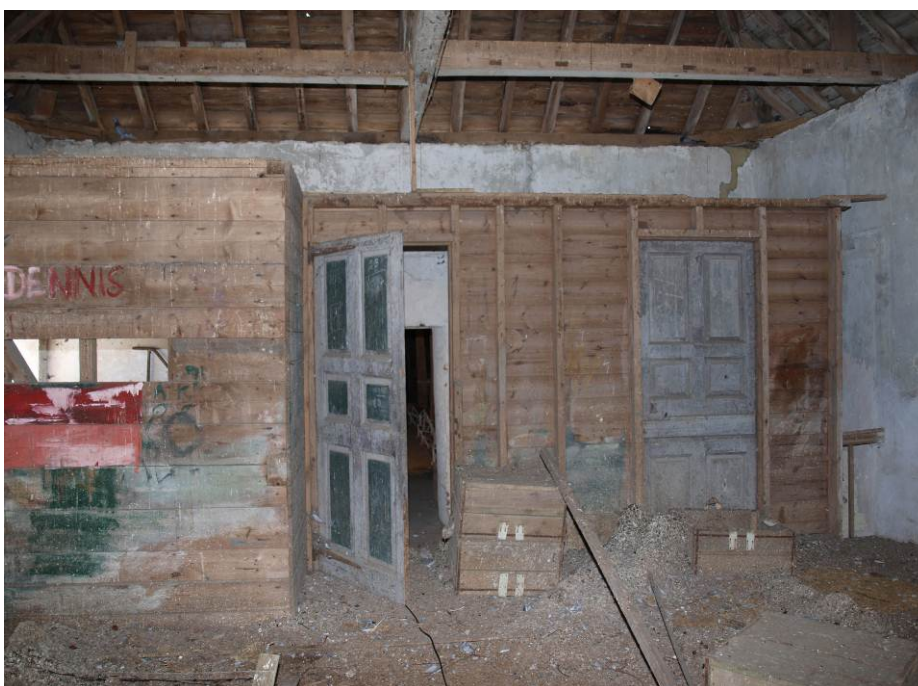
Plate 24

The partition between Room 22 and the stair showing the six-panel doors, viewed from the north-east

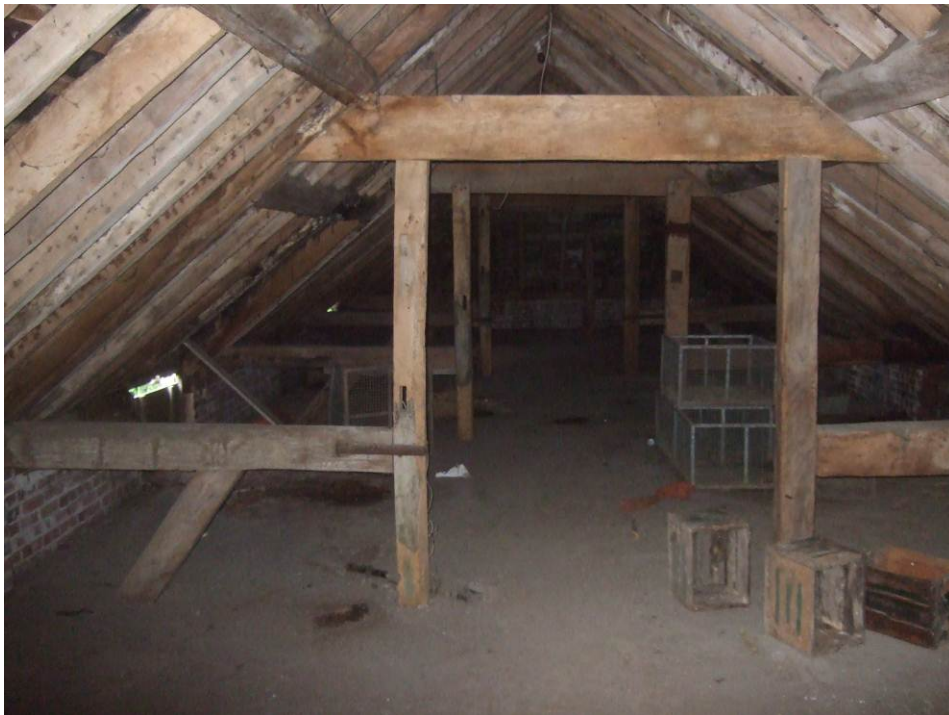
Plate 25

The roof over the north-east part of the central range, viewed from the south-west

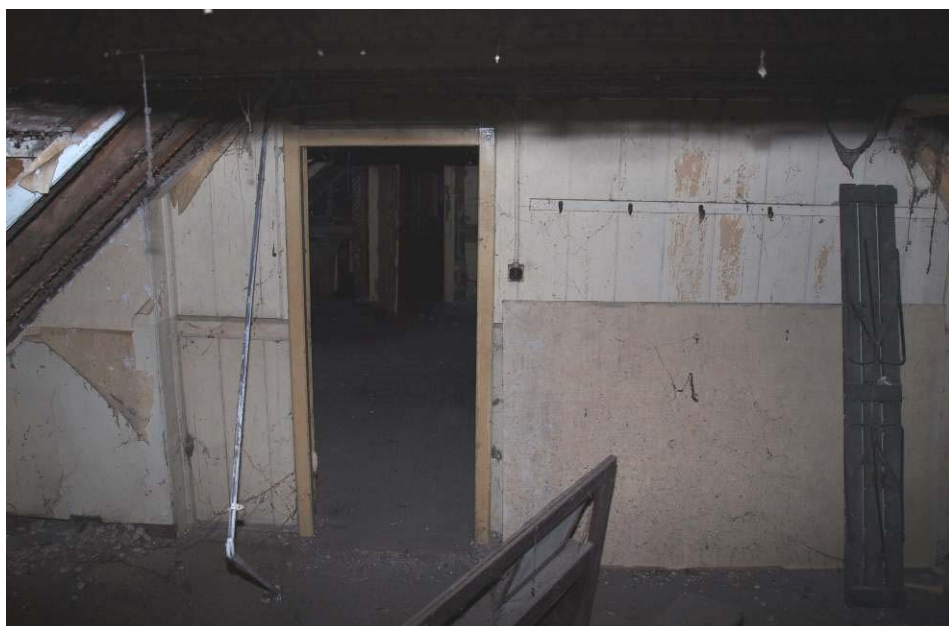
Plate 26

The north-west room of the suite of first-floor rooms over the north-east range, viewed from the north-west

north-western wall to a series of attic rooms. The partitions between the rooms are formed in regular studs covered with vertical matchboarding (Plate 26). There were low walls of lath and plaster fixed to ashlar pieces nailed to the rafters and ceilings of the same form, fixed to the soffits of collars positioned at each rafter pair. The laths and plaster have been removed, leaving stains and nails in the timbers. The visible doors are of plank-and-ledge construction within plain timber frames. The rooms were served by electricity: there are light switches inside the doorways.

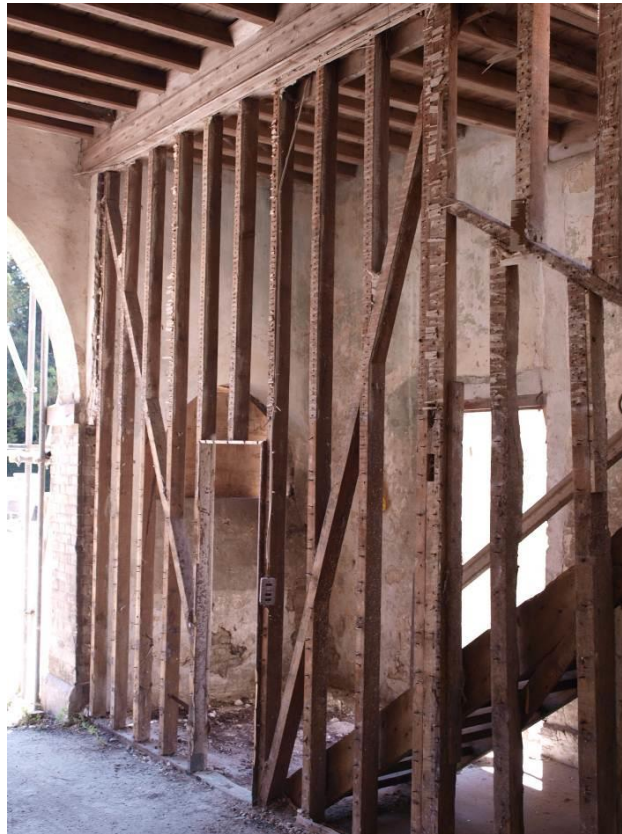
Plate 4.1: Primary braced partition on south-western side of entrance way (43)

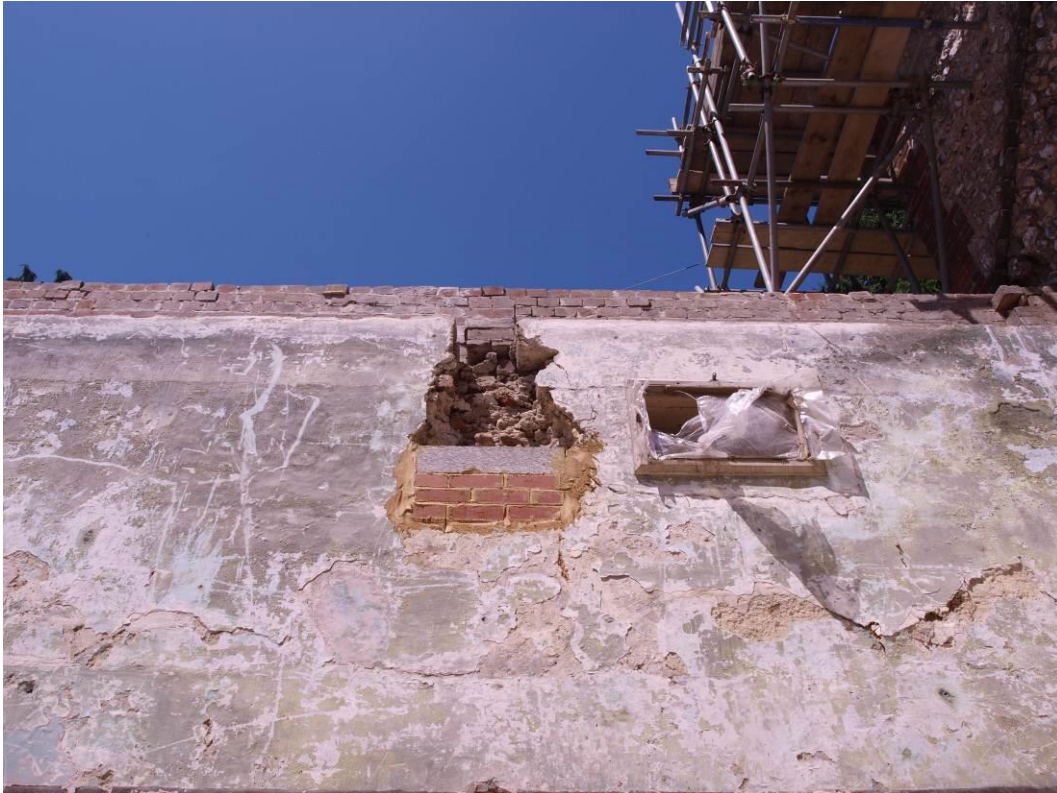
Plate 4.3: Possible vent on north-west wall of Room 1 (36).

- 3.2 The walls generally retained their plastered finish in Room 1; however, floors had been dug out and the levels reduced by up to 0.4m. This revealed walls to be founded on a mix of brick, flint and chalk rubble. Small exposed areas of walling were visibly of the same type of construction (Plate 4.2). The original construction utilised chalk block quoins at the junctions of external walls and partition walls.
- 3.3 Fragmentary remains of possible vents for a ventilation system were visible at high level around the perimeter of the room; however, these have been modified by recent repairs and this could not be ascertained (Plate 4.3).

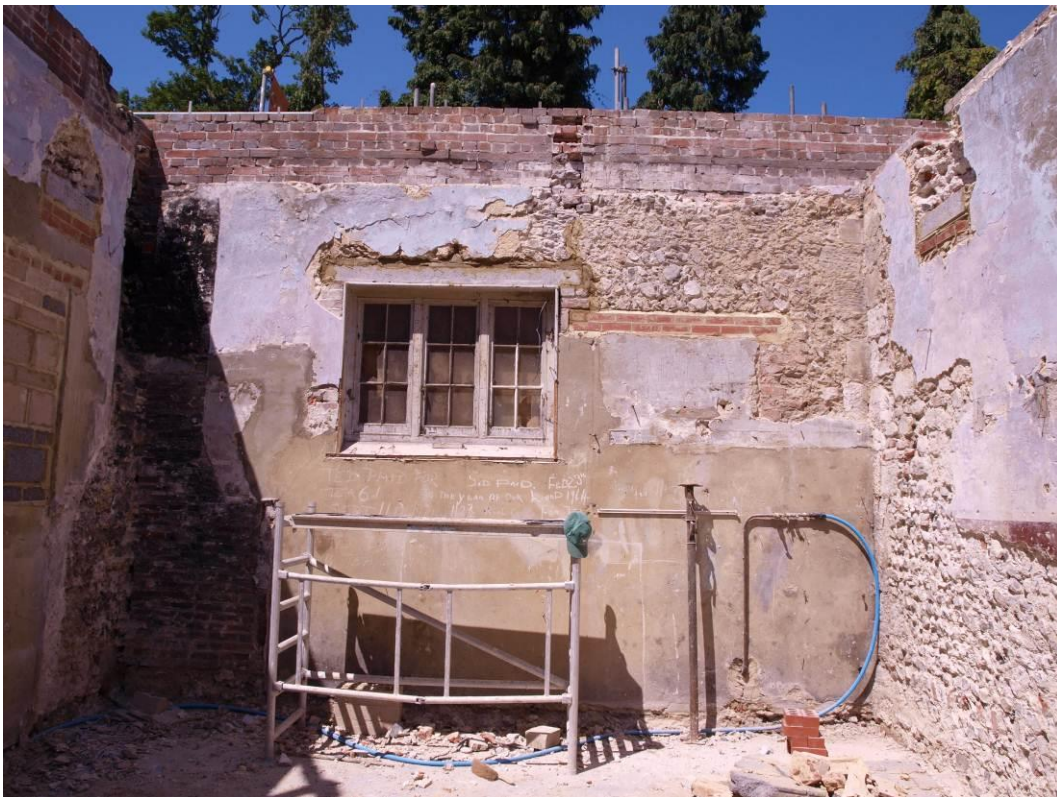
Plate 4.4: North-west wall of Room 2-4; location of former chimney breast to south and chalk block quoin construction of original partition wall to north (28).

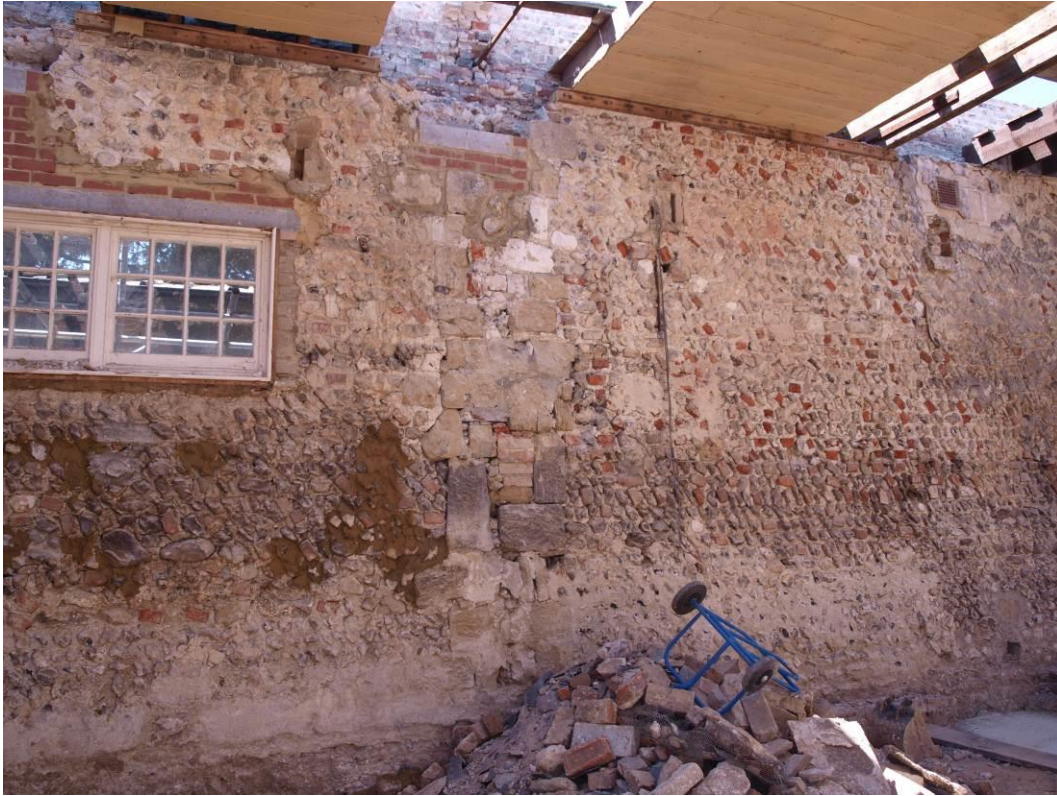
Plate 4.5: Chalk block quoins in south-west wall of Room 5 indicate the former location of an original partition wall (13).

- 3.7 Removal of the wall linings revealed evidence for the location of an original partition wall, indicated by the remains of chalk quoins in the south-west external wall, a detail seen in the construction of the other original partitions. Its location demonstrates that the southern doorway to the courtyard is a later addition (Plate 4.5). The south-eastern bungaroosh partition wall, founded on chalk rubble, is a later insertion, indicated by a straight joint at its junction with the exterior walls. An area of chalk blocks located centrally within the wall is of unknown purpose (Plate 4.6). Possible vents, as seen in Room 1, are located at high level around the perimeter of the room.

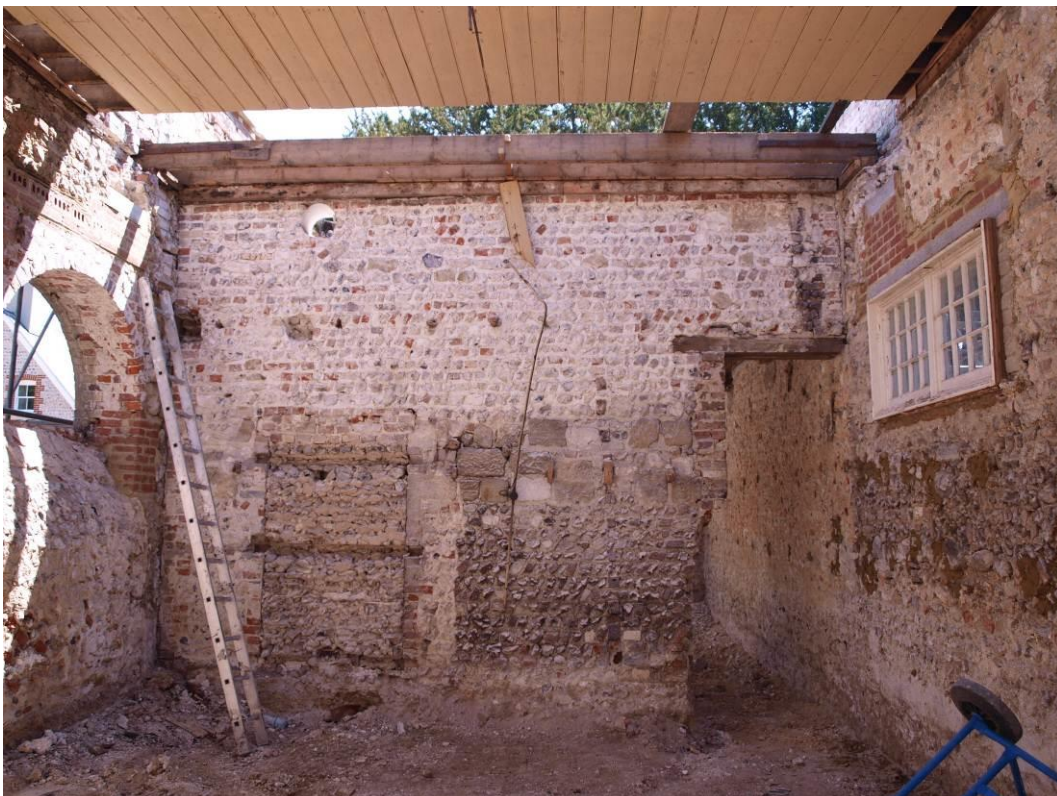
Plate 4.6: Blocked doorway and area of chalk blocks in a later partition wall forming the south-east wall of Room 5 (12).

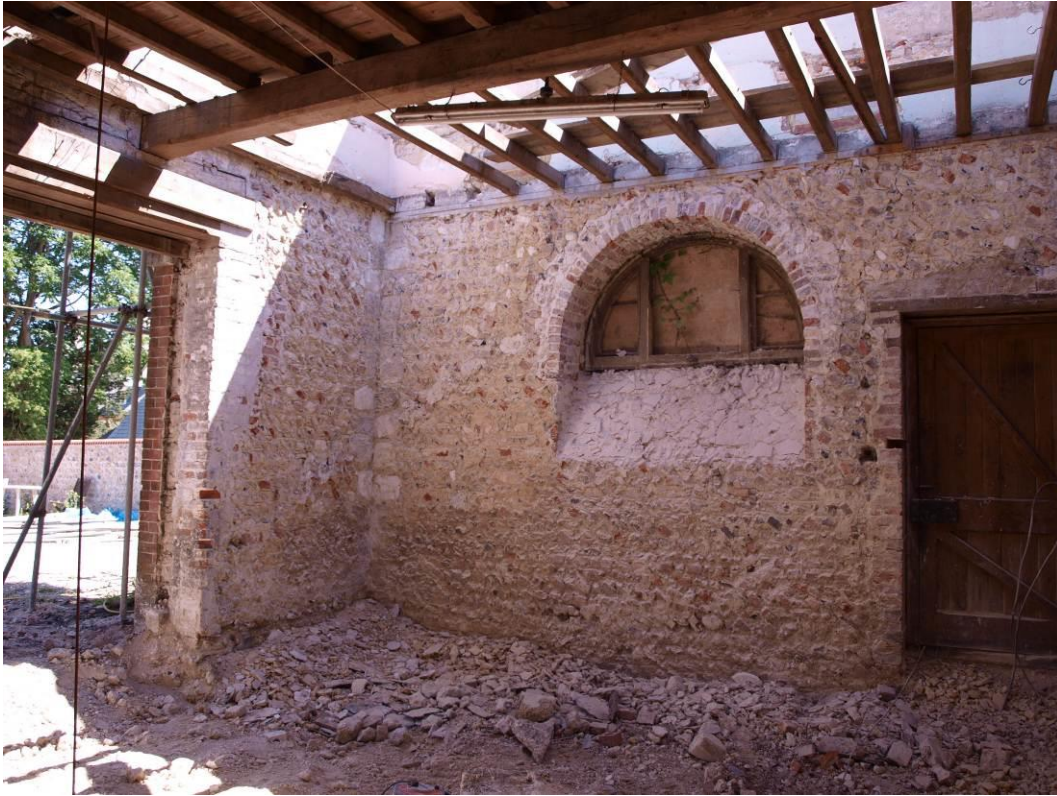
Plate 4.7: Site of former stair in Room 7; the blocked doorway seen externally is not visible internally (4).

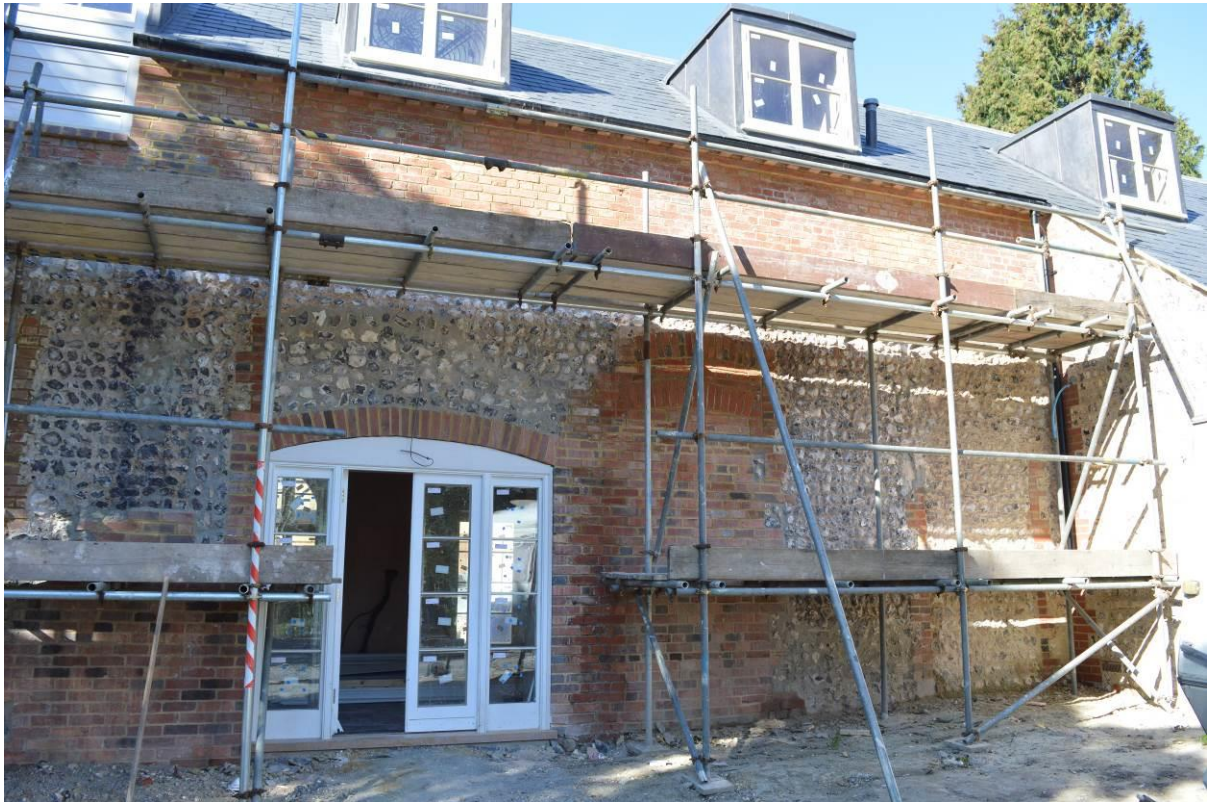
Plate 4.11: Brick quoins indicate former doorway to north-east elevation, blocked with coursed flintwork (right-hand side of photo) (59)

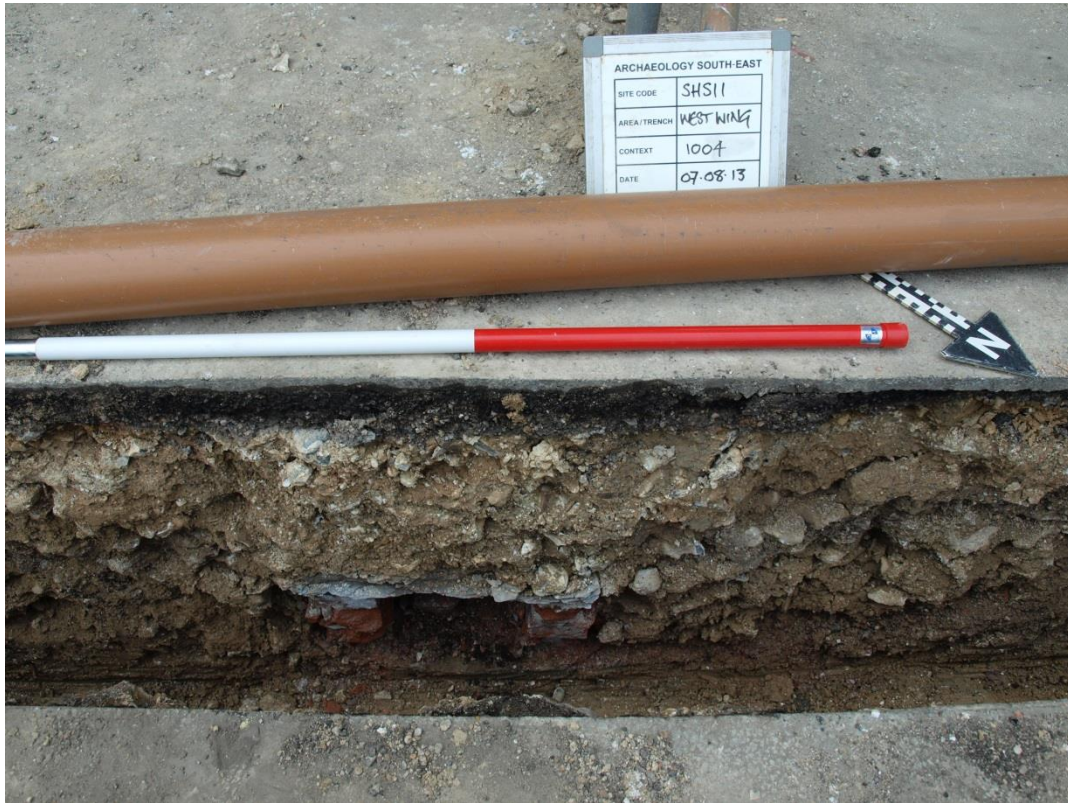
Plate 5.5: Stone-capped brick culvert [1004], looking south-west.

4.1.2 Along the western Drainage run two stone-capped brick culverts ([1004] and [1005]; Plates 5.5 and 5.6) and two clay pipe drains were observed, leading to down-pipes from the West Wing of the stables. Additionally, a couple of wall footings ([1002] and [1003]) of flint in lime mortar were observed to the northwest of the excavation (Plates

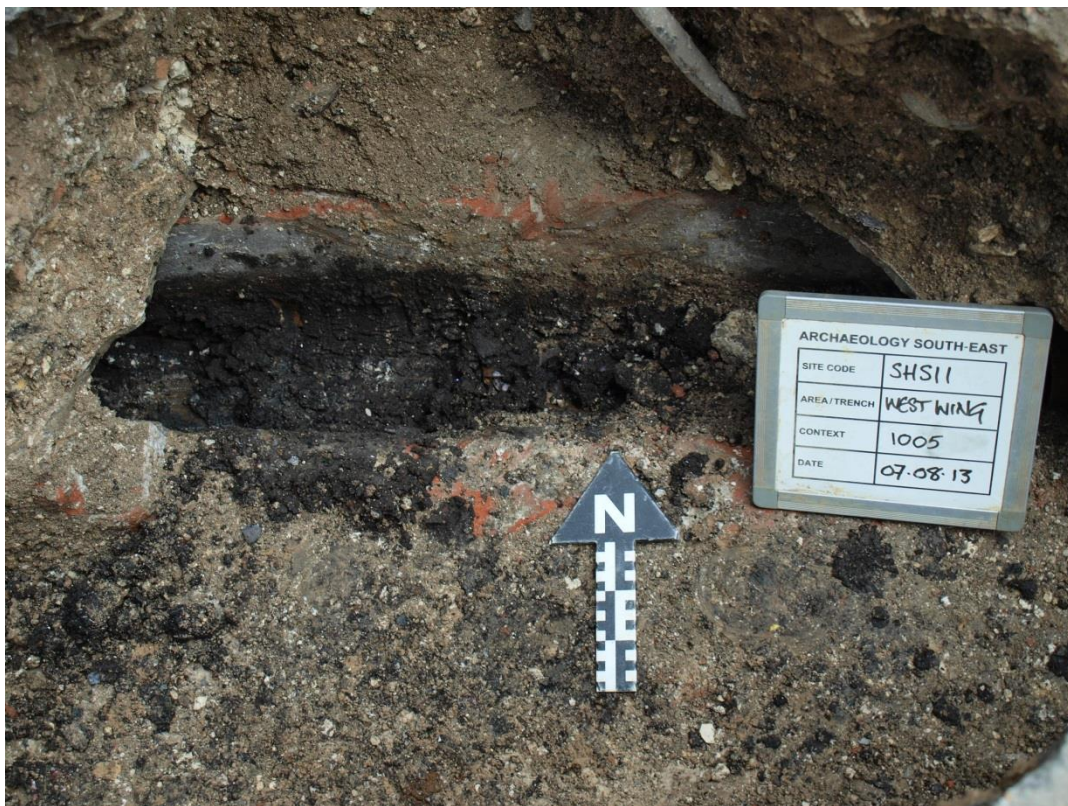
Plate 5.6: Stone-capped brick culvert [1005], looking north.

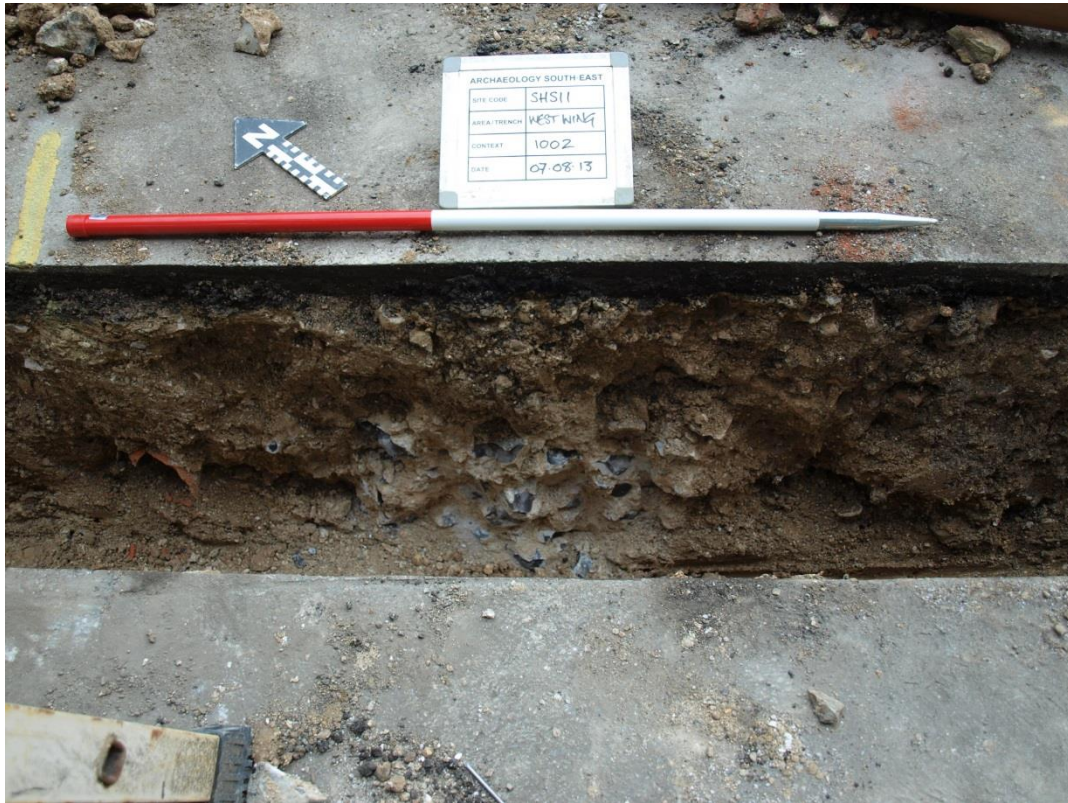
Plate 5.7: Flint and lime mortar wall [1002], looking north-east.

5.7 and 5.8). It was not possible to observe the alignment of the wall due to the minimal width of the excavation. The footing for the stable wall [1006] was observed to the northwest of the trench (Plate 5.9).

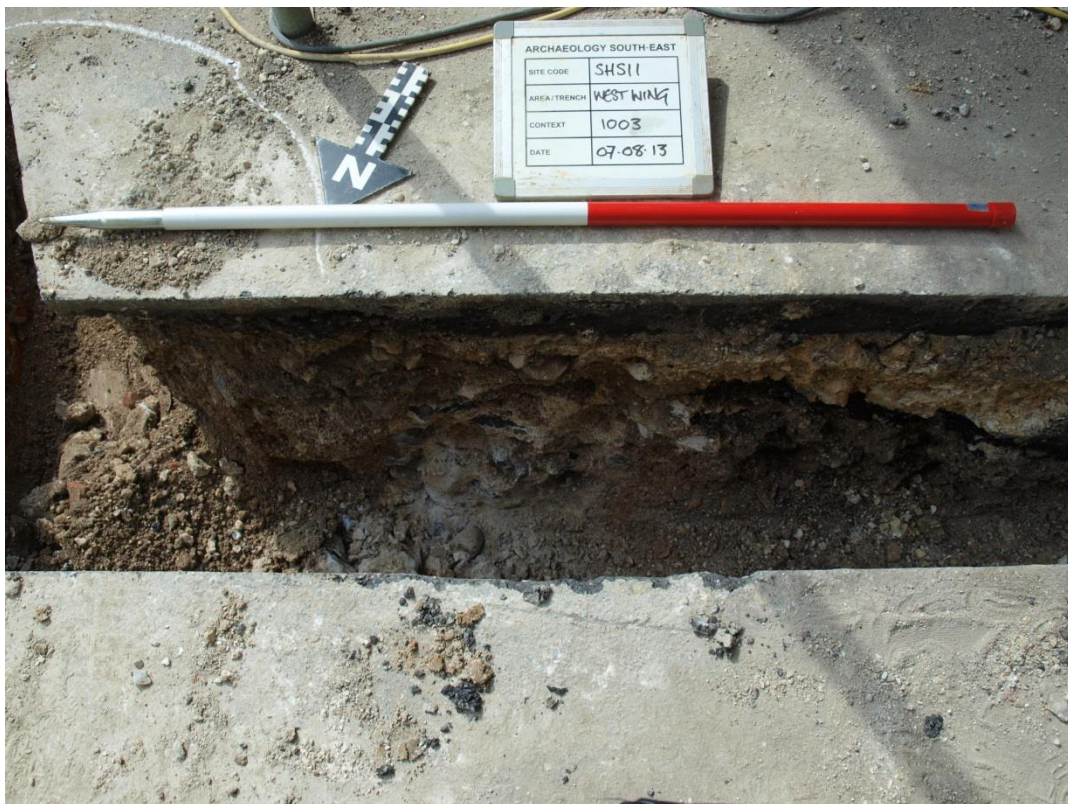
Plate 5.8: Flint and lime mortar wall [1003], looking south-east.

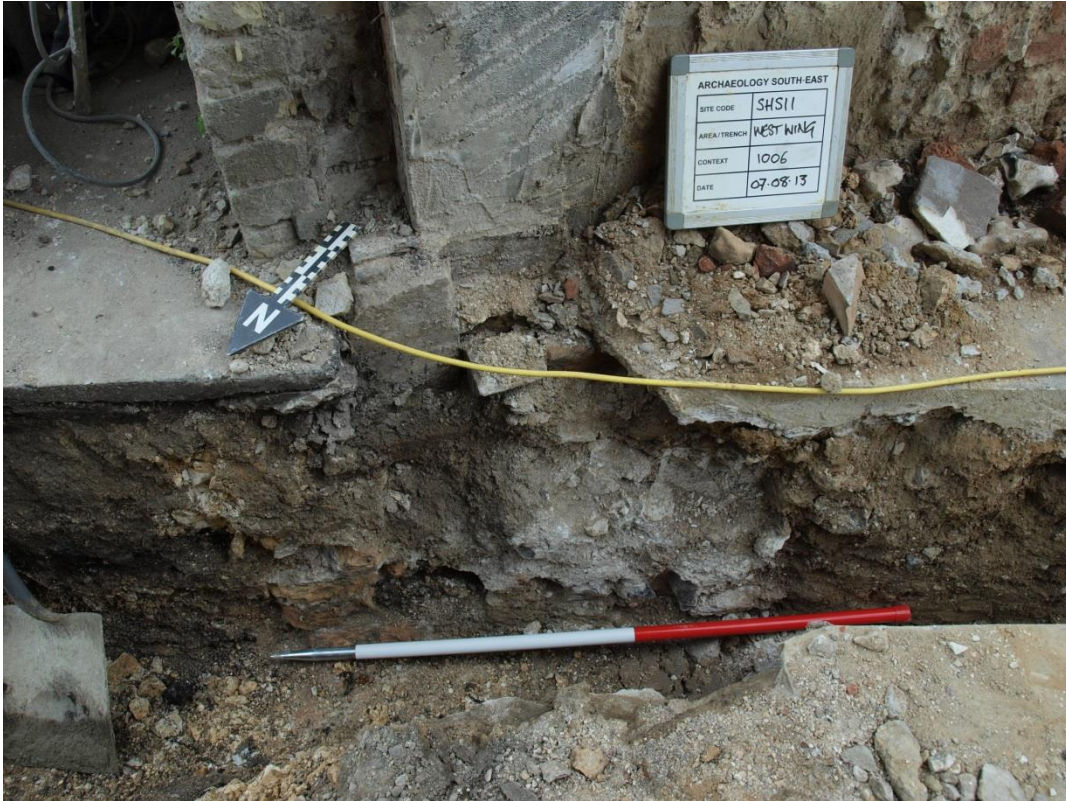
Plate 5.9: Wall footing [1006], looking south-east.
