**An Archaeological Watching Brief
at Dominican Friary Ruins, Mill Road,
Arundel, West Sussex**

**ASE Project No: 5218
Site Code: DFA11**

ASE Report No: 2013027

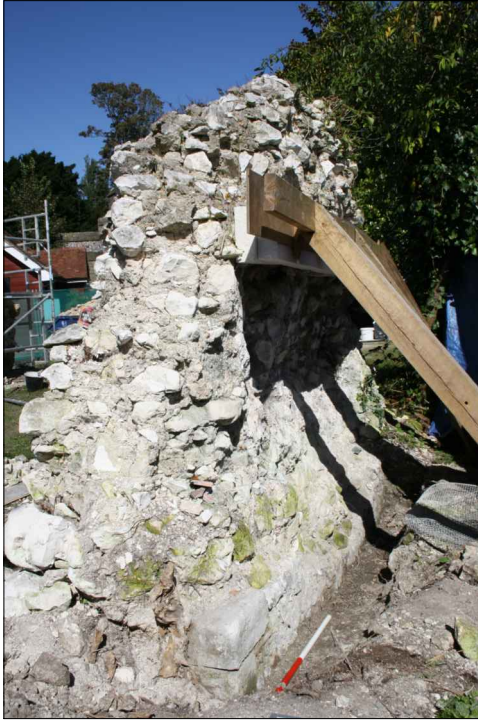
Figure 3a. Wall G, south east elevation

4.1.2 A layer of overburden [001] was excavated to the limit of excavation, 3.96mOD. This overburden both overlay and abutted a section of flint faced wall [002] and clunchstone inner core [003] (the latter two contexts being present both above and below ground). Context [002] consisted of a flint facing within a light grey pebbly lime mortar with ashlar quoins on the south western extent. Many of the flints forming the flint facing had been split lengthways and a single tile and two bricks were observed within the facing. Clunchstone [003] overlay [002]. No other archaeological deposits, features or finds were encountered.

- 5.1 The archaeological watching brief revealed a flint facing to the below ground remains of Wall G. Wall G is interpreted as part of one of the buildings forming the medieval friary at Arundel. The presence of quoins at the south-western extent of the surviving wall suggests that this was the corner of building. Brick and tile within the facing, along with the uneven flints, some split lengthways, towards the centre of the exposed section may indicate a later repair to the wall.
- 5.2 Extensive modern overburden was revealed but the excavation did not reveal the full thickness of it. However, this material, which is likely to relate to work carried out at the site during the 20th century, has offered significant protection to the flint faced wall.
