**Archaeological Watching Brief Report:
Royal Military Canal, Green Lane, Hythe, CT21 4DY**

ASE Project No: 5965

ASE Report No: 2013044

March 2013

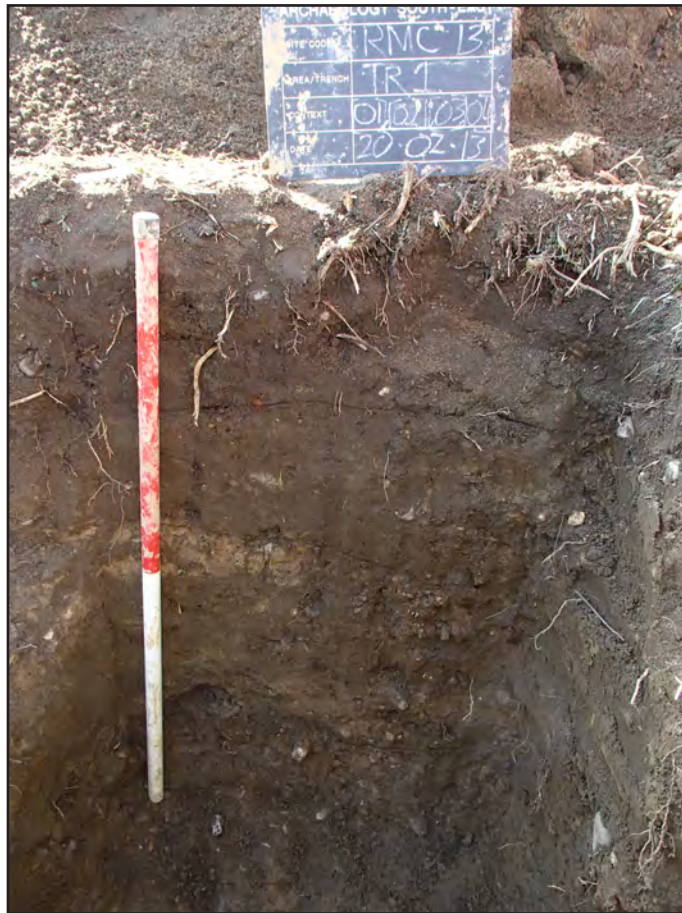
4.3.1 No natural deposit was identified in test pit 1, the lowest strata observed being a moderately loose dark greyish brown silty clay with mottles of grey [004] (Figure 4). Included within the clay were moderate to frequent quantities of small pebbles. The deposit was interpreted as either made ground of the canal bank or upcast deposits from the dredging of the canal. The deposit was identified at a depth of 0.80m within test pit 1 and was 0.30m thick continuing below the depth of the test pit.

4.3.2 Overlying the pebbled clay layer was a deposit of mid greyish brown sandy silt with occasional small patches of yellowy brown sand and yellowy brown clay [003]. This layer which was 0.40m thick was also interpreted as upcast dredged sediments or possible made ground of the canal bank. One small

Trial Pit 1 : Section.

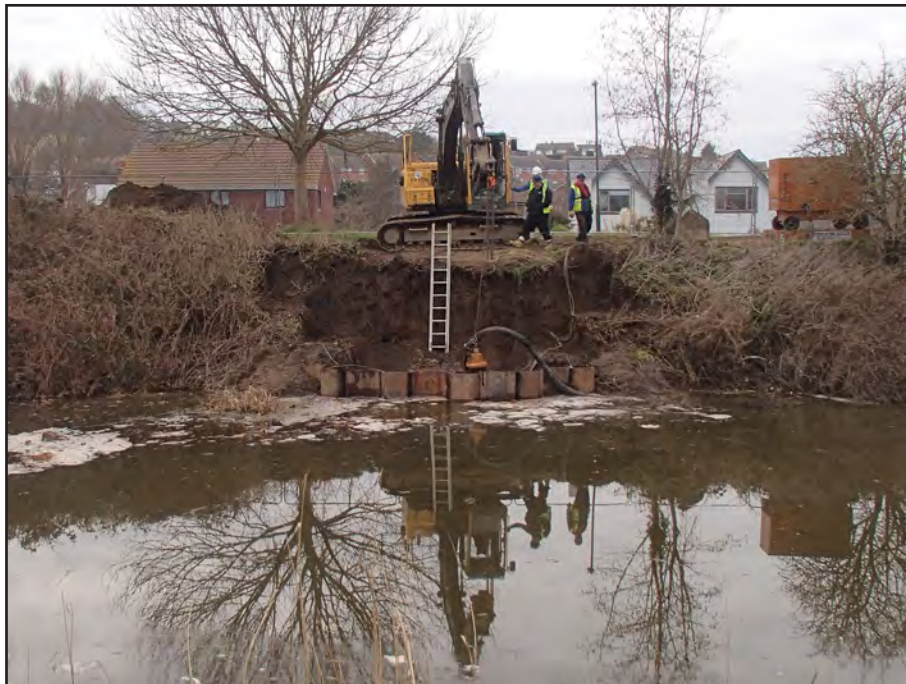
© Archaeology South-East		Royal Military Canal, Green Lane, Hythe - Watching Brief	Fig. 4
Project Ref: 5965	March 2013	Photographs of monitored works	
Report Ref: 2013044	Drawn by: DJH

View of monitored groundworks looking north.

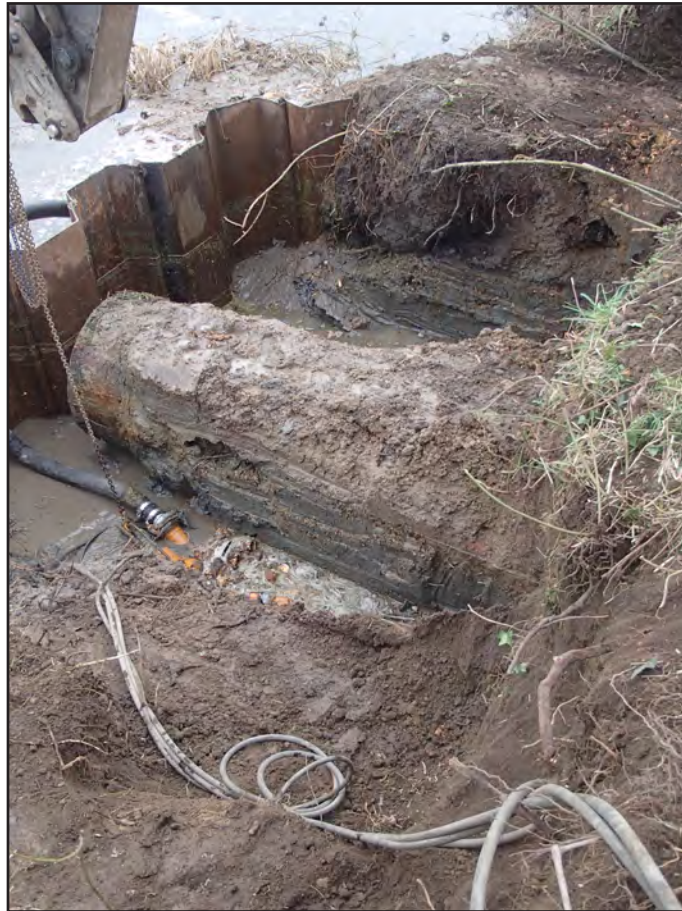
4.2.1 The lowest deposit identified was firm bluish grey clay [007] identified in the lowest exposed levels of groundwork excavation by machine.

4.2.3 Overall, the context had the appearance of anaerobic water deposited silts and could either be the natural Tidal Flat Deposits of clay and silt discussed above (see 1.2.1), or be silts deposited within the canal. The blue grey colour and general sterility suggest a natural origin.

4.5.2 The lowest deposit was the bluish grey clay discussed above (see 4.2) [007]. The culvert outfall pipe was directly surrounded by this deposit suggesting that it was laid directly onto the clay during its original installation.

Blue grey clay (007) underlying culvert outfall pipe.

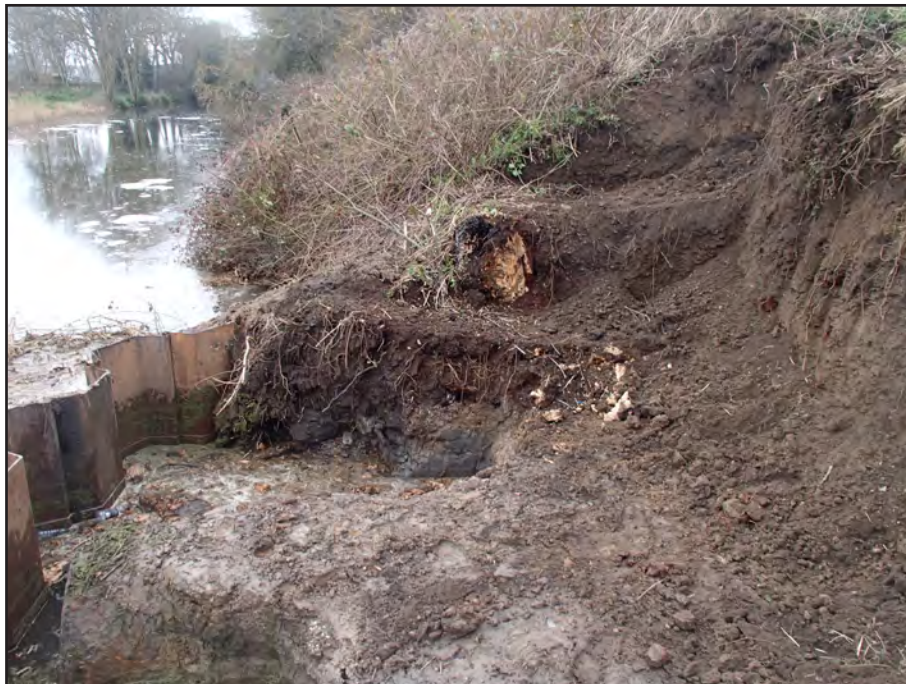
4.5.1 The excavation of the groundworks by machine over the culvert pipe reflected the findings of the trial trenches. Overall the deposits disturbed were the backfill deposits from the construction of the culvert (Figure 5).

4.5.3 Overlying clay [007] was a deposit of mid brown sandy silt with moderate quantities of pebbles which was the same deposit as the lowest identified layer in test pit 2 [006]; this layer was over 2.20m thick at the depth of the culvert pipe.

East facing section of monitored area during excavation.
