**ST. ANTHONY'S HOUSE, 25 BOW ROAD,
LONDON BOROUGH OF TOWER HAMLETS**

HISTORIC BUILDING RECORD

**Site Code: BWR13
Project No. 6019
Report No. 2013066**

March 2013

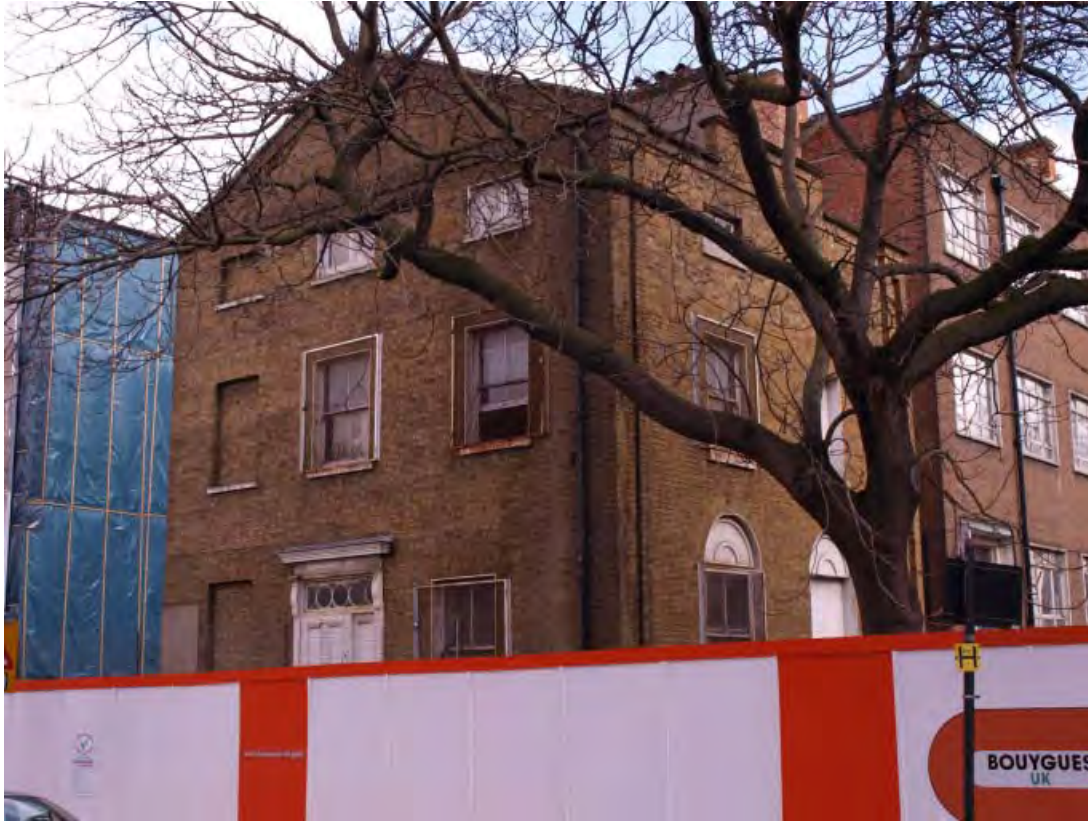
Plate 1 West and south elevations of the building, looking north-east (1)

- 5.1 The building extends south-south-east to north-north-west (hereafter simplified south to north). Located at the junction of two roads, the building presents two key elevations: that to the west which faces onto Coborn Street and which contains the principal entrance to the building; and that to the south, which faces onto Bow Road (Fig. 9; Plate 1).

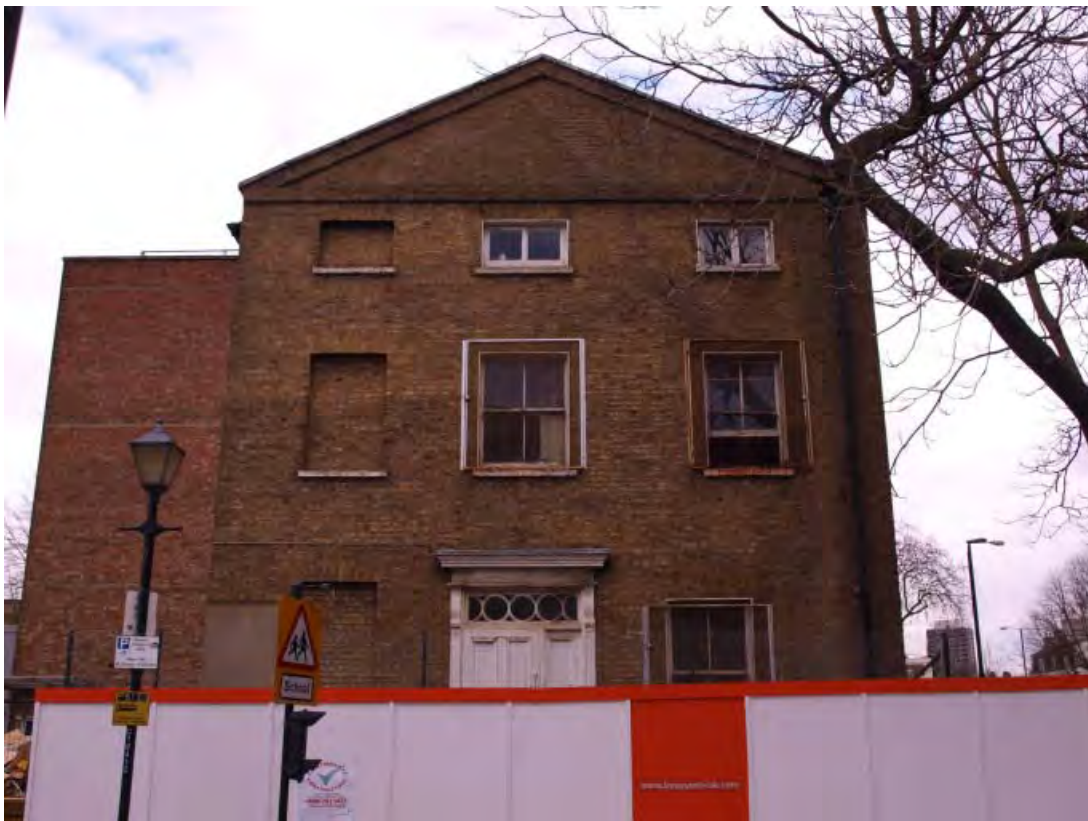
Plate 2 West elevation of the building, looking east (32)

- 5.3 The principal, west elevation comprises a three-window range, with the main entrance and windows above it being located slightly to the north of centre (Fig. 9; Plate 2). The entrance is reached by a flight of stone steps guarded by a modern iron balustrade. It has a wide doorcase with a bracketed shallow hood (apparently a replacement) and a rectangular overlight, with circular pattern to the glazing (Plate 3). The door is of four panels, the lower two being flush and with a reeded moulding; the upper two being recessed and with a more chunky moulding. There is also a reed-moulding to the rail. On the right-hand side of the door is a full-height side panel with the same mouldings. The doorway has a stone threshold, which on the left-hand side retains part of an iron boot scraper.

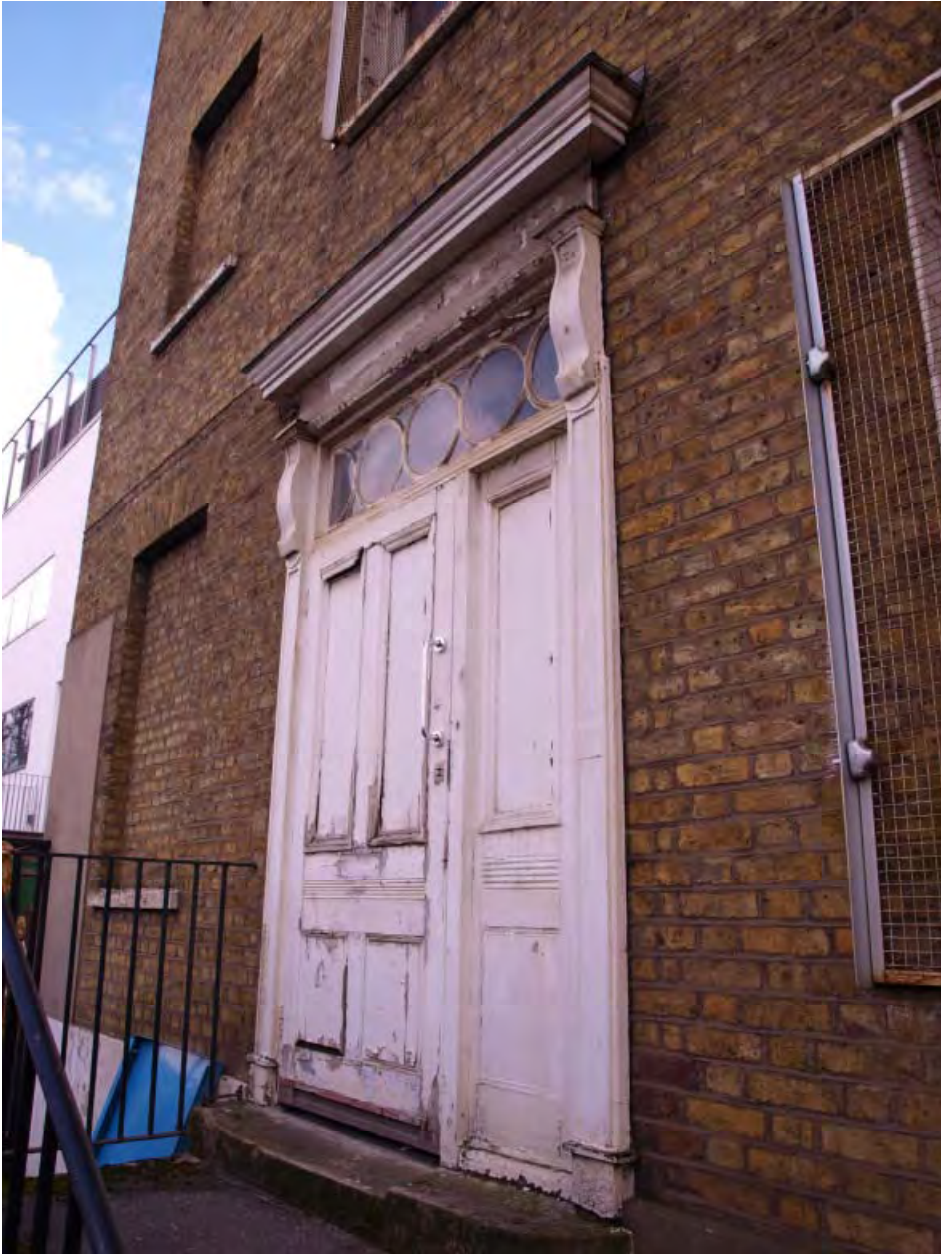
Plate 3 Main entrance, looking north-east (3)

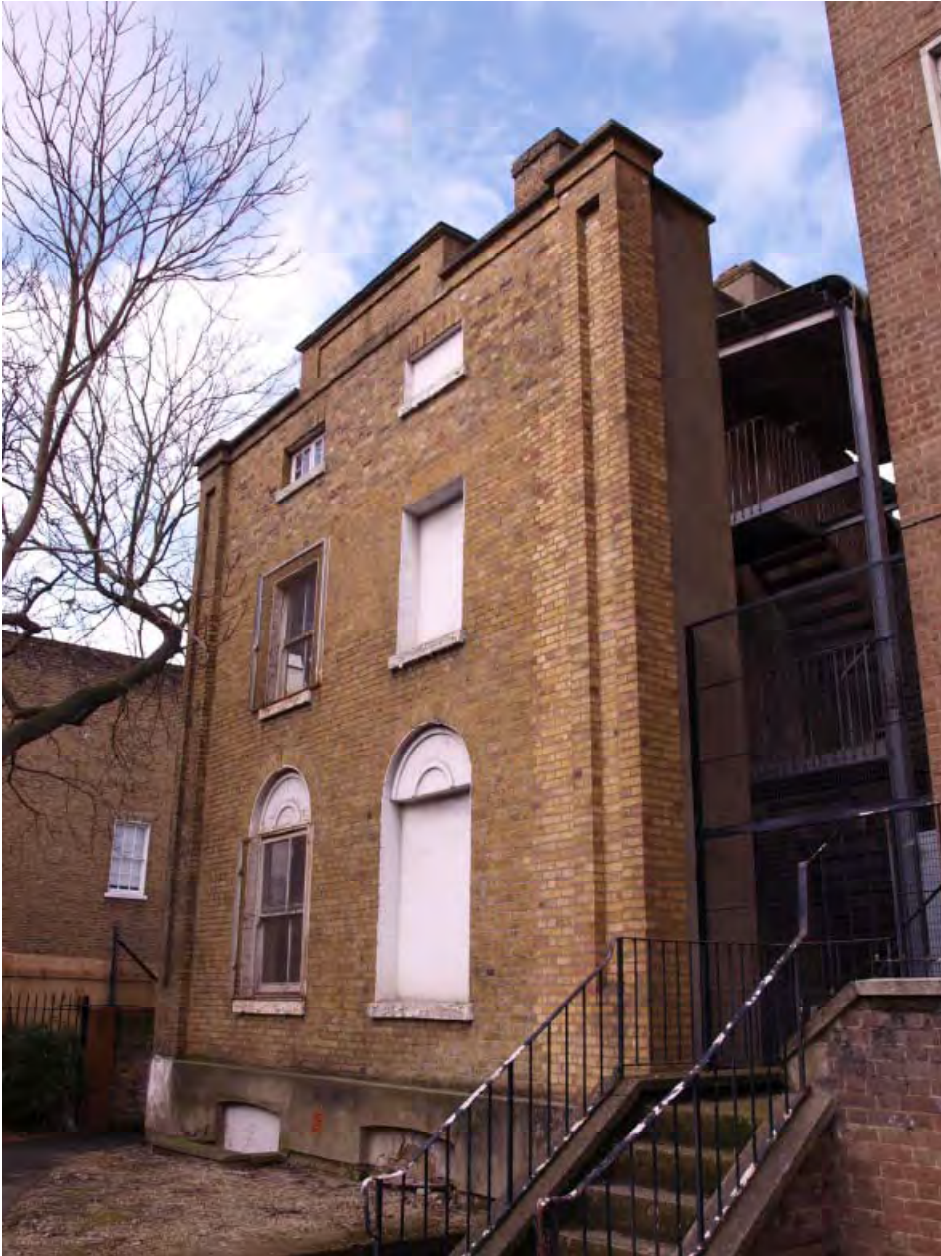
Plate 4 South elevation, looking north-west (4)

- 5.5 The south elevation has the appearance of a two-window range, though this is misleading as the right-hand windows, which are blind, are located on the line of the party wall between No. 25 and its now-demolished neighbour (Fig. 9; Plate 4). The left-hand end of the elevation has a brick pilaster, which is matched at the right-hand end in modern brickwork.

- 5.6 The true basement window has a light-well, though the window itself is now boarded over. On the ground floor the windows are set within round-arches of gauged brickwork, with semi-circular stucco patterns to the tympana. The ground and first floor windows comprise 2/2 pane sashes as those on the west elevation, while the second floor windows contain modern casements. The second floor window heads are formed of flat soldier arches, the brickwork at second floor level having been rebuilt at some point in the 20th century. The wall head forms a simple parapet, with a central rectangular pediment.

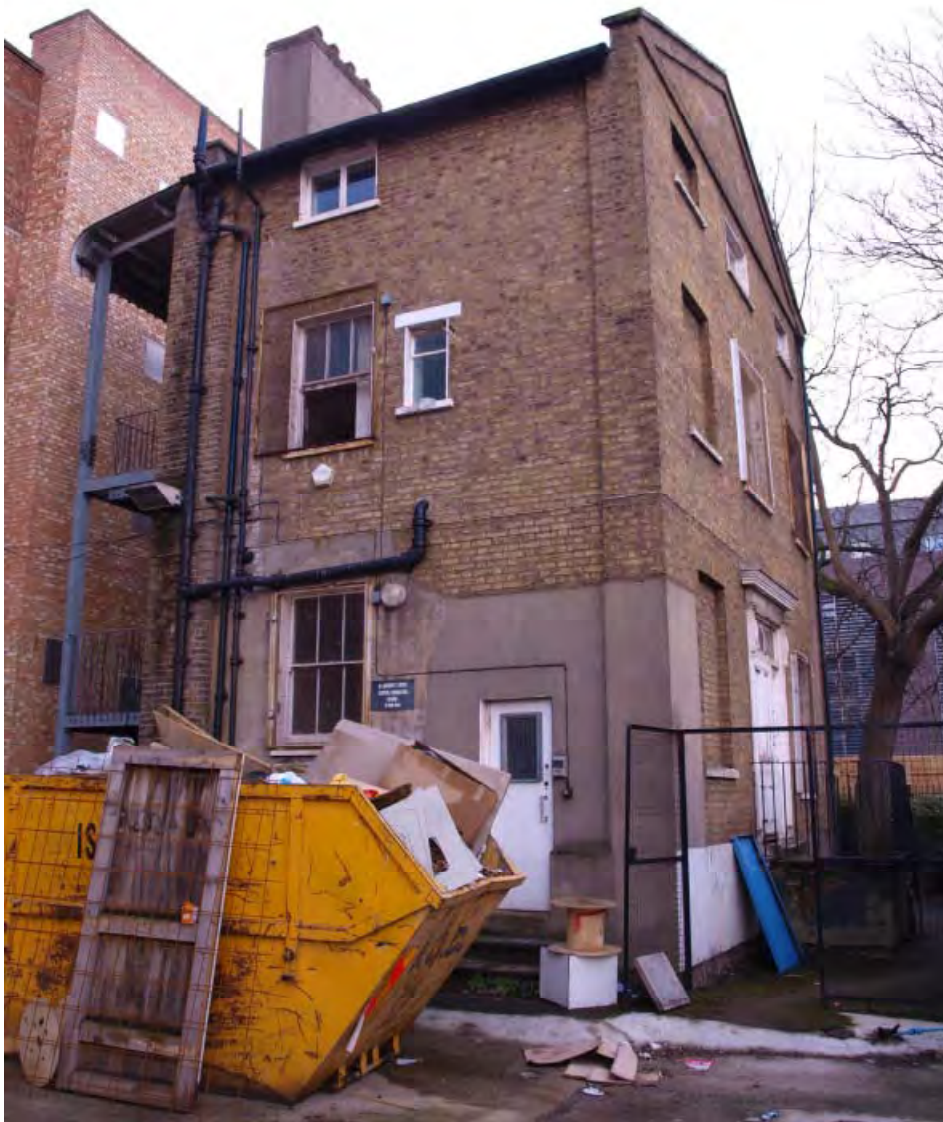
Plate 5 North elevation, looking south-east (2)

- 5.7 The north elevation bears evidence of modification (Plate 5), largely in connection with the former extension recorded on the Ordnance Survey mapping (Figs. 6 & 7). Where it has been removed, the exposed area has been finished with cement render, which now conceals the underlying brickwork. On the right-hand side, at ground floor level, is a rear entrance approached by three modern steps and containing a modern fire door. To the left there is a single original window aperture to each floor: at basement level the window is concealed by boarding; at ground and first floor levels the windows are 20th century 3/3 pane double-hung horned sashes; while at second floor level the window is a modern casement as elsewhere. An additional, small, iron-framed window with top-hung light window has been inserted on the first floor to serve a WC. The eaves over-hang on this side of the building.

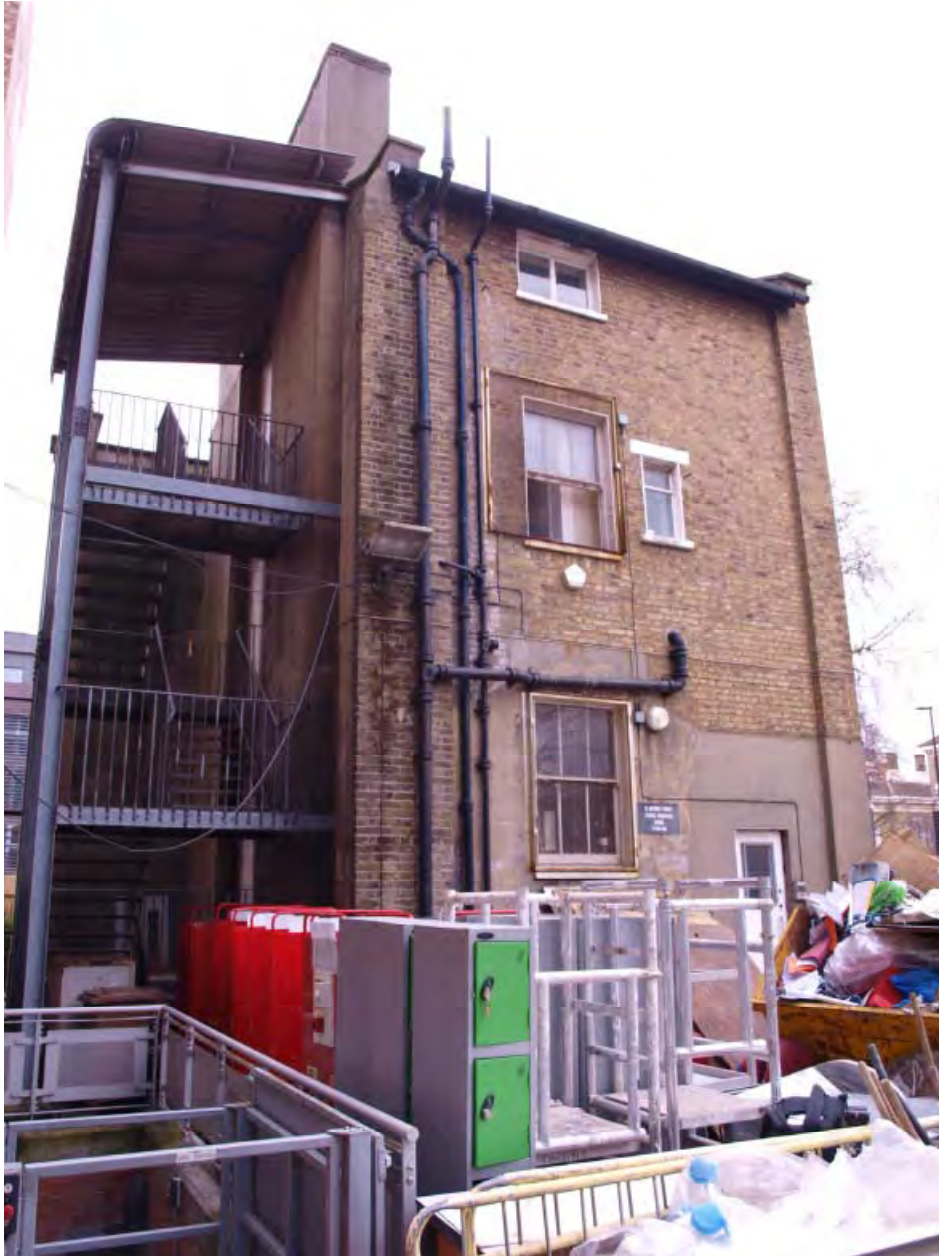
Plate 6 East and north elevations, looking south-west (29)

- 5.8 Following the removal of its neighbour, the east side of the building was rendered. The wall is essentially plain, with the exception of a modern fire escape flanked on either side by a projecting chimney stack (Plate 6).

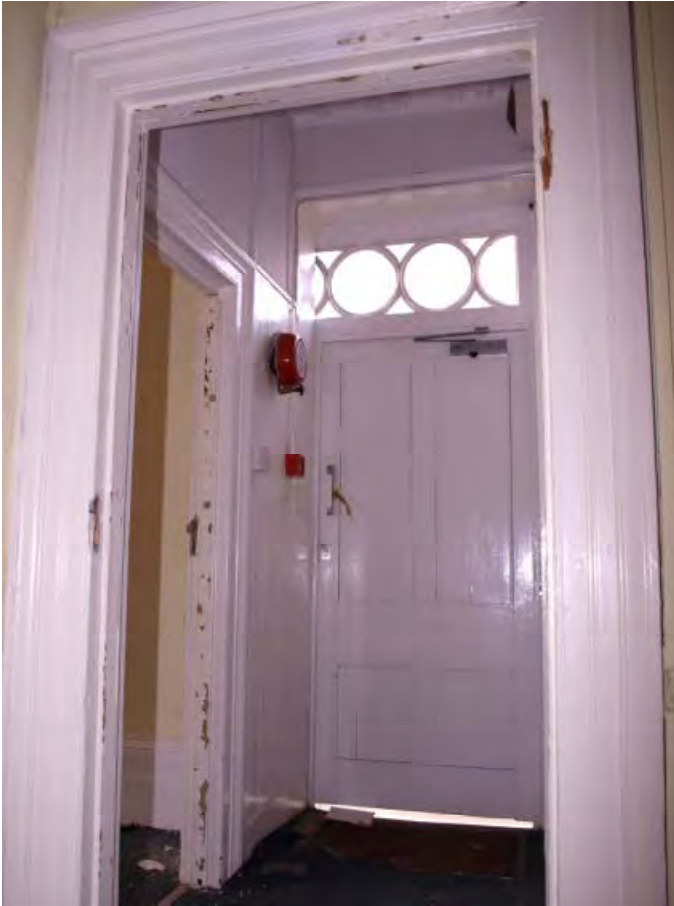
Plate 7 Entrance hall (Room 1) showing partition wall bisecting main entrance, looking west (6)

- 5.11 The hallway (Room 1) is small – the main partition wall which divides the house north and south rather oddly bisecting the entrance between doorway and side-panel (Fig. 8; Plate 7). Within the hallway, the wall is finished with vertical bead-moulded boarding, to the east of which a doorway leads into Room 2. A further door within the east wall leads into Room 3. Both doorways retain their original moulded architraves. The room has a simple moulded skirting, and a 'flat' cornice of paired modillions with inset oval (Plate 8). The cornice is interrupted in the north-west corner by modern partitioning which now encloses the staircase.

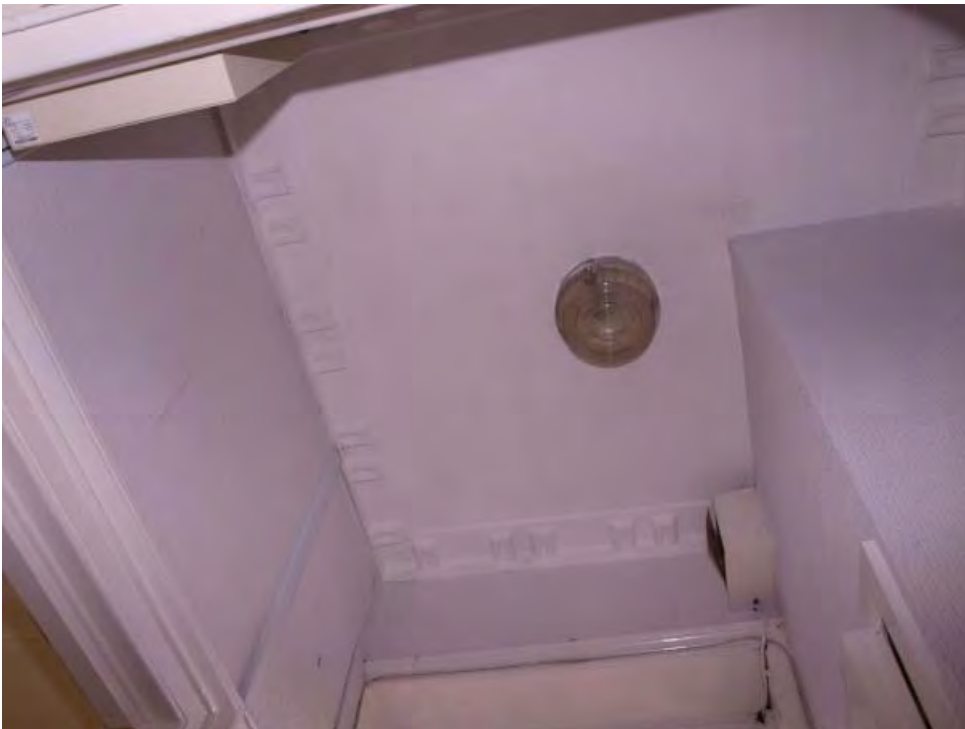
Plate 8 Cornice in Room 1 (7)

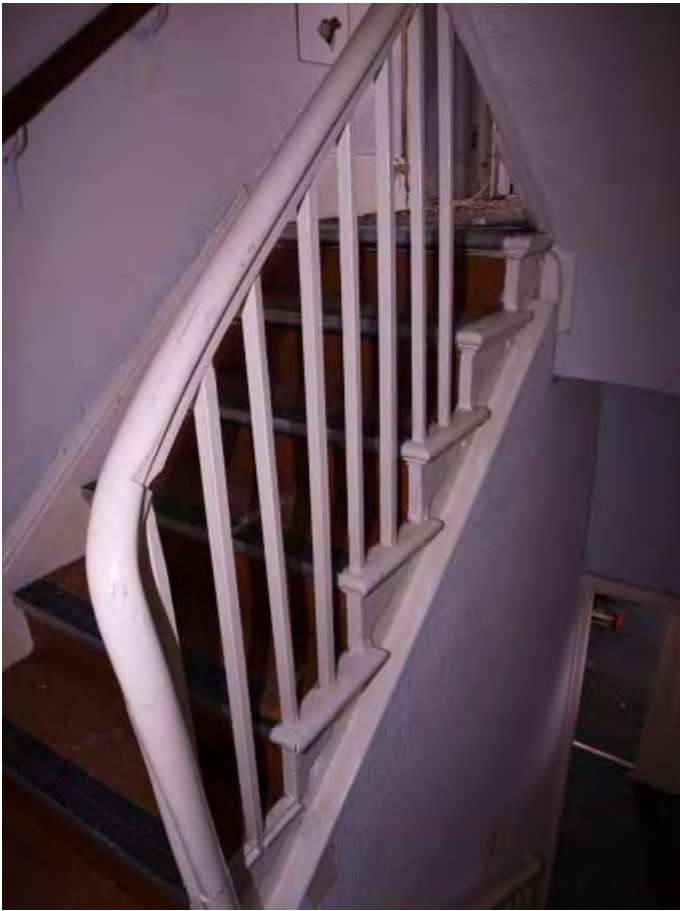
Plate 9 Ground to first floor flight of staircase, looking south-east (16)

- 5.12 The staircase is of dog-leg form with winders. Between ground and first floor level it consists of an open string, with simple bracket decoration to the tread-ends (Plate 9); while the upper flight is a closed string. The balustrade is formed of slender stick balusters, linked by a simple ramped handrail. Two column newel posts are left visible on the upper flight/landing (Plate 10), and there is also a single pendant with roundel decoration. The stair terminates at ground floor level with a curtail step, which protrudes through the modern partition wall.

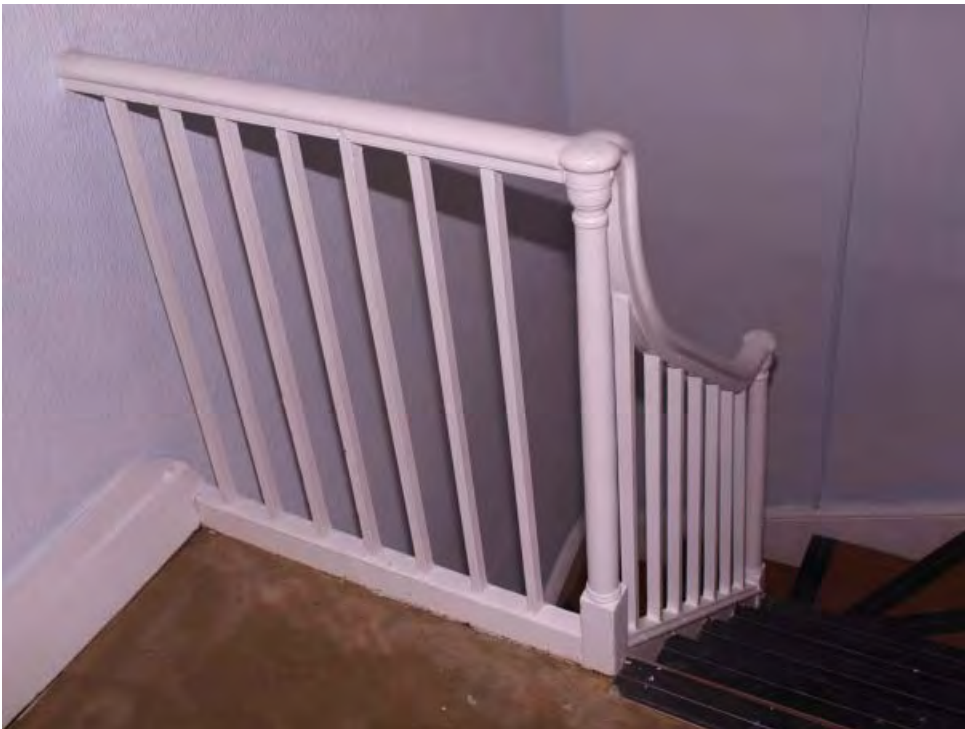
Plate 10 Staircase as seen from second floor landing (Room 7), looking north-west (25)

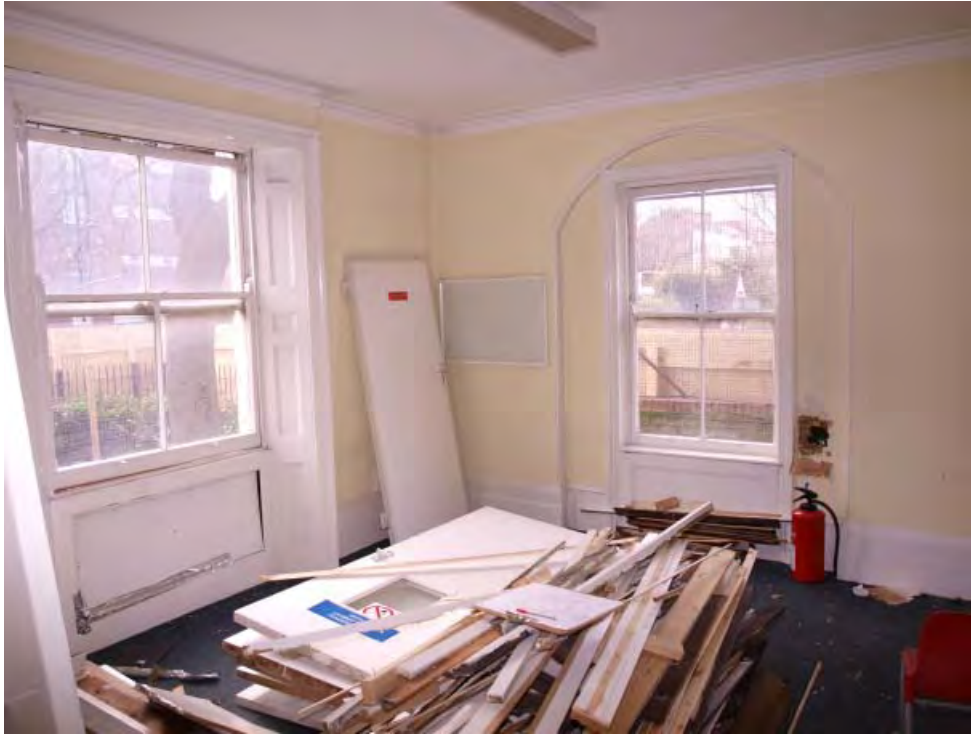
Plate 11 Room 2, looking south-west (8)

- 5.13 Rooms 2 and 3 would have formed the principal reception rooms of the house, and are linked by a double-width doorway with original moulded architrave. Room 2 occupies the southern half of the building and has a 2/2 pane sash window on each the south and west walls (Plate 11). The south window has splayed reveals which house folding shutters with recessed moulded panels. The west window sits within a segmental-arched recess and has vertical sliding shutters contained within a panelled shutter-box below. The east wall has a projecting chimney breast with blocked fireplace. A cupboard has been inserted to the south of the chimney, and to the north there is a doorway to the fire-escape. The room is encircled by a high moulded skirting and a reeded cornice. There is also an ornate ceiling rose.

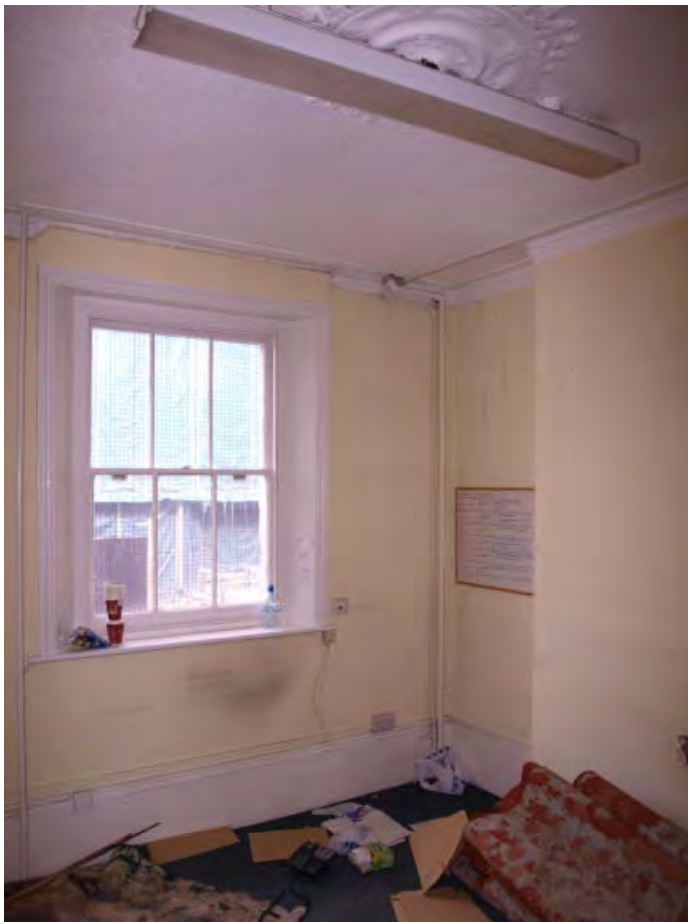
Plate 12 Room 3, looking north-east (12)

- 5.14 Room 3 has a single 3/3 pane sash window on the north wall; it has splayed reveals, but no shutters (Plate 12). A chimney breast with blocked fireplace projects forwards from the east wall. The room has the same high skirting, moulded cornice (Plate 13) and ceiling rose as Room 2.

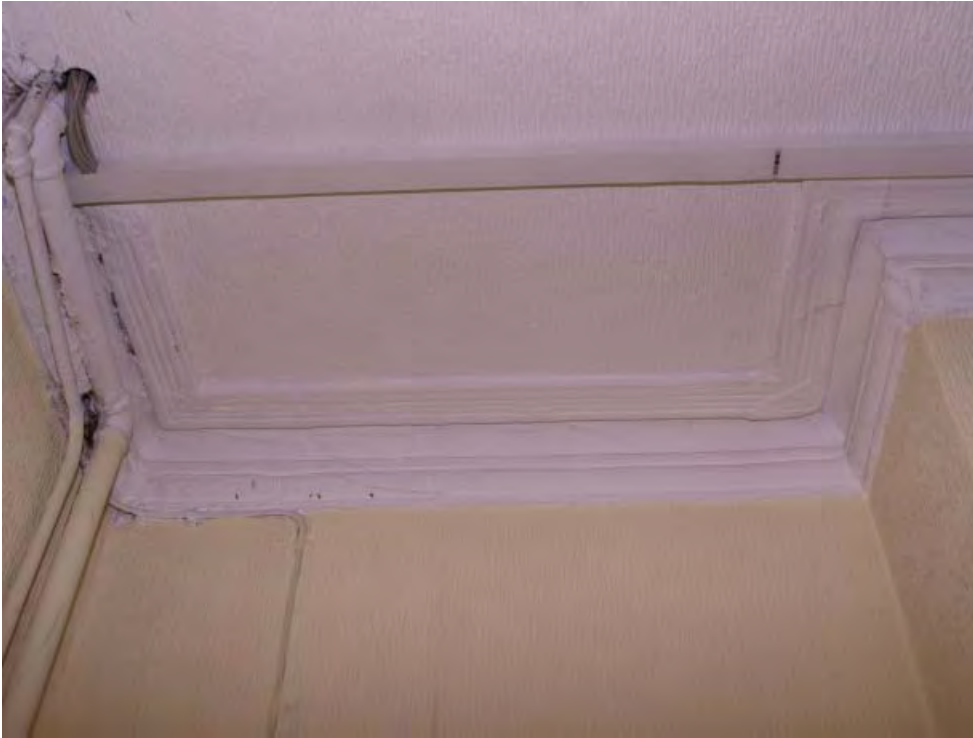
Plate 13 Cornice in Room 3 (14)

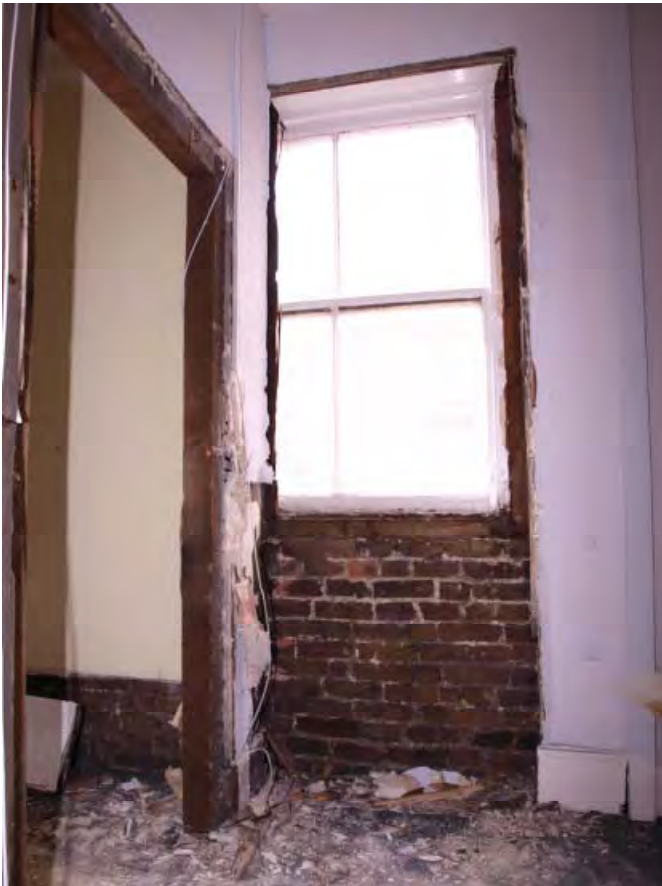
Plate 14 First floor landing (Room 4) showing window bisected by partition wall, looking west (18)

- 5.15 Room 4 comprises the first floor stair landing. Like the entrance hall below, the principal partition wall dividing the north and south rooms rather clumsily bisects the window located on the west wall (Plate 14). Some of the plasterwork has been stripped from the west wall revealing poor quality place bricks, laid haphazardly in a lime mortar. Toothed into this brickwork at irregular intervals is a pilaster buttress formed of similar brickwork, which receives the west end of the partition wall. The landing has a simple moulded skirting as the ground floor hallway and stair, but no cornice. As below, the stair has been enclosed by modern partitioning.

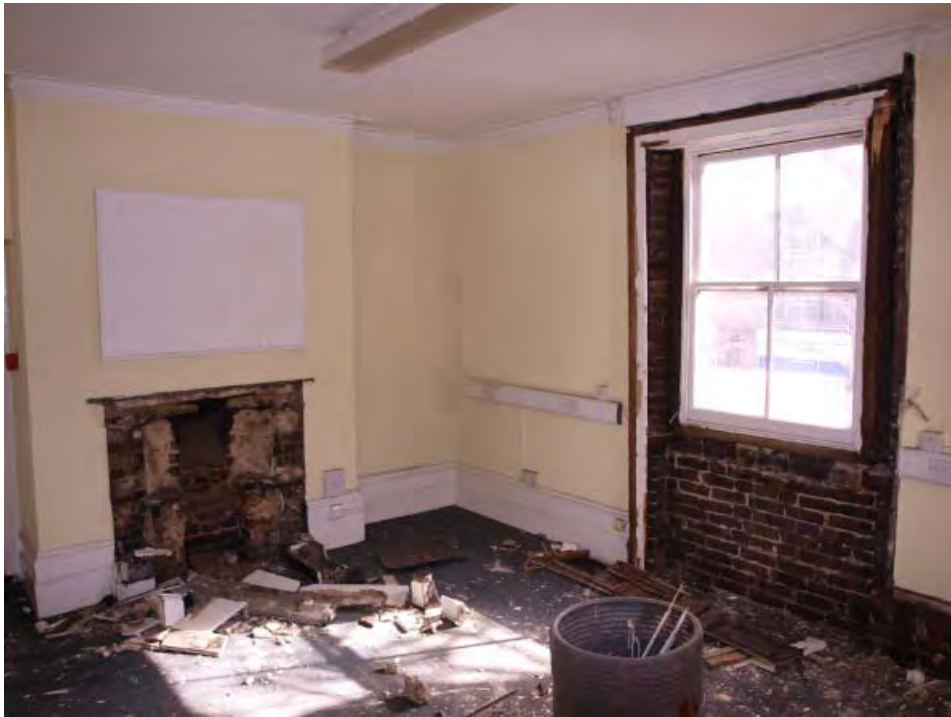
Plate 15 Room 5, looking south-east (21)

- 5.16 Room 5 would have originally formed the principal bedroom. There is a single window opening on the south and west walls; each has slightly splayed reveals and a 2/2 pane sash window, though vertically-sliding shutters have recently been removed (Plate 15). A fireplace is located on the east wall, though its chimney-piece has also been removed. Fragments lying nearby suggest that it was of similar form to that still surviving in Room 6 adjacent (see Section 5.18). A door to the fire-escape is located on the north side of the chimney breast. The north and east walls retain a high moulded skirting, and a moulded cornice as Rooms 2 and 3 below.

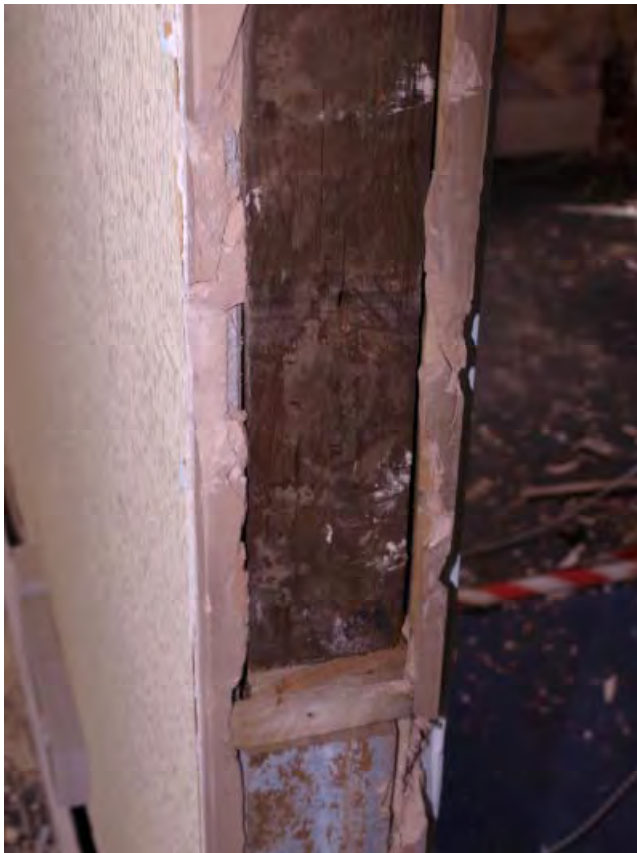
Plate 16 Stud exposed on west side of inserted doorway between Rooms 5 and 6. Shows small section of a Baltic merchant's mark (top) and truncated brace (covered by modern timber) (22)

- 5.17 The north (partition) wall contains the doorway from the landing, plus another doorway which leads directly into Room 6. The composition of the partition wall on the north side of the room has been exposed by the removal of the doorway architraves, plus a few small investigation holes. It is of primary-braced stud construction, in Baltic softwood (a fragment of a Baltic merchant's mark is visible on one of the studs), and has a lath and plaster finish. The doorway from the landing is original and is neatly jointed and pegged; the doorway to Room 6 on the other hand is clearly a later insertion, as it truncates a brace, the ends of which are visible on either side of the doorway (Plate 16).

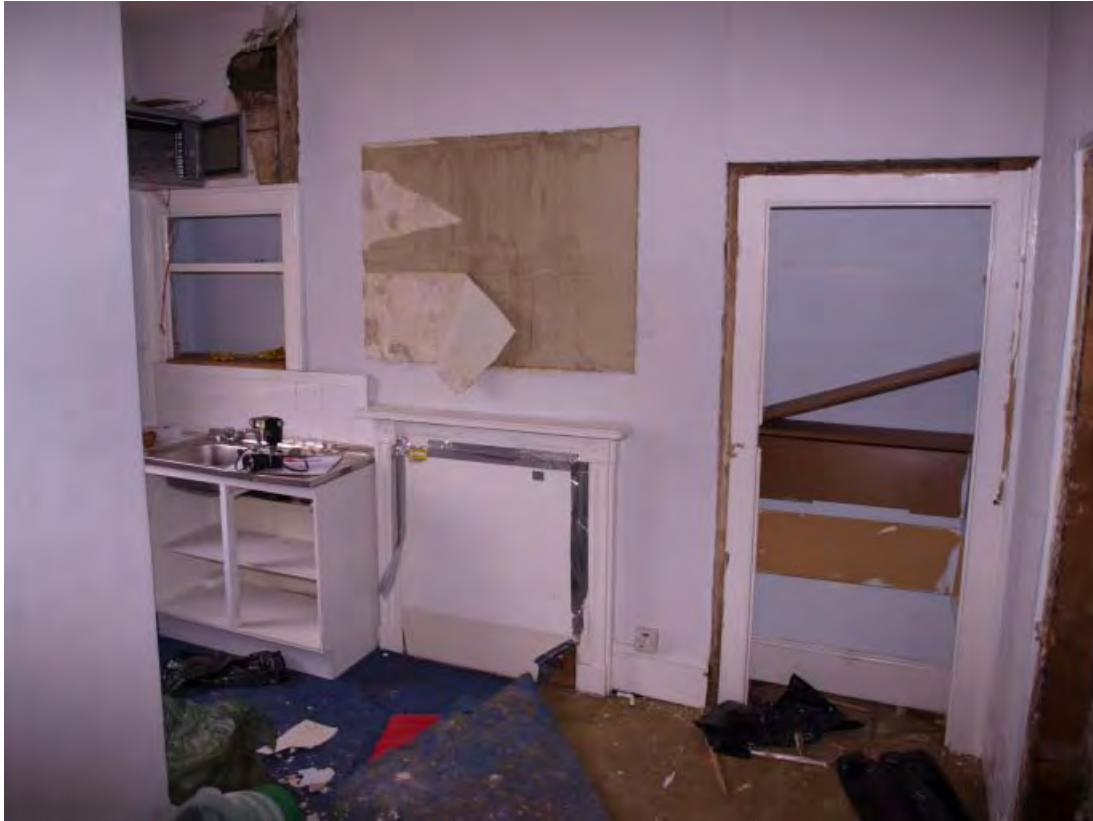
Plate 17 Room 6, looking north-east (24)

- 5.18 Room 6, originally a second bedroom, has latterly been used as a staff kitchen. A WC has been inserted in the north-west corner of the room. The north wall has a 3/3 pane sash window, west of which is a small iron-framed window with wired glass inserted to light the WC. The east wall contains a fireplace with timber chimney-piece: it has a lozenge to the lintel and corner paterae with roundels (Plate 17). There is a cupboard located within the recess on either side of the fireplace. The room has a simple, moulded skirting.

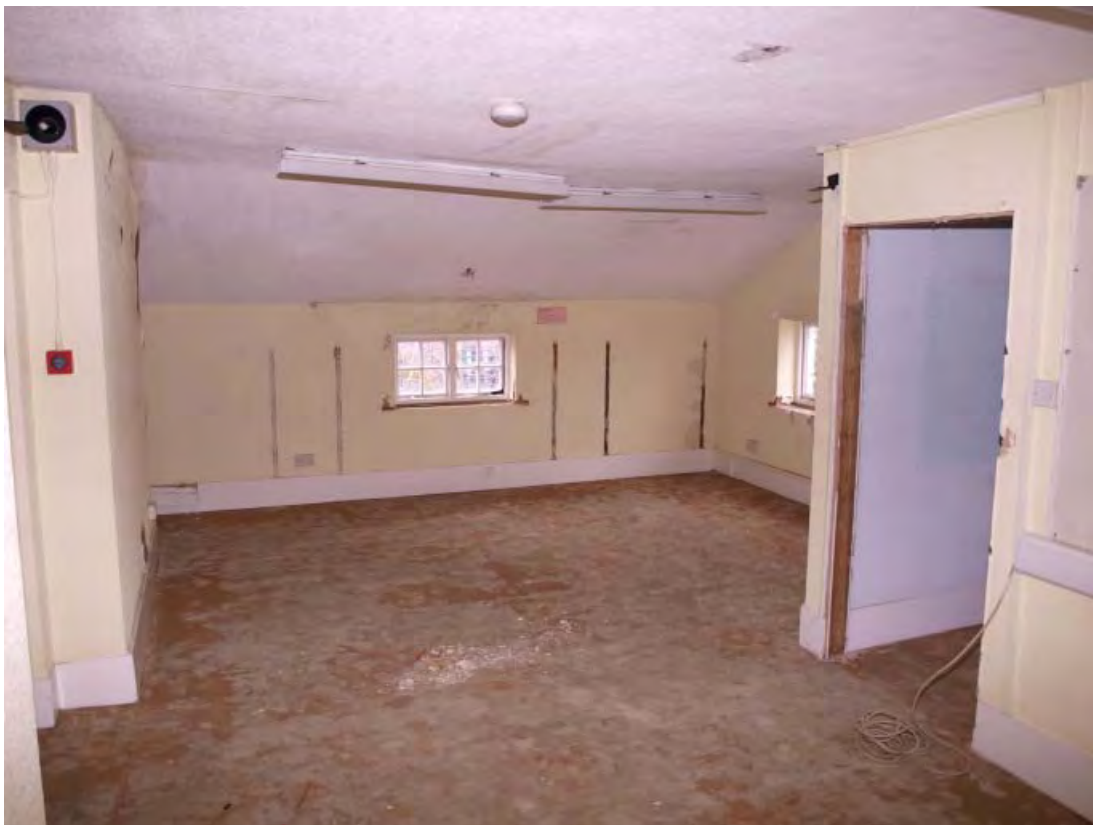
Plate 18 Room 8, looking south-west (27)

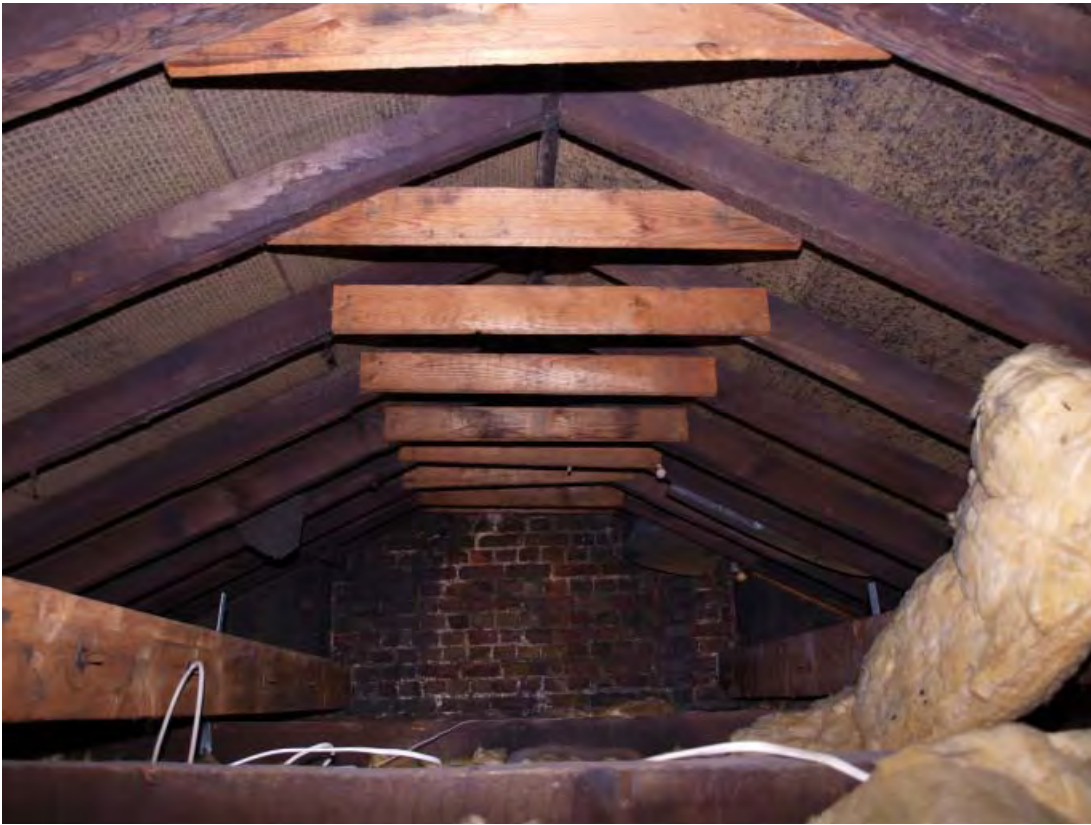
Plate 19 Roof, looking east (28)

5.21 The roof was viewed from the hatch in the ceiling of Room 7. It comprises rafter couples to a ridge board which is interrupted by the principal rafters (Plate 19). Secondary collars have been nailed to each couple, and the slate roof covering and battens have been replaced. The gable end walls are of poor quality place bricks, laid in lime mortar, as observed on the west side of Room 4.

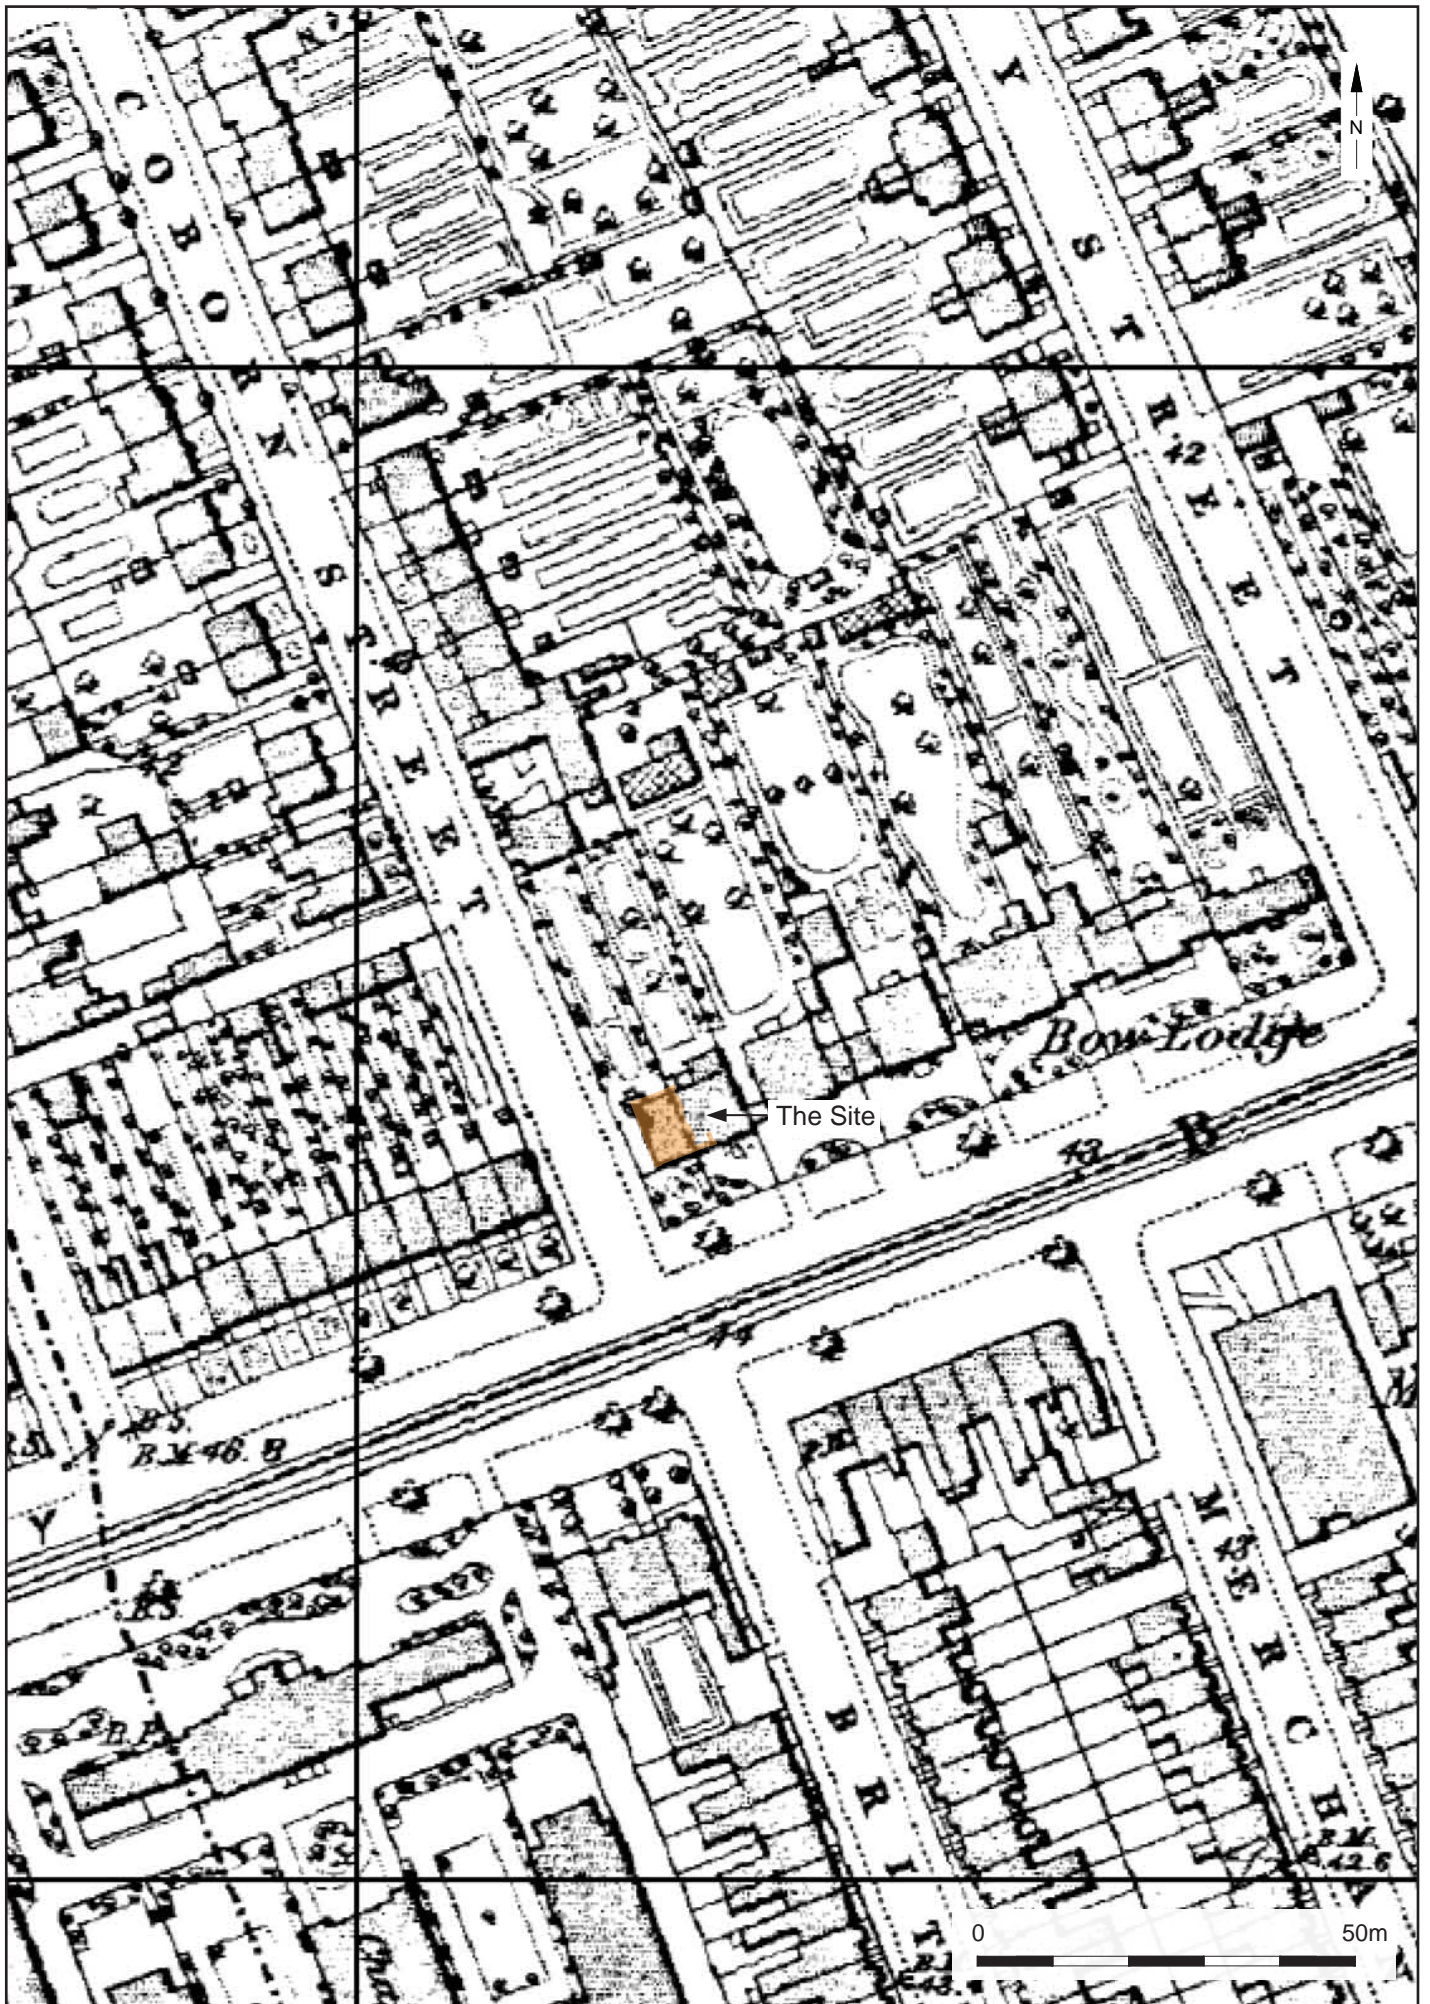
© Archaeology South-East		St Anthony's House, 25 Bow Road, Tower Hamlets	Fig. 5
Project Ref: 6019	March 2013	Ordnance Survey map, 1869-76	
Report Ref: 2013066	Drawn by: GH

- 4.2 By 1869-76 (Fig. 5) Ordnance Survey mapping shows the building to form one of a semi-detached pair of houses (Nos. 25 and 27). The pair are of unequal size, No. 25 forming the smaller of the two. The map shows the building to conform to its present footprint, with the exception of a small projection at the rear in the location of the existing rear doorway. There is a small garden to

6.4 It is known from the Ordnance Survey mapping that the building was extended to the north at some point between 1869-76 and 1896 (Figs. 5 & 6). This addition no longer survives, though the 2/2 pane sashes appear to date from this broad period.
