**ST. ANTHONY'S HOUSE, 25 BOW ROAD,
LONDON BOROUGH OF TOWER HAMLETS**

HISTORIC BUILDING RECORD

**Site Code: BWR13
Project No. 6019
Report No. 2013066**

March 2013

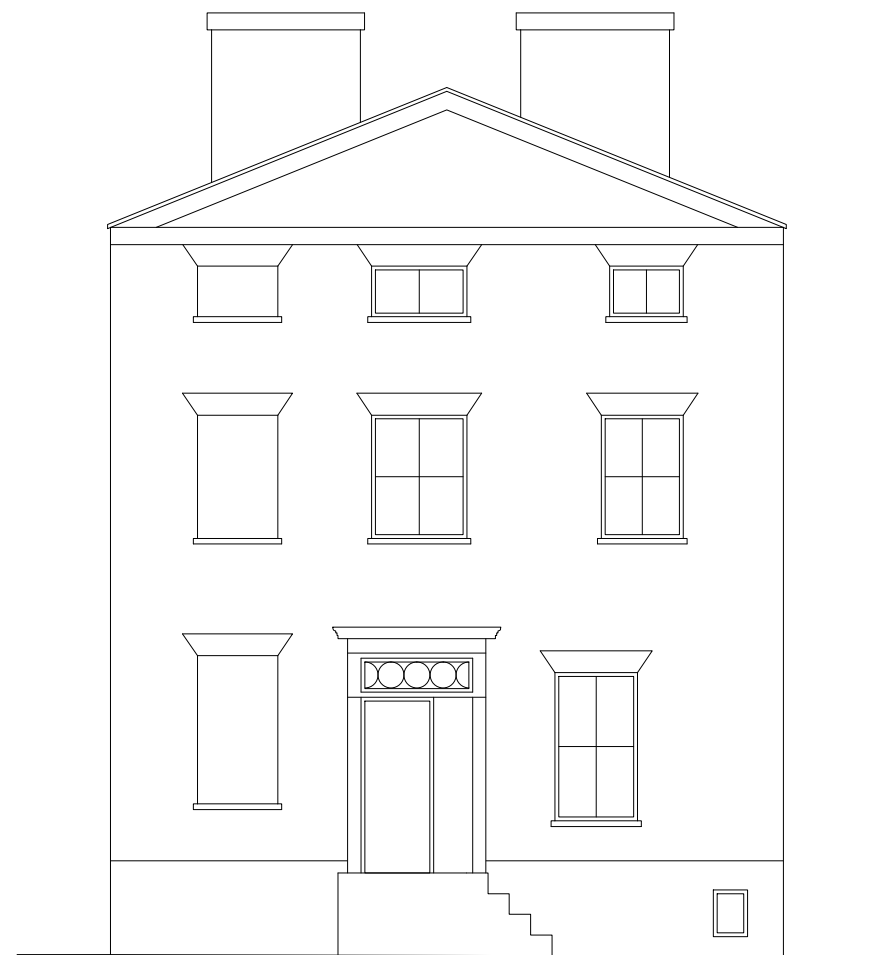
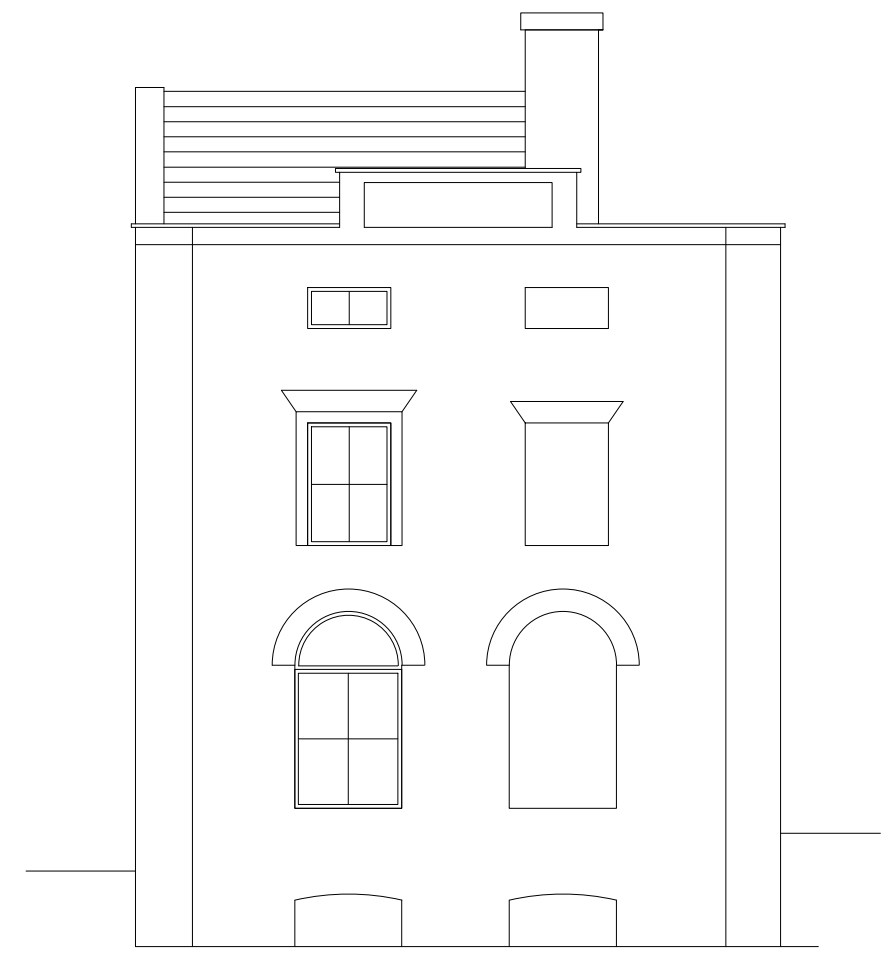
WEST ELEVATION

NORTH ELEVATION

SOUTH ELEVATION
