**An Archaeological Evaluation  
at Holyport School, Berkshire.**

**ASE Project No:6014  
Site Code: HMS13**

**ASE Report No: 2013075  
OASIS id: archaeol6-146827**

**March 2013**

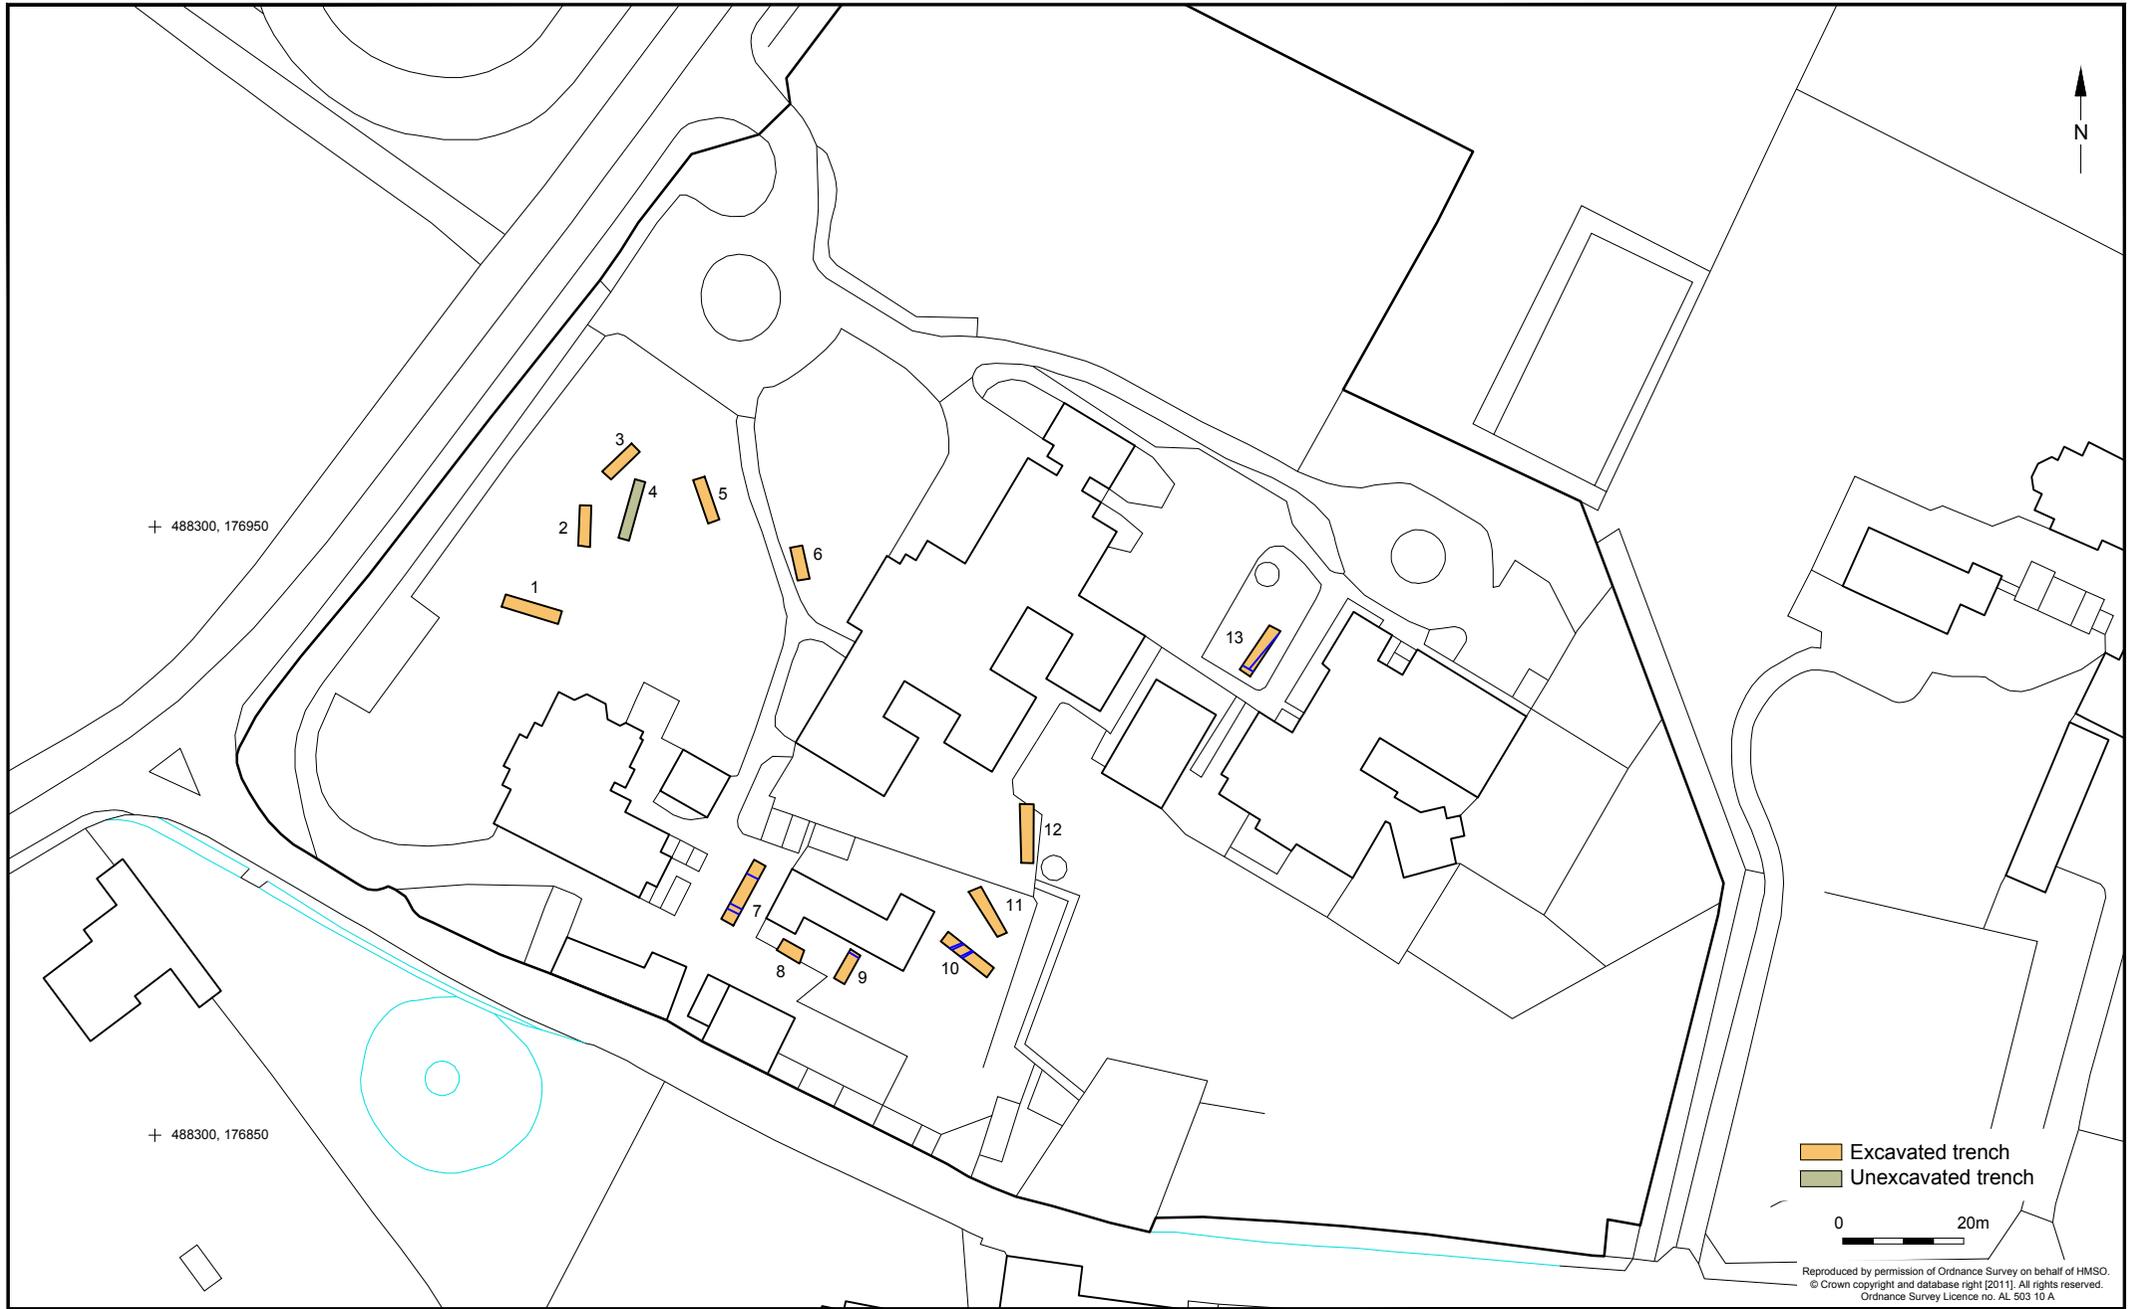
© Archaeology South-East		Holyport Manor School, Maidenhead	Fig. 2
Project Ref: 6014	March 2013	Trench location	
Report Ref: 2013075	Drawn by: JLR

## 4.0 RESULTS (Figure 2)

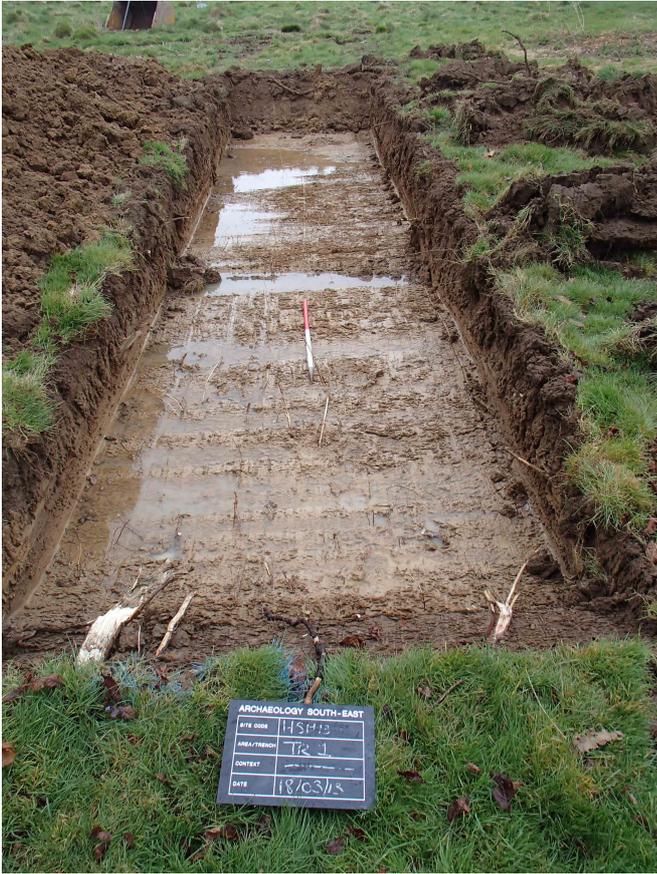
4.1.1 Trench 1 was located to the north of the Victorian House and was orientated approximately east west. The natural [1/003] was a sticky yellow-orange occasionally sandy silt clay and was reached at 29.08m AOD. This was overlain by a light to mid orange brown silt clay subsoil [1/002], which in turn was overlain by the topsoil [1/001]. No archaeological features were recorded in this trench (Figure 3). The water table was reached at c.10cm above the natural.

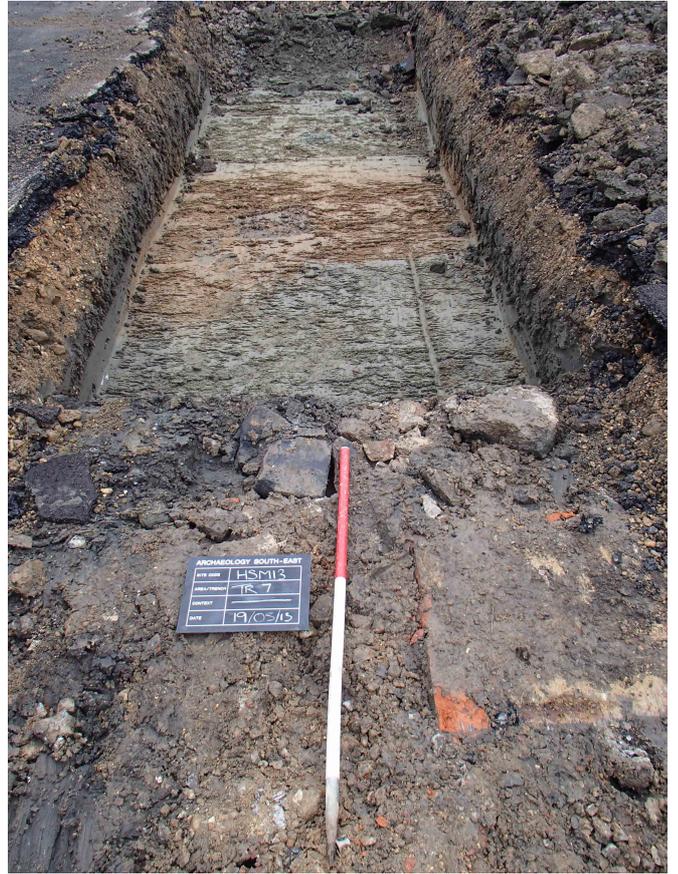
4.7.1 Trench 7 was located within the footprint of Building 2 and was orientated north east to south west. This trench was shifted slightly west due to the presence of overhead cables and shortened due to a service at the north eastern end. The natural [7/003] comprised a orange yellow silt clay with green-blue bands of clay and was reached at 29.20m AOD. This was overlain by a dark grey brown clay [7/005] from which several sherds of willow pattern

pottery and a small ceramic jar were recovered. This was then overlain by the hardcore [7/002] and tarmac [7/001]. The trench contained a modern concrete post [7/004] but no archaeological features were observed in this trench (Figure 3).

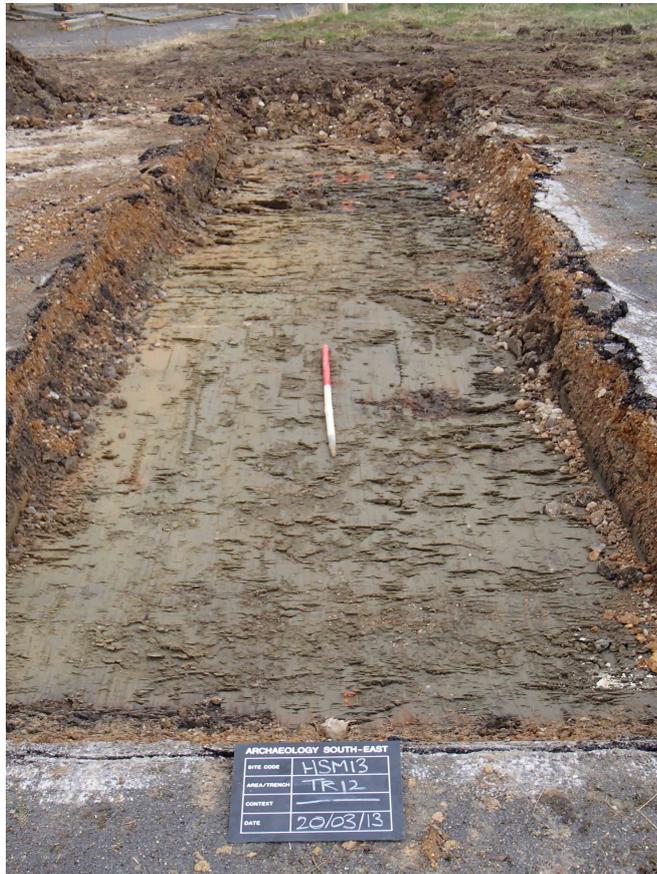
4.12.1 Trench 12 was located on the north side of the garden wall and was orientated north south. The natural [12/003] was reached at 29.13m AOD and was a stiffer clay than that recorded in other trenches with bands of green-blue clay similar to that seen in Trench 7. This was overlain by a levelling layer [12/002] comprising crushed brick and the tarmac of the playground [12/001]. No archaeological features were recorded in this trench (Figure 3).
