**An Archaeological Watching Brief Report:
All Saints Parish Church, Kingston-Upon-Thames, Surrey**

**Project No: 5727
Site Code: AAS 10
Report No: 2013080
OASIS ID: archaeol6-147724**

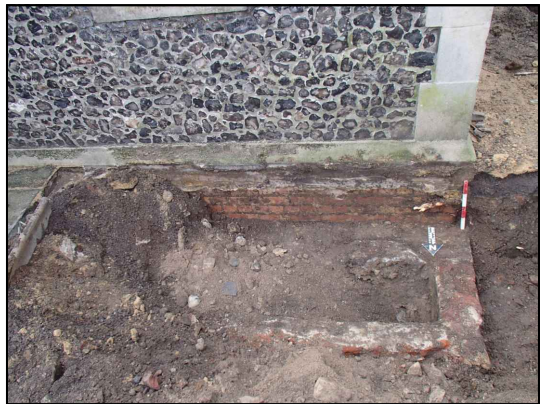
Tomb 103

Tomb [103] (fig. 5), measuring 2.50m east-west and 0.80m wide (as revealed), was reduced to a depth of 0.5m and no coffin or human remains were found within. The location of this tomb meant that it would have been truncated during the extension of the choir vestry in the 1920's and the presence of concrete [105] along the foundations supports this. In light of this truncation and the absence of a coffin within this tomb, it is likely that the contents of the tomb were reburied elsewhere during groundwork associated with the extension.

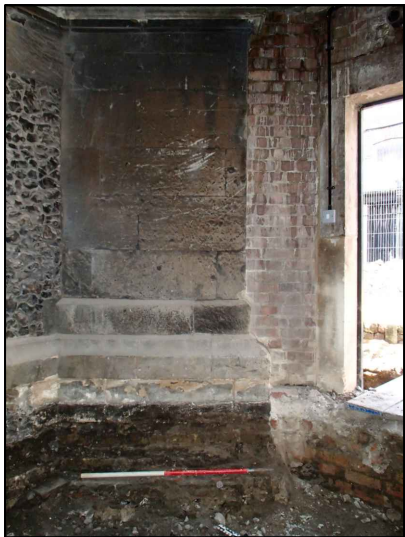
Chimney in vestry room

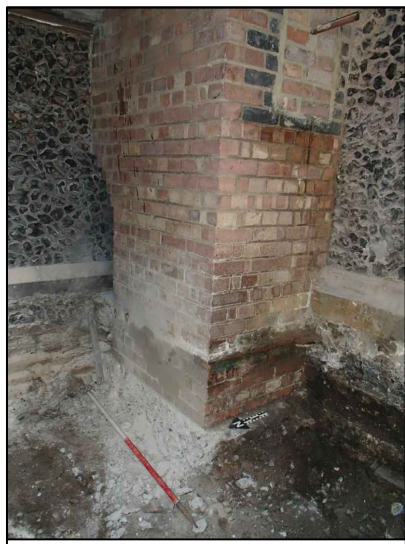
Original buttress in vestry room

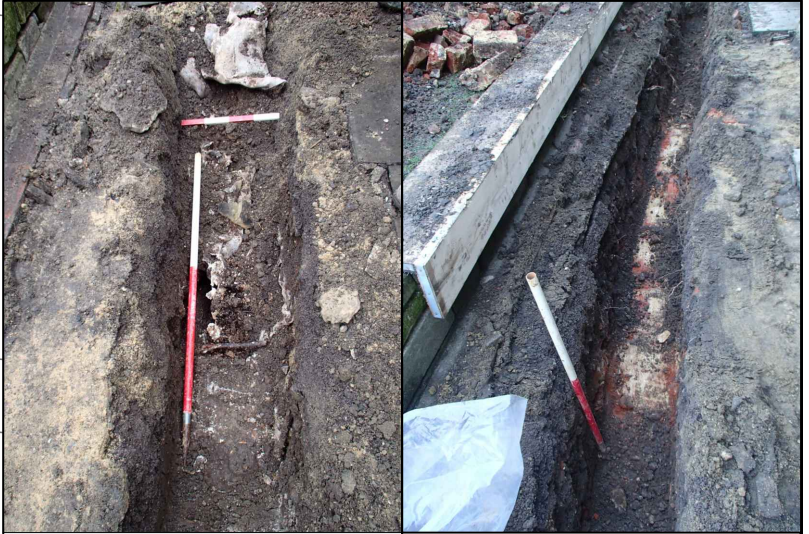
© Archaeology South-East		All Saints Church, Kingston-Upon-Thames	Fig. 6
Project Ref: 5727	December 2014	Service trench excavation north of Church and north-west porch	
Report Ref: 2013080	Drawn by: RHC

The remains of a previously disturbed lead coffin [107] were also found within the service trench to the north of the choir vestry at a depth of only 0.30m below ground level. The grave cut was not visible around this coffin, but it was recorded as [106]. The absence of a clear grave cut is not unusual in cemetery soil due to the mixed nature and level of intercutting in burial activity; however, the absence of a cut here, the level of disturbance and the shallow nature of burial, all suggest that this coffin was placed/relocated here during a previous phase of groundwork. The coffin was crumpled and had separated into pieces. The basic onsite assessment during lifting indicated that the skeleton [108] was adult and was probably that of a female individual. No coffin/name plate was recovered.

Disturbed burial 106 - 109

Tomb 110

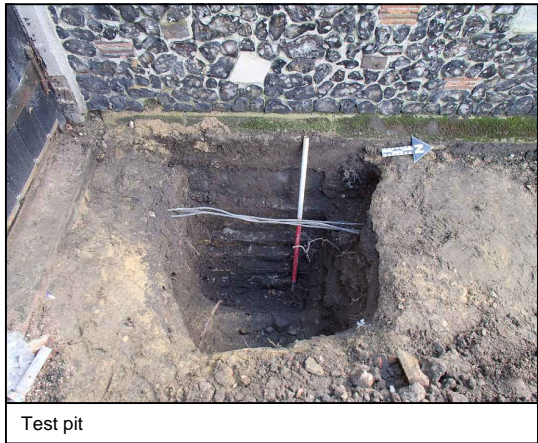
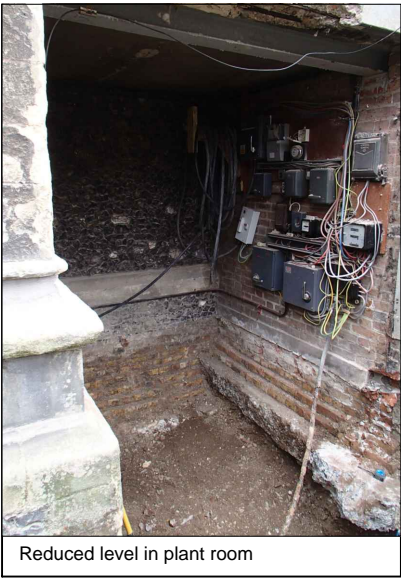
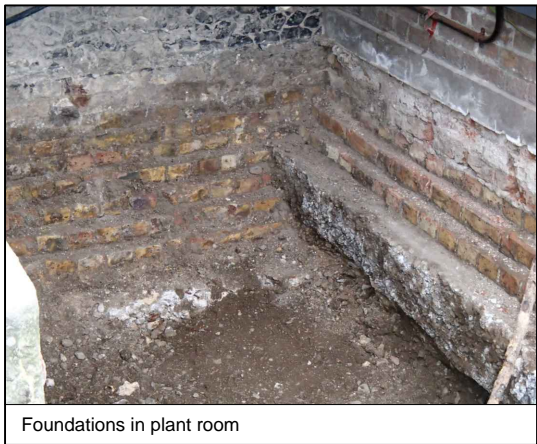
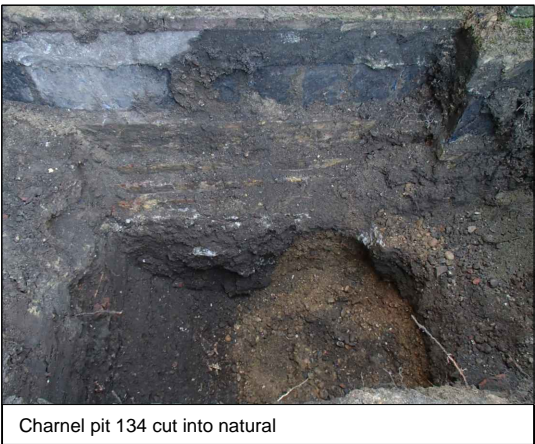
© Archaeology South-East		All Saints Church, Kingston-Upon-Thames		Fig. 7
Project Ref: 5727	December 2014	The plant room excavations		
Report Ref: 2013080	Drawn by: RHC

The foundations of the nave and choir vestry walls were revealed at c.8.14mOD during these excavations and consisted of three stepped courses

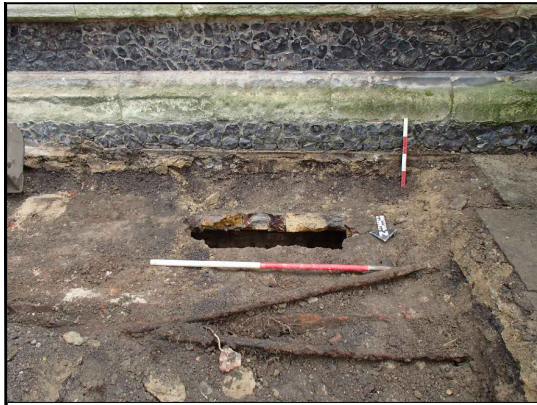
A red brick tomb [118] (fig. 8) bonded with yellow sandy mortar, measuring 2.50m east-west and 1.00m wide, was found adjacent to the north transept wall at a depth of 8.01mOD. Following the discovery of the lead coffin [119] within the top of this tomb, specialist consultants RBE were contacted in order to assist with the lifting and reburial of the coffin and any further coffins that were potentially buried beneath it. Prior to their arrival, the cemetery soil around the tomb was removed to the base of the tomb (1.75m deep and 2m below ground level) and a small test hole was excavated in the side of the tomb to try to ascertain whether further lead coffins were anticipated. The test-hole revealed frequent disarticulated human bones and other possible lead coffins. Further excavation upon the arrival of RBE concluded that the tomb contained four lead coffins [119, 141, 142 and 143] (from top to bottom) which had clearly been relocated at some point, because they were placed randomly (e.g. coffin [119] was placed with the head at the eastern end of the tomb, which is very unusual in Christian burial grounds) and the dates did not make stratigraphic sense. All of the coffins were intact and were lifted by RBE for reburial in the reburial pit. Three of the coffins had partially legible name plates, which suggested that they were all from the same family (the Penfolds). They read as follows:

Tomb 118

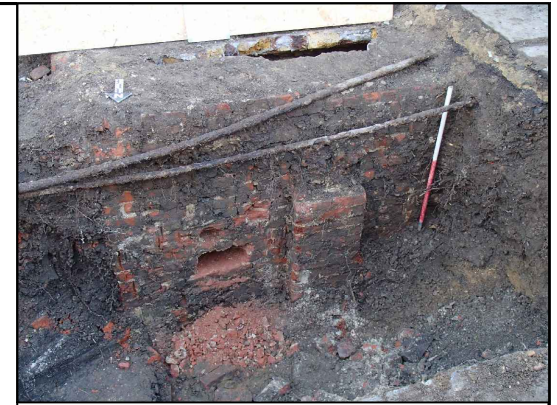
Tomb 118 revealed to required reduced depth

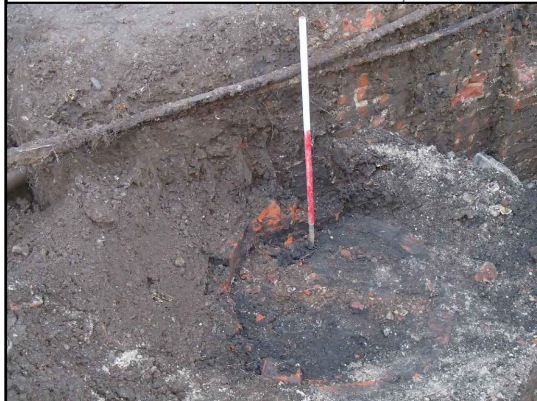
A circular red brick-lined feature [130], measuring c.1.10m in diameter with a depth of more than 2.00m, was found during the excavations for the north-east porch extension at a depth of 8.00mOD. Given its presence within a cemetery, it is unlikely to represent a well; it seems far more probable that it functioned as some kind of soakaway. The feature was revealed 0.20m below ground level, but was heavily disturbed with loose bricks which meant that it was not very clear until a depth of about 1.40m where the cut [129] was seen through the natural substrate [128]. The lower fill observed within this feature was dark grey brown clayey silt [131] which was at least 1.50m thick. This was overlain by an upper loose, light yellowish brown mixed silt/mortar/sand fill [132] (0.50m thick) containing frequent loose bricks. The feature is located very close to the north-eastern corner of a tomb, but the relationship between these features was not clear due to the obscurity of their construction cuts.

Circular structure/well 130 and tomb 118

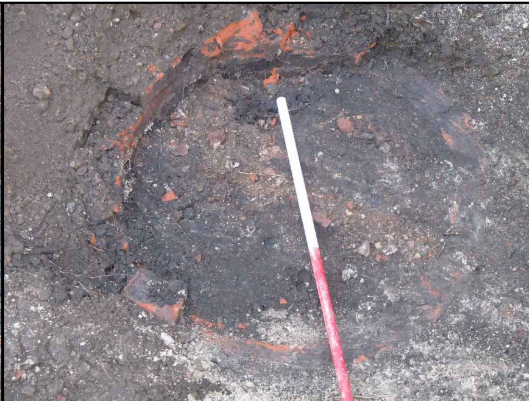
Circular structure/well 130

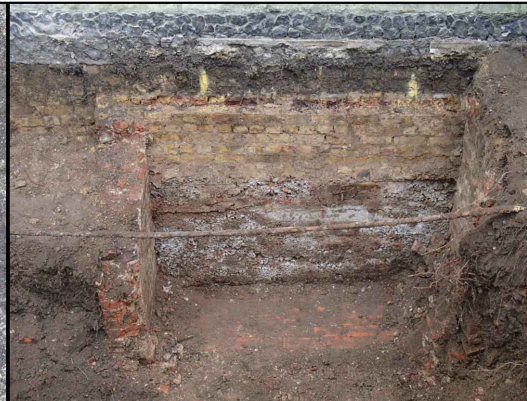
The foundations of the north transept wall were revealed (7.26mOD) during these excavations as a 1.00m deep footing consisting of courses of yellow bricks [146] over a concrete rubble ledge [147]. The overlying superstructure is flint-faced, although the materials within the core of the wall were found to include frogged-bricks and reused stone.

Tomb 118 and foundations 144-147

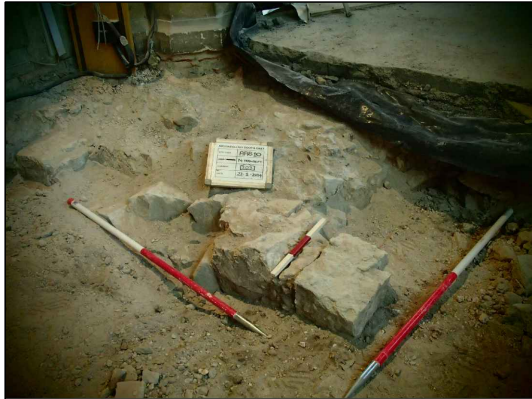
Foundation [203]

Two stone foundations [202 and 203] were revealed on a rough north to south orientation beneath the extant columns, between the north aisle and the north transept, at approximately 7.89mOD and 7.79mOD respectively (fig. 11). These foundations had incorporated reused lime-washed dressed sandstone blocks (one of which had a mason's mark and probably derived from a sill). A sample of re-used 16th to 17th century tile was recovered from

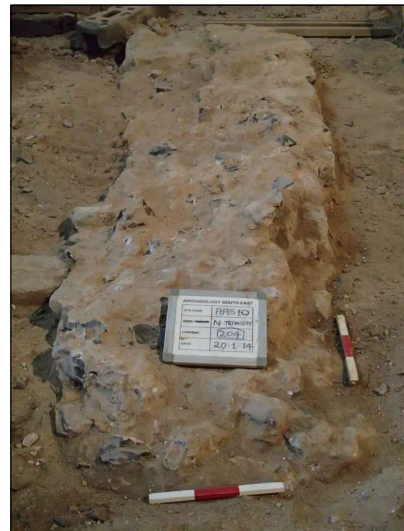
Foundation [204]

A roughly-hewn limestone and flint wall foundation [204] orientated east to west (measuring 3m x 1.05m) was identified during the ground reduction in this area (fig. 11) at a depth of approximately 7.64mOD. Only a small segment has survived due to truncation by tomb [207/208] in the south-west corner and by a modern foundation trench [210] at the eastern end. Due to the height of this structure it was necessary to reduce it slightly under the supervision of a monitoring archaeologist. A test-hole beneath the floor of the chapel of the Holy Trinity indicated that this wall originally extended to the east before it was truncated for redevelopments to the church (e.g. the construction of the concrete foundation [211] under the arch between the north transept and the chapel), probably in the 1970's.

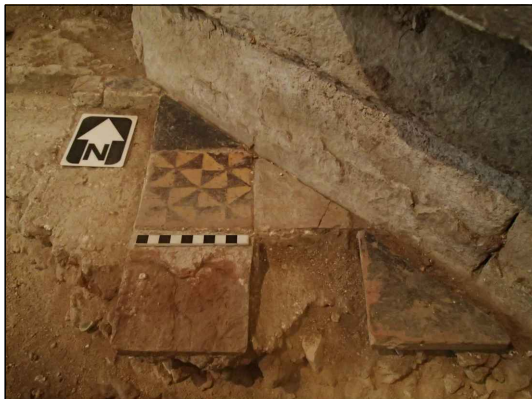
Tile floor [222]

The earliest context in this area was a flint and mortar foundation located beneath the base of the north-east pier [237] at approximately 7.96mOD. This measured approximately 0.40m by 0.50m and at least 0.40m deep. Partially overlying this was a layer of mid brown silt [236], beneath made ground [235]. These formed the foundation layers for a tile floor [222], which was located at approximately 8.02mOD. The tiles from [222] have been dated to the 13th to 14th century (fig. 11).

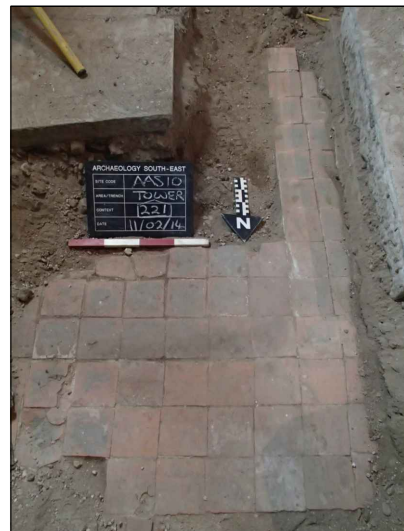
Tile floor [221]

Another area of floor [221] was recorded to the south at 8.00mOD. The floor had clearly been disturbed, with some loose tiles observed within made ground. The tiles have been dated to the 16th to 17th century (fig.11). Floor [221] had been truncated by tomb [225].

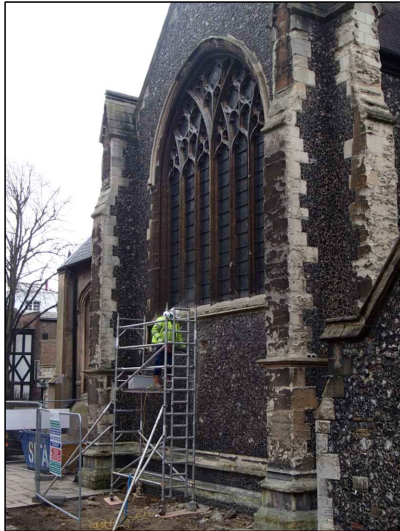
A test-hole, measuring 0.40x0.20m, was cut into the northern wall of the North Transept. A brick with a frogged imprint and a reused stone were found within the core [114] of the wall during the excavation of this test hole (fig. 12). This suggests that this part of the building is a later addition to the main structure, probably dating to the second half of the nineteenth century when the North Transept was supposedly extended.

North transept - test hole in wall

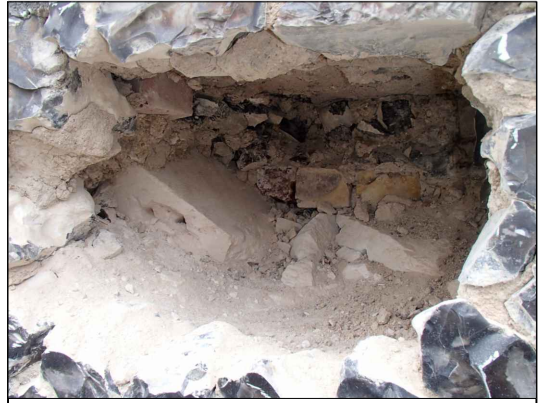
Close-up of test hole in northern transept wall

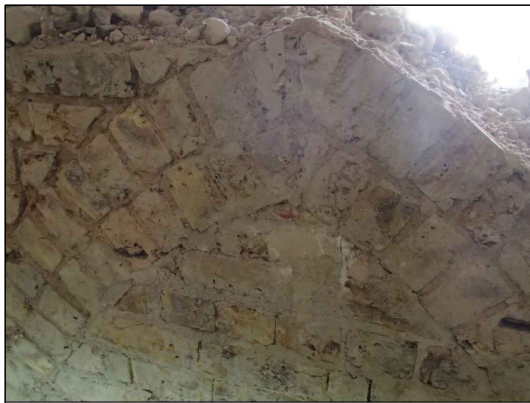
An in-filled door head/lintel was located during the modifications to the north transept wall for the new north-east porch. Based on a watercolour illustration of the church in 1787 showing this doorway, it is thought that this feature dates to the 18th century.

Brick arch door head (from internal wall face looking north)

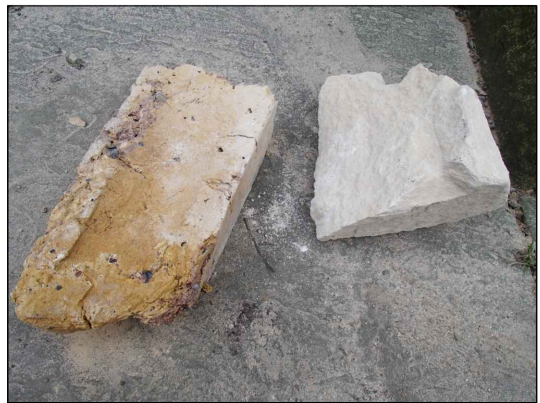
Brick and reused stone in core of northern transept wall

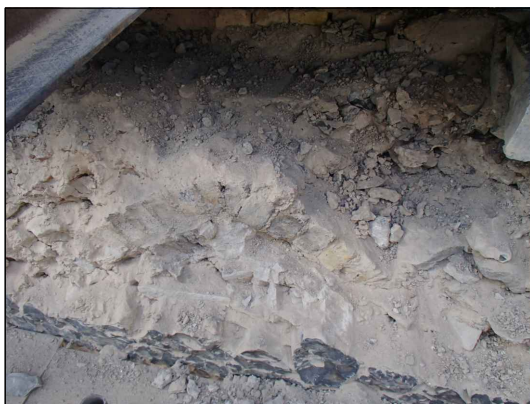
Brick arch door head (from external wall face looking south)

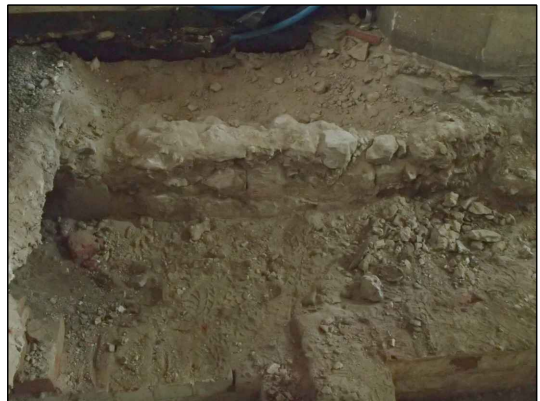
Wall foundation [239]

A 3.00m stretch of wall was uncovered, orientated north to south on the west side of the south transept [239] (8.06mOD). It was constructed of rough limestone blocks (approximately 27cm by 19cm by 12cm) and measured approximately 0.19m wide and 0.30m high (fig. 14). It had been truncated at the northern end by an upstanding pillar. A second wall foundation, orientated east to west was located adjacent to the southern wall of the south transept [270]. Of similar construction to [239], this foundation measured approximately 4.36m east to west by at least 0.25m wide and 0.25m high. This was similarly constructed of rough limestone blocks

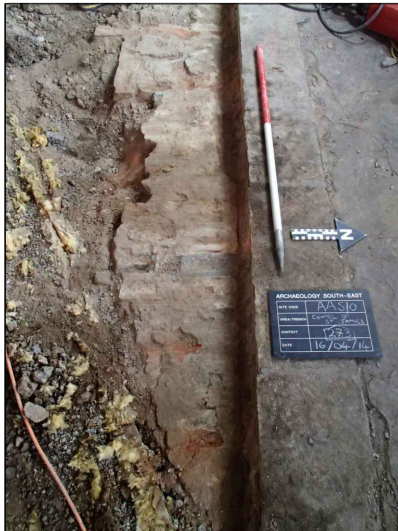
Possible floor [273]

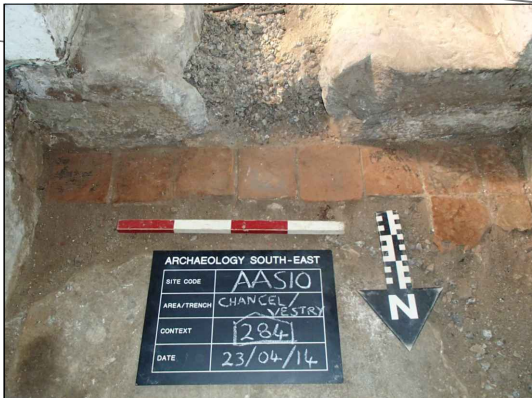
Tile floor 284 looking south

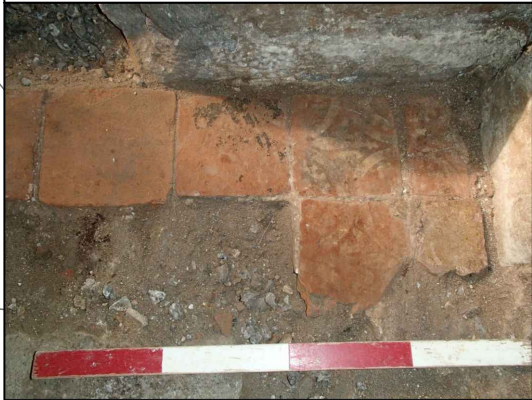
Decorated tiles 284

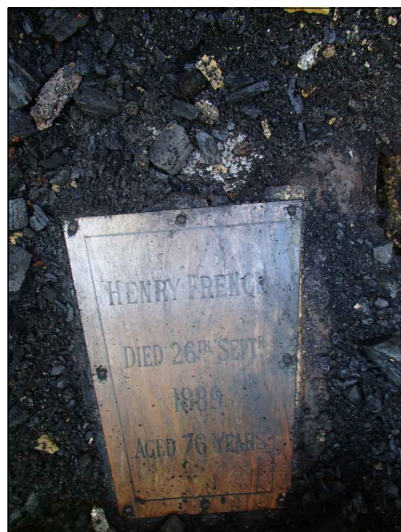
Name plate on coffin 153

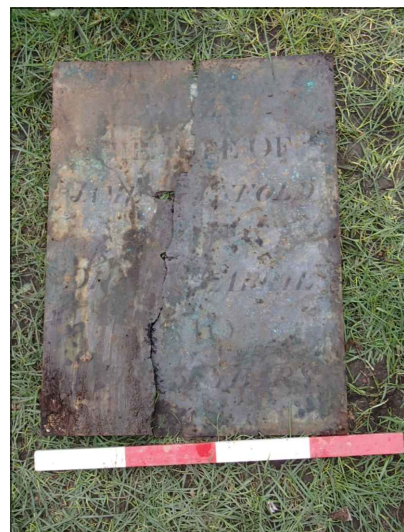
Name plate from 143
