**Archaeological Watching Brief Report  
Hardham Priory, Hardham  
Pulborough, West Sussex**

**Scheduled Ancient Monument No: 29279  
Scheduled Monument Consents: HSD 9/2/12088**

**ASE Report No: 2013013  
ASE Project No: 3735  
Site Code: HPC 09  
OASIS id: archaeol6-150903**

**July 2013**

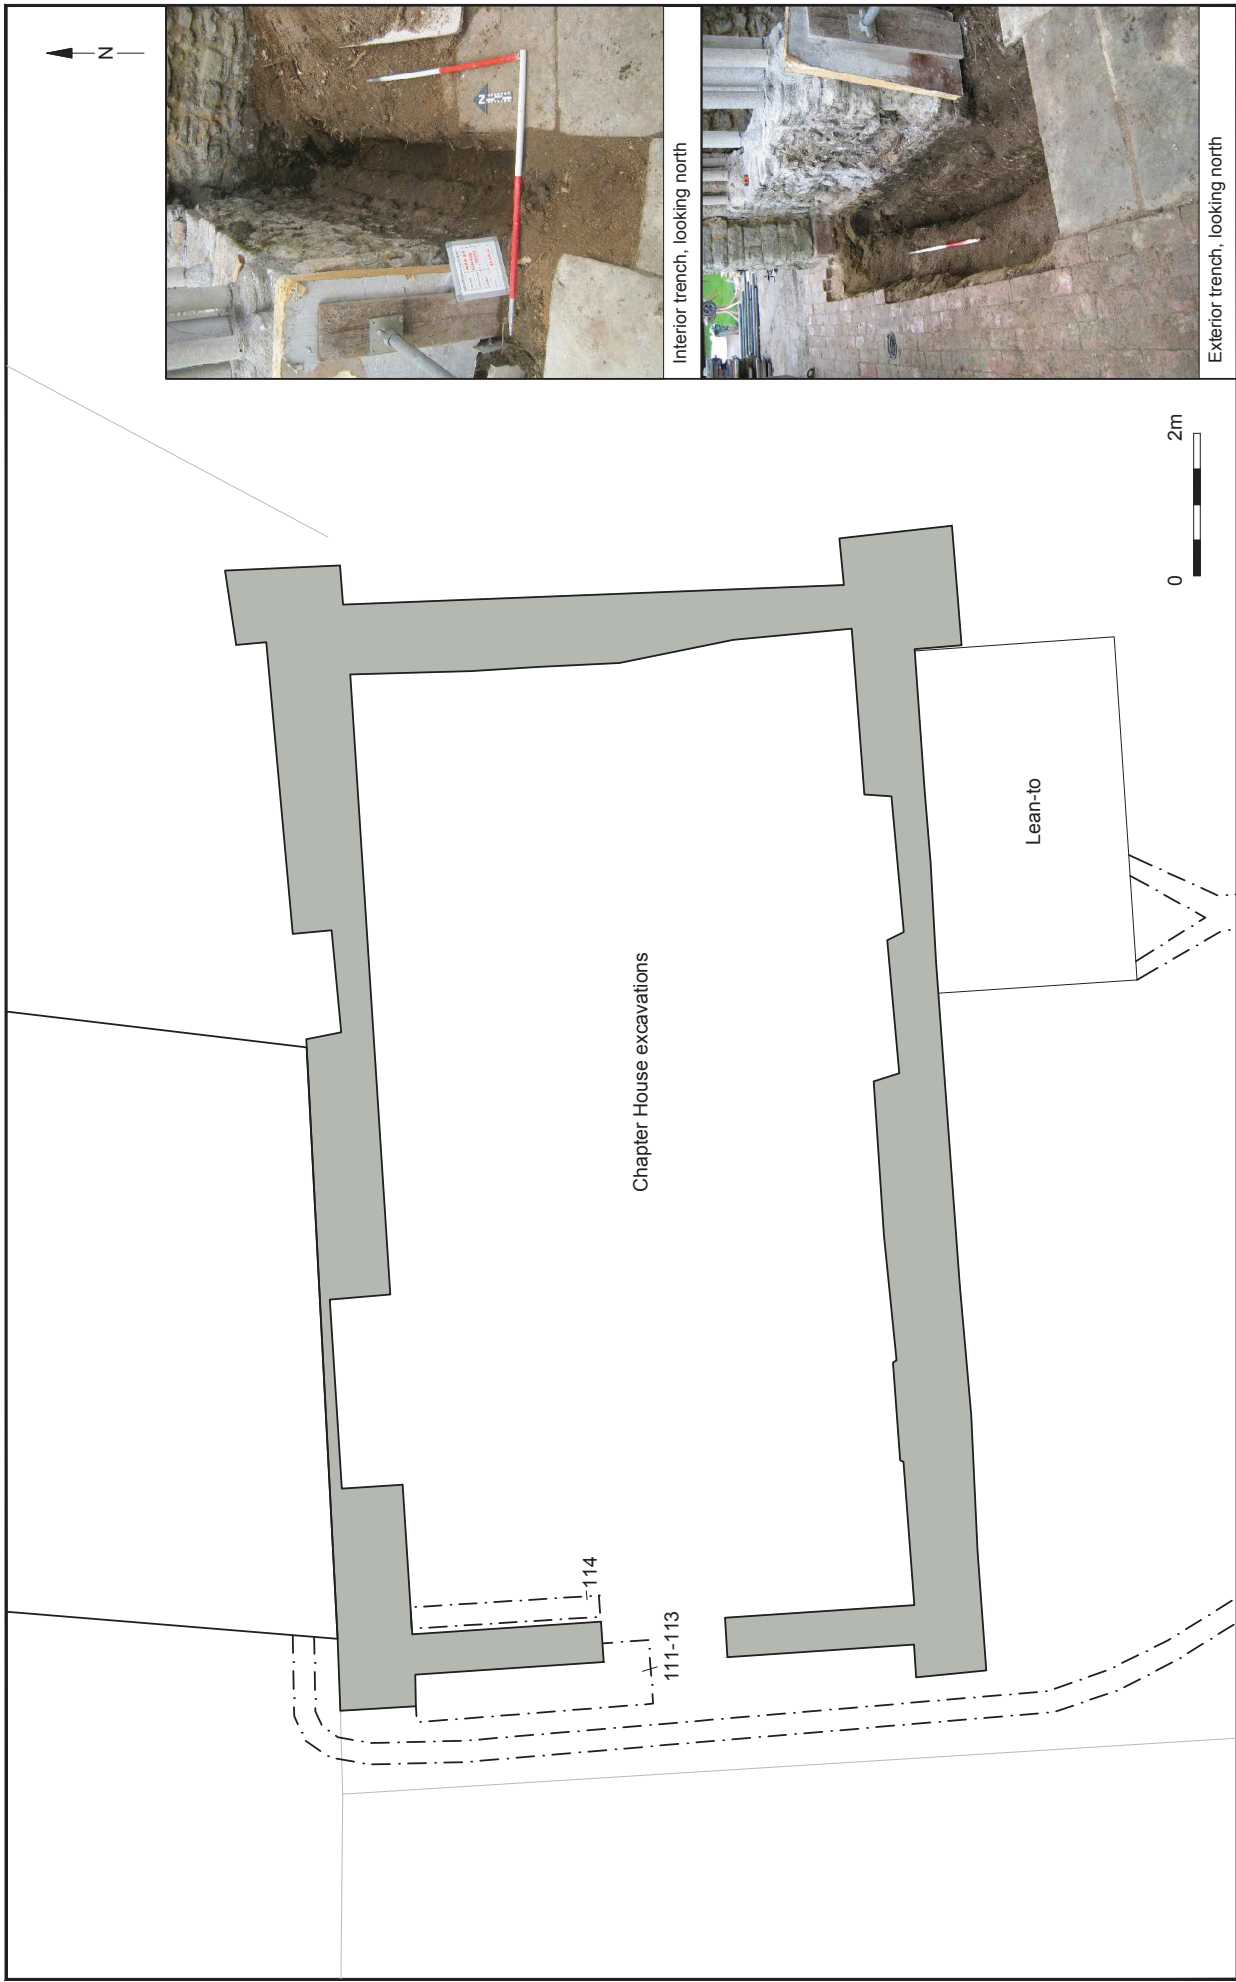
Fig. 4

- 4.3.5 A small trench measuring 3.4m in length, 0.9m in width and 1m deep was hand excavated to reveal the external western face of the foundations for the Chapter House. A second trench measuring 2.90m long, 0.52m wide with a depth of 0.65m was also excavated inside the western end of the Chapter House building. The trenches were dug to determine the stability of the foundation.

- 4.3.6 In the external trench loose rubble [111] was removed to reveal the foundation which consisted of irregularly coursed Greensand stone blocks [112]. These were seen to continue below the base of the 1m deep trench.

- 4.3.3 In the interior trench mid grey-brown heavily rooted silty clay [114] was removed to reveal the other side of the foundation.

Chapter House Excavations: plan and photographs

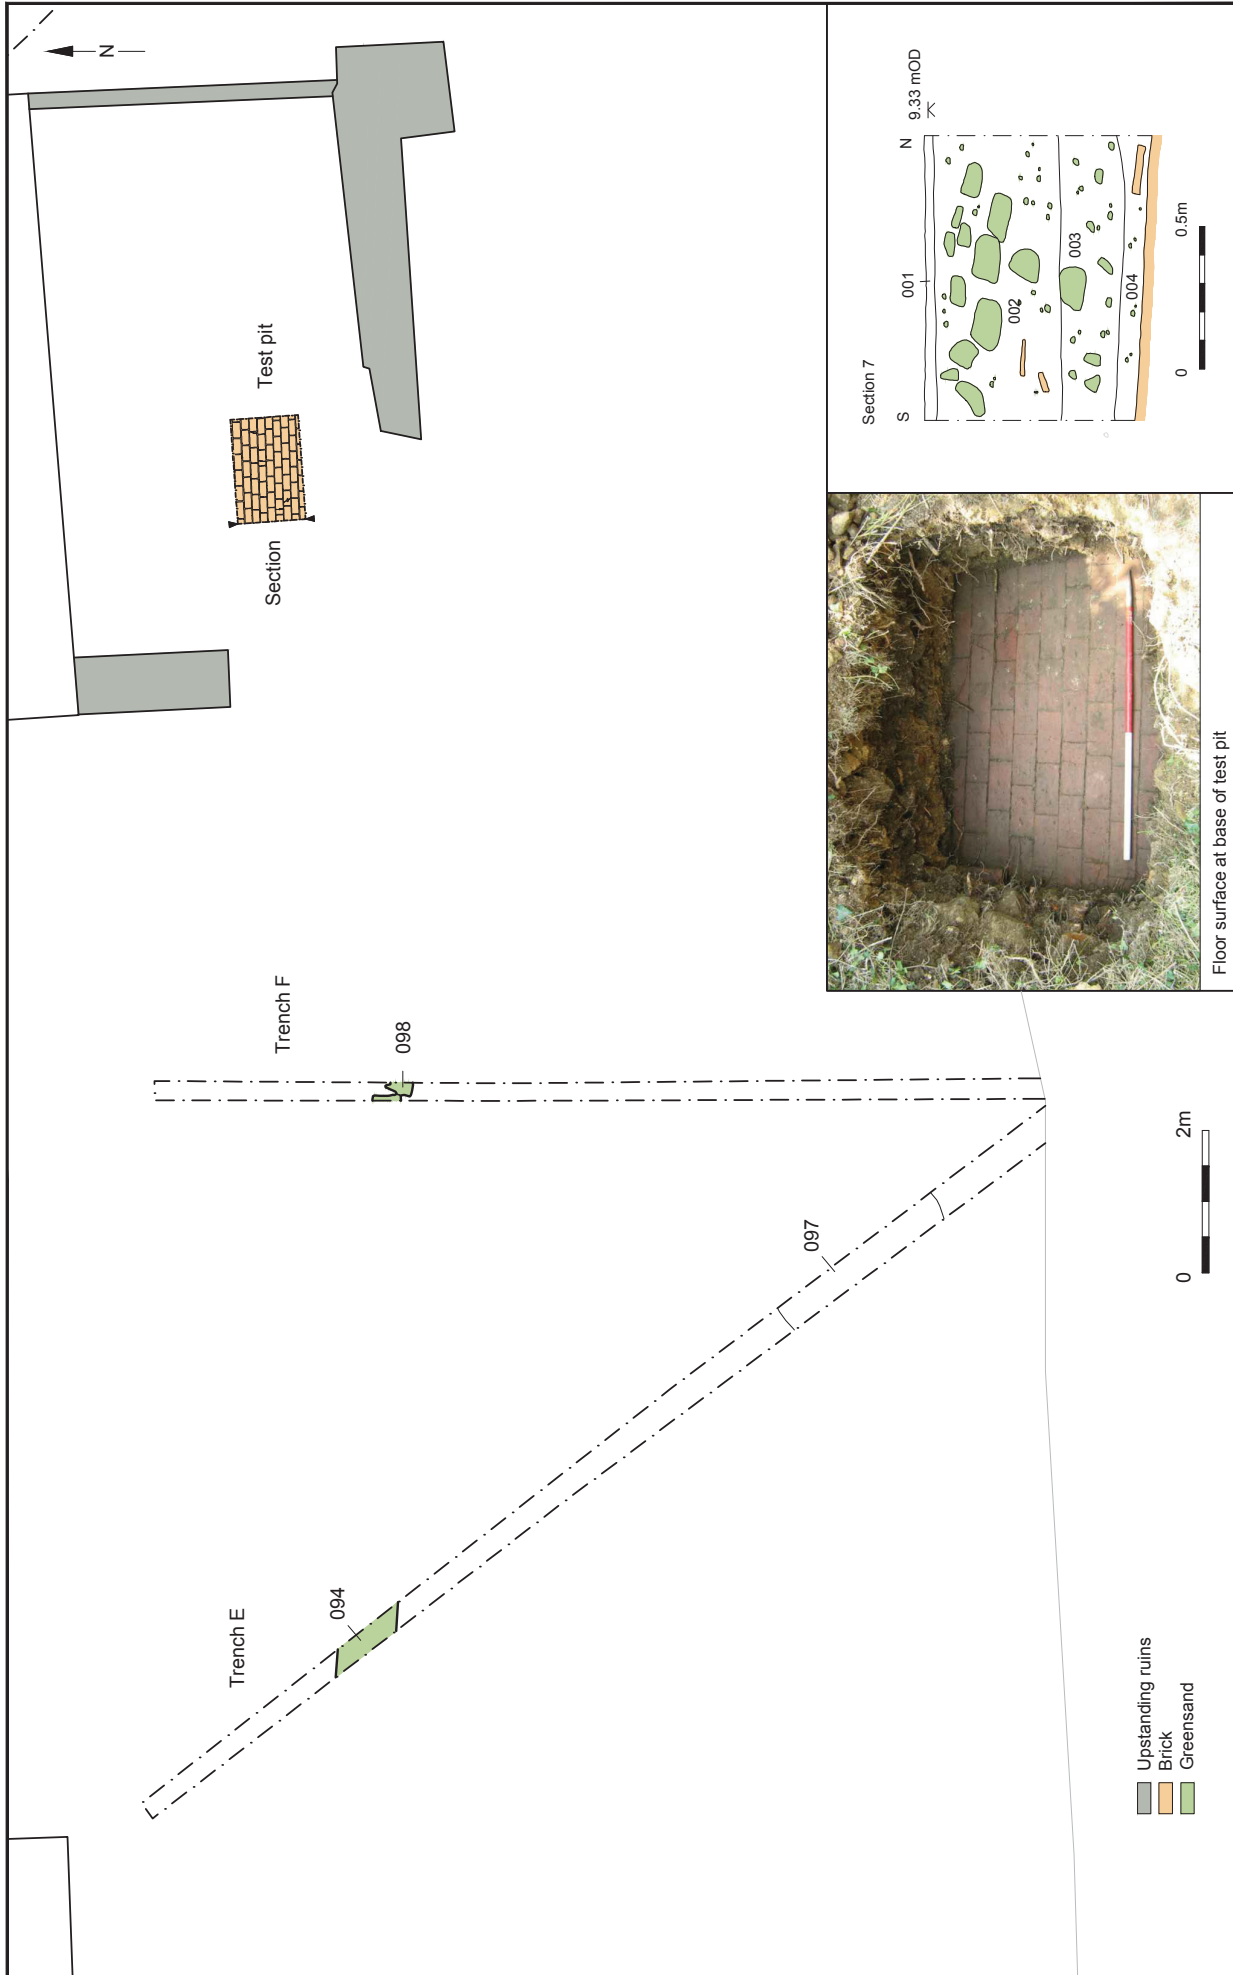
Fig. 8

- 4.8.2 At the base of the test pit brick floor [5] constructed of red brick paviors each measuring 100mm in width and 210mm in length, arranged in a running bond on an east - west orientation and bonded with mortar. Apart from the subsidence of part of the flooring, it was well constructed and survived in very good condition.

Hardham Priory Kitchen  
 Southern service trenches and test pit: plan, section and photograph

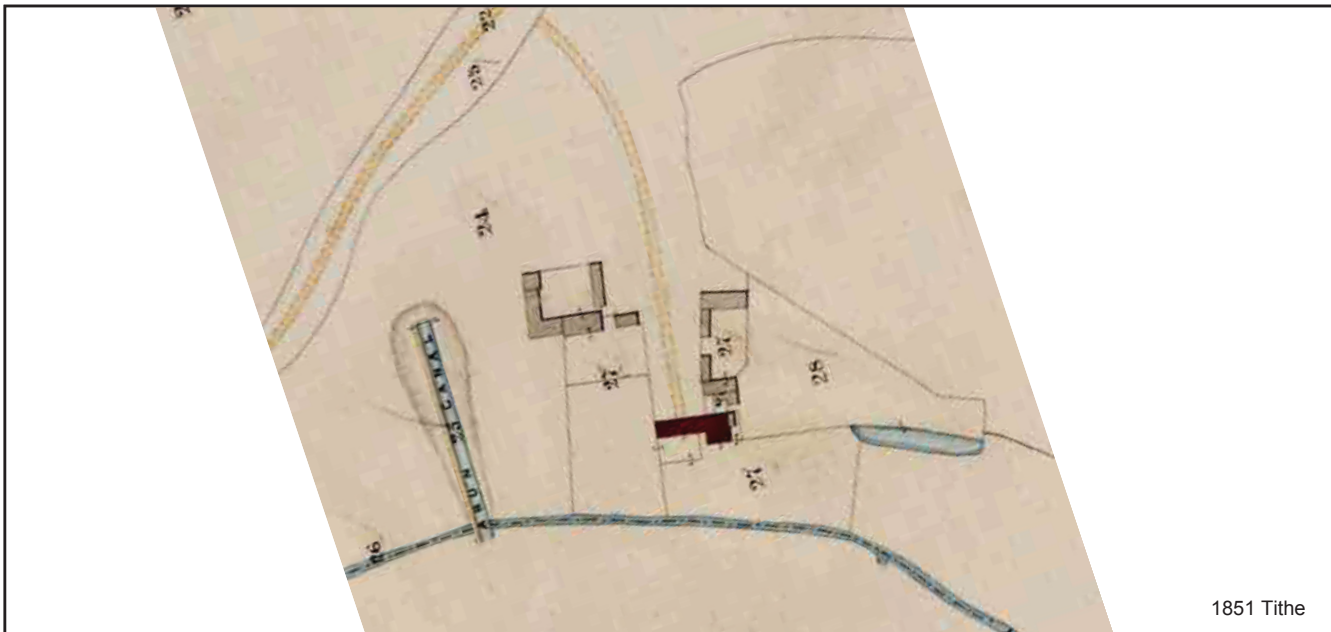
© Archaeology South-East		Hardham Priory Kitchen	Fig. 10
Project Ref: 3735	July 2013	1851 Tithe, 1876 OS and 1897 OS maps	
Report Ref: 2013013	Drawn by: JLR

- 7.13 By 1897 (Figure 10), the eastern wall [62] had apparently been removed and this area/courtyard appears to have been extended out to the east. Further cobbling [115] was noted to the east of this and may have been within the new extended area (Figure 10).
