**FORMER METHODIST CHURCH,
381C OLD FORD ROAD, TOWER HAMLETS, LONDON, E3 2LU**

HISTORIC BUILDING RECORD

(English Heritage Level 3)

Report No. 2013109

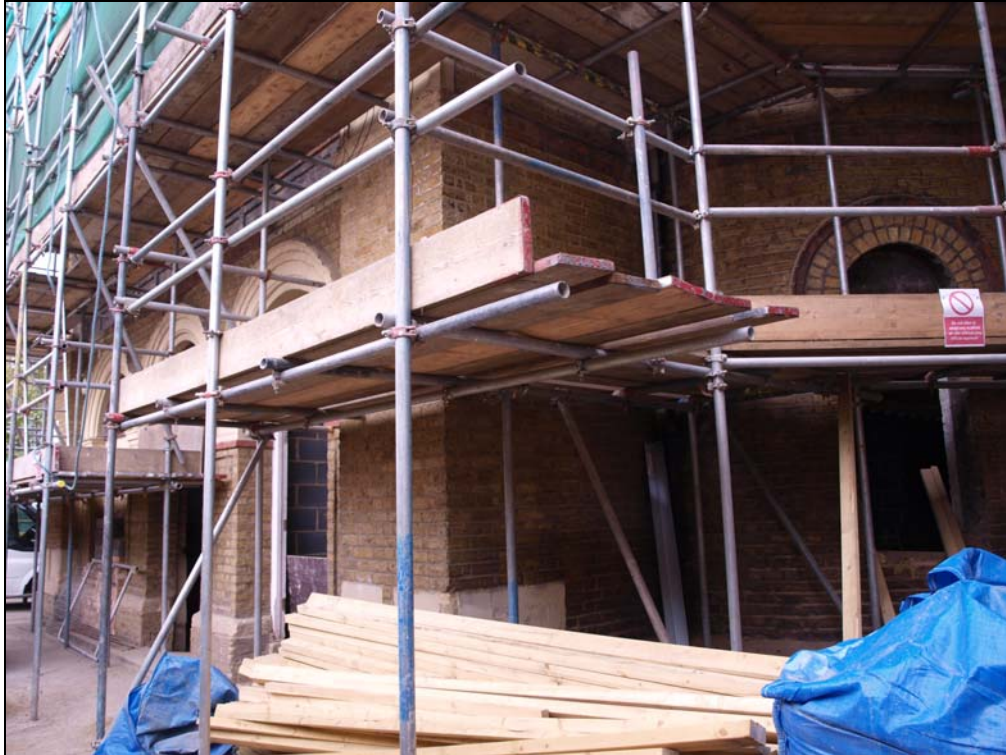
Plate 3. Arcade in south elevation (22)

5.2.2 The lower part of the central elevation comprises an arcade with three semi-circular arches spanning approximately 7.75m (Plate 3), the main entrance to the building being located in an opening beneath the easternmost arch (the door to which had been removed but is illustrated in Figure 8 and shown in Plate 25 and Plate 26). A photograph in the London Metropolitan Archives (LMA) shows that all three sections of the arcade originally had doors of the

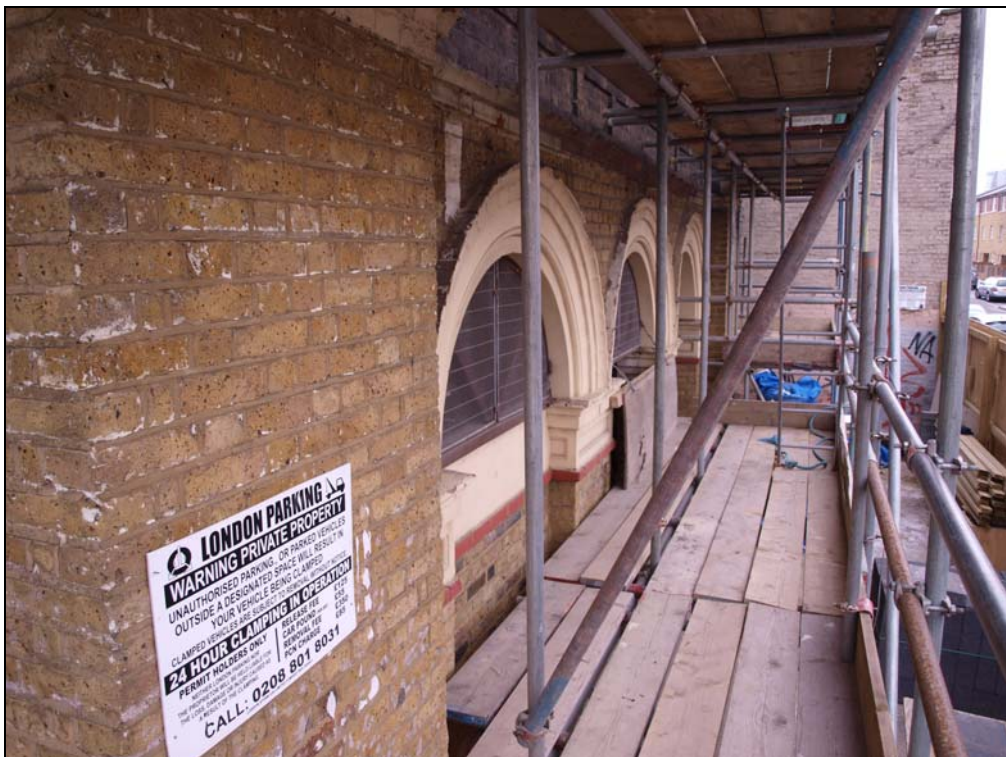
Plate 4. Arches to arcade in south elevation (20)

- 5.2.3 The openings to the arcade are framed by pilasters with slightly recessed panels in the brickwork. The pilasters rise to decorated capitals from which the arches spring. The arches themselves are formed of ashlar cut stone with decorative moulding to the front (Plate 4).

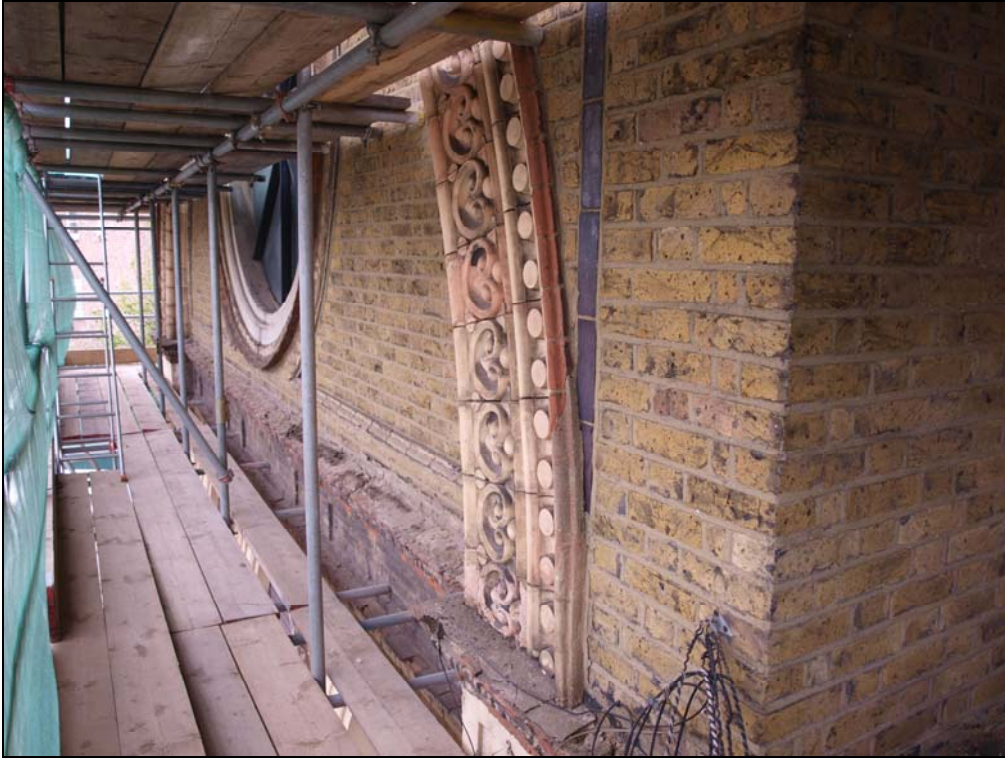
Plate 5. Arch over arcade in south elevation (4)

- 5.2.5 From the pilasters springs a large ornately decorated arch (Plate 5) spanning most of the upper section of the elevation, and holding a large central circular window of eight segmented lights (diameter approximately 2.70m). The glazing bars are of bevelled wood and there is no frame to the masonry. The lights are of reinforced safety glass. This window is likely a replacement as the windows to the east and west elevations are of a much more decorative form (see below). The masonry of the window is of curved ashlar cut blocks with moulding to the exterior face, surrounded by brick headers which are in turn surrounded by moulded orange-red brick. The panels formed between the arch and circular window are outlined by a band of moulded decoration.

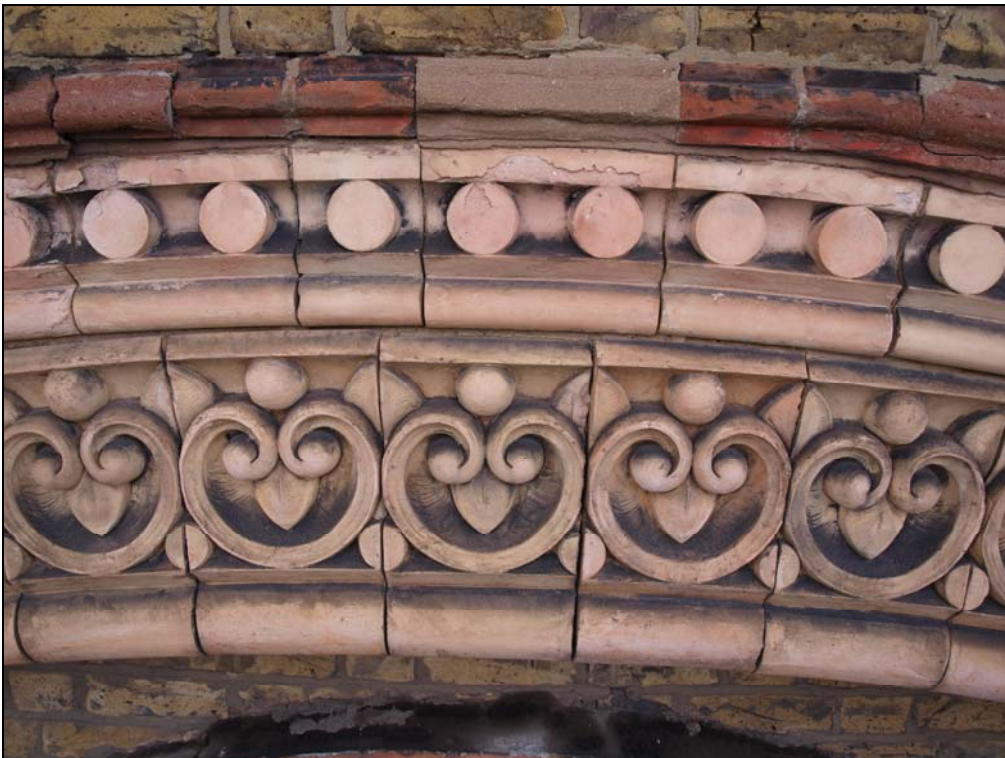
Plate 6. Detail of decoration to arch in south elevation (11)

- 5.2.6 The decoration of the arch is formed by two bands of tile. The inner band has a bevelled lower edge with a stylised floral pattern above. The outer band again has a bevelled lower edge and a circular stud pattern above. The tile bands are enclosed by a semi-circle of moulded orange-red brick (Plate 6). The entire arch is framed by a horizontal course of Staffordshire Blue engineering bricks running the full width of the gabled part of the elevation (also extending along the protruding parts of the west and east elevations) flush with the top of the arch, and vertical bands of the same engineering bricks rising from the outer edges of the arch to meet the horizontal course.

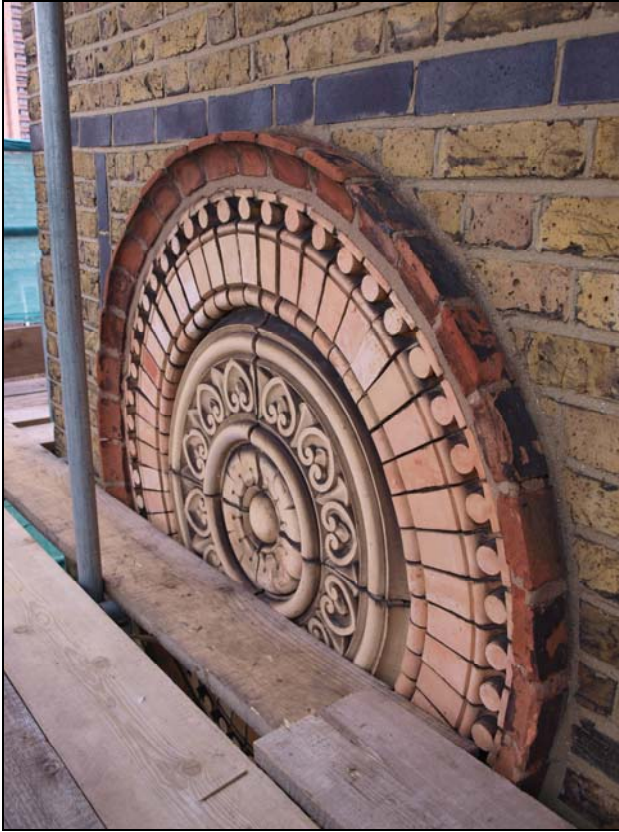
Plate 7. Detail of roundel in south elevation (12)

- 5.2.7 In each corner formed by the engineering brick frame is a large roundel of decorative tiles, approximately 1.40m in diameter (Plate 7). The inner section is cream coloured with the same stylised floral decoration used in the main arch. This is surrounded by a band of pinkish segments with a bevelled inner edge, flat central section and circular studs to the outer edge. The whole is

enclosed by a band of moulded orange-red brick. One of the inner segments is stamped with "Doulton Lambeth".

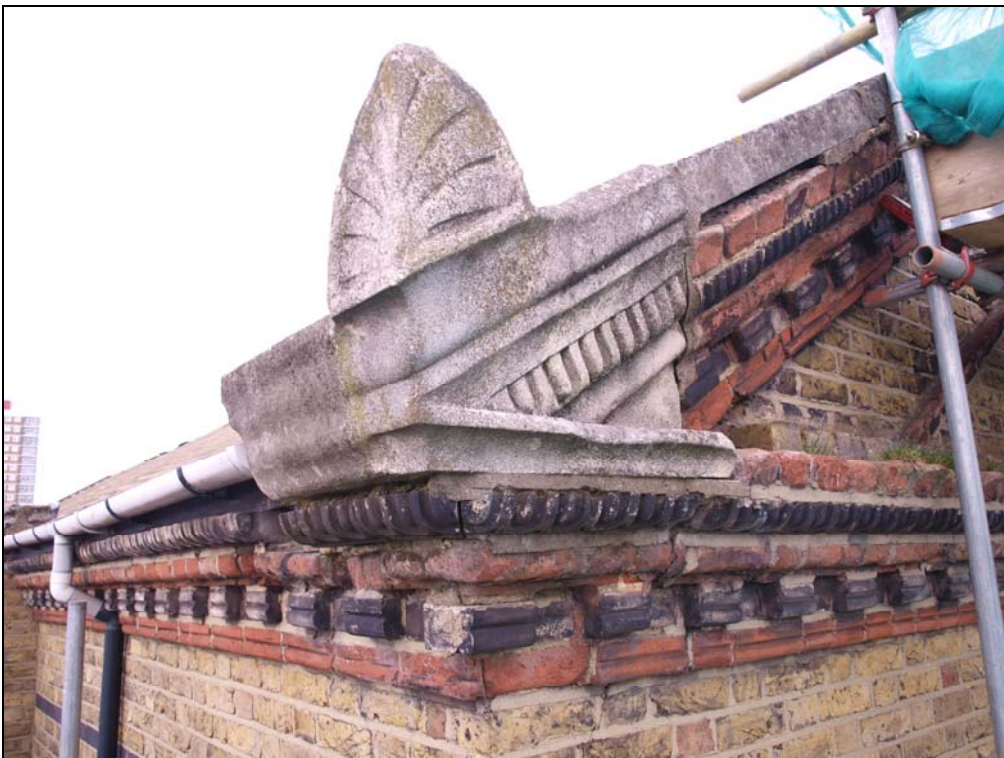
Plate 8. Detail of pediment decoration, south elevation (13)

5.2.8 Five courses above the horizontal band of engineering bricks is an ornate string course, the top of which is level with the eaves of the gabled section. This comprises a band of slightly moulded orange-red brick, a band of modillions, a further band of moulded brick, a band of egg and dart decoration, and an upper band of moulded orange-red brick cornice (Plate 8). Matching decoration to the gable verges forms a pediment to the gable end, the tympanum of which is plain apart from a band of moulded orange-red brick following the pitch of the roof, and a central inscribed stone plaque. The inscription is undecipherable, having been filled with mortar. The gable is capped with slabs of artificial stone coping and the ends decorated with 'scallop' shaped castings, with a similar cast finial existing at the apex.

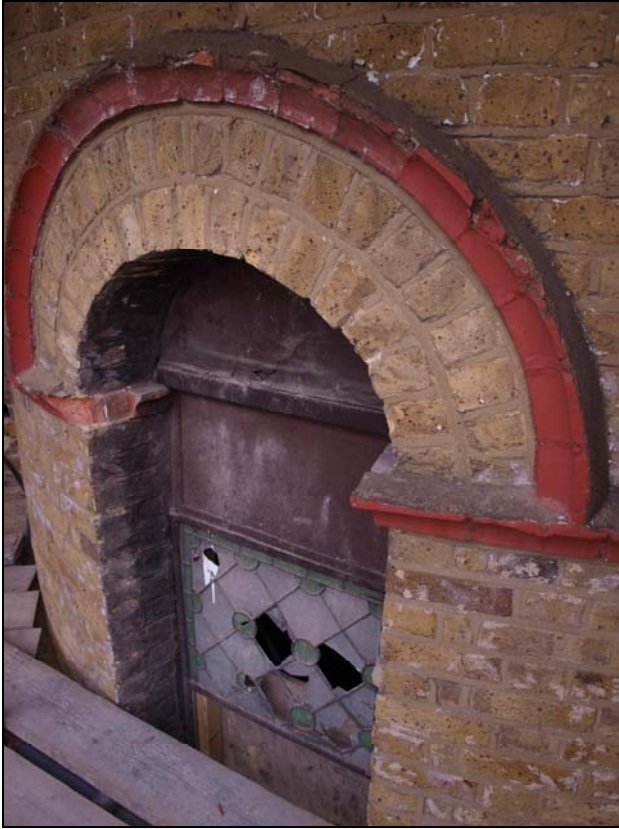
Plate 9. Window in western turret, lower level (21)

5.2.9 The quarter circle turrets flanking the pedimented façade each hold two windows, one above the other, separated by a continuation of the decorative moulded orange-red brick banding on the pedestal capitals of the central façade. This wraps around the turrets and the first buttress on either side of the south elevation. The windows are tall and narrow (approximately 1.80 by 0.80m) with semi-circular arches formed by two courses of on-edge headers (Plate 9). String courses of moulded orange-red brick extend around the turrets at the level from which the window arches spring, and the same moulded bricks have been used to surround the arches. The sills are chamfered and of orange-red brick. At the time of recording the upper windows had been removed, as had that in the lower opening on the eastern turret. The lower western window, however, partially survived. Within the arch, and extending four courses below it, the window opening is shuttered with sheet metal, below which a single light remained formed of white frosted glass diamond segments and green frosted glass circles with lead muntins. The lower part of the window does not survive.

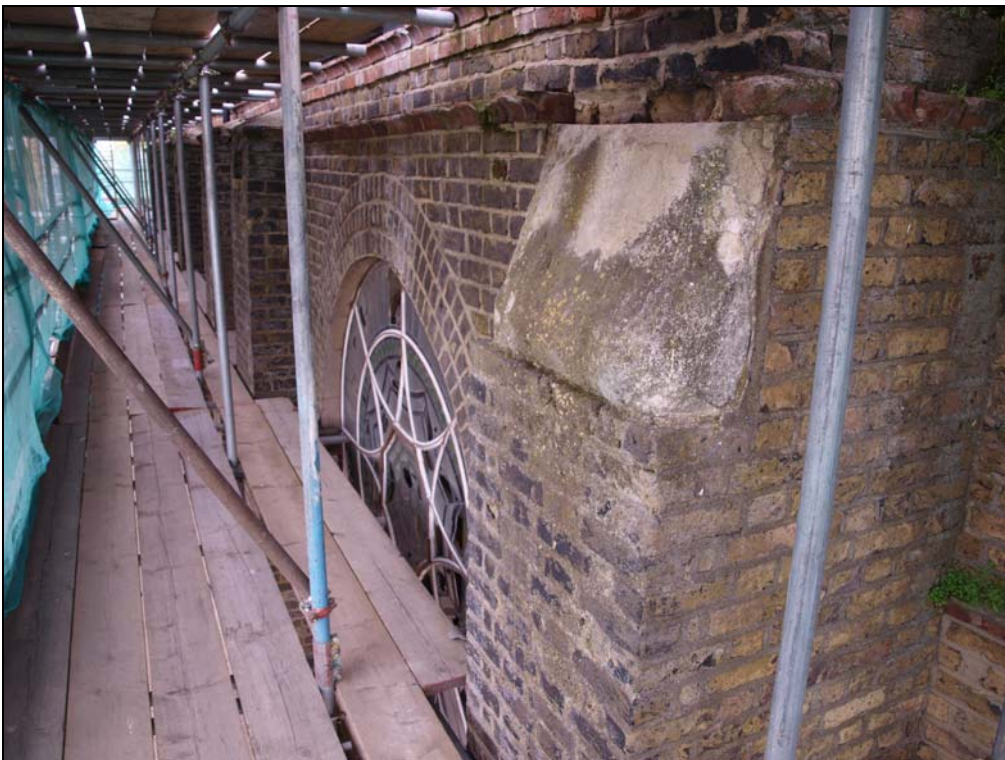
Plate 10. Buttress at west of south elevation capped with limestone, and window of west elevation (7)

5.2.12 The two buttresses forming the edges of this elevation are capped with chamfered limestone blocks (Plate 10).

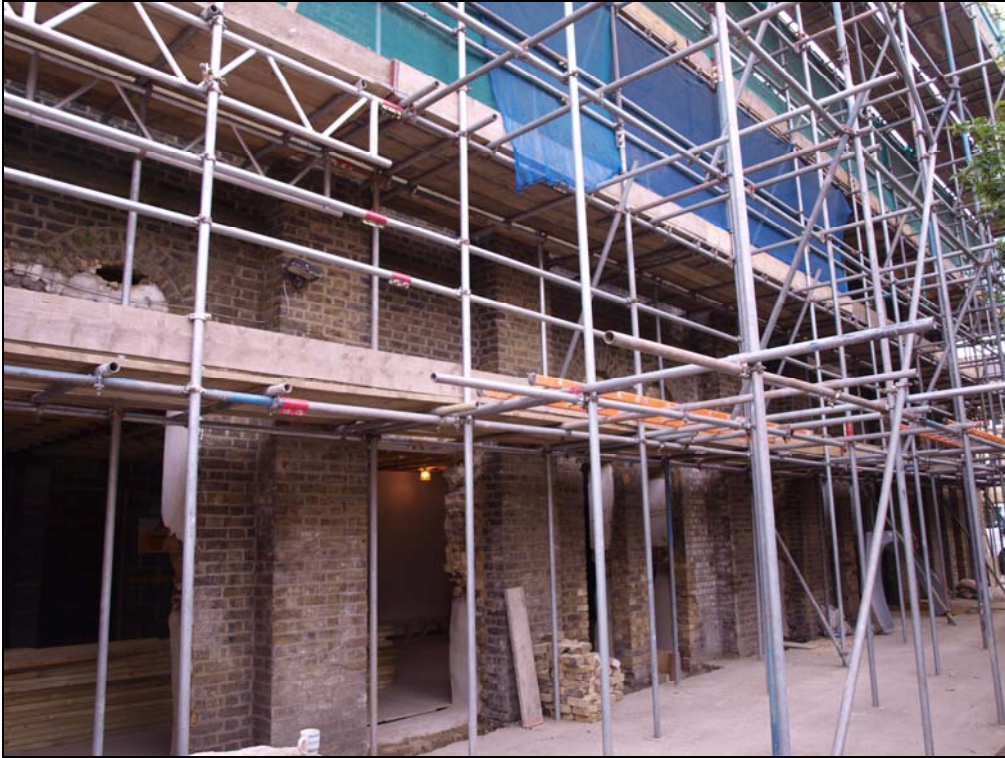
Plate 11. Buttresses in west elevation dividing it into alternating wide and narrow panels (23)

- 5.3.2 The central section of both west and east elevations are divided into alternating long and short panels by a series of paired brick buttresses which rise to eaves level, with four wide and three short panels in each elevation (Figure 9, Figure 10 and Plate 11).

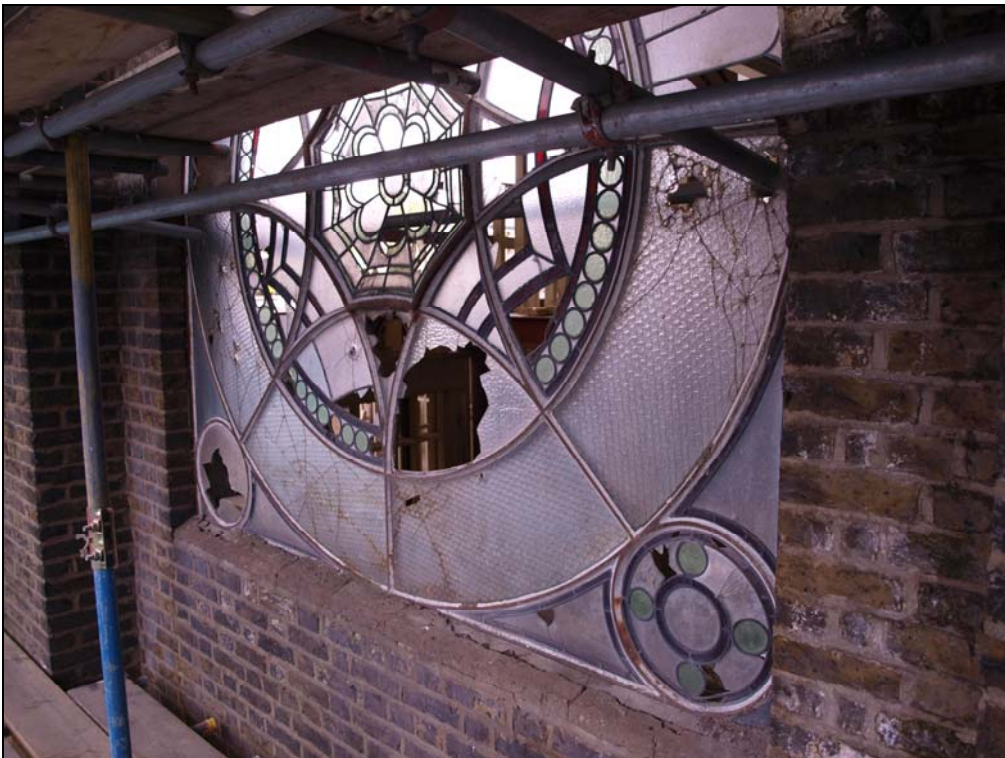
Plate 12. Lower part of window, upper level of west elevation (19)

- 5.3.5 At the upper level each of the wide panels holds a single arched opening containing a large, almost full width window, semi-circular at the top and squared at the bottom (Plate 10 and Plate 12). The sills of these openings are of chamfered brick, the arches above of three courses of on edge headers. The windows themselves are fairly ornate, the main body being formed by two concentric circles, the outer circle divided by iron radial glazing bars into eight equal segments. The inner portion is further sub-divided by curved glazing bars which span the inner ends of alternate radial glazing bars, creating a central octagonal area with concave edges. This central portion is hinged laterally to create a cantilevered opening. The central octagonal section is decorated by a floral motif in green and white stained glass with a web-like surround, which is continued in less detail to the edge of the inner circle and bordered by a ring of small circles in green glass. The outer circle is divided into radial segments with rounded ends (seven segments between each radial glazing bar). The lower corners of each window hold circular panels, each with a central circle of white glass and smaller circles of green glass at each cardinal point.

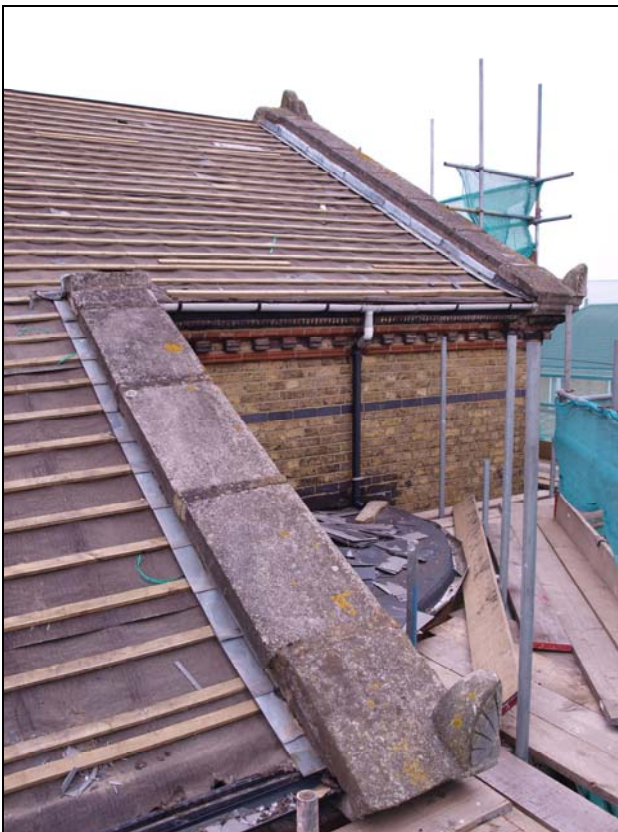
Plate 16. Coping to gable end of roof, south elevation (16)

5.2.11 The verges of the gable to the main range of the building are decorated in a similar (though slightly less ornate) fashion to those of the pediment, also with a coping of artificial stone, the ends being decorated with the same 'scallop' shaped casting.

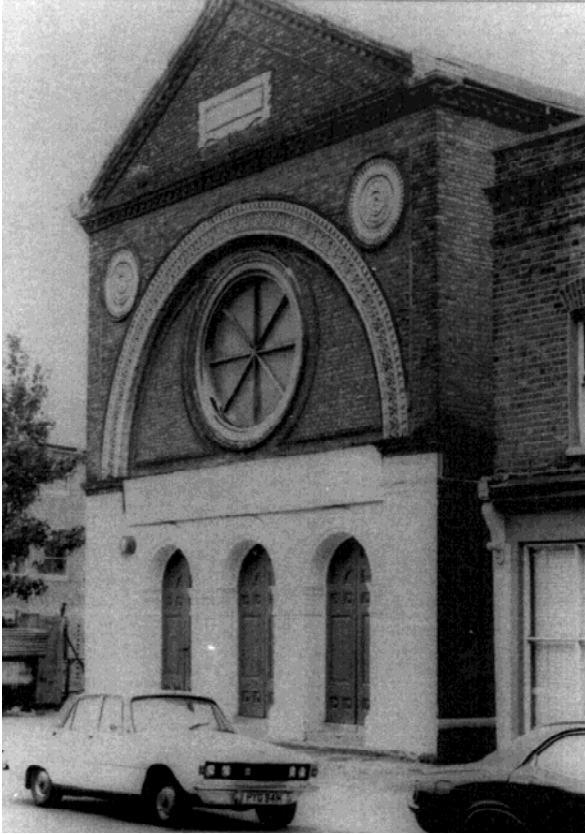
Plate 25. Photograph of south elevation, 1979. © Frank Phillips

same style (Plate 25), and quarry tiled steps (a fragment of which survived), which led into the building. The measured survey provided (dated 14th September 2012) shows two of the opening mostly blocked, with semi-circular lights within the arches. These lights are of four equal segments, divided by wooden frames and of plain glass. They currently have metal bars to the interior and grills to the exterior. At the time of recording the central section of the arcade had been unblocked. Given the existence of the archive photograph showing all three openings with similar doors, the semi-circular lights may be later additions, perhaps added at the time of blocking in order to maintain a degree of daylight to the lobby.
