**71-77 AND SOUTH STREET COMMERCIAL CENTRE,
SOUTH STREET, BISHOP'S STORTFORD, HERTFORDSHIRE
(Centred at NGR TL 488 209)**

**HISTORIC BUILDING RECORD
(ENGLISH HERITAGE LEVEL 3)**

ASE Project No. 6241

Report No. 2013181

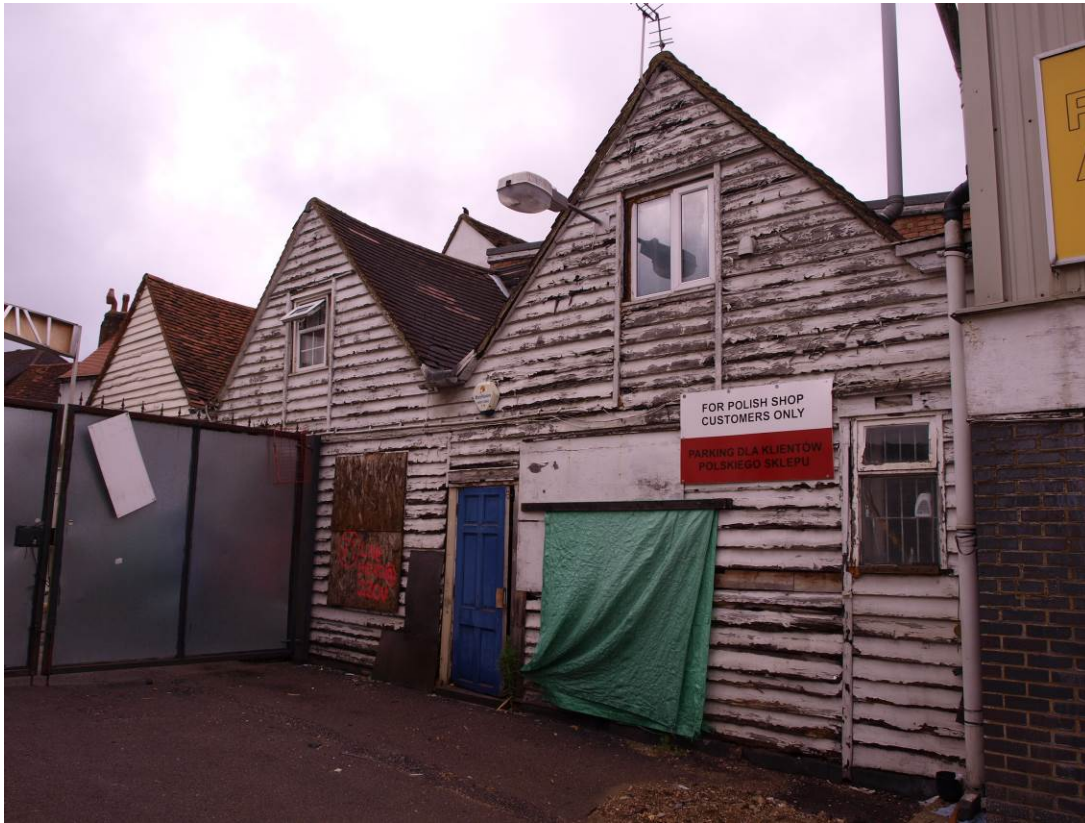
Plate 1: 71 South Street, south elevation, looking north-west (29)

- 6.1.1 The building runs east west, and is of two storeys, with the upper floor being contained within attics (Plate 1). The principal elevation, which faces south, consists of a series of three pitched roofs at upper floor level, with three gable ends facing south. The roof is clad with clay tiles; the eastern roof-slope of the central bay and the roof of the eastern bay have modern replacement clay tiles; older handmade clay tiles are retained on the roof of the western bay and the western slope of the central bay. The gables have simple cloaked verges. A window is located centrally in both the central and eastern gable; these windows are modern uPVC additions. The western gable is blank. The roofs of the central and eastern bays are linked by a later roof extension at the back of the building; this has a flat felt roof, uPVC window and is clad with weatherboarding (Plate 2). The building is clad with painted weatherboarding,

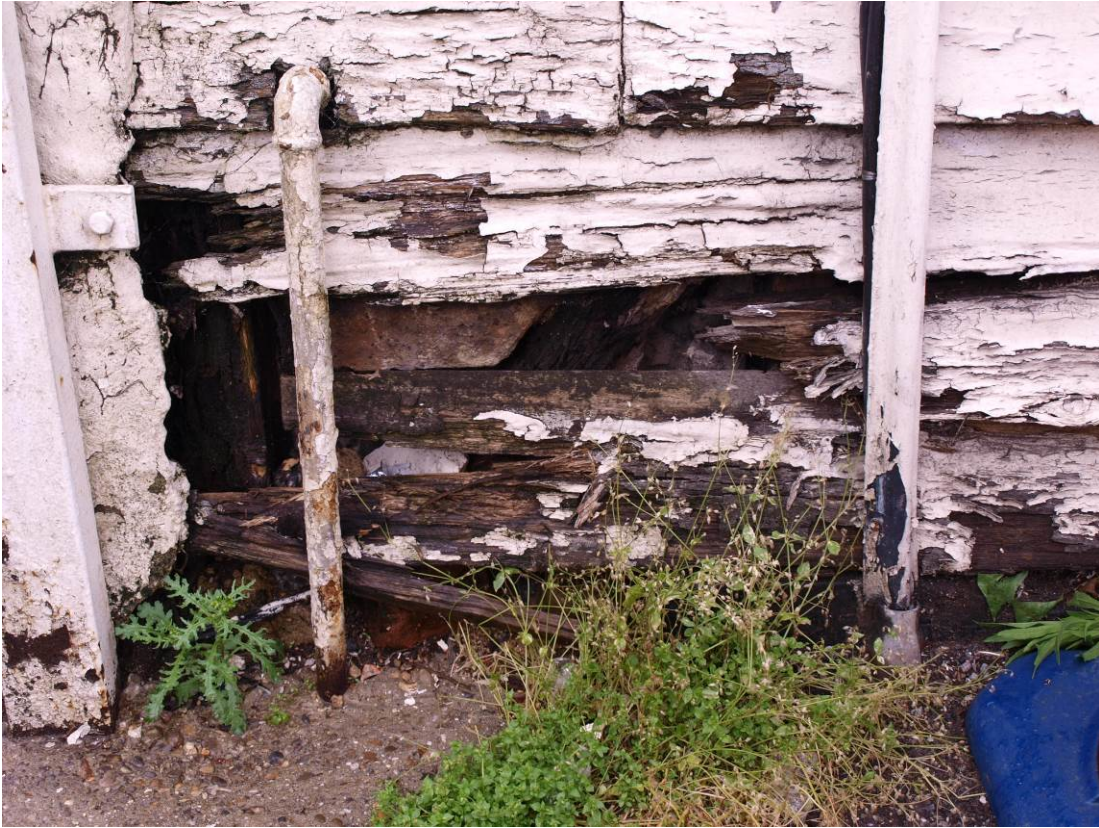
Plate 3: Primary bracing (33)

which is truncated by slender vertical timbers to either side of the upper floor window openings. These timbers extend down, suggesting the openings originally formed loading doors, the lower halves of which have subsequently been infilled. At ground floor level, at the east end of the elevation, there is a possible infilled door with a later timber window with top-opening light inserted, similarly defined by a slender vertical timber. At the western end of the eastern bay, a modern six-panel timber door has been inserted in a possible modified earlier opening. Two later window openings have been inserted into the central bay; these are now boarded over on the exterior. The westernmost bay is blank. An area of the exposed underlying construction at west end of the elevation demonstrates square section softwood framing with primary bracing (Plate 3).

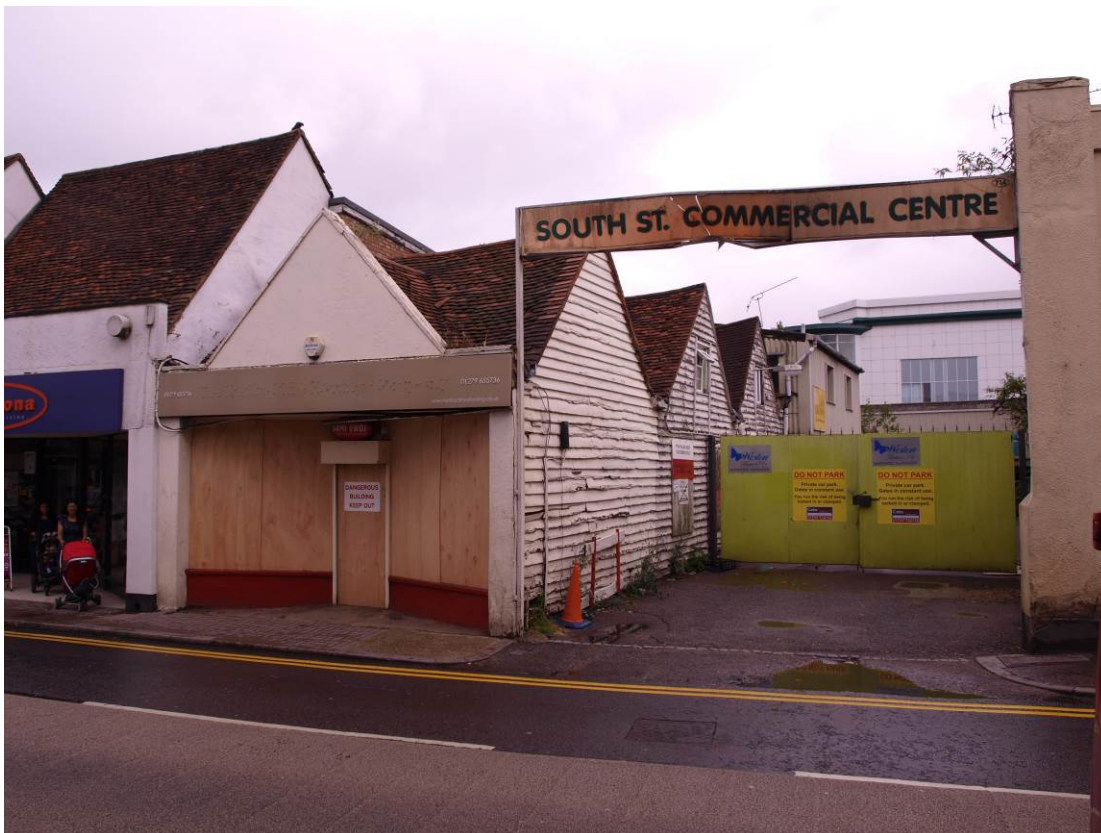
Plate 4: West elevation, looking north-east (27)

- 6.1.2 The west elevation faces South Street (Plate 4). This has been modified with the addition of a 20th century shopfront. The shopfront forms a canted recess, with central door. The underside of the recess is clad with softwood boarding. The shopfront has a simple timber frame with an absence of mouldings, rendered brick pilasters and stallriser and a modern fascia. A rendered pediment above the fascia is attached to the roof behind forming a small pitched roof extension clad with matching handmade clay tiles.
- 6.1.3 The east and north elevations are obscured by later development.

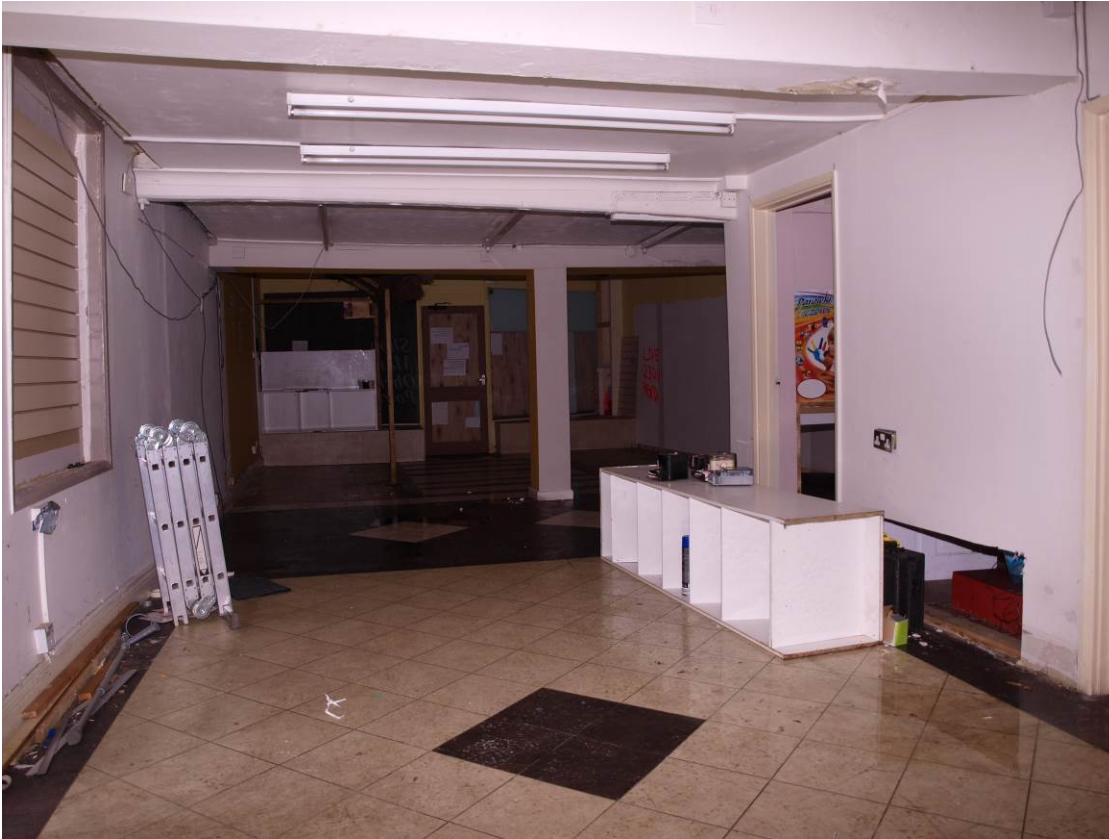
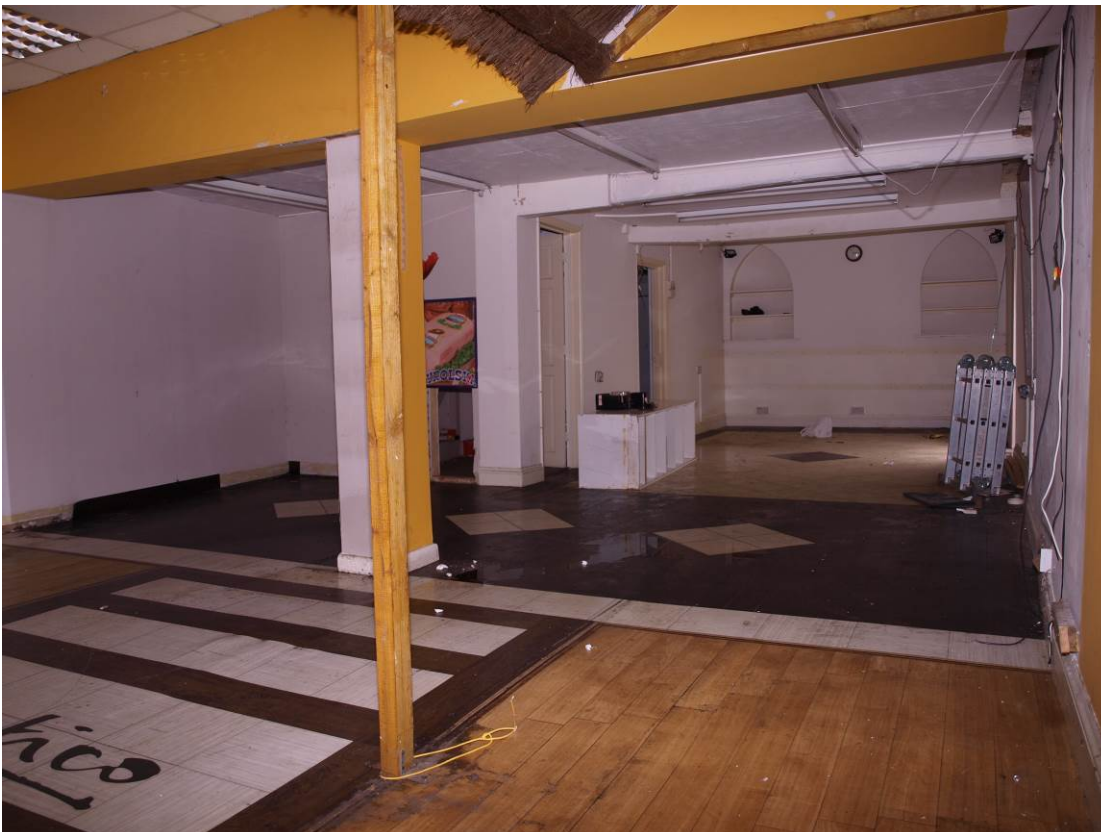
Plate 5: Room 1, looking west (1)

- 6.1.4 The building is accessed via the shopfront doorway or the central doorway on the south elevation, both of which lead into Room 1 (Plates 5 and 6). This is an open room divided into 5 bays, as defined by downstands within the ceiling. The walls and ceilings have been overboarded, generally with plasterboard, though there is a suspended metal framed ceiling in the westernmost bay and modern textured ceiling in the adjacent bay to the east. The floor is covered with modern tiles. The interior is fairly plain with simple moulded skirting throughout. The shopfront is located at the western end of the room, and is simply moulded with a central two-panel glazed door and two rudimentary plywood display plinths built out beneath the shop windows. At the east end of the room, two arched alcoves have been inserted into the wall forming small recessed shelving areas. On the southern wall, there are two window openings; the easternmost is framed with a simple timber surround, the westernmost has been blocked. It is not possible to ascertain whether these are situated in the location of original openings due to later coverings.

Plate 6: Room 1, looking east (3)

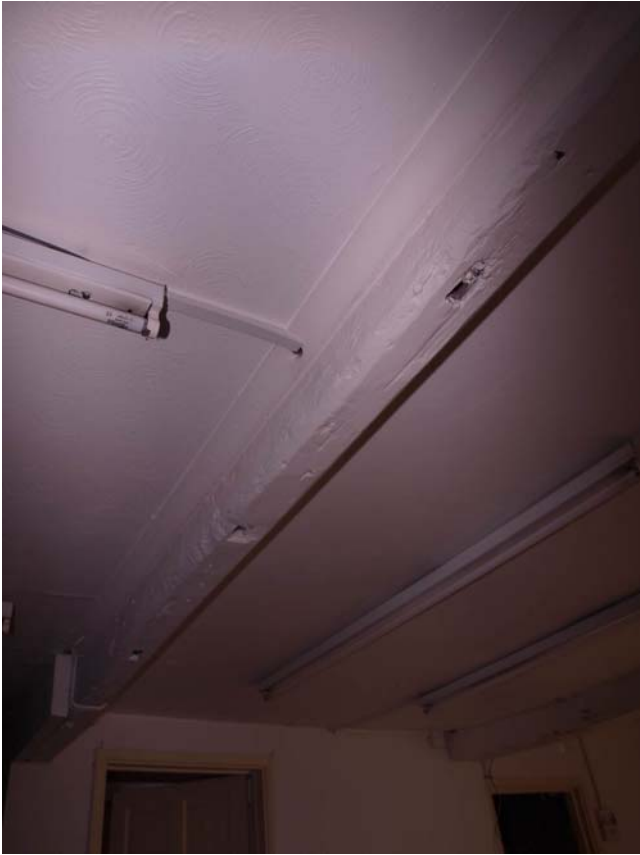
Plate 7: Mortices for former partition (16)

- 6.1.6 Between the western and central bays, a chamfered timber joist running north-south contains a series of mortices, suggesting a partition formerly existed in

this location (Plate 7). Timber joists between the remaining bays to the east are plain and appear later additions or replacements.

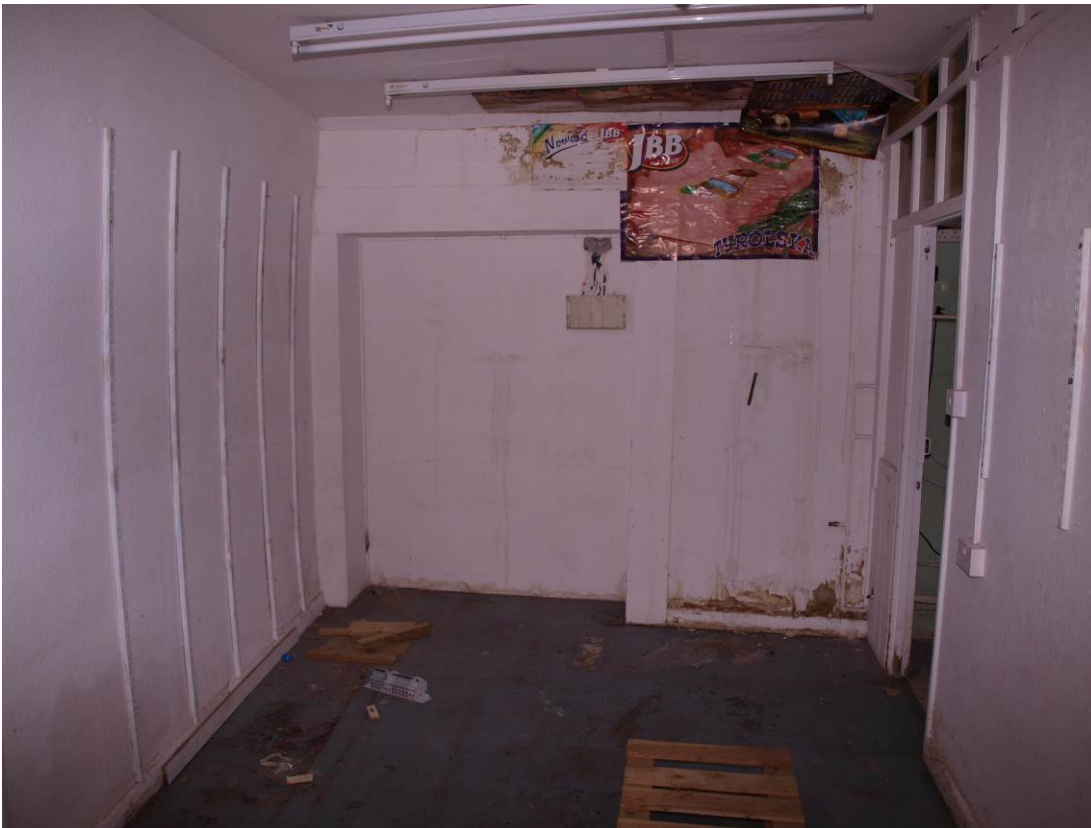
Plate 8: Room 2, looking west (4)

- 6.1.8 Room 2 is a small room with modern linoleum flooring and papered wall-coverings obscuring the underlying construction. There is a regular square section timber joist running north-south midway across the room. The north wall displays prominent concave bowing (Plate 8). A wide blocked doorway on the east wall is a later fire door; this was visible from the attached building to the east. Within the south wall, at the east end, a door set within a glazed partition leads to a small kitchen (Room 3) and WC. The partition is of likely 1930s date with a door of four stacked fielded panels and a simple metal rim-lock (Plate 9).

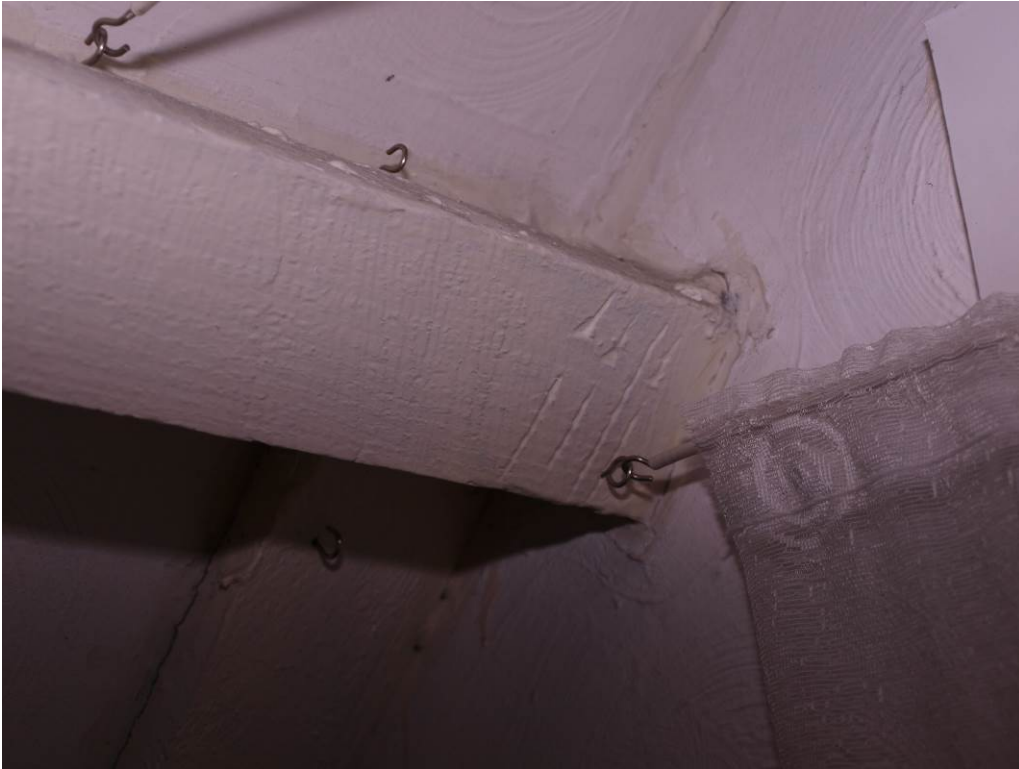
Plate 11: Carpenter's marks to purlin (18)

- 6.1.17 Room 9 is located south of Room 5. Purlins exist on both sides, with mortices for queen struts, and carpenter's marks: III and IIII (Plate 11). At the base of the southern wall, the wall-plate and a gently curved timber kerb are visible; the kerb is bolted to the wall-plate with two large square section bolts (Plate 12). In the south-west angle, a diagonal brace has been boxed in, in the south-east angle, the brace has been removed; a mortice for a matching brace can be seen in the wall-plate. On top of the wall-plate there is a square section timber with possible Baltic merchant's marks on the inner face.

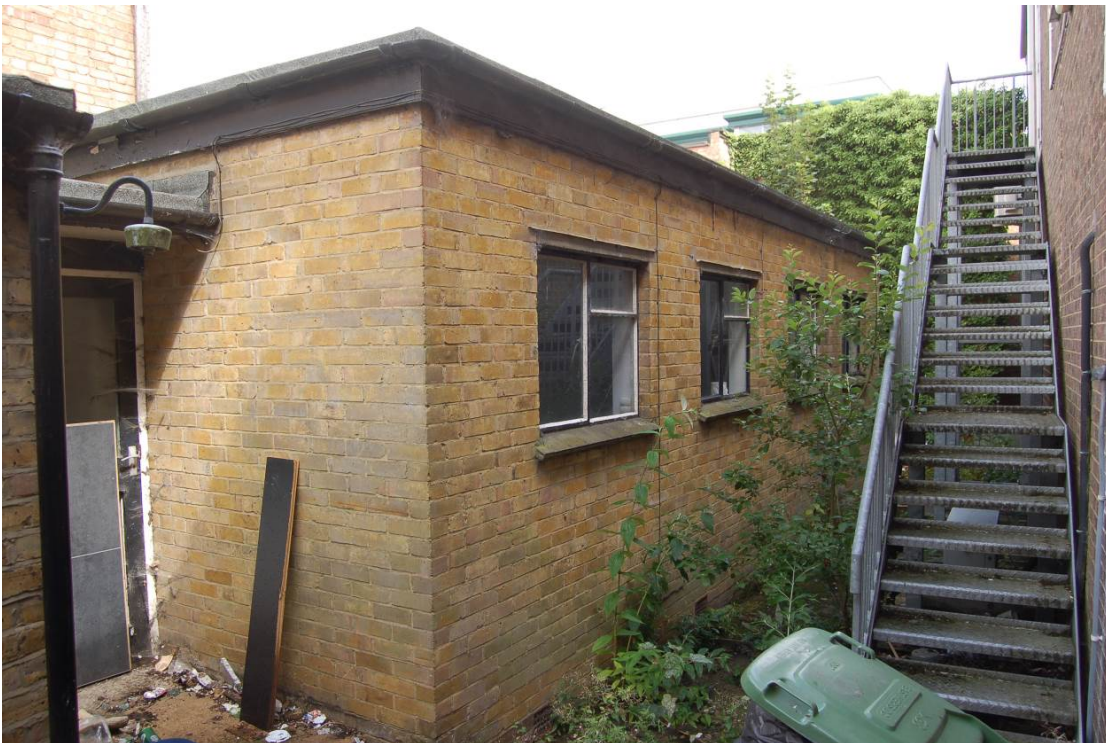
Plate 14: Modern extension to the west (57)

- 6.2.3 To the east, a straight joint in the brickwork marks the junction of the original building with a later, single storey extension. This is also constructed in yellow brick in slightly brighter tone and is probably contemporary with the inserted ground floor windows. The brickwork is set in cement mortar with weatherstruck pointing. The extension has one metal casement window to its eastern end, and a flat asphalt roof. Further to the east, at a lower level, is a small addition with a combination of flat and lean-to roofs, with asphalt covering. This contains a doorway with a ledged and braced timber door with six glazed upper panels and brass handle. A further flat-roofed extension to the east, constructed in yellow brick, and a small, rendered link building, both of more recent date, were not examined in any detail (Plate 14).

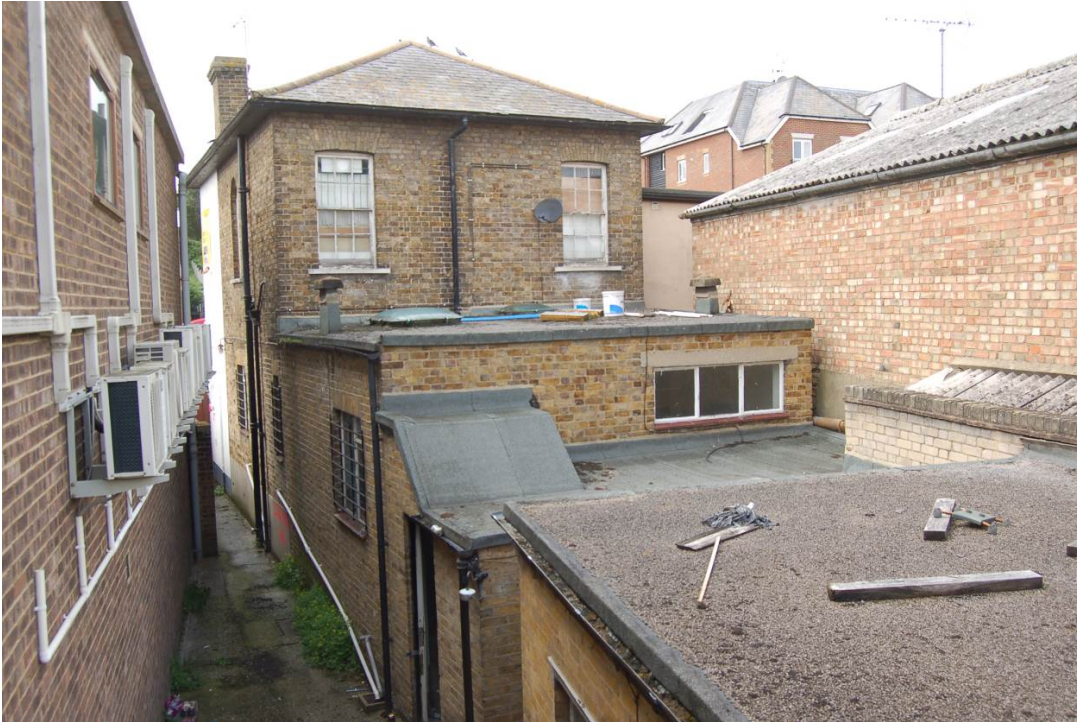
Plate 15: South and west elevations, looking north-west (60)

- 6.2.4 The east, rear elevation of the principal building is only visible at first floor level, having been extended at ground floor level (Plate 15). The upper floor has two windows with gently cambered flat brick arch heads, sliding timber sashes of six-over-six panes and stone cills. It is constructed in the same type of yellow brickwork in Flemish bond. The ground floor extension contains a

high level window with concrete lintel and tiled cill. The further addition to the east has one 1930s/40s top-opening fanlight window.

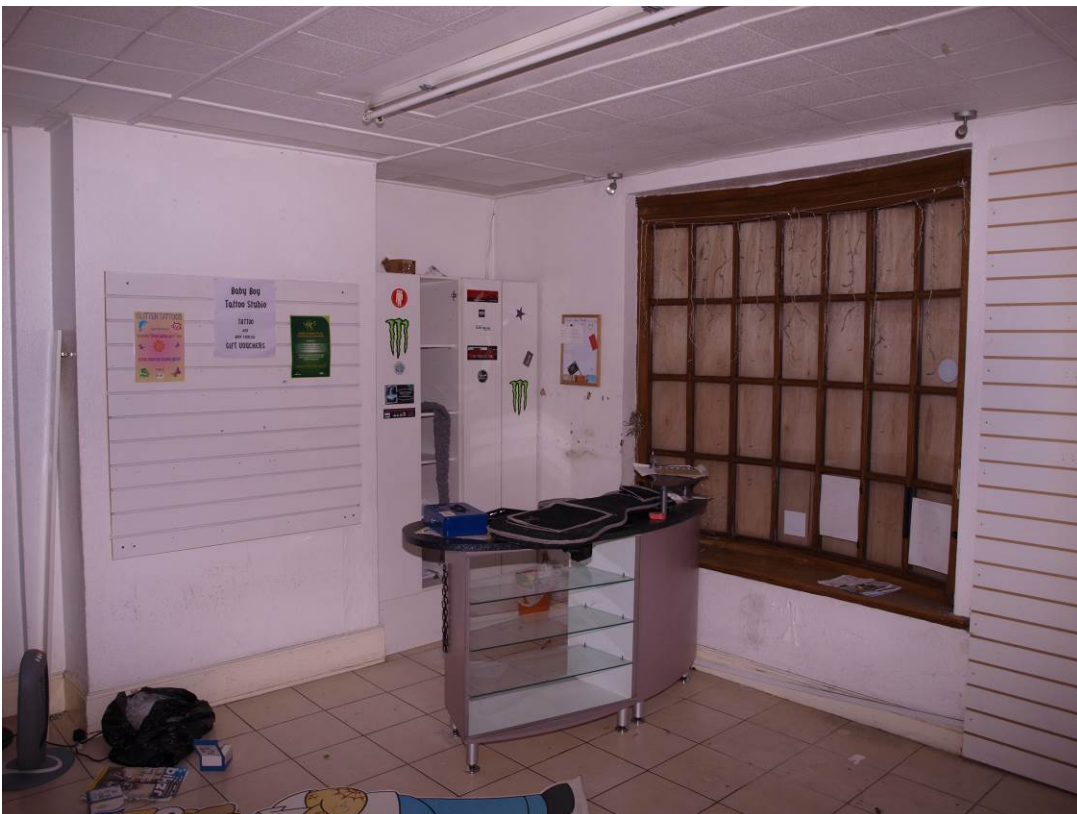
Plate 16: Room 2, looking south-west (45)

- 6.2.6 Room 2 is the principal room on the ground floor (Plate 16). It has a modern suspended ceiling and tiled floorcovering. Deep skirting with a simple moulding survives around the perimeter of the room except on the western side where it has been replaced with more shallow skirting, and on the north side which now forms part of a corridor to the rear rooms and which has modern skirting. There is a central chimney breast on the southern wall; the fireplace has been removed. On the west wall is a bow window of twenty-eight panes; the frame is hardwood, with square section glazing bars and a wide oak cill with rounded nosing.

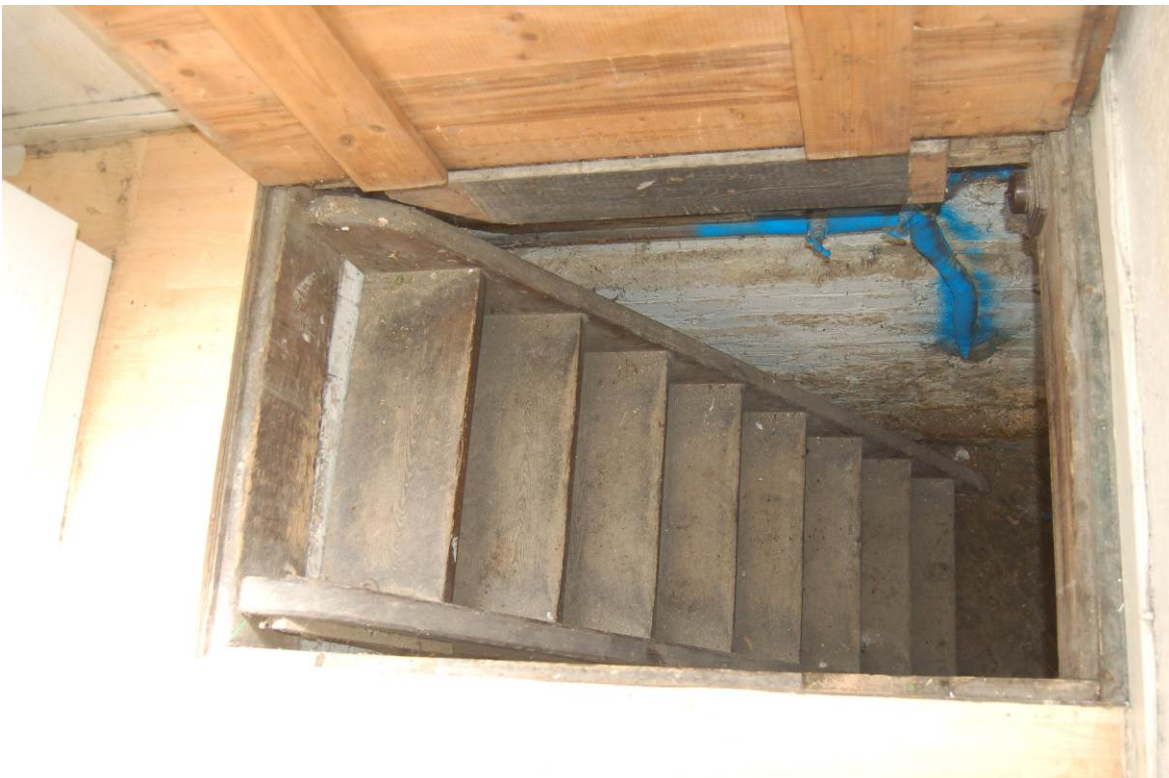
Plate 18: Trap door and steps leading to cellar (56)

- 6.2.8 Rooms 4 and 5 are located south of the corridor. Both have suspended ceilings and modern floor and wall coverings, and plain shallow skirting. A trap door in the south-west corner of the floor of Room 4 leads to the cellar (Plate 18). These rooms appear to have been contrived from a single large original room.

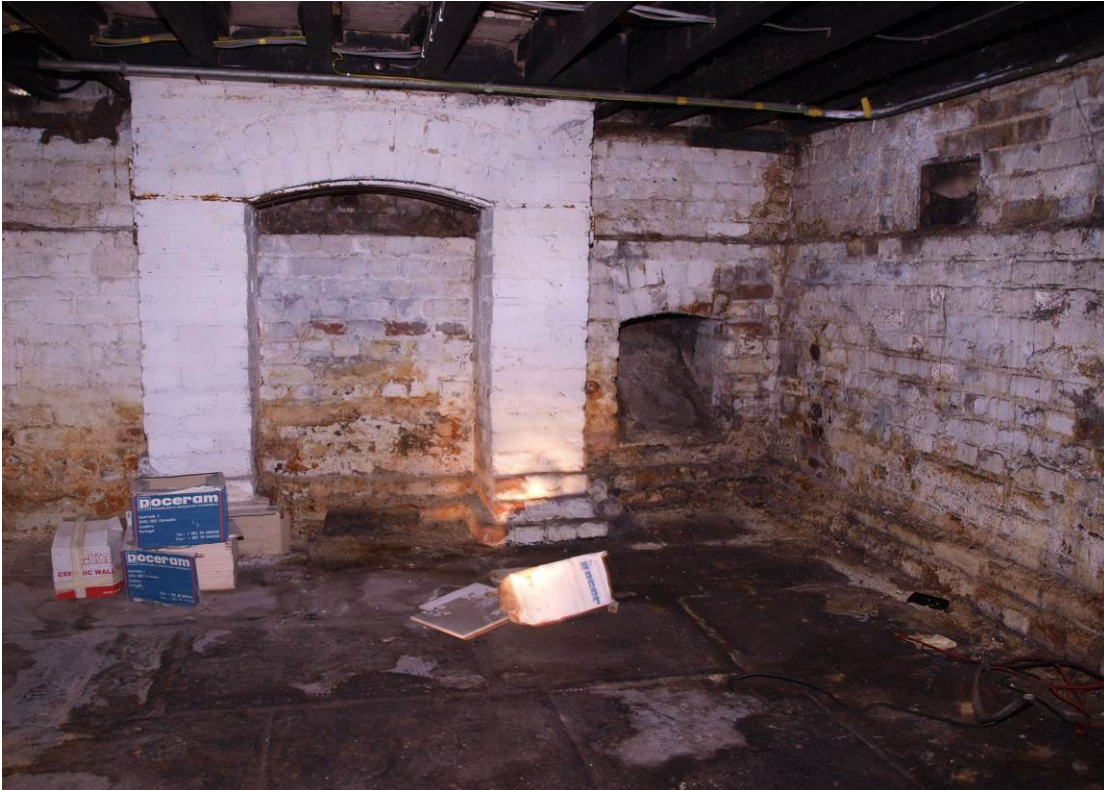
Plate 23: Cellar, looking south (54)

6.2.18 The cellar is accessed via a flight of steep timber stairs, through a trap door in the floor of Room 4. It has a low ceiling constructed of deep section softwood joists with narrow softwood floorboards above. The walls are constructed of brick, in stretchers with courses of headers, with a stepped/staggered brick plinth around the perimeter of the cellar. The brickwork has been painted; where this has failed the bricks can be seen to be of smooth orange-red type. A brick relieving arch is constructed beneath the chimney stack on the southern side. To the west side of the stack is a coal chute, and two ventilation holes covered with metal grilles are located in the west wall. The floor is covered with large stone flags (Plate 23).

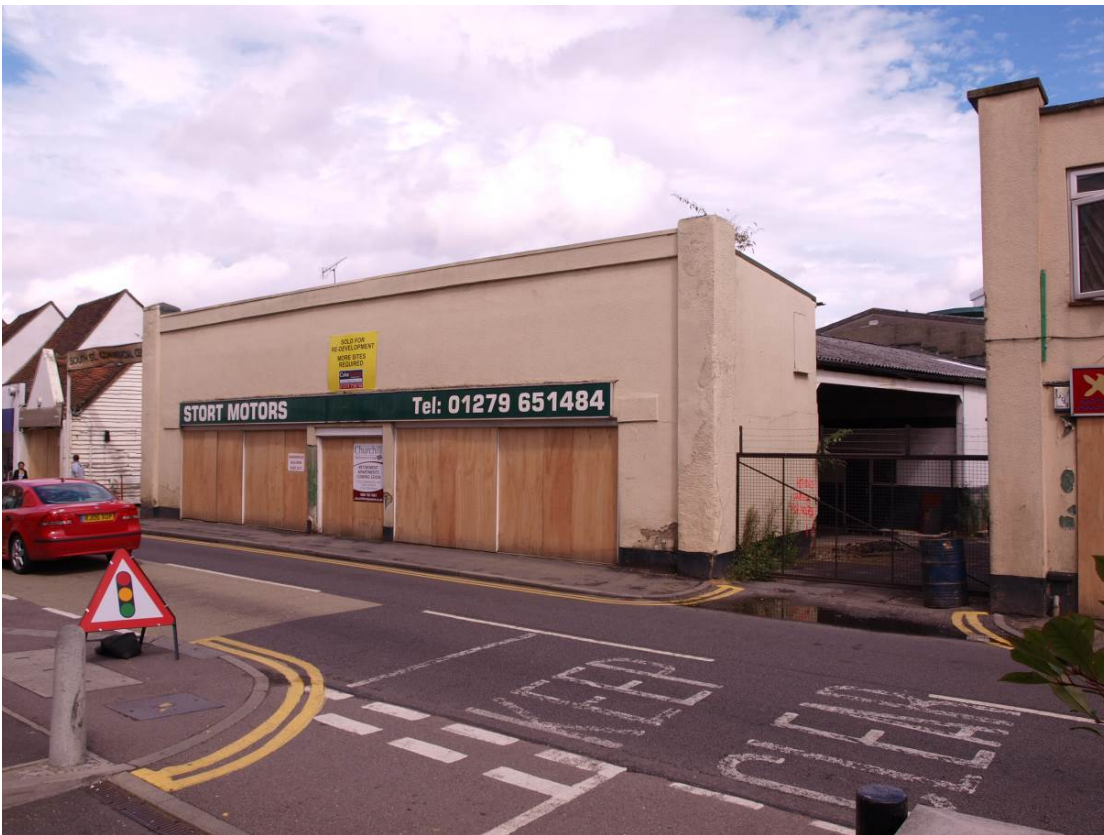
Plate 24: 73 South Street, west elevation (95)

6.3.1 73 South Street is a former car showroom. The principal building faces onto South Street and has a wide frontage to its west elevation, with large windows at ground floor level only, and a central doorway; all were boarded over at the time of inspection. The building is two storeys in height, but presents a blank façade at first floor level. The front elevation has a plain square pilaster at either end, with pyramidal capping on the northern side; this is missing on the southern side. A long modern fascia runs the full width of the building above the ground floor glazing. This elevation is rendered. The roof is a mono-pitch roof sloping down from the front parapet (Plate 24).

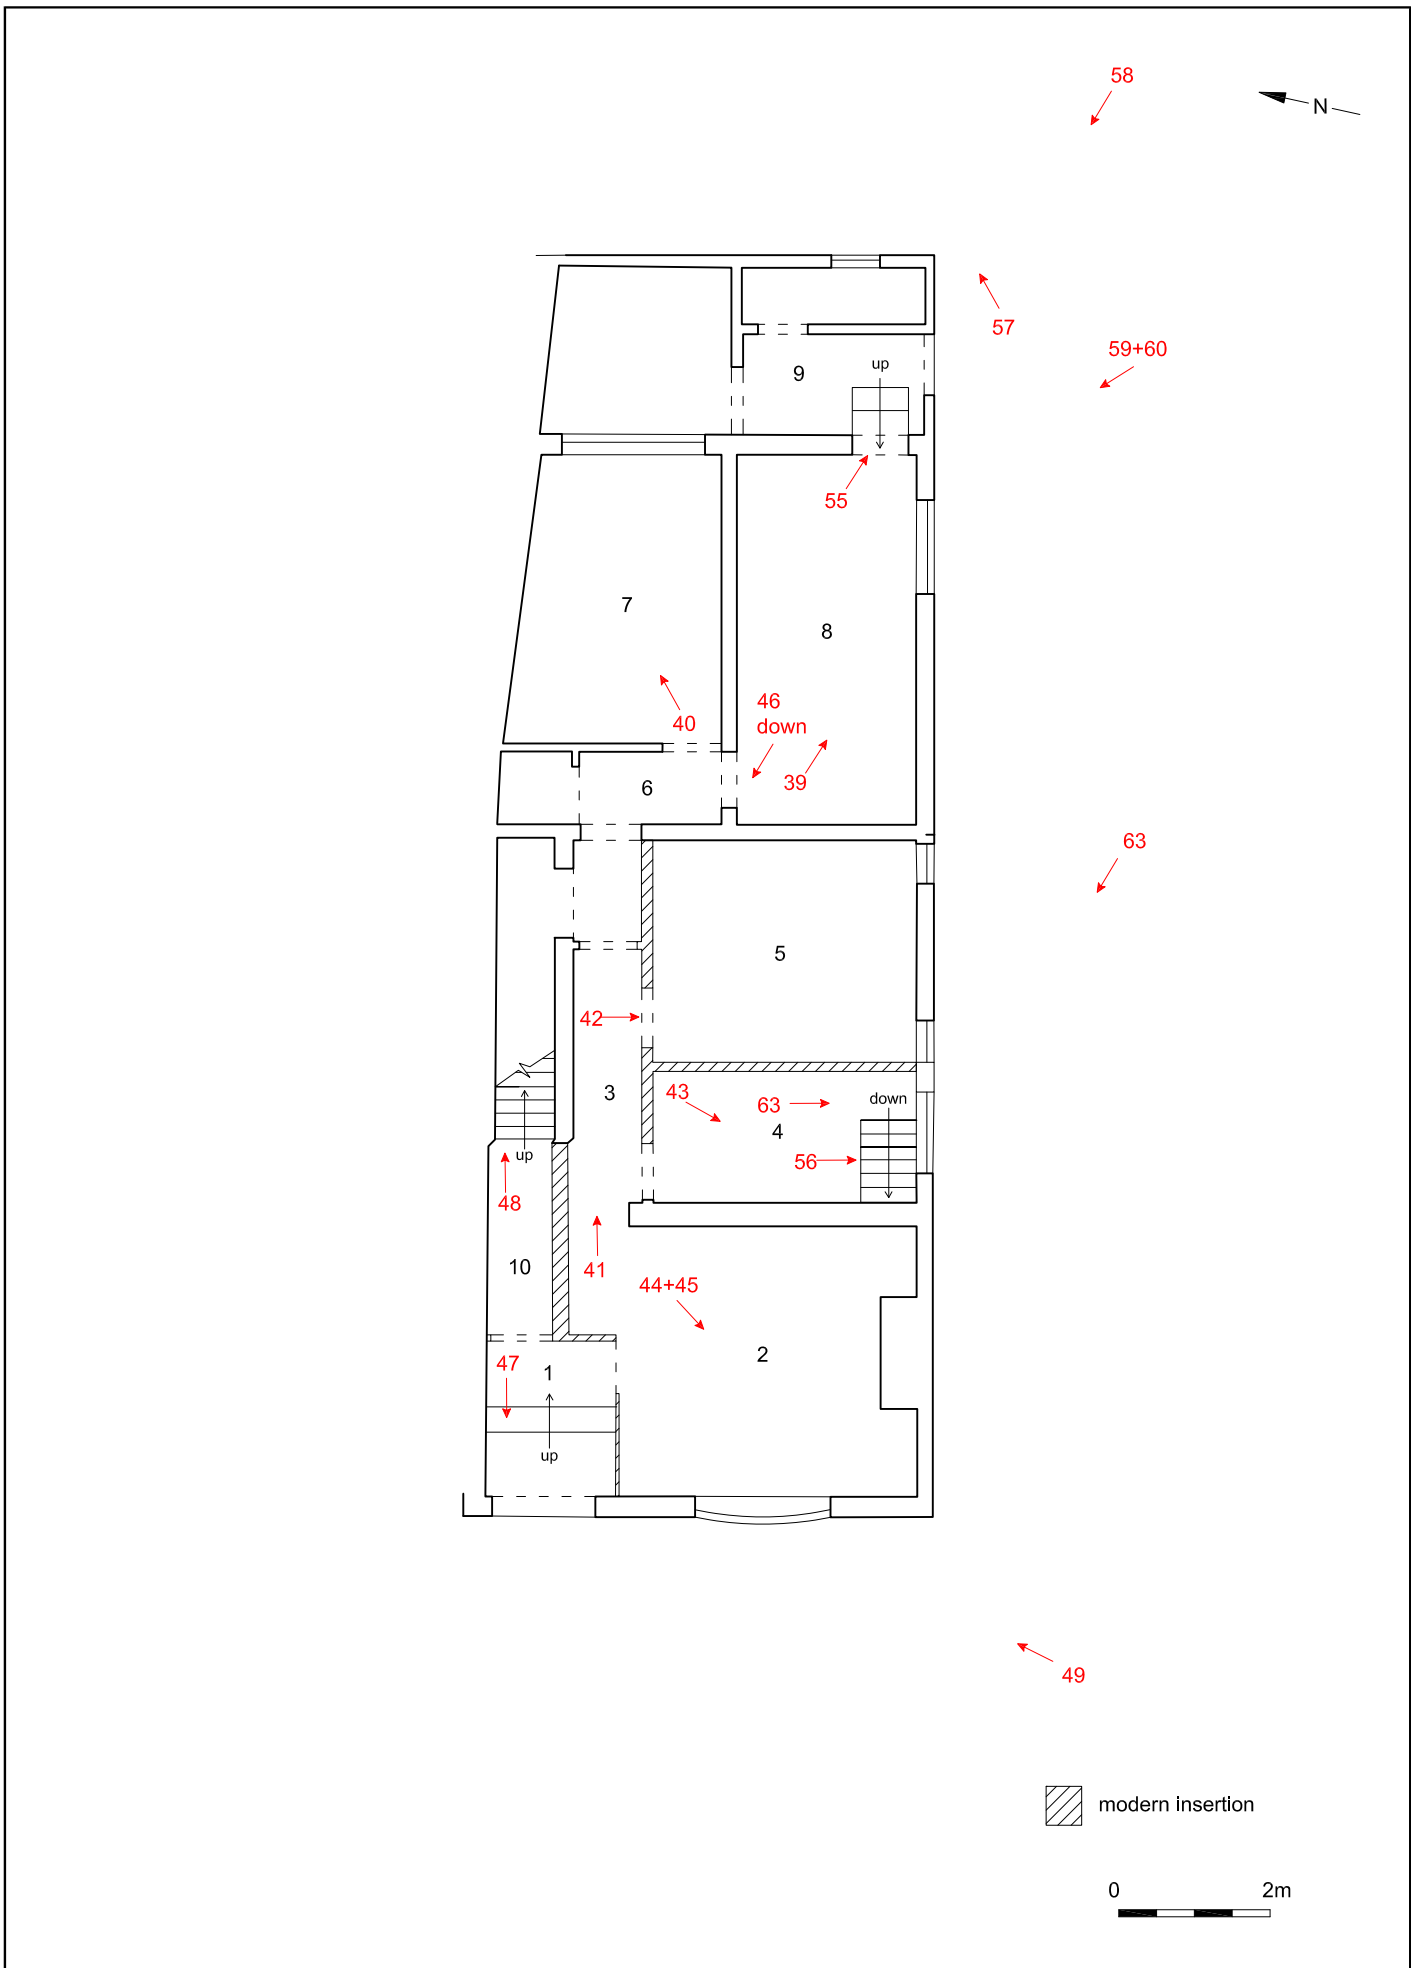
© Archaeology South-East		71-77 & South Street Commercial Centre, South Street, Bishop's Stortford	Fig.14
Project Ref: 6241	August 2013	77 South Street: Ground floor plan and photo locations	
Report Ref: 2013181	Drawn by: KRH

Interior – Ground Floor (Fig. 14)
