ST MARK'S CHURCH, ROSE LANE, MARK'S GATE

HISTORIC BUILDING RECORD

(ENGLISH HERITAGE LEVEL 3)

ASE Project No. 6291

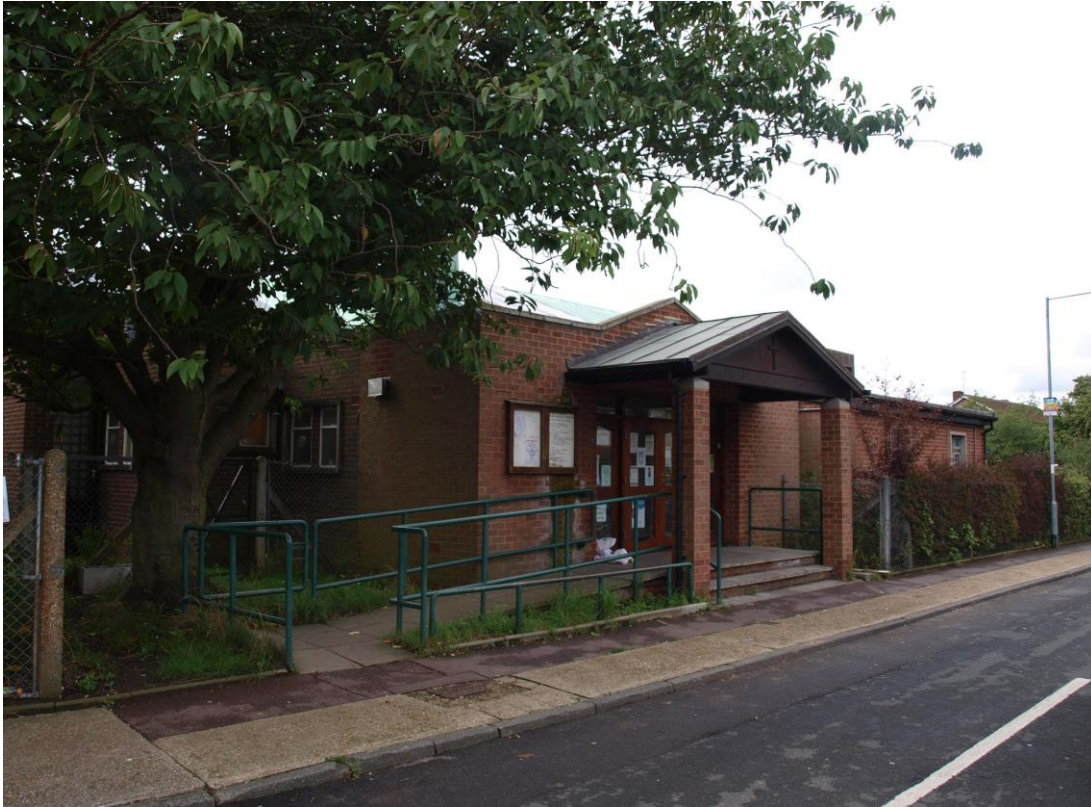
Plate 1: The principal entrance on the north elevation, looking south-west (20).

- 6.1 The Church has, in effect, two formal elevations, as it occupies a corner site and fronts onto both Rose Lane and Arneways Avenue.
- 6.2 The north elevation, facing Rose Lane, is the principal elevation and contains the main entrance to the church (Plate 1). This is now contained within a later extension to the building of pale brown brick mottled with blue tones. The extension forms a single storey structure, largely flat-roofed with a central pediment, in front of which is a simple, open-sided porch defined by two square brick piers and a pitched roof, which echoes the profile of the pediment. The porch roof is clad in copper with standing seams and has a gable of stained timber, with a timber cross affixed centrally. The porch is accessed via steps on the north side, and a side ramp on the east side. These are constructed of matching brick, topped with concrete slabs and both have tubular, painted metal railings. The main entrance doorway consists of simple, glazed double doors with glazed sidelights and three horizontal fanlights above. All are constructed of stained timber, and the frames of the doors and sidelights are detailed with bevelled outer corners and a central, wide, plain transom, creating polygonal panes of glazing.

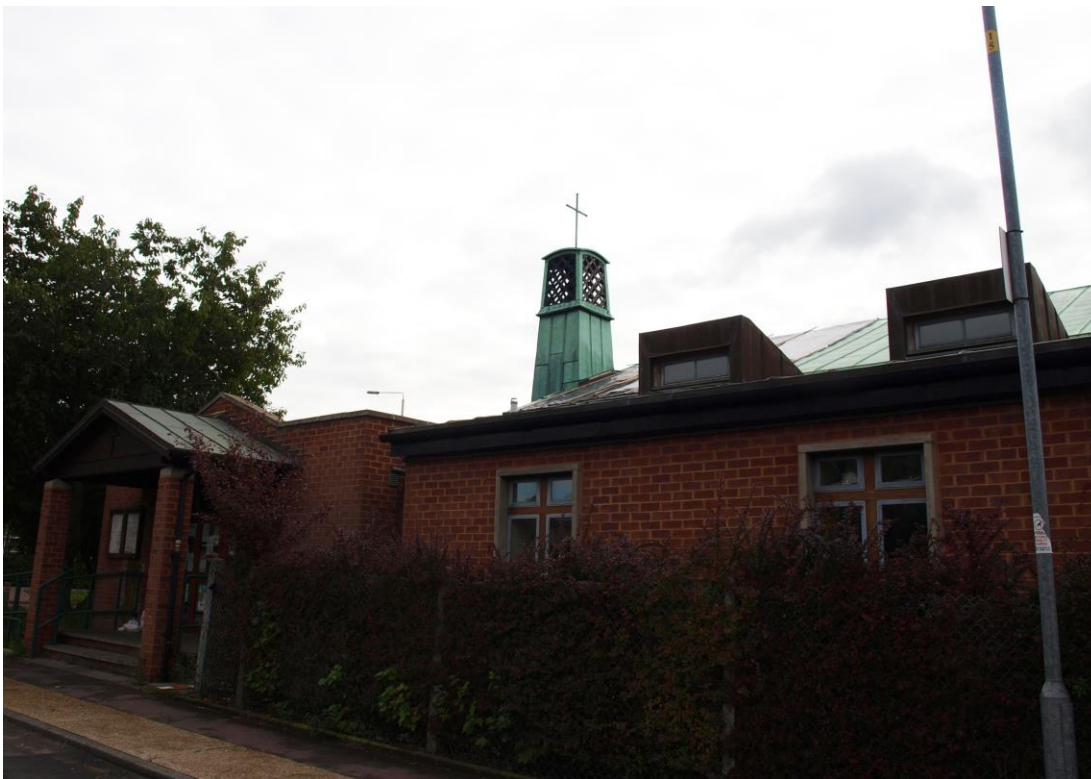
Plate 2: The north elevation, showing the meeting room, porch and bell turret behind (25).

- 6.3 East of the main entrance block is a small, single storey flat roof element, part of the original church and set back from the north building line. It is constructed in brown brick with a metal framed casement window facing north. West of the main entrance is the meeting hall, which is attached via a small, recessed brick structure with a flat roof. The meeting hall is constructed in the same brick, with two oak mullion and transom windows with metal casements and top-opening lights. The roof is mono-pitch, pitching south to meet the original building, and has wide timber soffits and is clad with copper sheet with standing seams. Two dormer windows are set in the roof; these are also clad in copper and have narrow, horizontal, metal-framed windows with central glazing bars (Plate 2). The meeting room block encloses the wall of the main nave behind; two small sections remain visible at both the east and west ends, both with high level metal-framed windows.

- 6.4 The main roof to both the nave and chancel behind is clad in copper with standing seams, which has patinated to a bright green colour. A section of the copper has been removed at the east end of the nave, and is now covered with plastic sheeting. A small copper-clad bell turret projects above the junction of the chancel and nave (Plate 2). This is four-sided and tapers to a curved top; it has lattice work to the upper third and is surmounted with a cross.

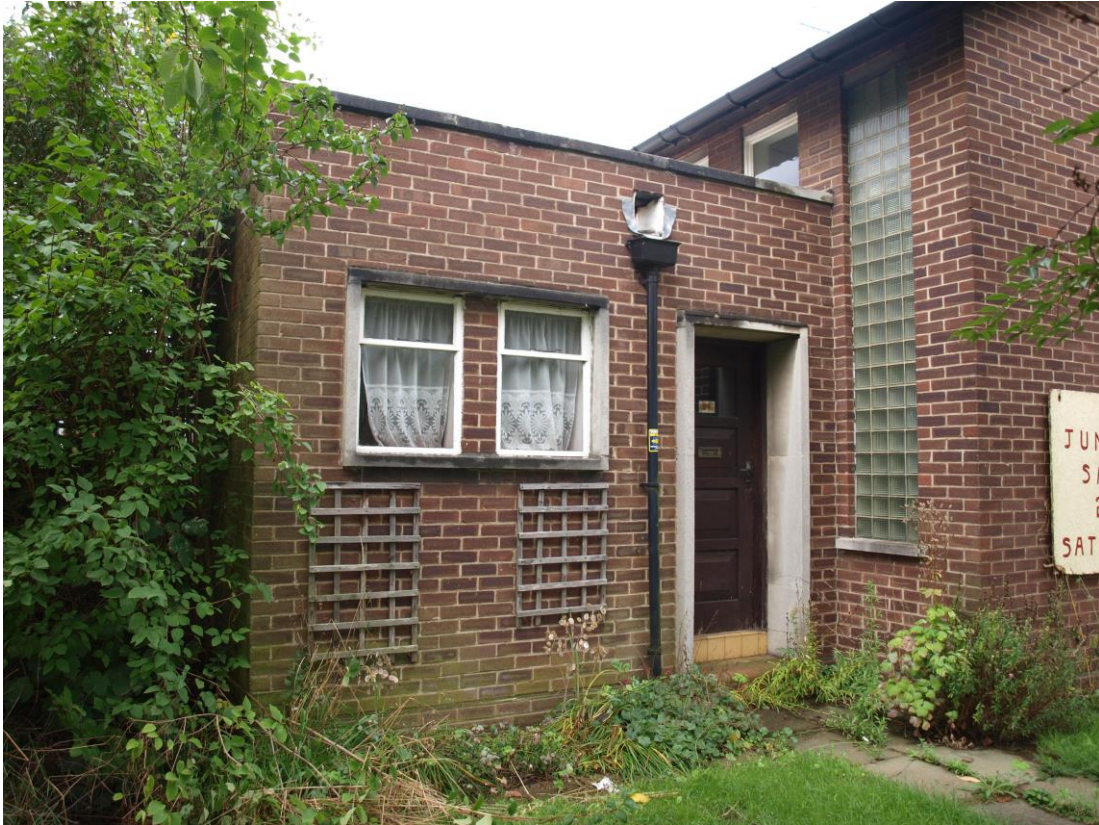
Plate 3: The east elevation of the vestry (16).

- 6.6 The east elevation is fairly plain, all constructed from brown brick in stretcher bond. It consists of the central chancel and sanctuary, which is two storey in height, with lower, single storey flat-roof elements to either side (Plate 3). To the south is the vestry, which has a pair of metal-framed windows with top-opening lights set in a concrete surround, immediately north of which is a timber door of four stacked panels; the bottom three are simply bevelled and the top panel is glazed. The doorway has a tiled step set on a brick threshold and is also set in a concrete surround. The chancel and sanctuary is gabled, with a deep overhanging verge with timber bargeboard. Detailing is provided by a cross constructed in projecting brick with a tiled centre located beneath the gable. Below this is a timber sign, engraved with 'St. Mark's'; the text is painted black to give emphasis (Plate 4). To the north, the elevation continues as a series of single storey, flat-roofed brick elements, with concrete-topped parapets and matching windows, which then meet with the later entrance-way extension.

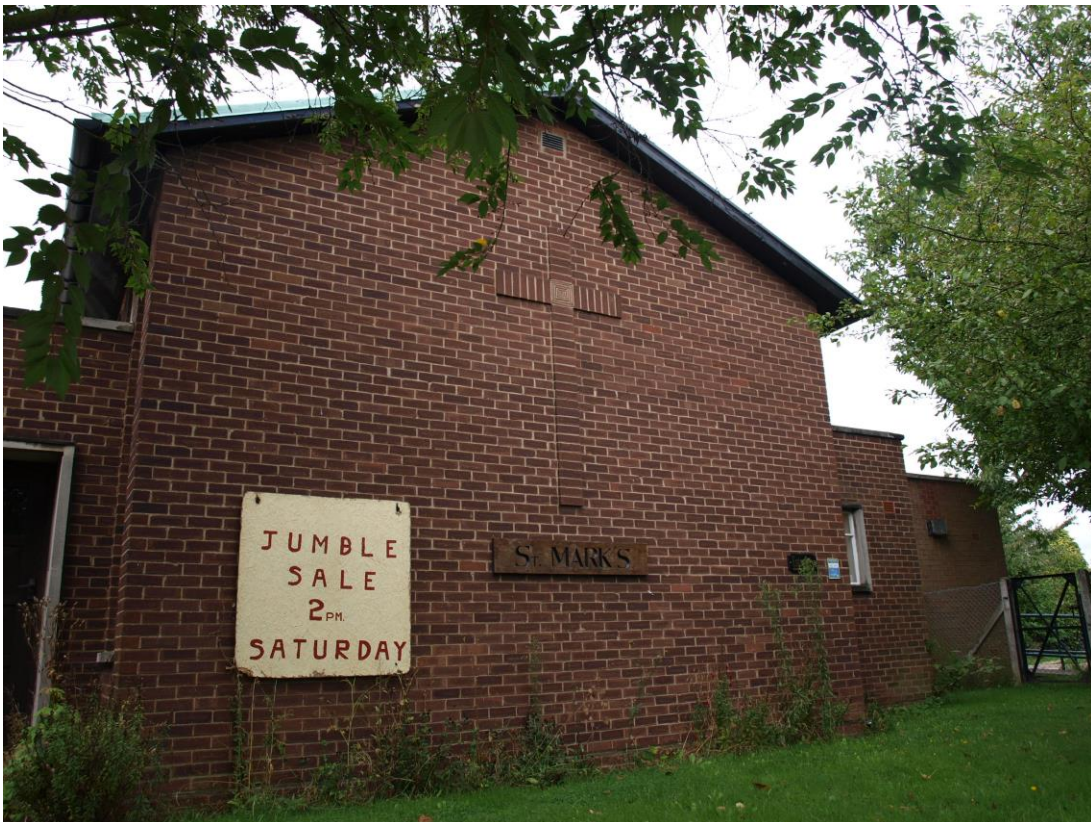
Plate 4: The east elevation of the chapel/choir and sanctuary (17).

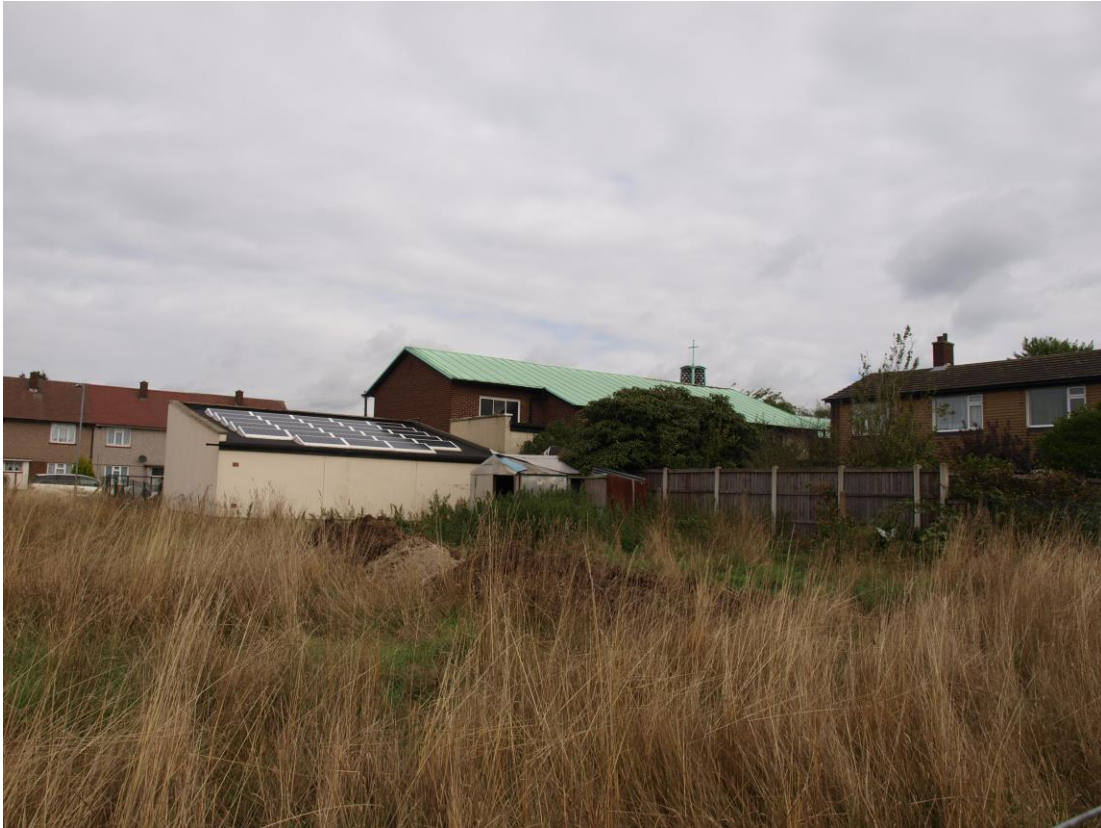
Plate 5: The south elevation (30).

- 6.7 The south elevation of the nave is a mix of render and brick, with a number of high level, metal-framed casement windows beneath the eaves. The roof is recessed at the west end below which is a small, rendered, flat-roofed extension, of one and a half storey height. The roof of the mono-pitched later addition to the west is covered with felt tiles and supports a number of solar panels (Plate 5).

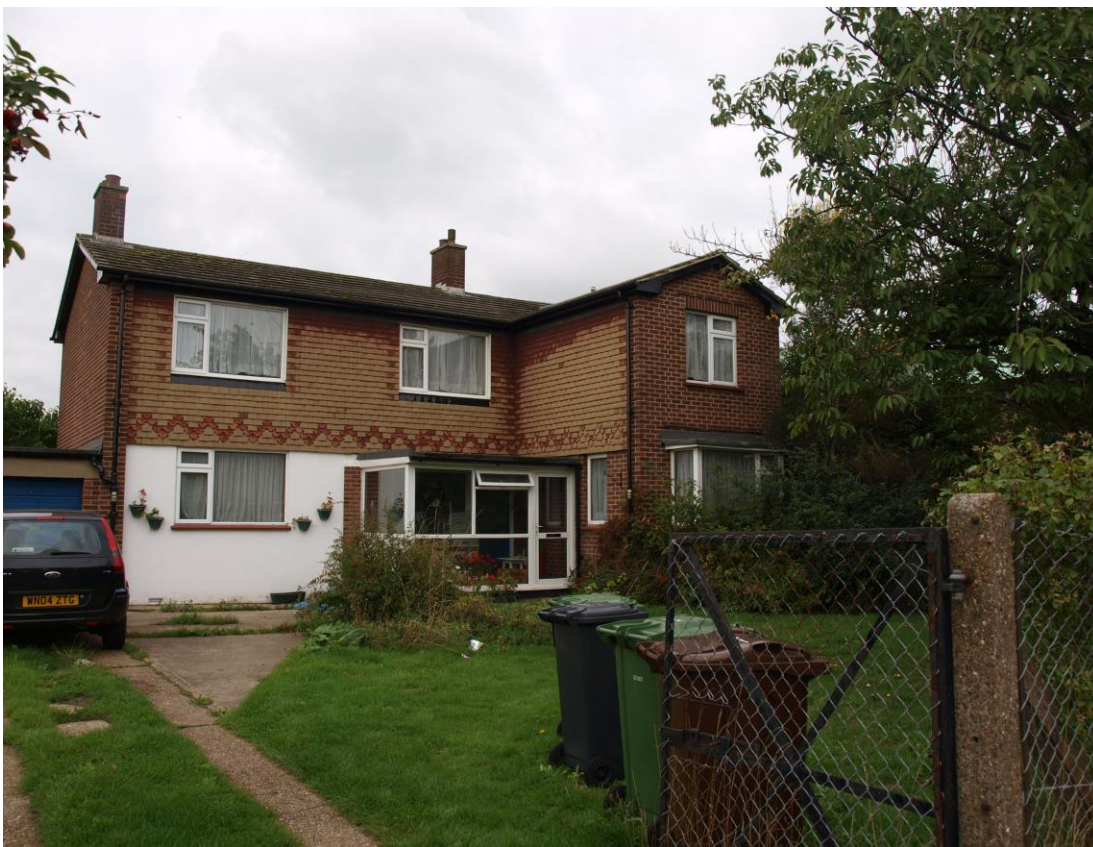
Plate 6: The Vicarage, looking north-west (13).

- 6.9 The vicarage is located south of the church, and is physically attached to it by a small, narrow, single storey link building. It is a two-storey, L-shaped building which fronts onto Rose Lane, rendered at ground floor level and clad with tile hanging to the upper floor. The roof is covered with cement tiles, and a simple brick chimney is located at either end. A two storey extension constructed in brown brick projects east from the north end of the front elevation. The building has uPVC windows and a projecting uPVC front porch with a shallow-pitched felt roof (Plate 6).

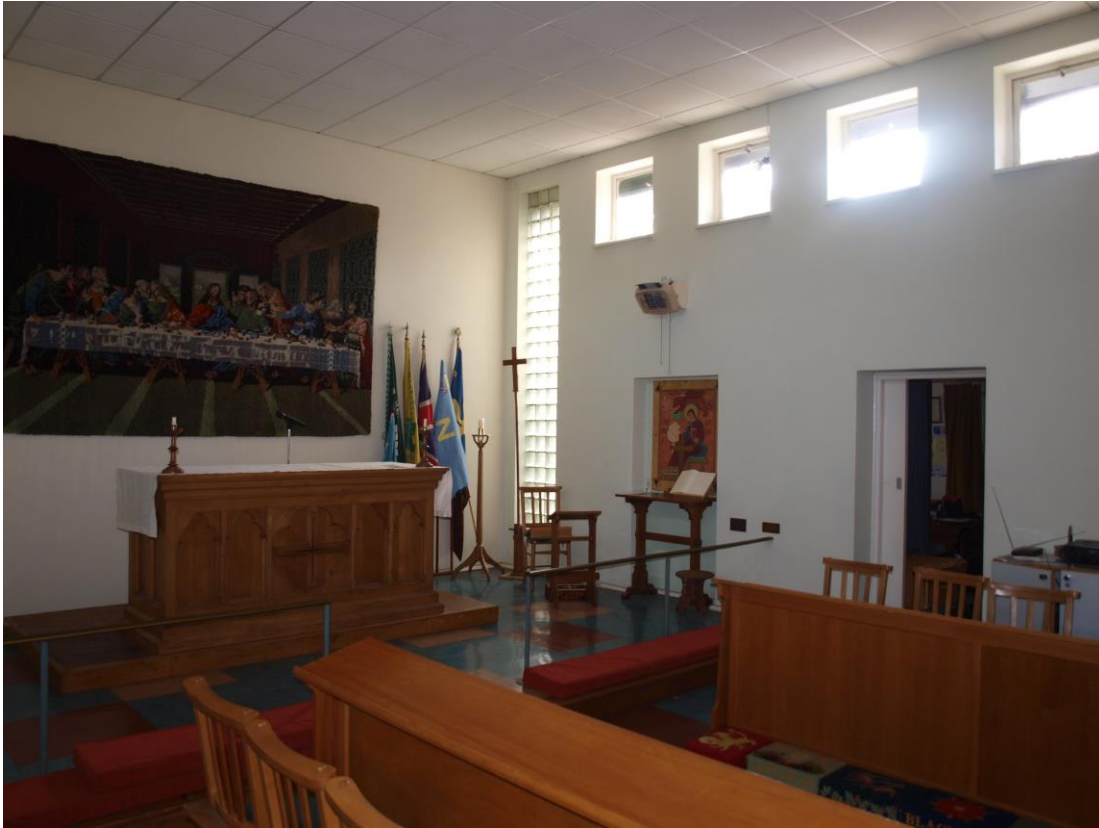
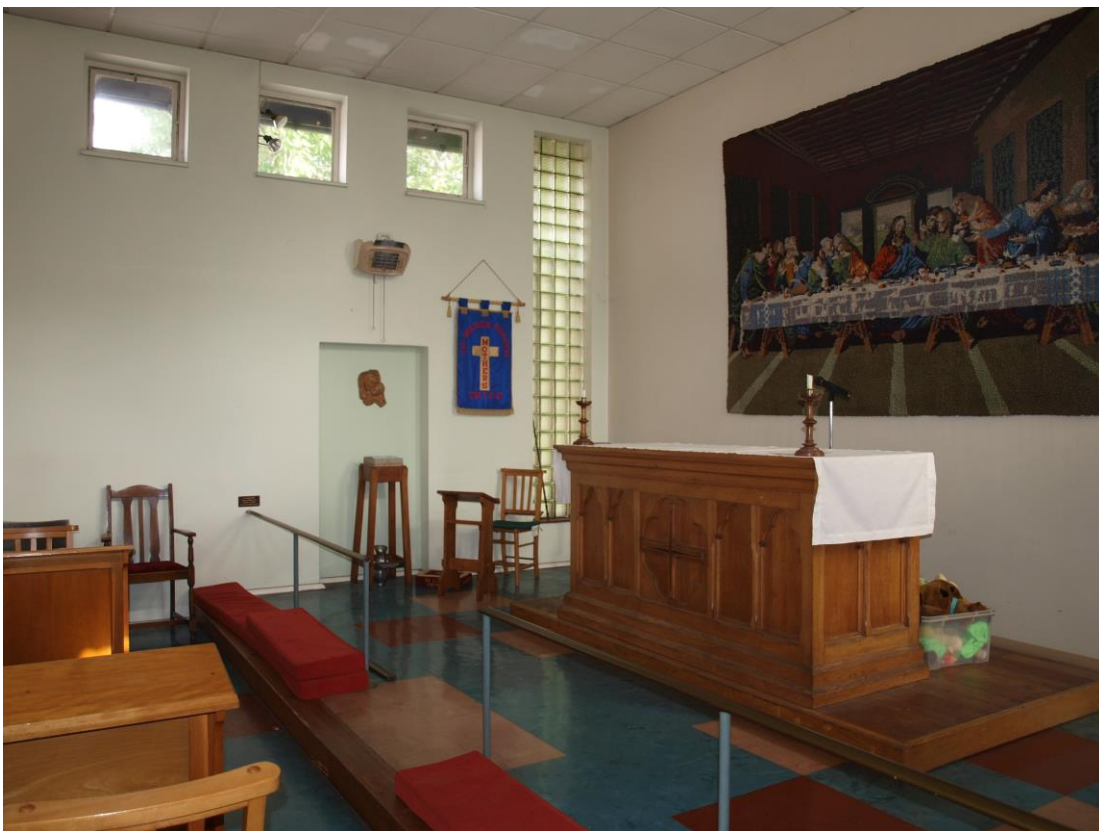
Plate 7: The chapel/choir and sanctuary, looking south-east (7).

Plate 8: The chapel/choir and sanctuary, looking north-east (6).

- 6.12 The chapel/choir (Room 3) is also plain in appearance, but has slightly more detailing than the nave (Plate 7 and 8). The walls are smooth plastered, the floor is covered with vinyl tiles and it has a suspended ceiling of polystyrene tiles. The sanctuary is located at the east end and has a slightly raised floor level, delineated from the chapel/choir by a simple timber rail supported by widely spaced, slender metal uprights. It contains a hardwood altar set on a raised platform; the altar's principal face is detailed with a central cross with arms of equal length, and two trefoil-headed panels to either side. The sides are also detailed with these panels. It is finished with a simply moulded cornice and plinth. Two single rows of simple, hardwood stalls, sit perpendicular to the altar, on either side of the chapel/choir. These consist of three panels with chamfered edges, with an angled boarded top and I-shaped side panels; chairs are placed behind. A piano is located in the south west corner. The south wall consists of a central doorway with plain timber sliding door. Two blocked doorways to either side form recesses and five square clerestory windows are situated at high level. At the east end is a full height narrow window glazed with glass blocks. The north wall has a matching full height window at its east end, and matching clerestory windows. There is a

- 7.3 The chapel/choir and sanctuary form a contemporary room; however, elements of the fittings provide a more traditional feel, such as the altar which employs trefoil-headed arch panels in its design. The simplicity of the room itself, with white painted, plastered walls, imparts a tranquil feel and provides emphasis and prominence to the wall hangings and fittings such as the altar and stalls. The light afforded by the full height glazing at the east end also adds prominence to the altar. The design throughout the nave and chancel/chapel, with abundant glazing, including full-height and clerestory windows was clearly intended to maximise the amount of natural light to these areas.

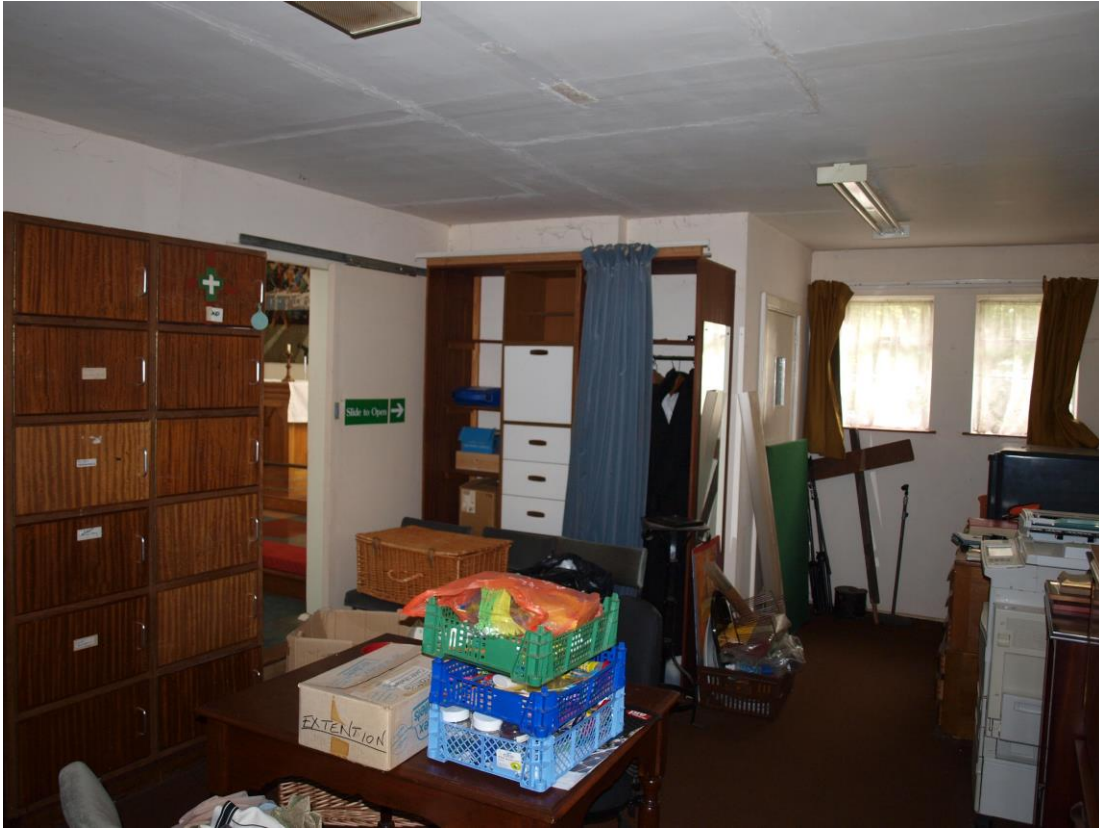
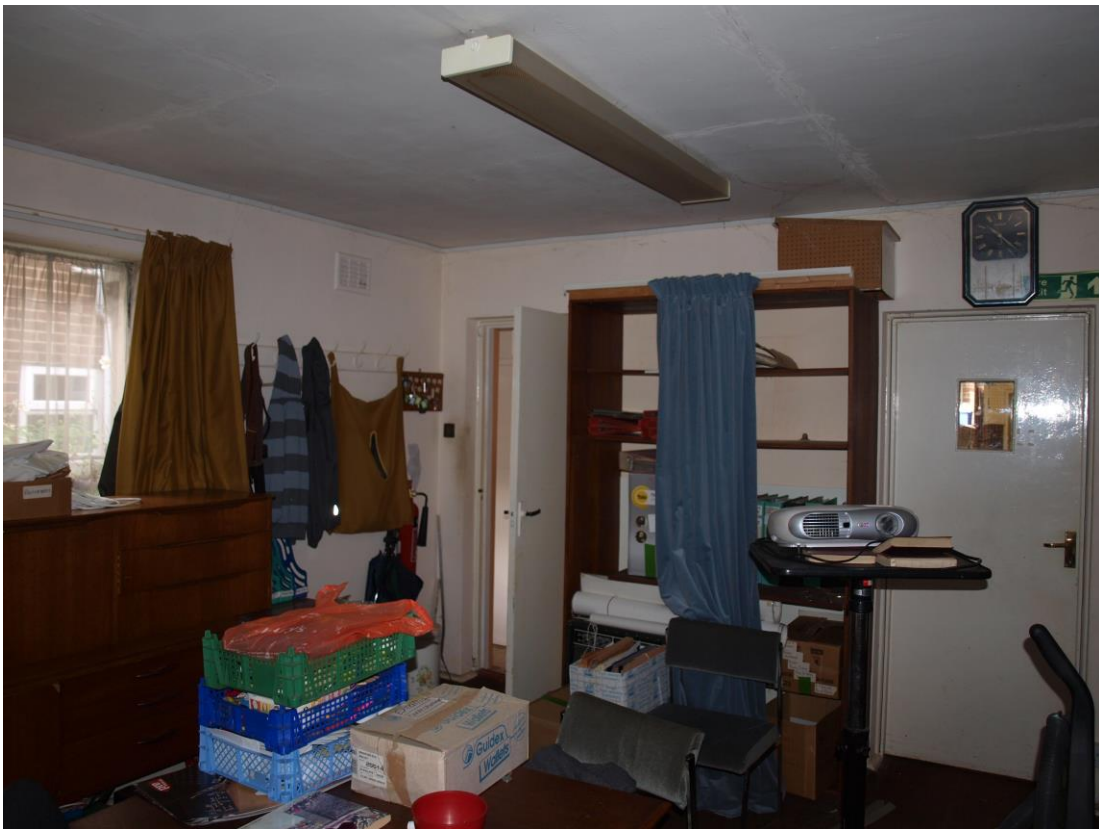
Plate 9: The vestry, looking east (4).

Plate 10: The vestry, looking west (5).

- 6.13 The vestry (Room 4) is accessed via the south door from the chapel/choir, and also serves as an office and store (Plates 9 and 10). It has plain plastered walls and ceiling with simple, quarter-round skirting. The floor is carpeted over vinyl tiles. The east wall contains two small metal-framed windows with top-opening lights and cills of terracotta tiles. The south wall has two larger metal-framed windows consisting of two fixed panes with a top opening light to one side, and tiled cills. The west wall has two doorways; the north door leads to the nave and the south to a small corridor/link which provides access to the vicarage. A small lobby is situated in the north east corner leading to an external door; the lobby has smooth plastered walls and ceiling and is floored with yellow quarry tiles. The door is hardwood with a glazed upper panel and is surrounded by a simple bevelled architrave.

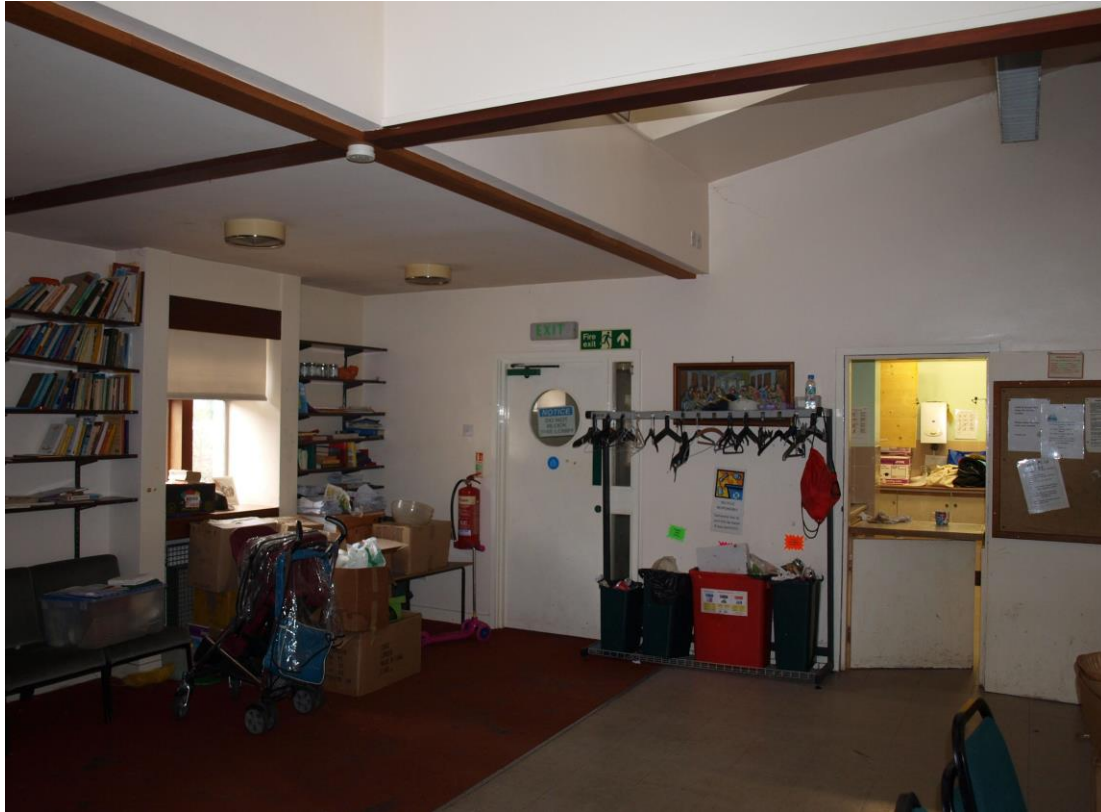
Plate 11: The meeting hall, looking north-east (11).

- 6.14 The church has been extended on its north side to provide an additional lobby, store rooms, larger kitchen area and a meeting hall (Room 5). The meeting hall is located immediately north of the nave; the former clerestory windows of which are now enclosed within the room. The room has smooth, plastered walls and ceiling; the floor is partly carpeted and partly covered with vinyl tiles. The ceiling is of an interesting design, being flat to the northern half of the room then sloping up to meet the main building in the southern half. The sloping ceiling contains two high-level dormers with metal-framed windows. The hardwood joists supporting the ceiling are exposed and form a cross detail (Plates 11 and 12). The east wall contains two doorways; the north leads to a small corridor to the lobby, the south to the kitchen. The north wall contains two windows which are metal-framed with hardwood mullion and transom and deep hardwood cills (Plate 13). The lower two panes are fixed, the upper are top-opening. The west wall contains three doors leading to storage cupboards. The south wall is formed by timber folding doors which lead to the nave. The kitchen to the east has smooth plastered walls which are partly tiled, and a range of kitchen cupboards and work surfaces. The meeting room links to the lobby to the east via a small, plain corridor with one high level metal-framed window and a storage cupboard on the north wall, and a storage cupboard on the south wall. Both cupboards have a set of double, plain, painted timber doors. The doors to the lobby and the meeting room are plain, painted timber with a circular upper panel glazed with Georgian wired glass.

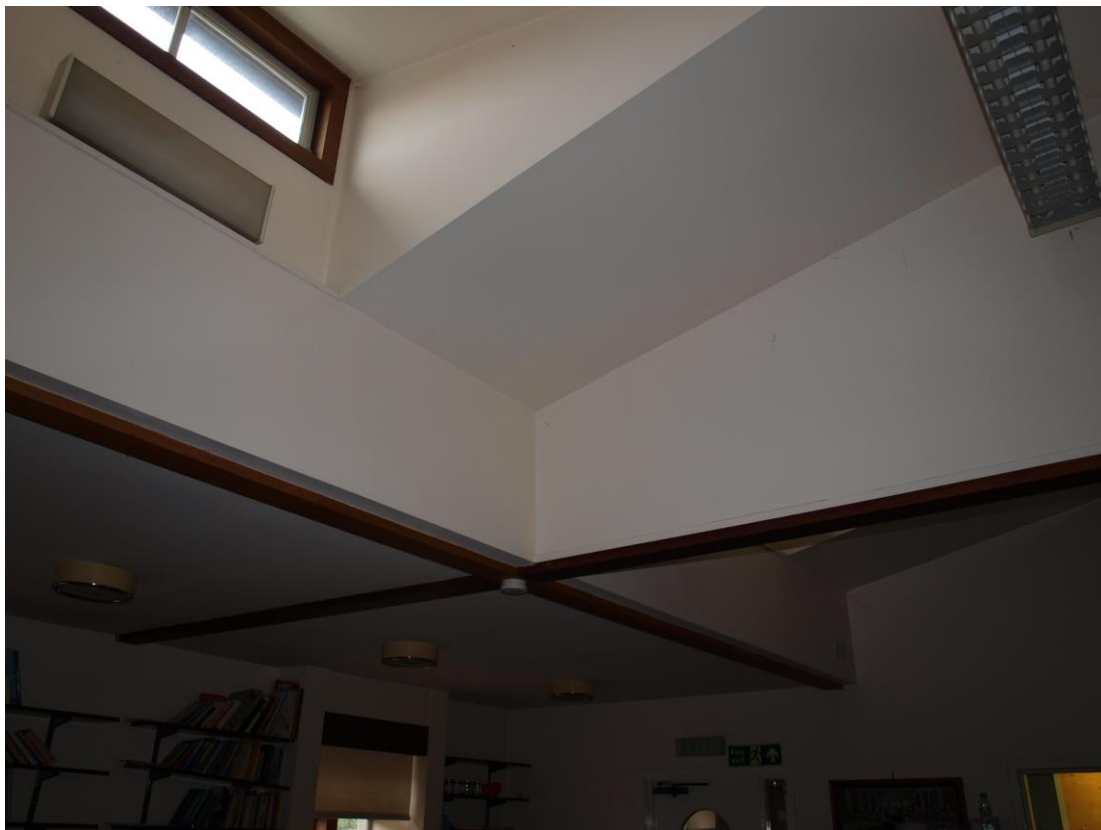
Plate 12: Detail of meeting hall ceiling (8) .

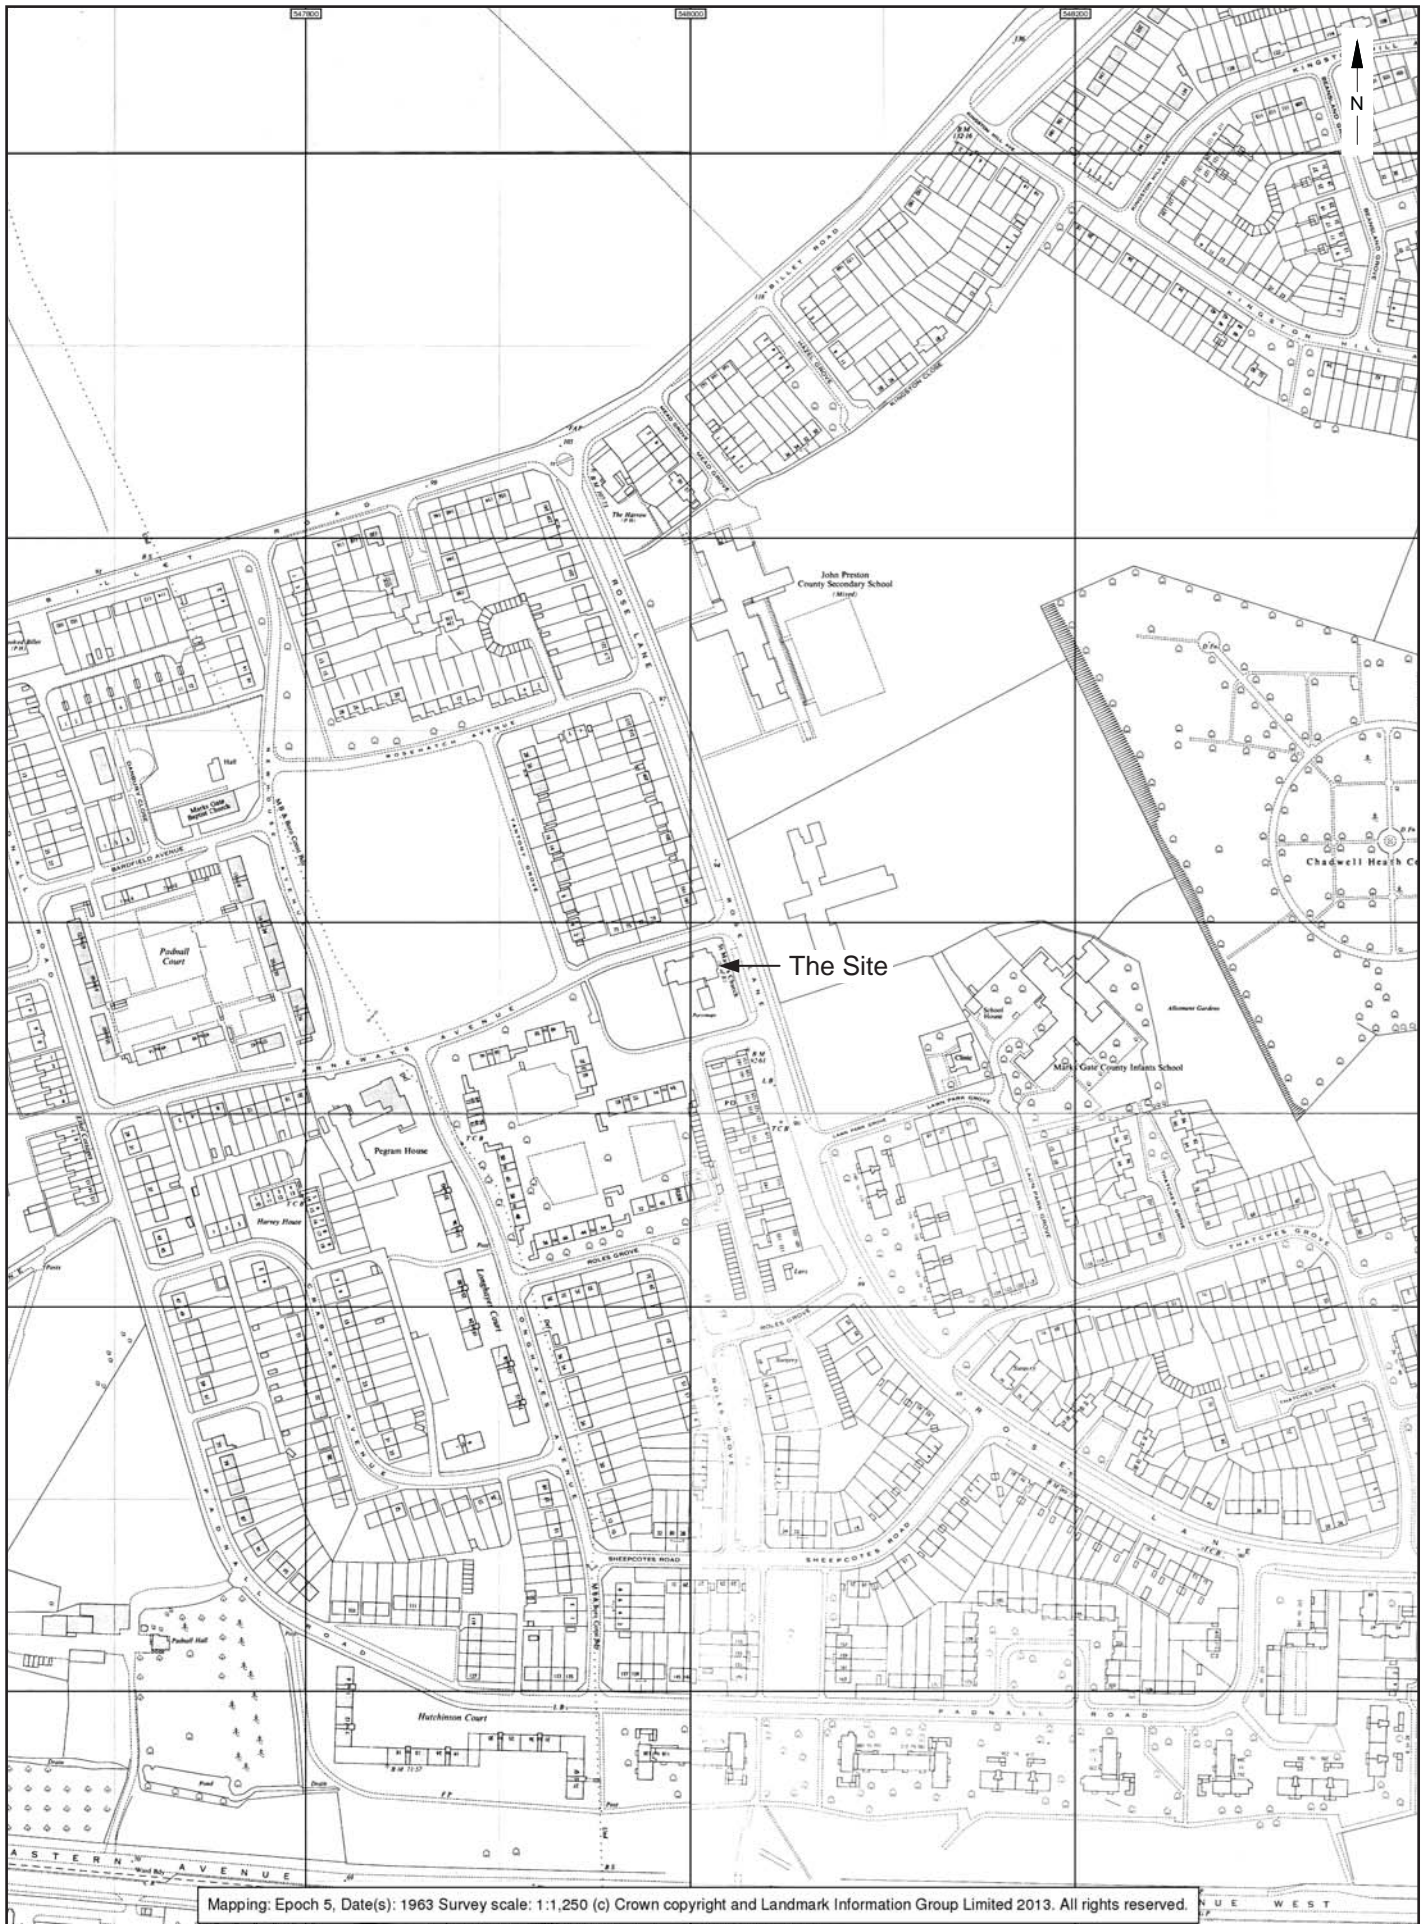
© Archaeology South-East		St Mark's Church, Rose Lane, Mark's Gate	Fig. 5
Project Ref: 6291	Sept 2013	OS map, 1963, 1:1250	
Report Ref: 2013235	Drawn by: JLR

- 4.1 Historic Ordnance Survey maps show that at the end of the 19th century the landscape of the Mark's Gate area consisted of open fields/farmland with scattered farmsteads and cottages (Fig. 3), with farms supplying the London markets, and local cottages supplying produce for Romford market (Baker, 1957). The site of St Mark's Church was historically an open field, probably belonging to either Roselane Farm to the east or Padnall's Farm to the south. The landscape remained largely unchanged until the 1950s (Fig. 4). Following the development of the sprawling suburb of Chadwell Heath to the south, the area was developed from 1954 by the Local Authority as the Mark's Gate estate. Two sites were allocated for religious purposes (The Marksman, March 1966), one being the site of St Mark's Church, the other being occupied by the Baptist Church on Bardfield Avenue, 250m to the west. By 1959 the planned estate was complete and included a primary and secondary school, shops and a post office, in addition to the two churches (Fig. 5).
