**Archaeological Watching Brief Report
Coach House Cottage, Mayfield
East Sussex**

**Wealden District Council
Planning Ref: WD/2013/0896/F**

**ASE Project No: 6278
Site Code: CHC 13**

**ASE Report No: 2013245
OASIS ID: archaeol6-165841**

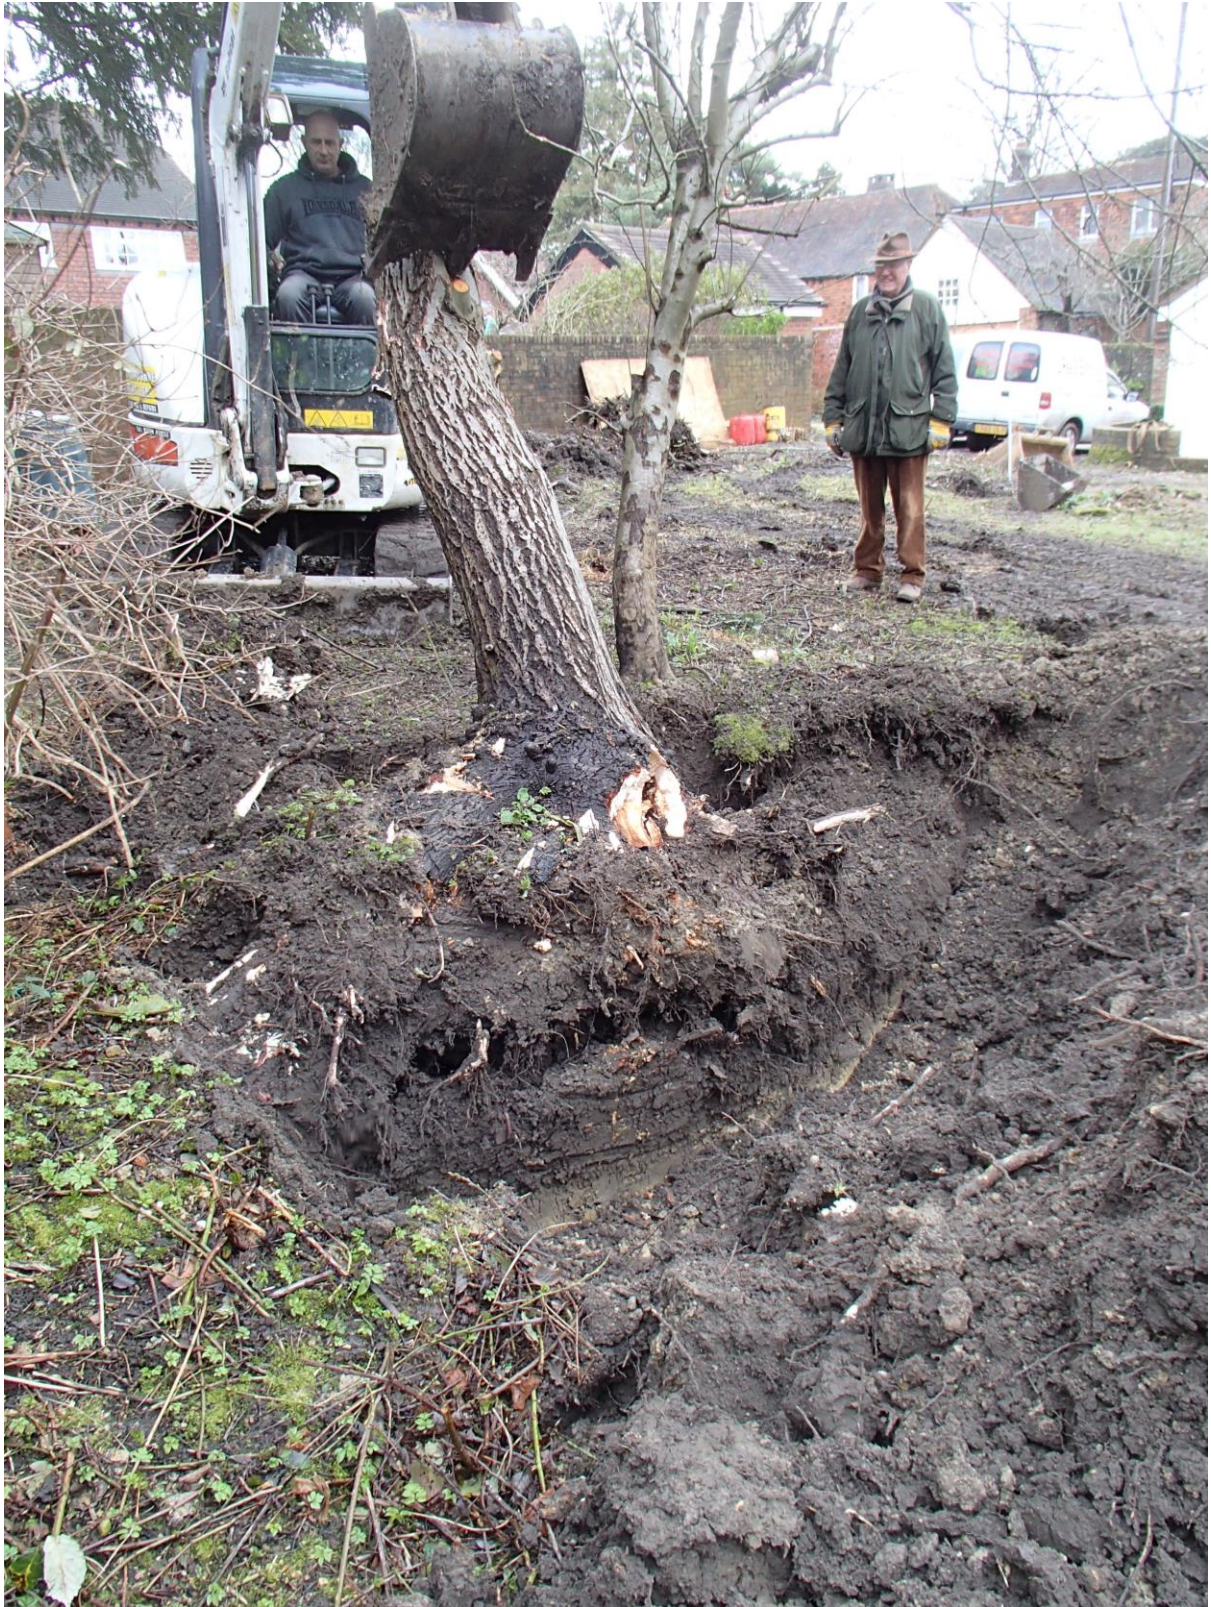
4.1.2 The removal of the twenty-five tree trunks and shrubs revealed the natural greyish yellow silty clay 'natural' geology [002] beneath a 0.55m thick deposit of friable, mid to dark brown silty clay topsoil, context [001]. No archaeological features, deposits or finds were revealed or recovered.

Photograph showing Phase 1 tree removal

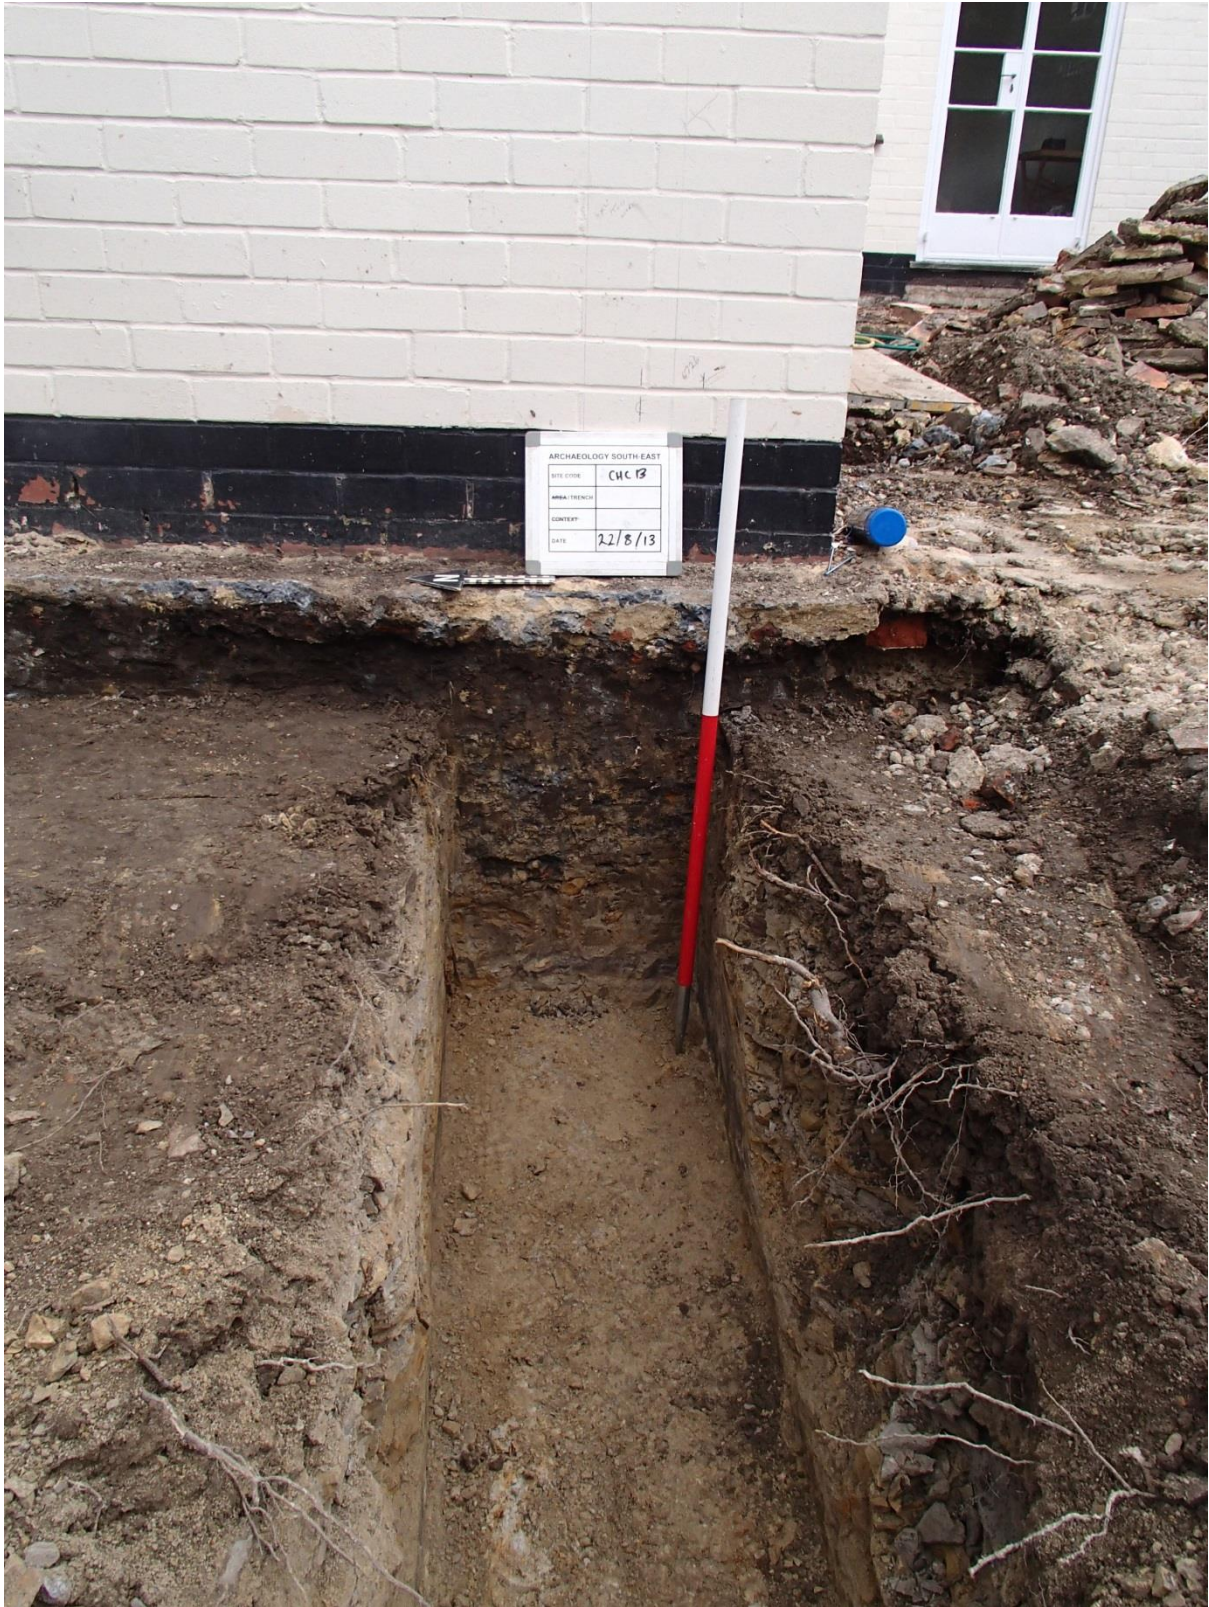
- 3.1.2 Phase 2 took place in August and involved ground reduction an area directly to the west of the existing property, measuring 4m x 6.72m. In addition, mechanical excavation of the footings for the proposed orangery to the south of the property. These were 0.5m wide and 0.4m deep. The area inside these footings was reduced by 0.25m. Phase 3 took place in November 2013 and involved ground reduction (also to 0.25m) adjacent to the existing house and the excavation of small drainage channels and a soakaway.

Photograph showing Phase 2 excavations for a foundation trench to the west of the existing building

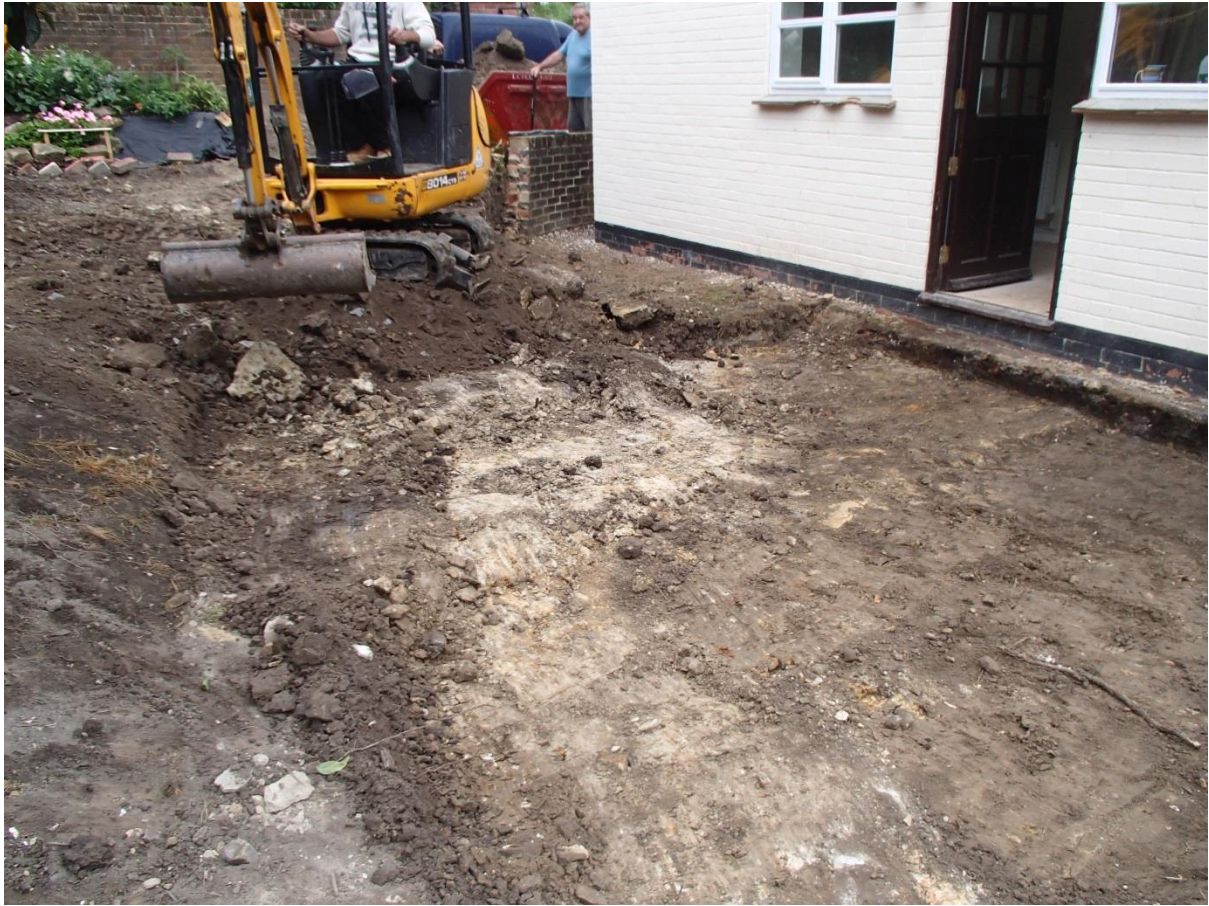
- 6.2 It is perhaps slightly surprising that no archaeological finds or features of note were found, however, this may be explained by the fact that the construction work for the extensions was very shallow and that the removal of trees in the garden caused only very localised disturbance. It might also be reasonable to assume from the results that the monitored areas only ever comprised gardens in the past.

Photograph showing the shallow nature of excavations within the footprint of the new extension to the west of the existing building (Phase 2)

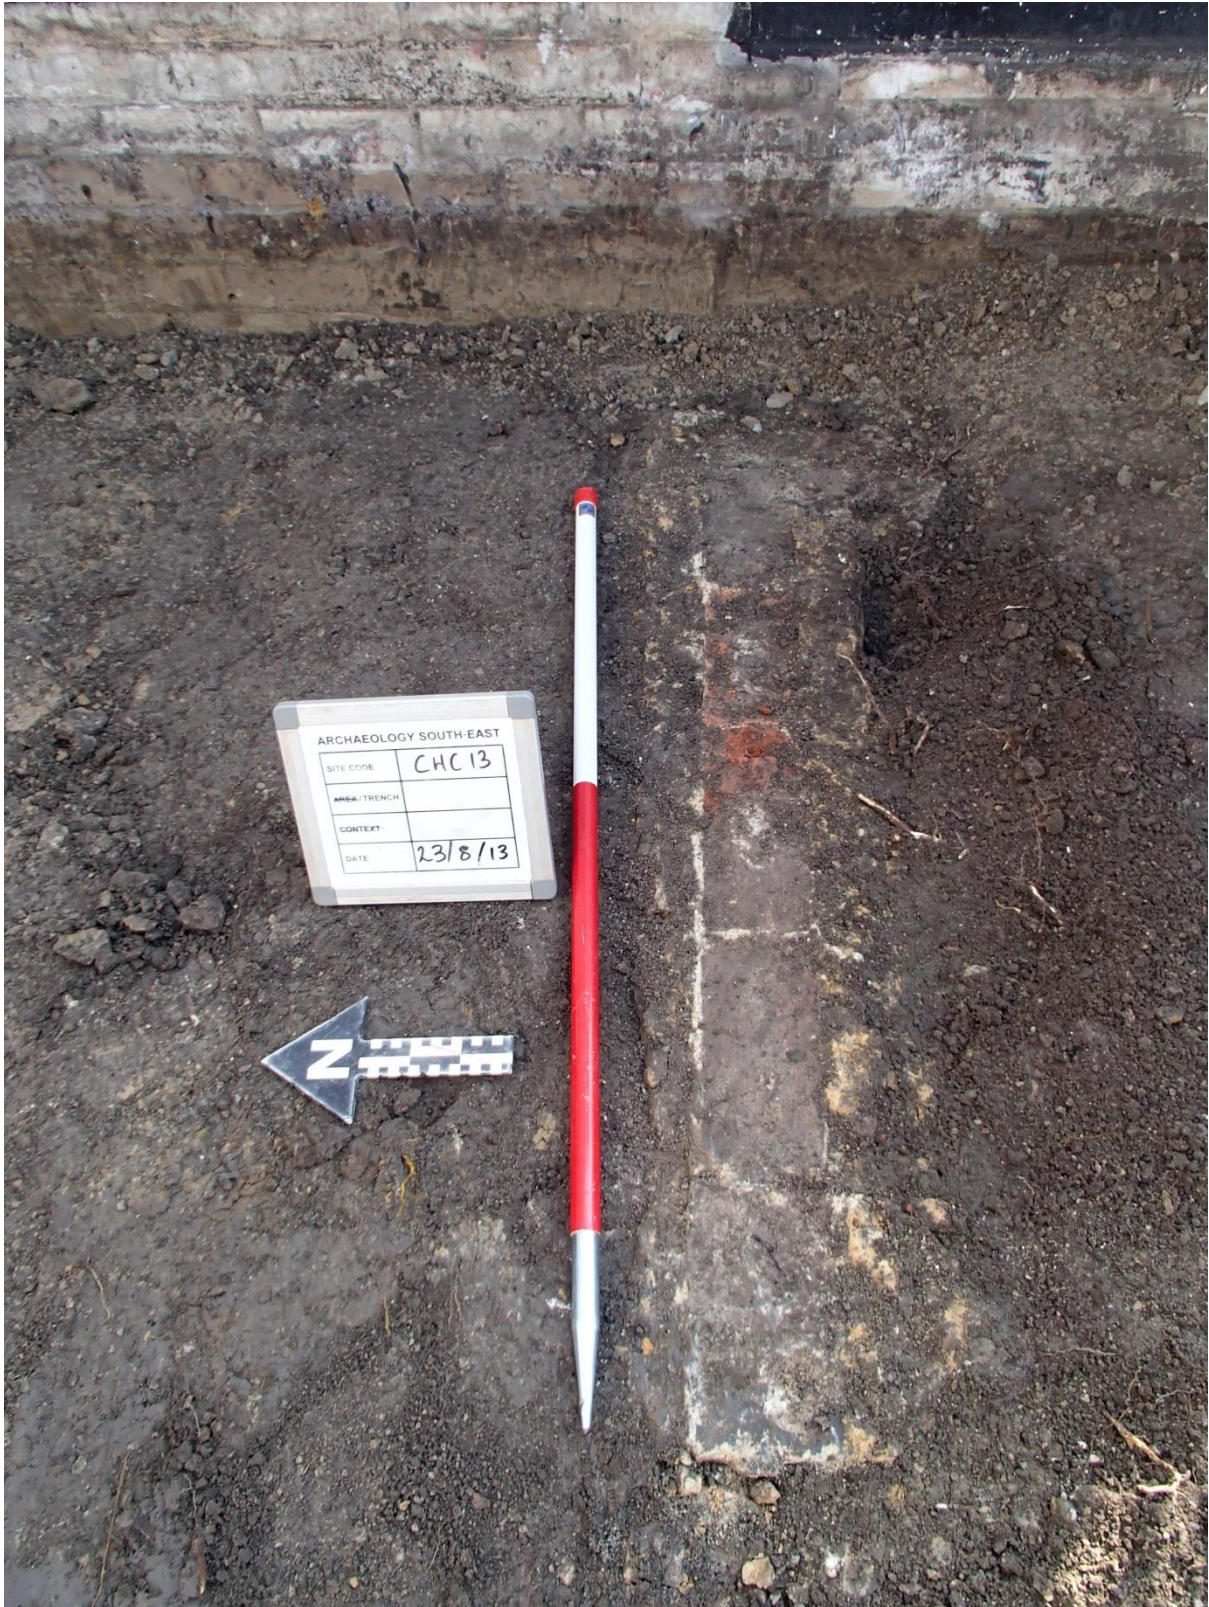
4.2.3 The only features encountered were a 1.4m long, 300mm wide stretch of modern brick-built garden wall [010]. The other feature identified was a 19th/20th century rubbish pit [012], located in the south-west section of the footing excavations. Due to the mixed nature of the made ground and disturbance evident on site, the edges of the pit were indistinct, and therefore the feature was of unknown extent. The fill, context [011] contained glass, metal cookware and ceramics, selections of which were recovered for dating purposes.

- 6.1 Very little of archaeological significance was identified during the archaeological watching brief. The remains of an old garden wall were discovered in the footprint of the orangery. This was most likely knocked down during the construction of the previous extension to the property. The rubbish pit dates from the late 19th century / early 20th century.

Photograph showing the modern garden wall revealed during the Phase 3 groundworks

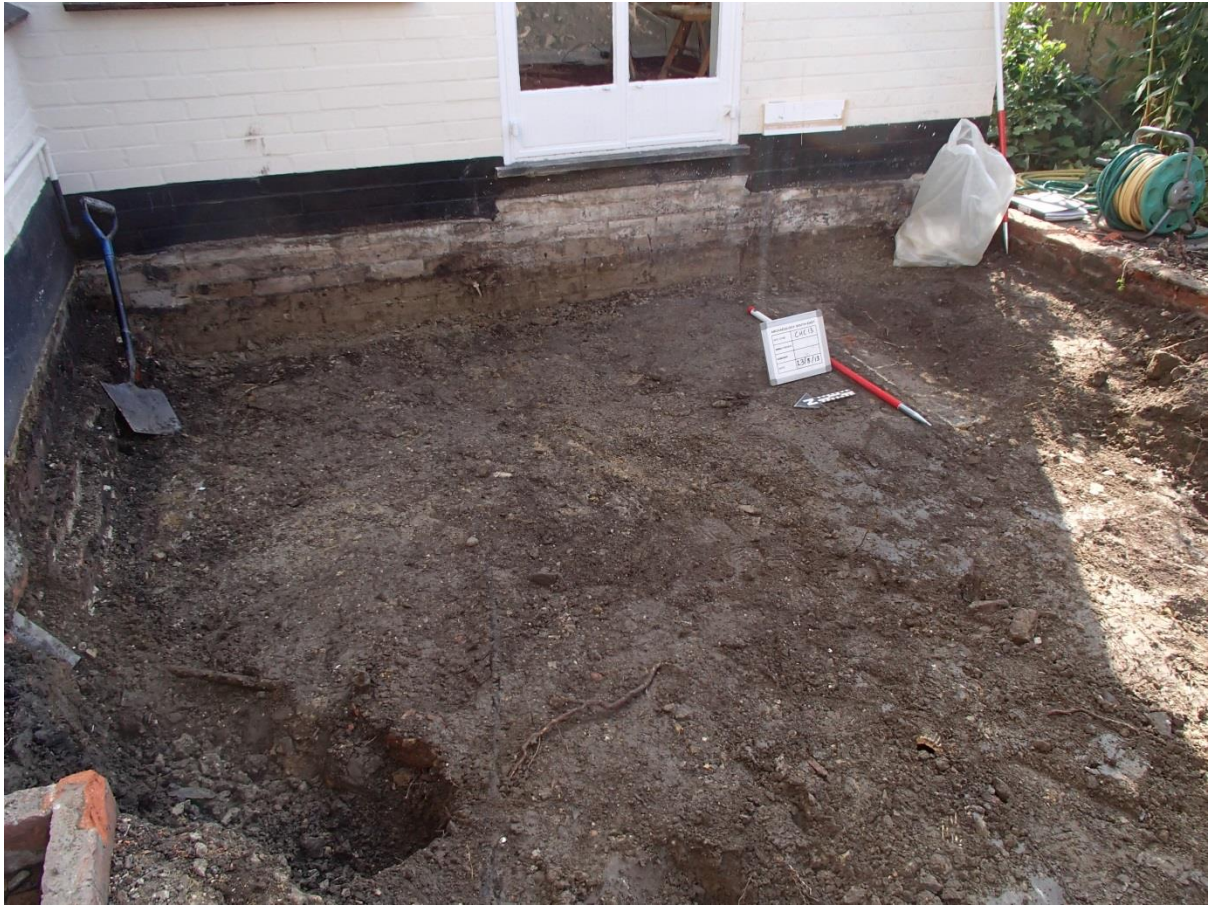
- 5.3.1 Context [11] contained a small assemblage of glass. Included is a cylindrical aqua Worcestershire sauce bottle as well as an aqua stopper, both embossed "Holbrook & Co". A clear glass square bottle was recovered as well. Both bottles are complete and of late 19th-century to early 20th-century date. In addition, the context contained two molten fragments of aqua glass, probably from bottles. A cork fragment was also found.

Photograph showing the 19th / 20th century pit during the Phase 3 groundworks (the modern garden wall can be seen in the background near to the ranging pole)
