Seaford Head Sixth Form Centre, Seaford, East Sussex

Historic Building Recording

An Historic Buildings Record
of
Seaford Head Sixth Form Centre, Seaford, East Sussex

Report No. 2013323

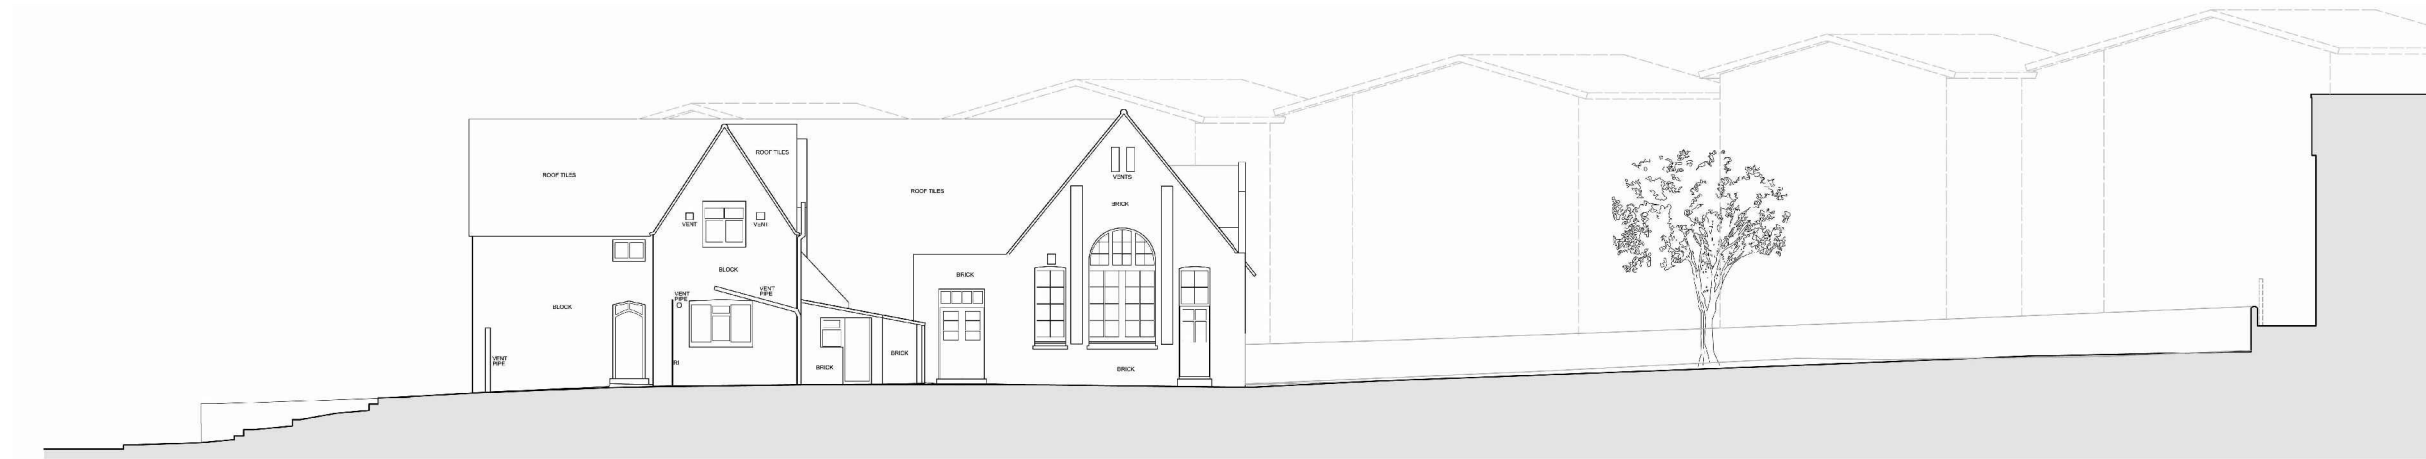
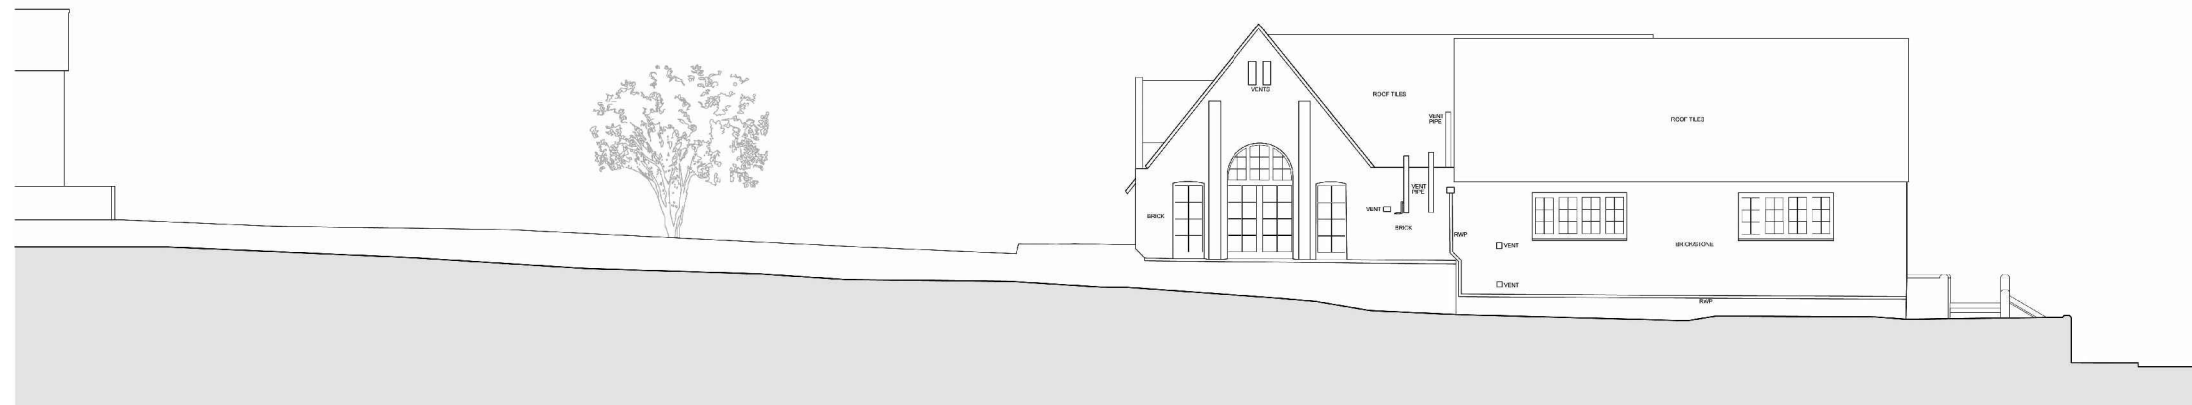
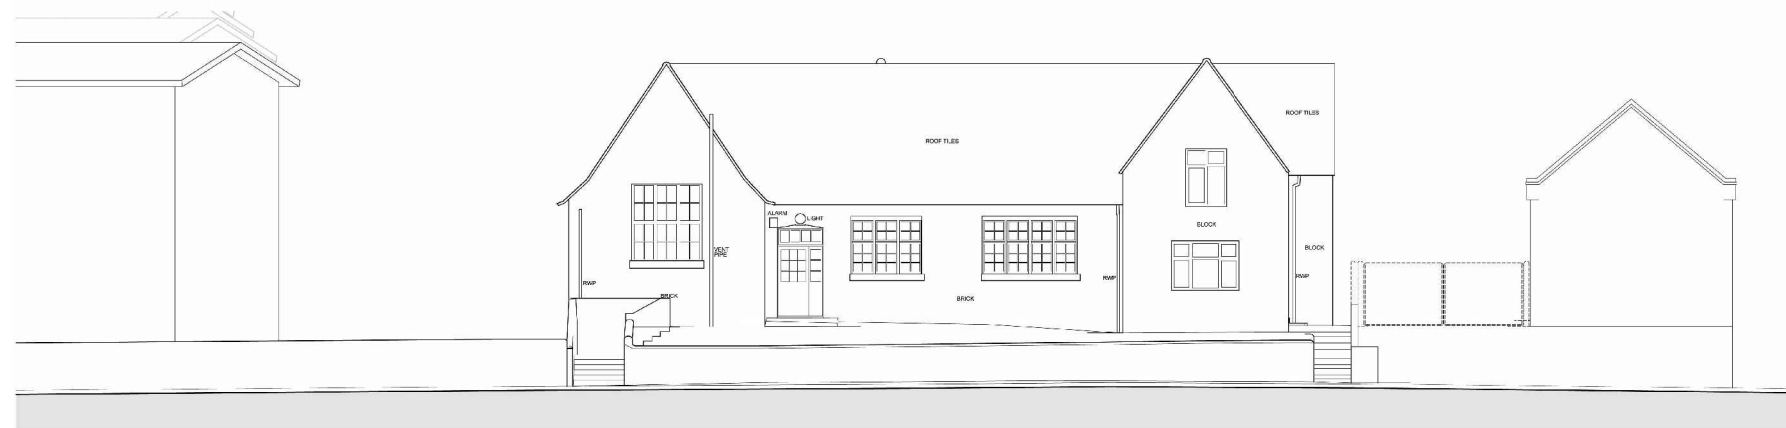
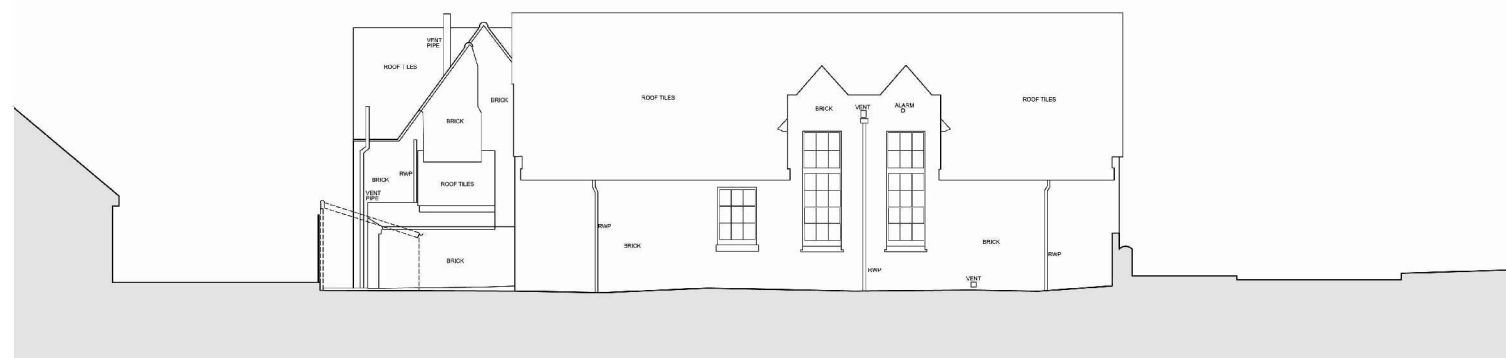
AA - EXISTING EAST ELEVATION

BB - EXISTING WEST ELEVATION

CC - EXISTING SOUTH ELEVATION

DD - EXISTING NORTH ELEVATION

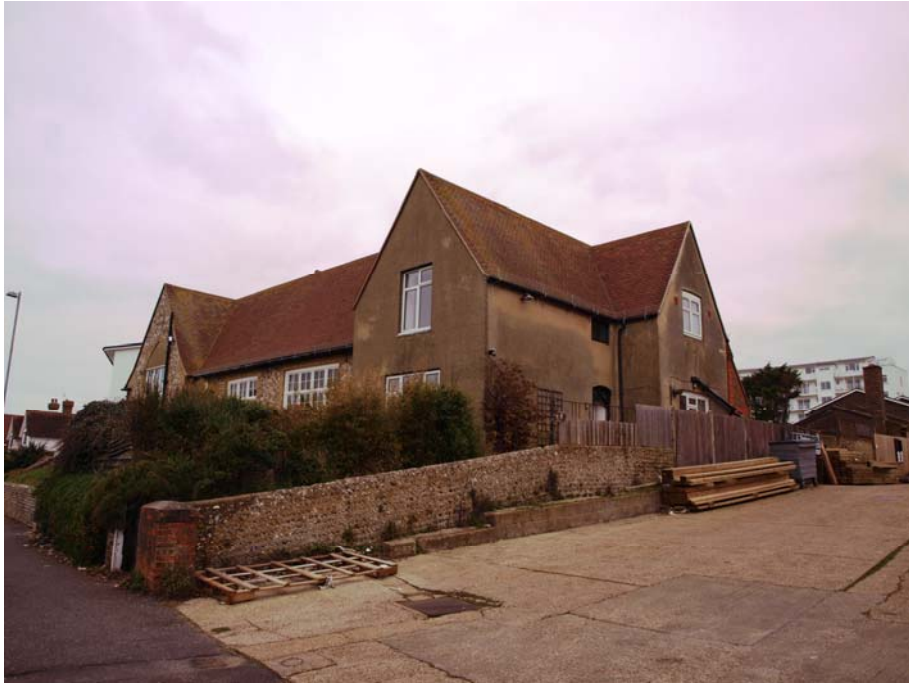
Plate 1

The main school building, looking northwest

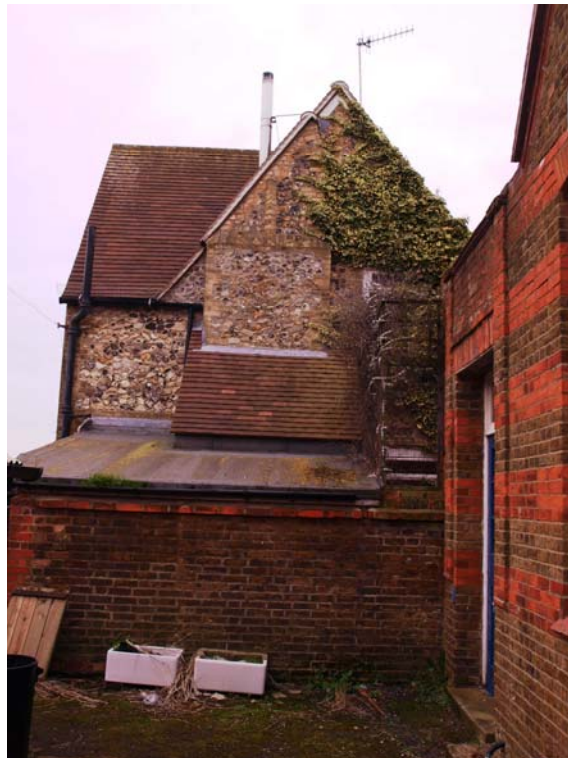
Plate 2

6.2.3 The house walls are of uncoursed flint with side-alternate quoins and other details of London stock brick. It is 'L'-shaped in plan, two stories in height and has a tiled roof with gable ends to the north, south and east. Externally, the south and east elevations are cement rendered with an incised ashlar effect. The south elevation has flat-headed windows with modern fenestration; those to the east have cambered heads, which are visible on the un-rendered north elevation as having brick sills and pointed segmental relieving arches. That part of the west elevation not abutted by the classroom block is wholly ivy-covered. The north elevation has the stump of a chimney stack with tumbled brickwork, which has been reduced in height and incorporated into the slope of the present roof. The house is entered from the east via a doorway with a cambered head containing a pointed segmental frame hung with a ledged and battened timber door, and lights in the spandrels above.

Caretaker's house, north elevation

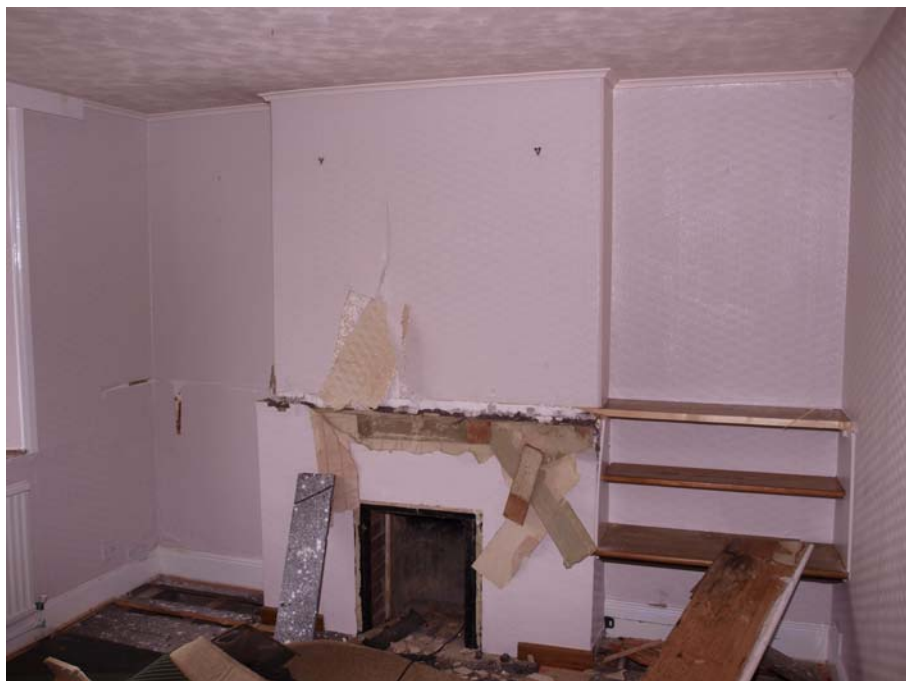
Plate 4

6.2.5 At ground floor level, the house has living rooms to either side of a stair, and a kitchen occupying the toe of its 'L'-shaped plan to the northeast. The doorways at this level retain their original moulded architraves but lack doors, and potentially original roll-moulded skirting extends throughout. The chimney breasts are present, but their chimney-pieces are no longer extant. The original herringbone brick floor survives only in the under-stairs cupboard.

Caretaker's house, ground floor living room

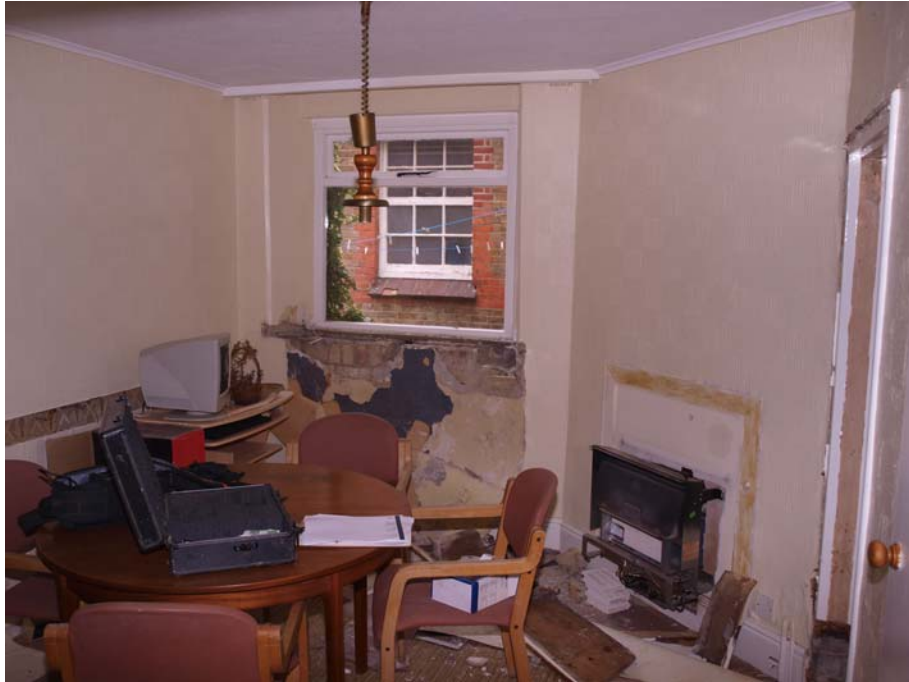
Plate 5 (6279-018)

Caretaker's house, ground floor dining room

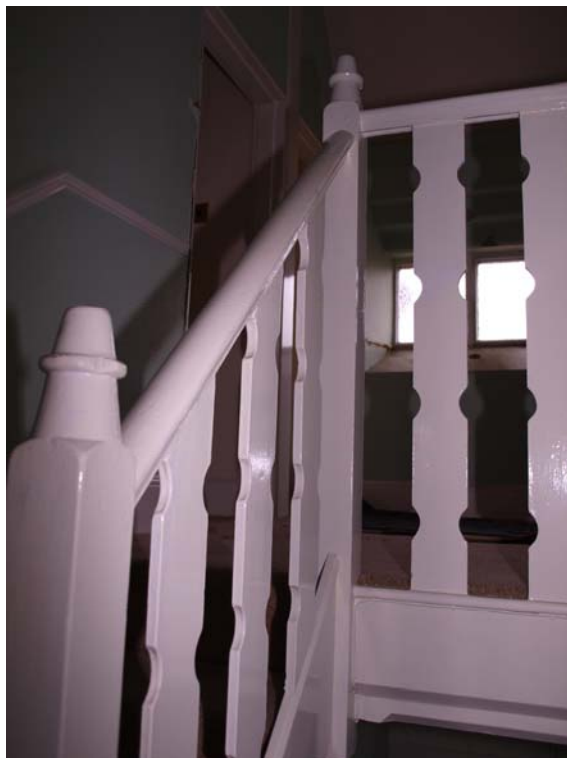
Plate 6

6.2.6 The dog-leg stair to the first floor level has symmetrical splat balusters and square newel-posts with simple conical finials. The landing has a curious two-light east-facing window with a sloping sill and lintel stepped to accommodate the slope of

Caretaker's house, detail of stair

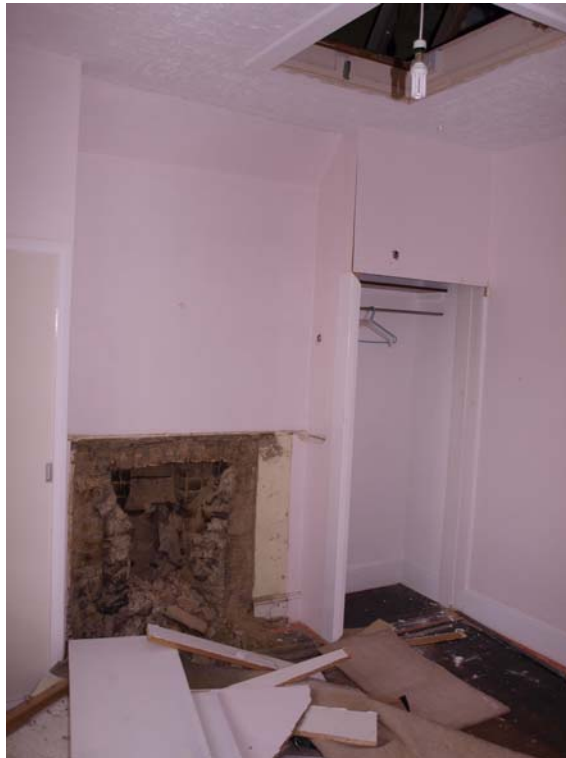
Plate 7

the roof. The bedrooms to the north and south retain their door architraves – hung with modern doors – and potentially original skirting. Both fireplaces are missing, but that to the south has an open brick fireplace with a segmental head of type intended to house an iron grate for coal. The room above the kitchen has been subdivided into a modern bathroom suite. The roof is of simple paired rafter construction with a ridge piece.

Caretaker's house, first floor bedroom

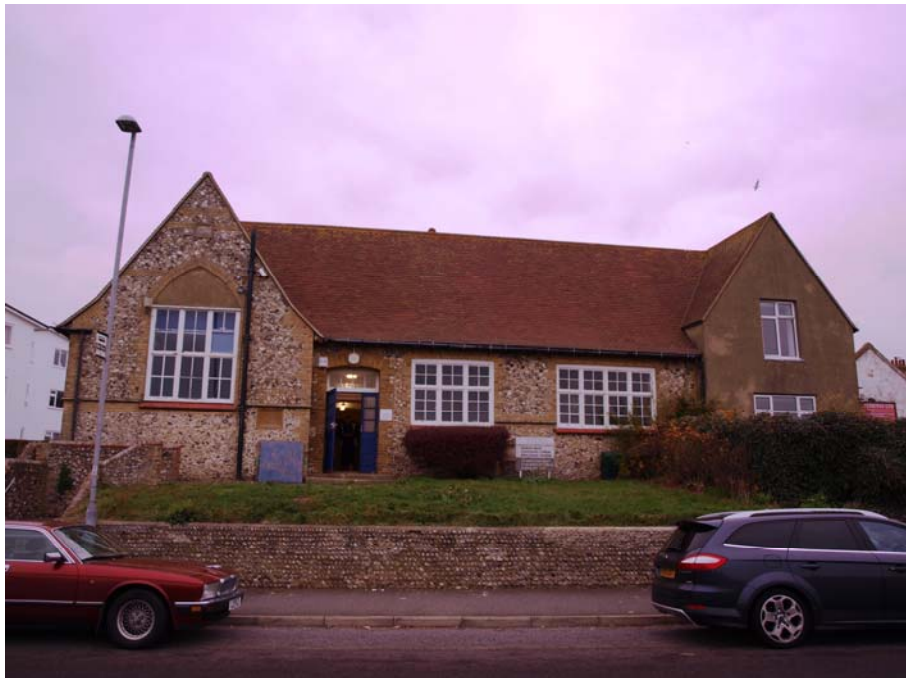
Plate 8

6.3.3 Like the caretaker's house, the walls of the classroom block are of uncoursed flint with side-alternate quoins, bands and other details of London stock brick. A presumed sandstone foundation stone in the south elevation, plaque in the south-facing gable and crest in the west elevation are all too weathered to interpret. The block is a single storey in height with a gable-ended tiled roof with sprocketed eaves and tumbled brickwork. It has large casement windows with cambered brick heads: that of the south-facing gable has a segmental pointed relieving arch above. The doorway is in the south range, it has a segmental head and two-leaf doors with glazed panels and a four-pane light above.

Classroom block, south elevation

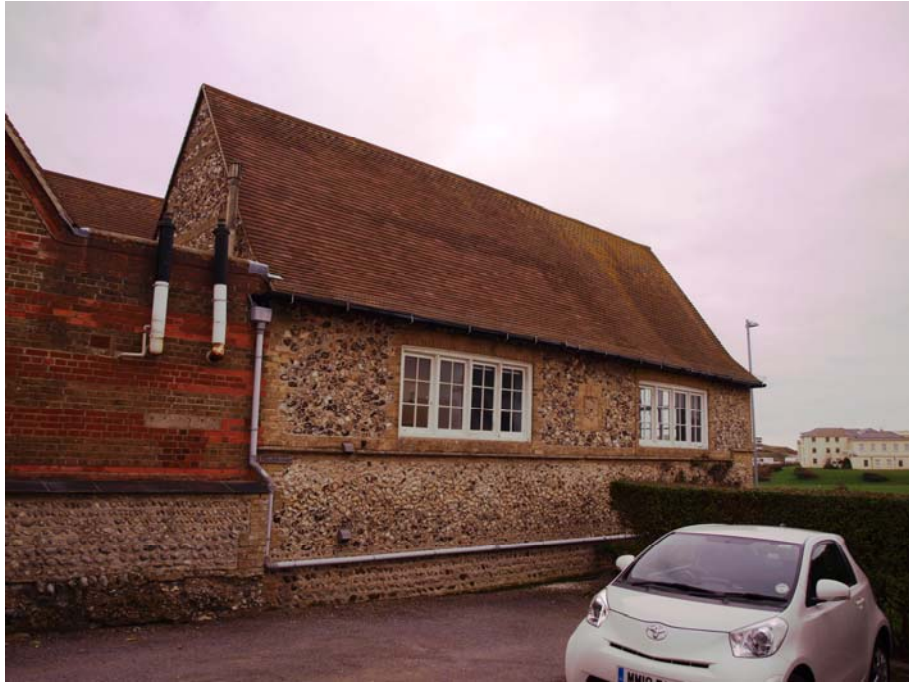
Plate 9

Classroom block, west elevation

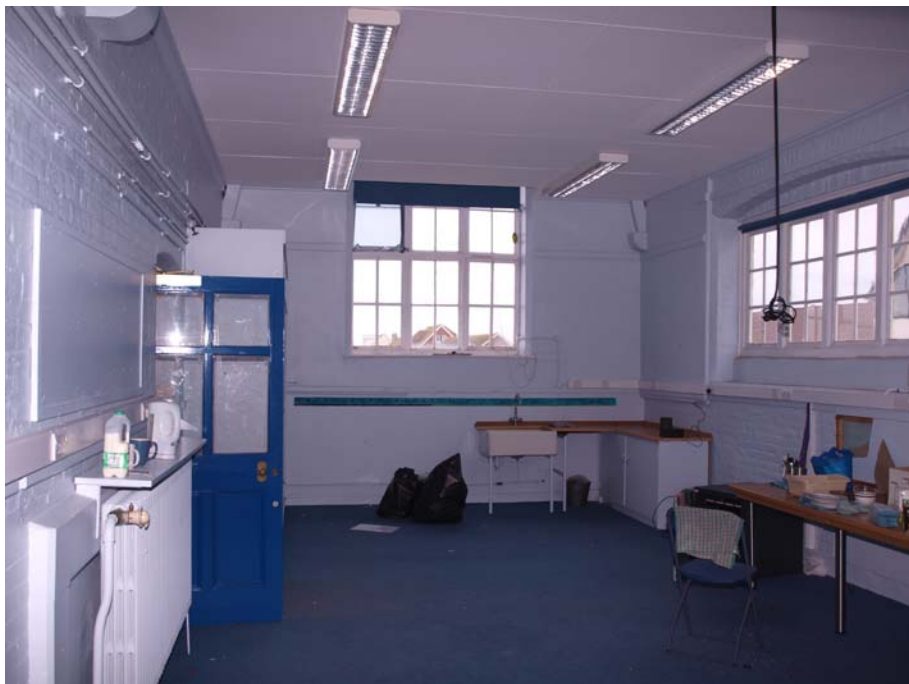
Plate 10

6.3.4 The classroom block originally consisted of a pair of large teaching rooms forming its south and west ranges divided by a short entrance passage. Each had a fireplace in its long wall with a chimney stack projecting externally: both stacks have since been truncated and incorporated into the school's interior. The simple chimney-pieces have stop-chamfered details and shallow moulded mantles. The classroom doorways have segmental heads and bull-nosed jambs and original six-panelled glazed doors with brass furniture. The windows lack architraves, and instead have bevelled jambs internally and simple timber sills. The roof is constructed from trusses resting on curved corbels and supported by curved wind-braces, and is matchboarded internally. Its structure is hidden in both rooms by a modern suspended ceiling. The north end of the western room has been subdivided into a separate classroom.

Classroom block, western room

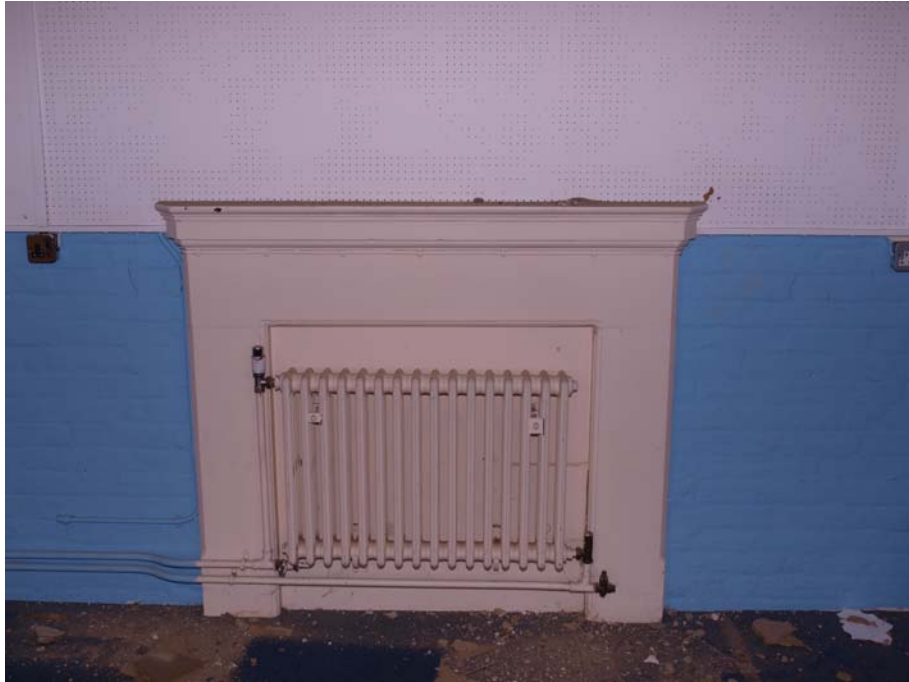
Plate 11

Classroom block, detail of chimney piece

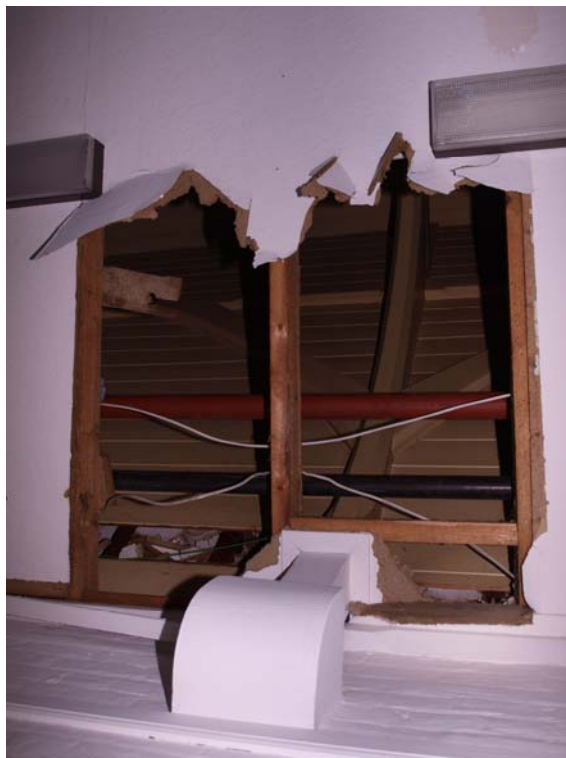
Plate 12

Classroom block, detail of roof truss

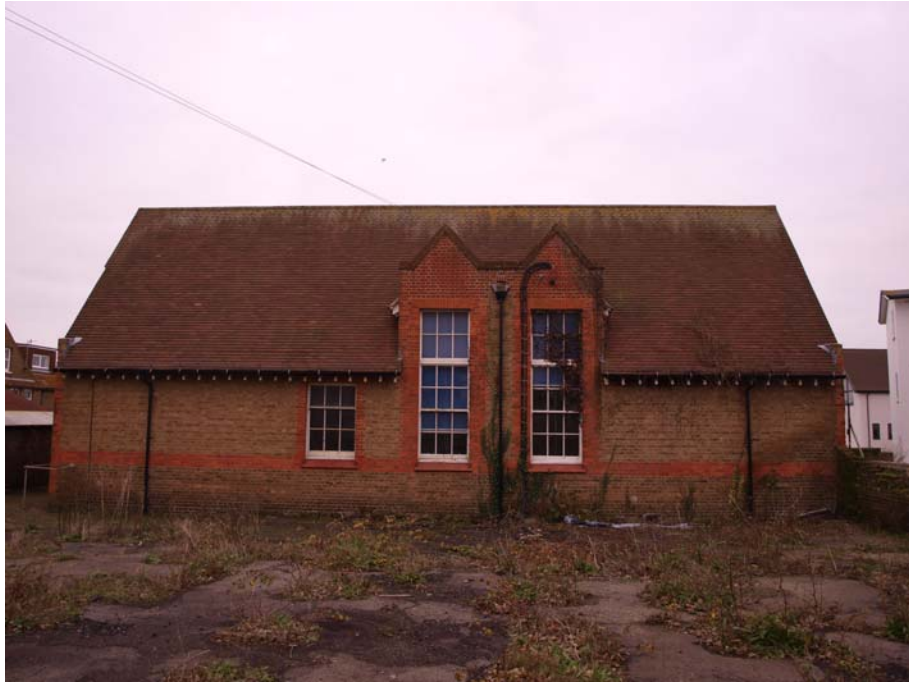
Plate 13

- 6.4.3 The hall block is made from London stock brick laid in an English bond, with quoins, bands and other details of red brick. Its west elevation rests on the site's west boundary wall, which is of flint with London stock brick quoins and matches the construction of the classroom block. The hall has a gable-ended tiled roof with pairs of tall rectangular louvred ventilation openings at its apex. The gables are dominated by large serliana windows with four-over-four pane timber sashes and tilting lights above. The eastern serliana incorporates a doorway on its north side, hung with a six-panelled timber door which has a four-pane light above. A second doorway with a flat head of soldier-course red bricks lies to the south of this window: it has an original two-leaf glazed panelled door leading to the corridor, which would have been the main egress to the playground. The hall's long north wall has a pair of exceptionally tall sash windows with rubbed brick heads partially housed within dormers, and an additional sash window of only two-over-four panes adjacent to the east.

Hall block, north elevation

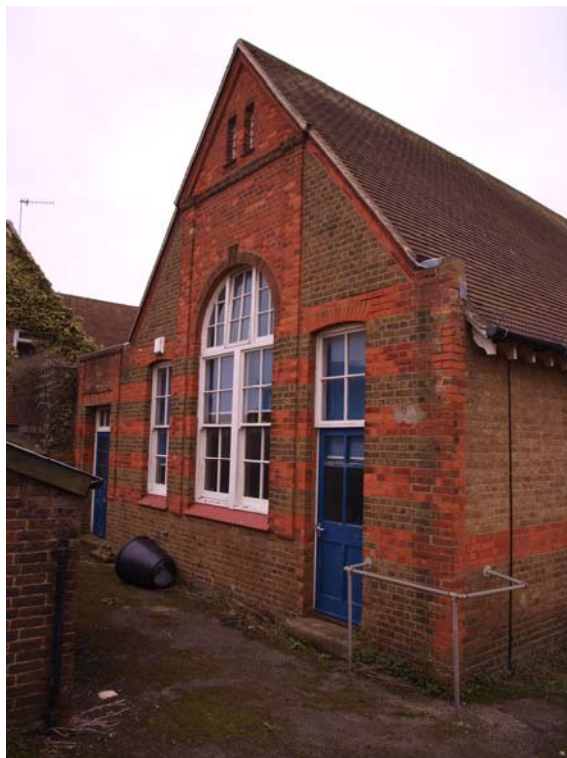
Plate 14

Hall block, east elevation

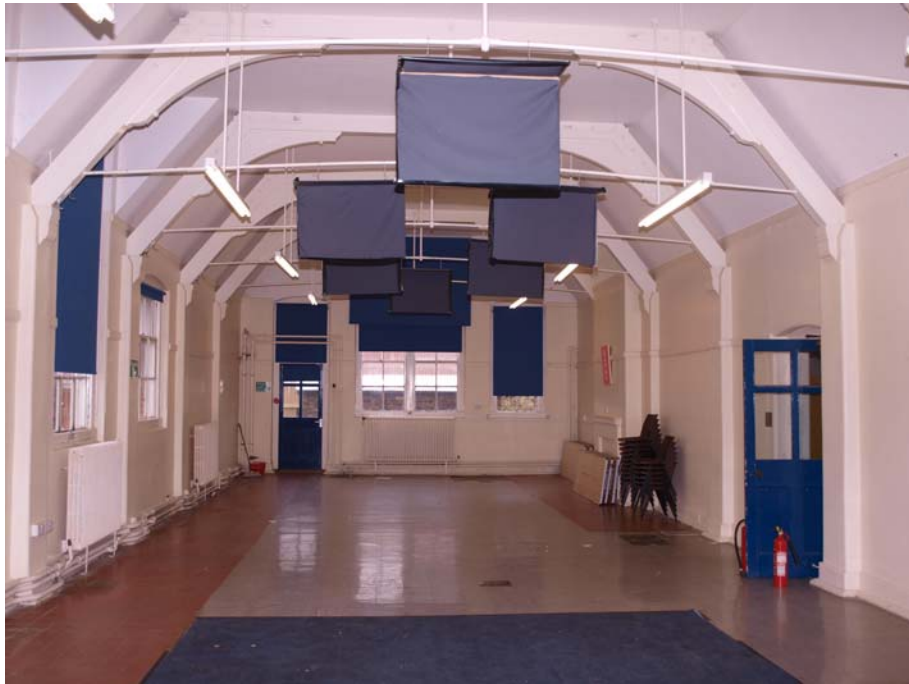
Plate 15

- 6.4.4 The hall is accessed via a corridor extending north from the original entrance passage of the classroom block, with which it communicates via a segmental archway. The doorway to the hall is has a segmental head of bull-nosed bricks: a second doorway lies adjacent. This, together with the relative narrowness of these doorways, indicates that the hall was originally intended to be divided into a pair of classrooms, or was otherwise segregated by age or gender. The hall itself has a modern floor covering and a pair of simple chimney-pieces similar to those in the classroom block. Its roof trusses are carried by moulded corbels resting on plain brick pilasters. The trusses have arched braces, iron brackets and collars, and were designed to be seen to roof height, although they are now partially obscured by a modern suspended ceiling.

Hall block, looking east

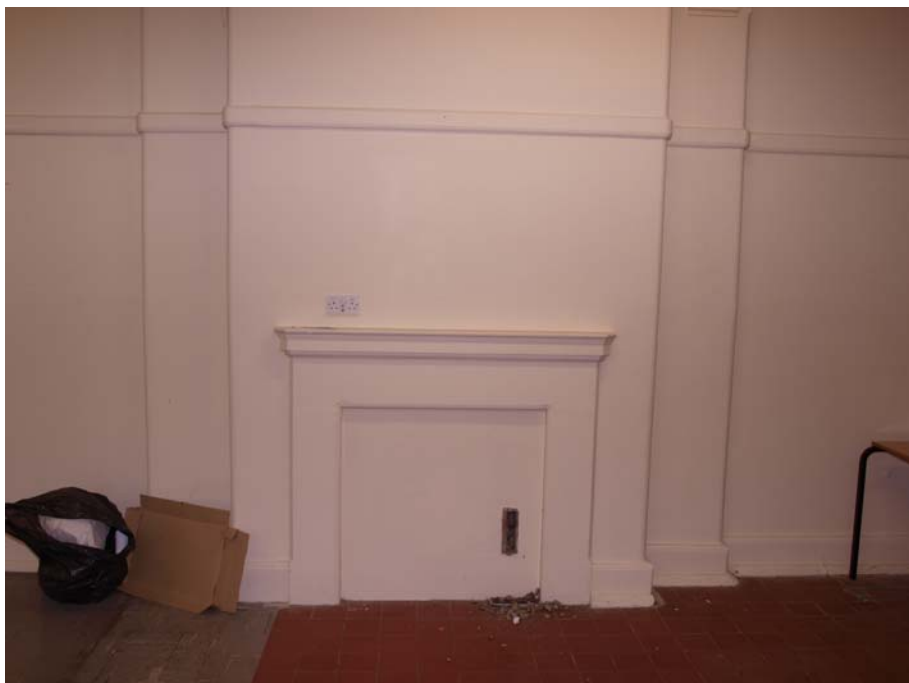
Plate 16

Hall block, detail of chimney piece

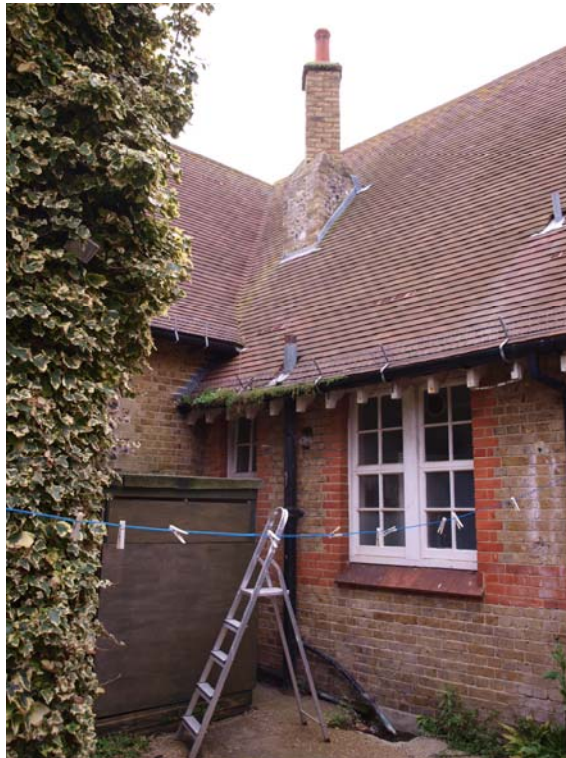
Plate 17

- 6.5.3 The toilet block is of identical construction to the hall block, and has a sloping tiled roof. It has pivoting windows with sloping tiled sills looking out into the central courtyard. A further pair of windows with fixed lights of twelve panes from the look over the courtyard from the north, associated with the hall block corridor. The courtyard itself is surfaced with concrete.

Toilet block, east elevation onto courtyard

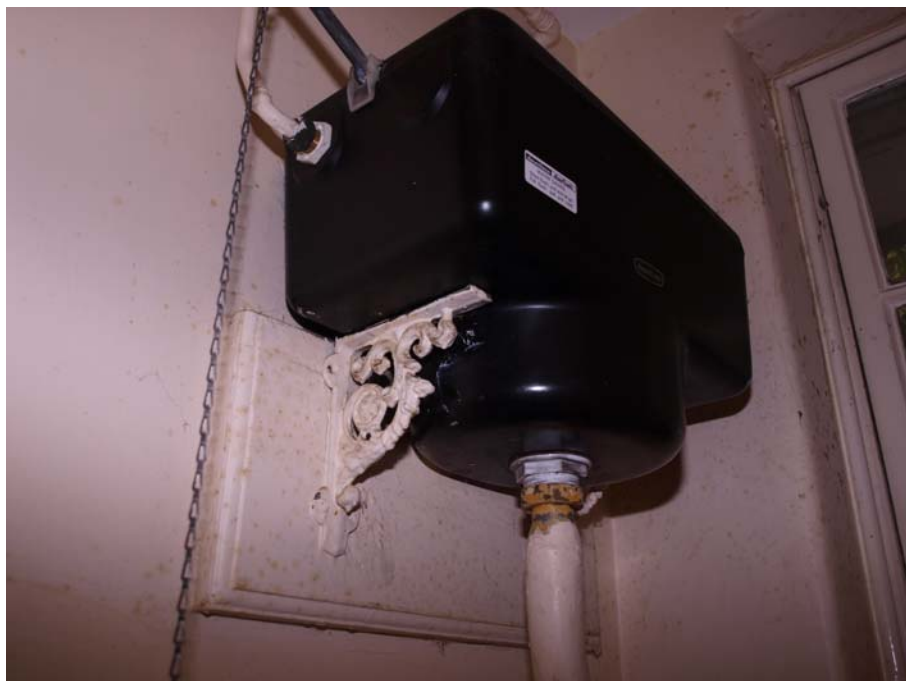
Plate 18

6.5.4 The block is divided into three toilets: male, female and a smaller one for staff. The staff toilet has an original six-panelled door and a second such door with a six-pane light above to its cubicle. The toilet is original with a replacement high-level cistern supported by elaborate original scrolled brackets. The basin and the brackets which support it may also be original to the suite. The male and female toilets are accessed via wide segmental arches not originally intended to be hung with doors, meaning that privacy would have been limited to the cubicles within. Their dividing wall is of timber planks, and they contain no original sanitary features.

Toilet block, detail of cistern

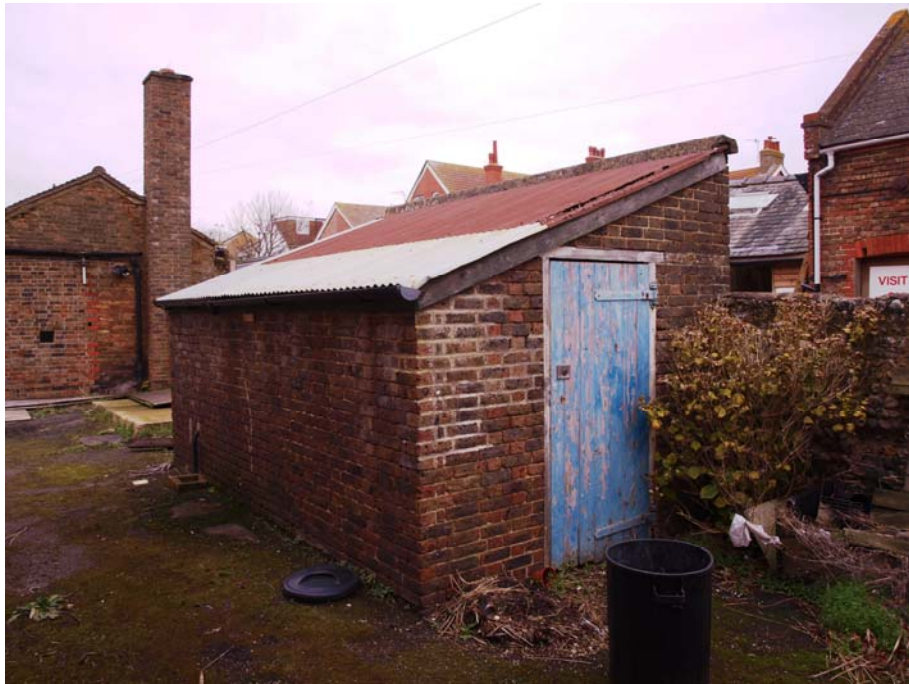
Plate 19

6.6.2 The shed is located opposite the east gable of the hall, and rests upon the site's east boundary wall. It is constructed from bricks dissimilar to those used in the main school building, laid in a Flemish bond, and has a doorway with a battened door and strap hinges in its south wall. Its single-pitched roof has a modern covering of corrugated metal. Its interior was not accessible.

Shed, looking northeast

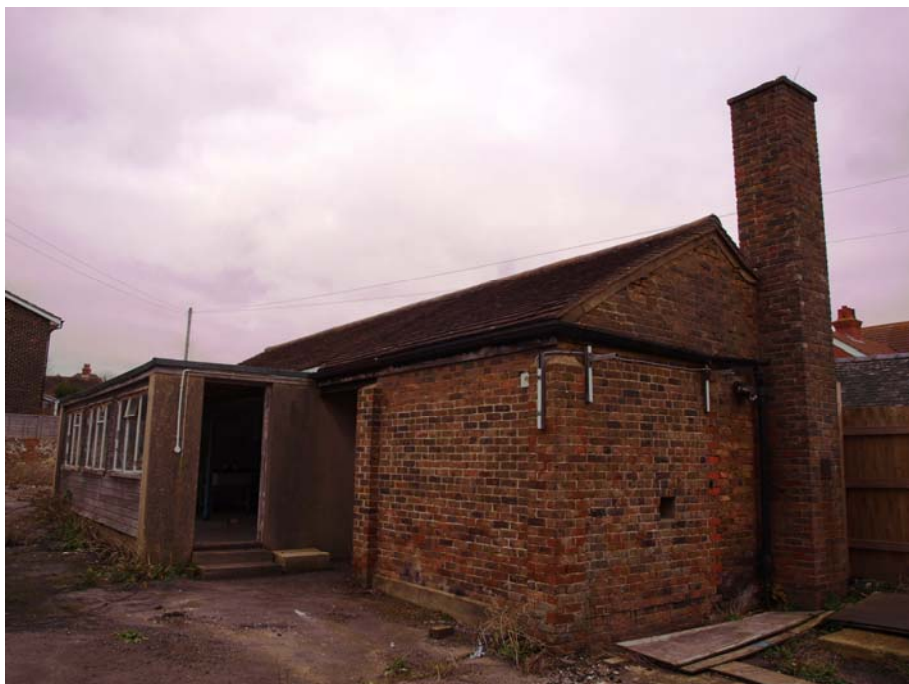
Plate 20

6.7.2 A single-storey detached classroom of red brick laid in an English bond lies to the north of the main school building, abutting the site's east boundary. It has a pitched roof with a prominent brick chimney abutting its south gable end. It has no original windows or doorways: its formerly open west wall has been replaced by a modern prefabricated extension, added between 1964 and 1974, which provides the building with access and light. A Flemish bond brick extension with a single-pitched roof abuts the building from the north. Internally, the building retains its open shedding to the south and a single large classroom to the north, notable for its steel tension trusses and the iron columns supporting a steel beam in the place of the original west wall.

Detached classroom, looking northeast
