**FINAL REPORT
ON ARCHAEOLOGICAL EXCAVATIONS AT
SOUTHAMPTON NEW ARTS CENTRE
ABOVE BAR STREET, SOUTHAMPTON
HAMPSHIRE**

**ASE Project No: 5821
Site Code: SOU 1634**

**ASE Report No: 2014179
OASIS ID: archaeol6-166357**

August 2014

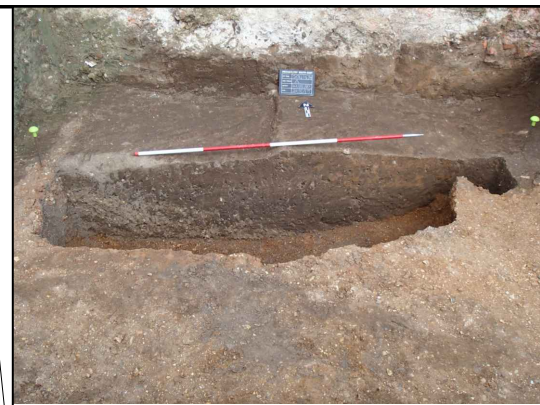
147 and 184 looking north

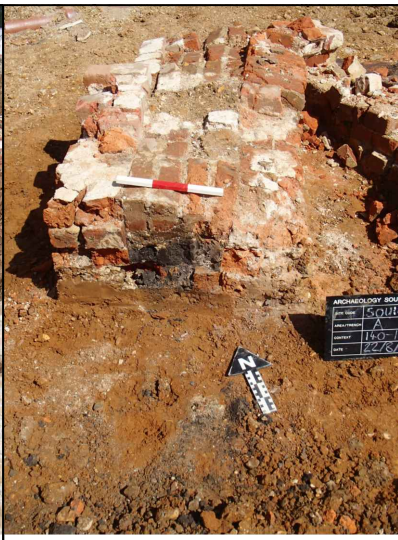
GP8 looking north

4.6.1.6 A large double-skinned filled-cavity wall (GP 8) ran from south-south-west to north-north-east across much of Area A, it was truncated in several places by later activity. The wall was constructed from red unfrosted bricks of a fabric used into the 19th century with a rubble-filled core with occasional laid bricks. It was initially thought that this feature could represent a drain or culvert but given the highly compacted rubble core and lack of brick base it has been interpreted as a wall. The height of the brickearth below the feature (between 15.17m and 15.32m aOD) is similar to that found in surrounding areas reaffirming that the features was a wall rather than a culvert. The wall was laid directly upon the natural brickearth preserved below it, due to the truncation of the brickearth it was unclear

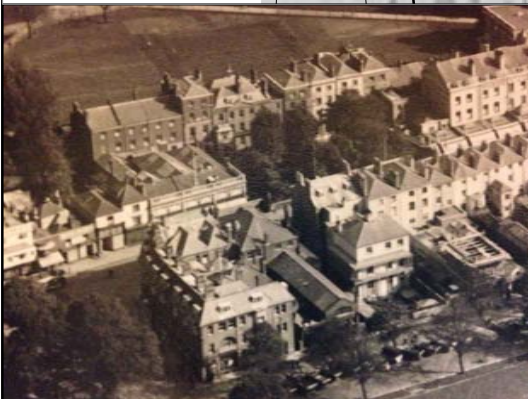
Aerial view of Lower Prospect Place 1927-8

- 4.7.1.1 The western portion of Area A underwent a change in land use in the early 20th century (probably around 1931, see Figure 9) with the Prospect Place gardens fronting Above Bar Street replaced by a row of shops which mirrored the shape of the previous gardens (Meager 2011). This activity was represented on site by a series of shallow concrete foundations (Structure B4) with the remnants of red brick walls set above. These
