Archaeological Monitoring and Excavation

Sea Defence Repair Works at

**Othona, Bradwell-on-Sea
Essex**

**ASE Project No: E8028
Site Code: BROFD 13**

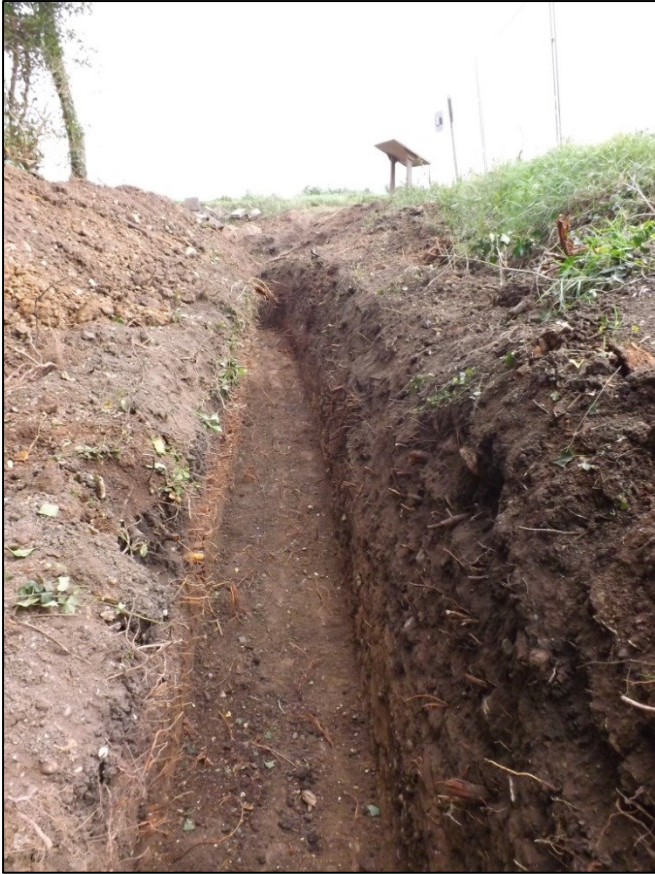
Figure 2: E/W arm of trench, looking east

4.2.1 In the east-west arm of the trench dark brownish grey topsoil [001] and subsoil [002] overlay mixed lighter brown clay and gravel [005] (figures 2 and 3). Roman finds consisting of tegula fragments and a piece of probable brick were recovered unstratified from machine removal of topsoil and subsoil in this area. These are likely to be residual finds from the fort deposited during modern activity. Also recovered was a single fired cartridge case used by U.S. forces in World War 2.

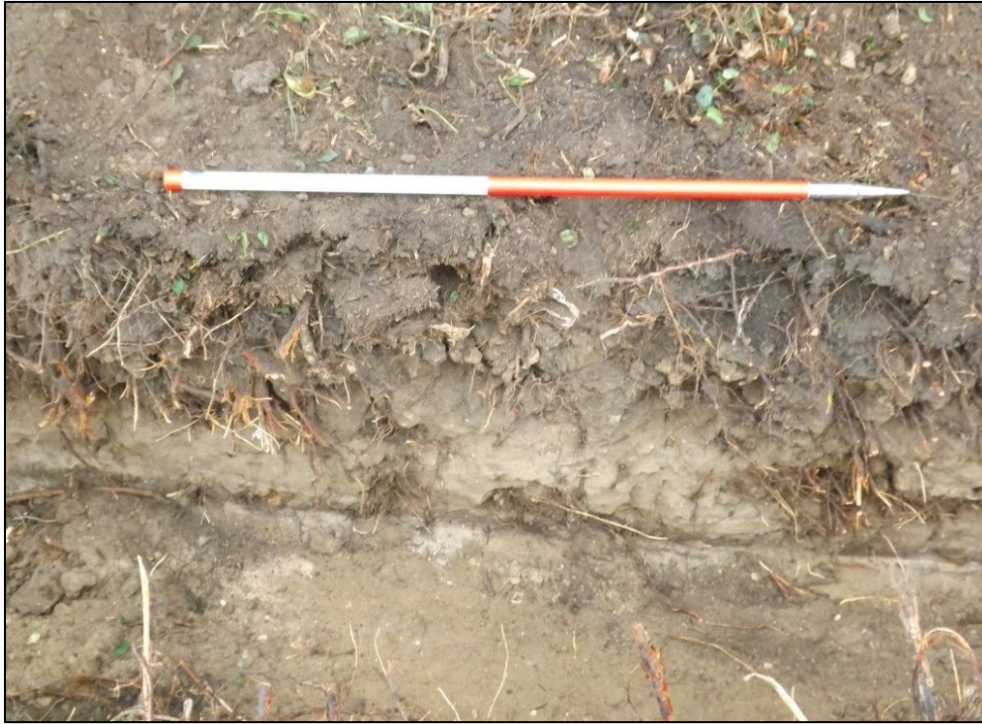
Figure 4: N/S arm of trench, east facing section (1m scale)

4.1.3 In the north/south arm of the trench, the topsoil [1] overlay subsoil [003] that was greyer in colour and more sandy in composition than in the west of the trench (Figure 4). The subsoil sealed a deposit of pale yellow sand [004] that was exposed in the bottom of the section and was seen in places to overlay shelly gravel and cleaner orange sand (Figure 5). Fragments of Roman building material that was significantly water abraded, including tegula, brick, tile and possible voussior where recovered from deposit [004].
