1 DOVE COTTAGES, FLETCHING STREET
MAYFIELD, EAST SUSSEX, TN20 6TL

HISTORIC BUILDING WATCHING BRIEF

Project No. 6180

Report No. 2013247

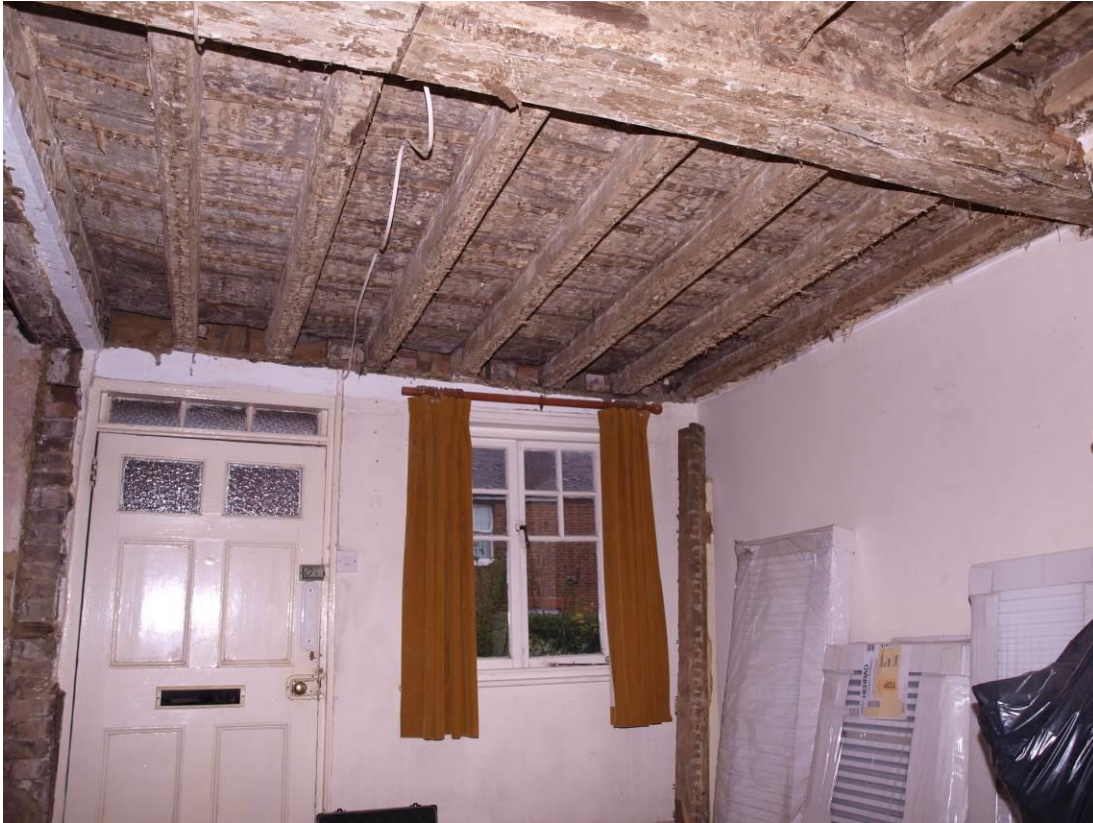
Plate 1: Ceiling to Living Room 01 (3)

- 5.1 Living Room 01 is the original hall of the building (Dickinson 2013). The ceiling finishes had been removed, and finishes partially removed at the base of the walls. The ceiling consists of a central hardwood girder running east-west, which is chamfered and stopped. The joists jointed into it run north-south and measure 100mm wide x 130mm deep. They are also chamfered and stopped. This detailing is quite delicate, and its incorporation demonstrates that the ceiling was intended to be seen. All show evidence of lime-washing (Plates 1 and 2). Stripes and nails on the joists and the original floorboards above show two phases of lath and plaster ceilings, first the boards in between the joists were ceiled and later a ceiling was inserted below the joists. A 'hatch'-like feature of unknown purpose has been inserted south of the central girder adjacent to the west partition wall. The original wide floorboards of the room above run over this feature without a break in their construction (Plate 3).

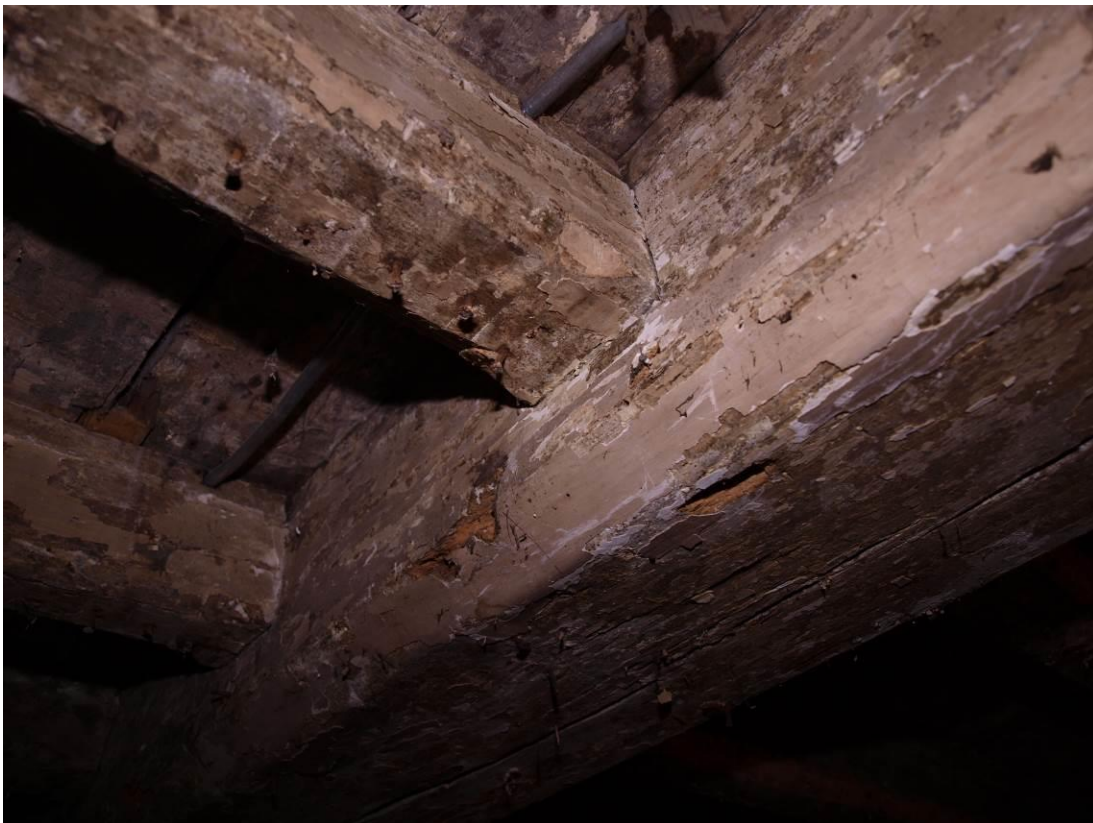
Plate 2: Detail of chamfer and stop detail to central girder and joists (5)

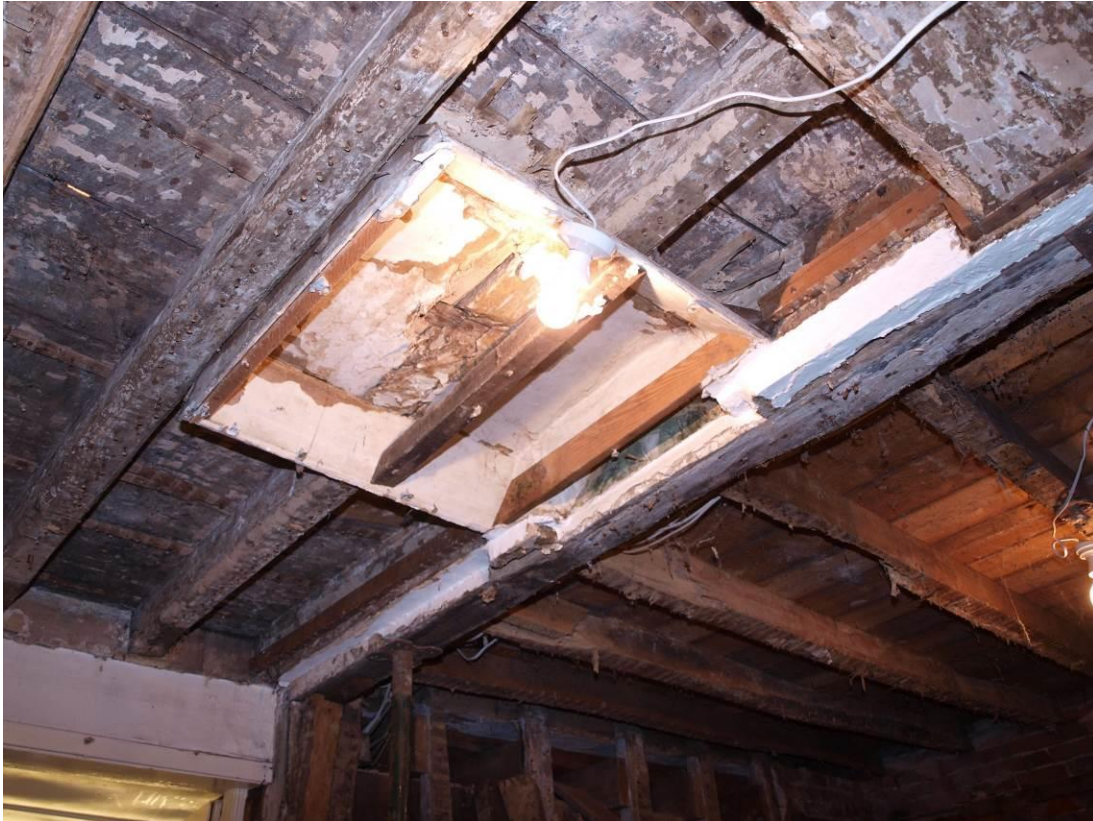
Plate 3: Feature in ceiling of Living Room 01, with concave mortice behind, and possible evidence of doorway head to left (10)

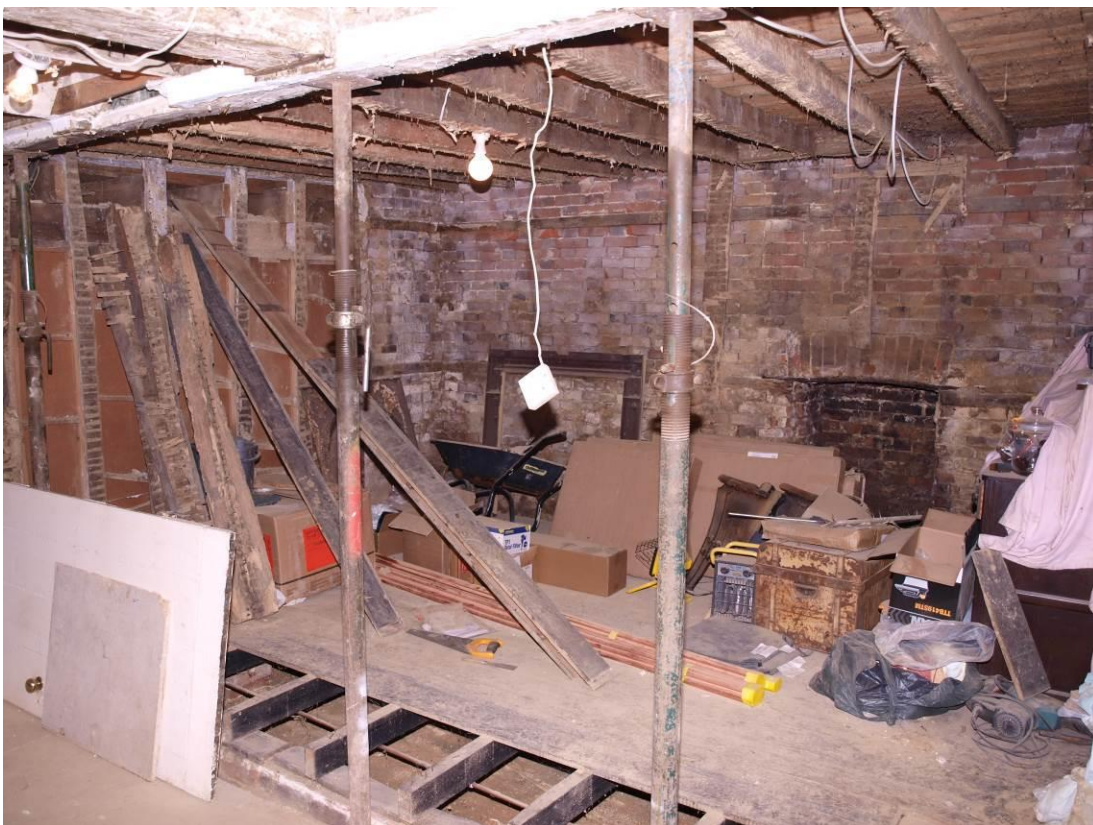
Plate 4: Ceiling to Living Room 02

- 5.4 Living Room 02 is identified as an original service room west of the main hall (Dickinson 2013). The wall and ceiling finishes had been stripped. The ceiling joists measure 100mm wide x 110mm deep and run east-west between the outer wall and the tie beam of the east partition wall. They are of fairly regular appearance and are a mix of sawn and more roughly hewn timber, probably softwood, and bear evidence of having had a lath and plaster finish (Plate 4). The floorboards of the first floor, exposed above the joists, are of softwood and vary in width from 210-230mm. The underneath of the hearth for the fireplace above is visible in the construction, framed in timber with iron bar supports, above which is a layer of wide laths and lime plaster. This appears to be contemporary with the joists.

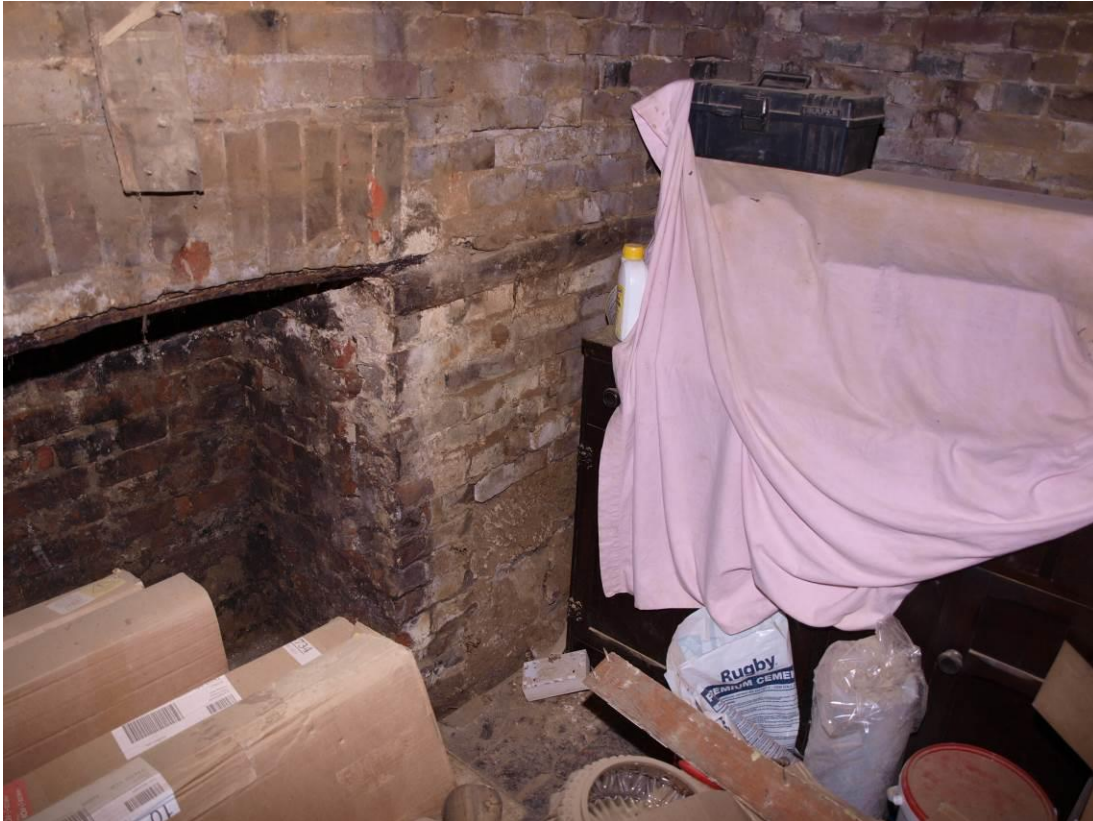
Plate 5: Detail of west wall of Living Room 02 (7)

- 5.5 The west wall is constructed in brick with the inclusion of timber bearers to which planks had been fixed vertically to carry a lath and plaster finish. The bricks are fairly creasy in texture, orange-red with some blue tones and occasional blue vitrified headers. They measure 220-240mm x 60mm. The brickwork is carried on a stone plinth of roughly hewn stone blocks (Plate 5).

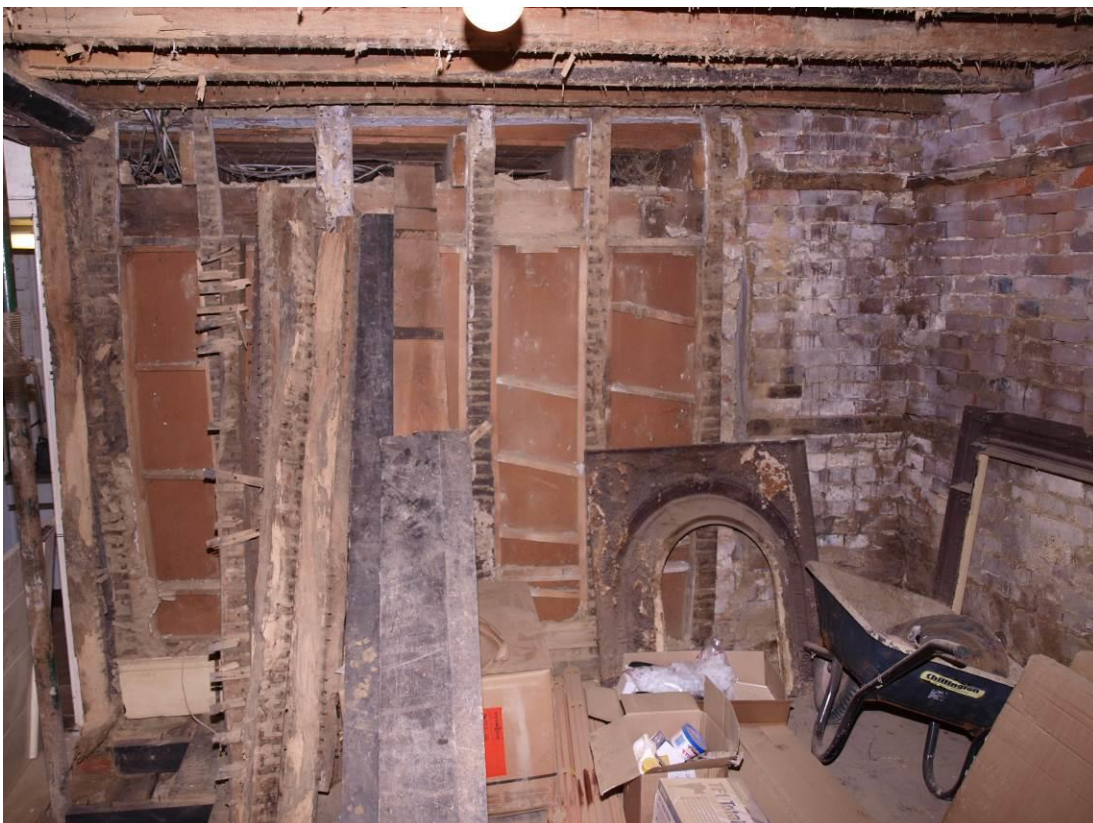
Plate 6: South wall of Living Room 02 (6)

- 5.6 The south wall consists partially of the same type of brickwork above a stone plinth, to its western end. The remainder of the wall is of timber-frame construction consisting of slender timber uprights, probably re-used, resting on a timber sole plate.

These bear evidence of a lath and plaster finish and are infilled with modern wood fibre board between (Plate 6).

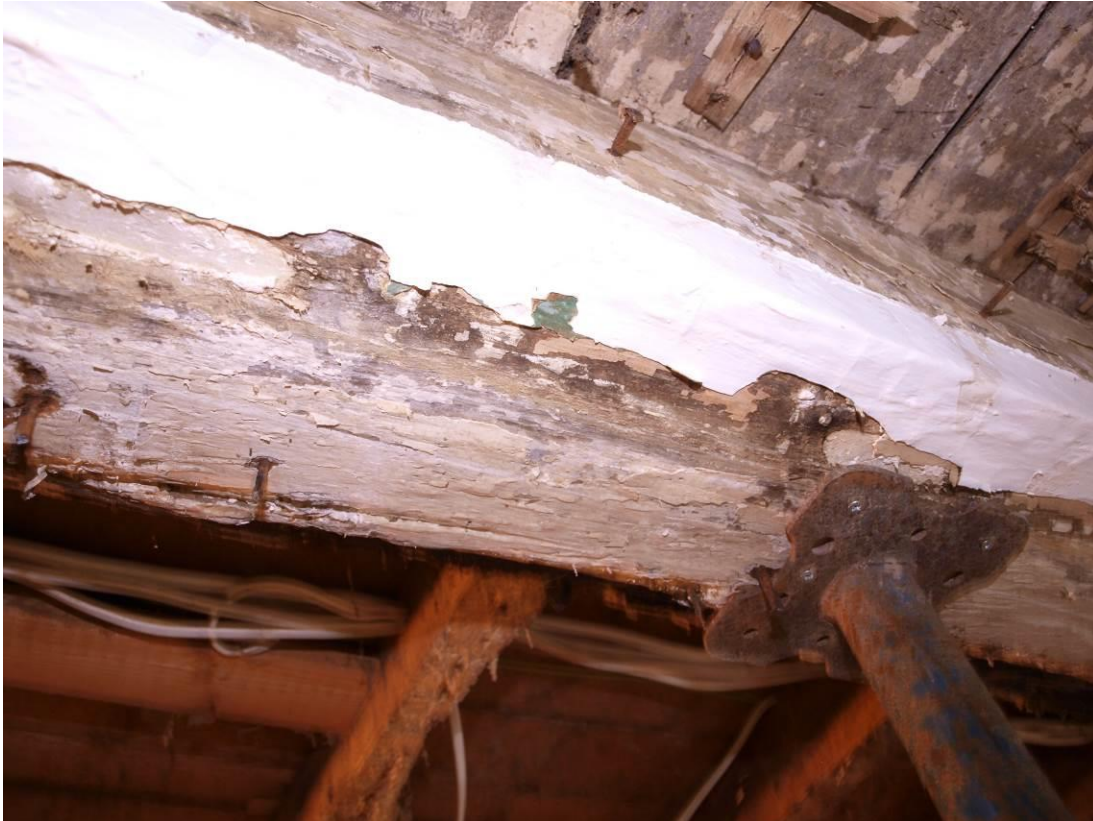
Plate 7: Stave mortices in tie beam of partition wall (13)

- 5.10 The tie beam shows signs of various alterations. The soffit of the tie beam shows evidence of mortices for earlier staves (now blocked with lime plaster): two north of the central girder and one south of it, which would have formed the original partition construction; demonstrating that the notched and nailed studs were a later addition (Plate 7). At its southern end the tie beam appears to have been subject to alterations. A large, concave mortice of unknown function has been roughly cut into the east face of the beam (Plate 3). South of this is a stave mortice which has been truncated by a rectangular mortice, adjacent to which is a possible doorway head – a rebate is located on the east face of the tie beam (Plate 3). A straight joint appears to run through the beam adjacent to the principle post at its southern end. At its north end, the beam is pegged and jointed to the principle post, which has been truncated and under-built in brickwork contemporary with the brick walls of Room 2.

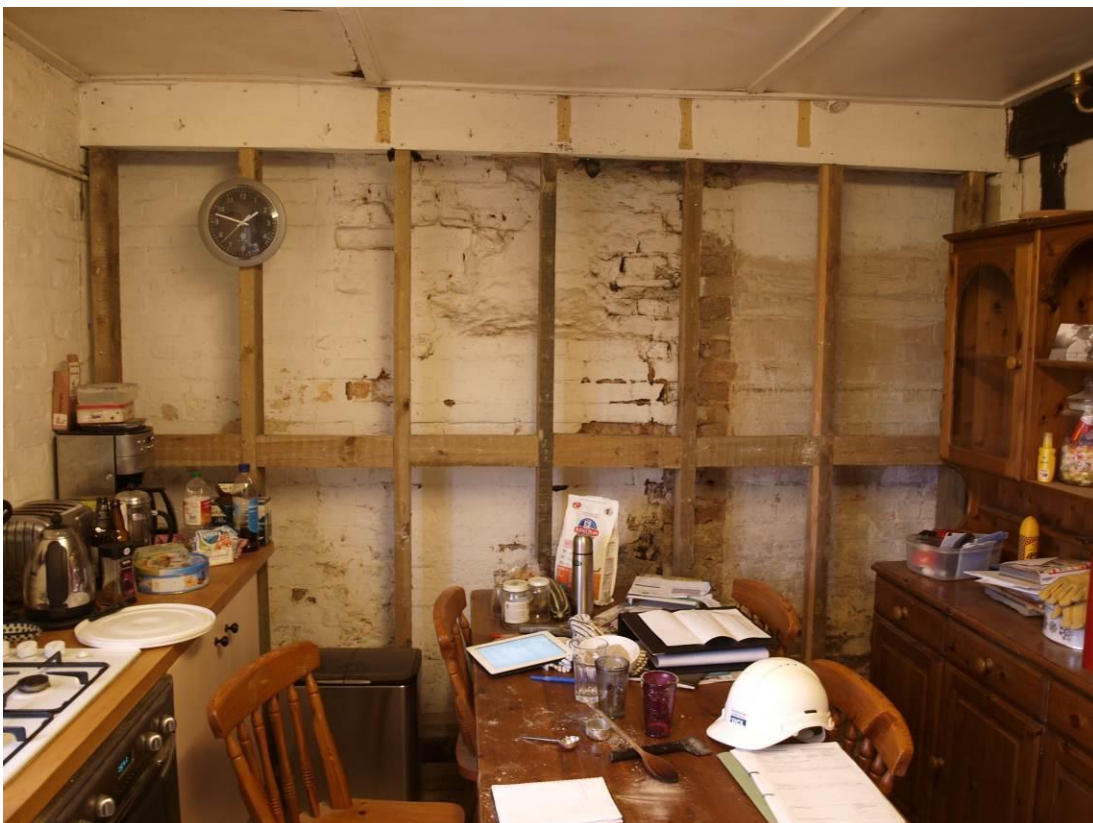
Plate 8: Site of former chimney breast on west kitchen wall (15)

- 5.12 The kitchen occupies a later extension at the rear of the building. Later finishes had been removed from the west wall showing painted brick behind a later stud partition of sawn softwood. Within the brickwork two straight joints show the location of the chimney stack formerly at ground floor level, the flue is visible above through the first floor/ceiling (Plate 8). A section of concrete floor removed in the south east corner of the room revealed brick paviments below, which are also present behind the later partition on the west wall. These measure 110mm x 230mm.

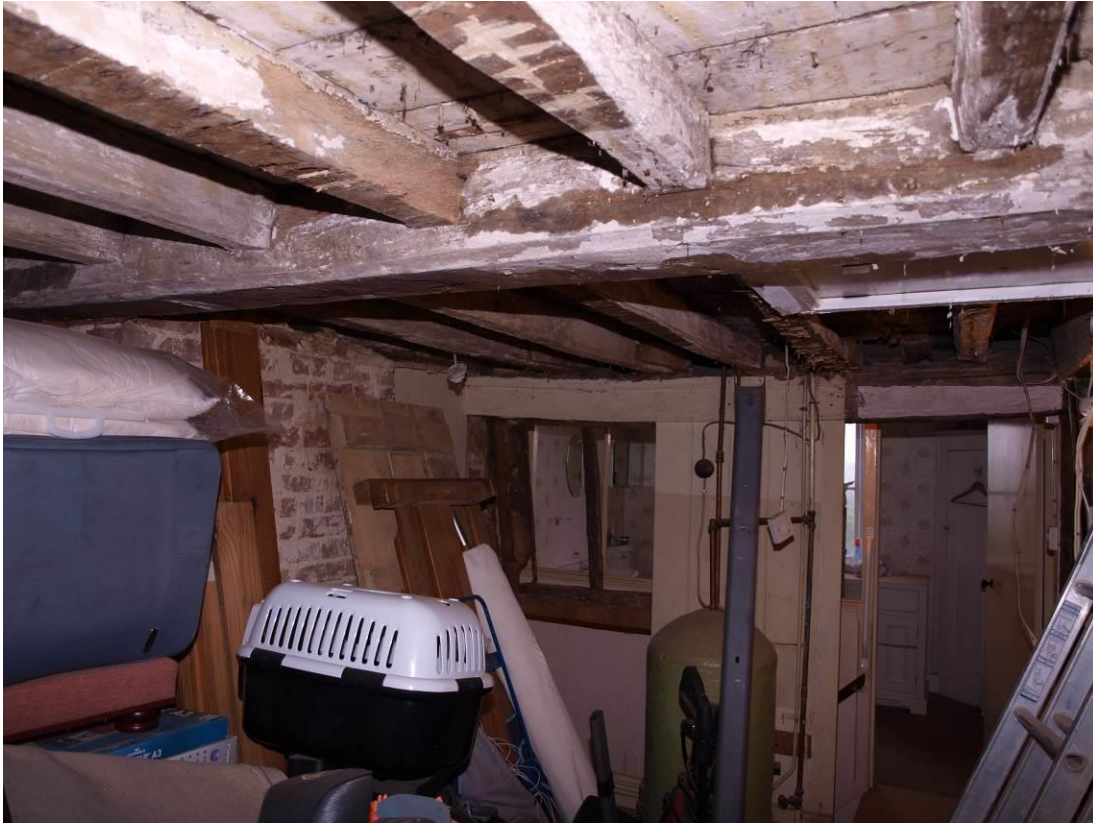
Plate 9: Ceiling to Bedroom 02 (26)

- 5.14 In Bedroom 02, finishes had been removed from the ceiling, the north wall and part of the east wall, south of and including the chimney breast. This room has a similar configuration to Living Room 01 below, with a central ceiling girder running east-west, and joists running north-south; all are chamfered and stopped (Plate 9). Again, there is evidence of lath and plaster to the joists and the floorboards above. The joists are resting on the wall plate although some have come free and some have timber packers between the joist ends and the wall plate. The exposed tie beam to the west shows that the later matchboard partition has been inserted west of the line of the original partition; evidence of the original line of the wall is provided by mortices for staves. There is evidence for a rebate for a former doorway at the north end of the tie beam, and a single pintle for a hinge survives (as noted in the previous survey).

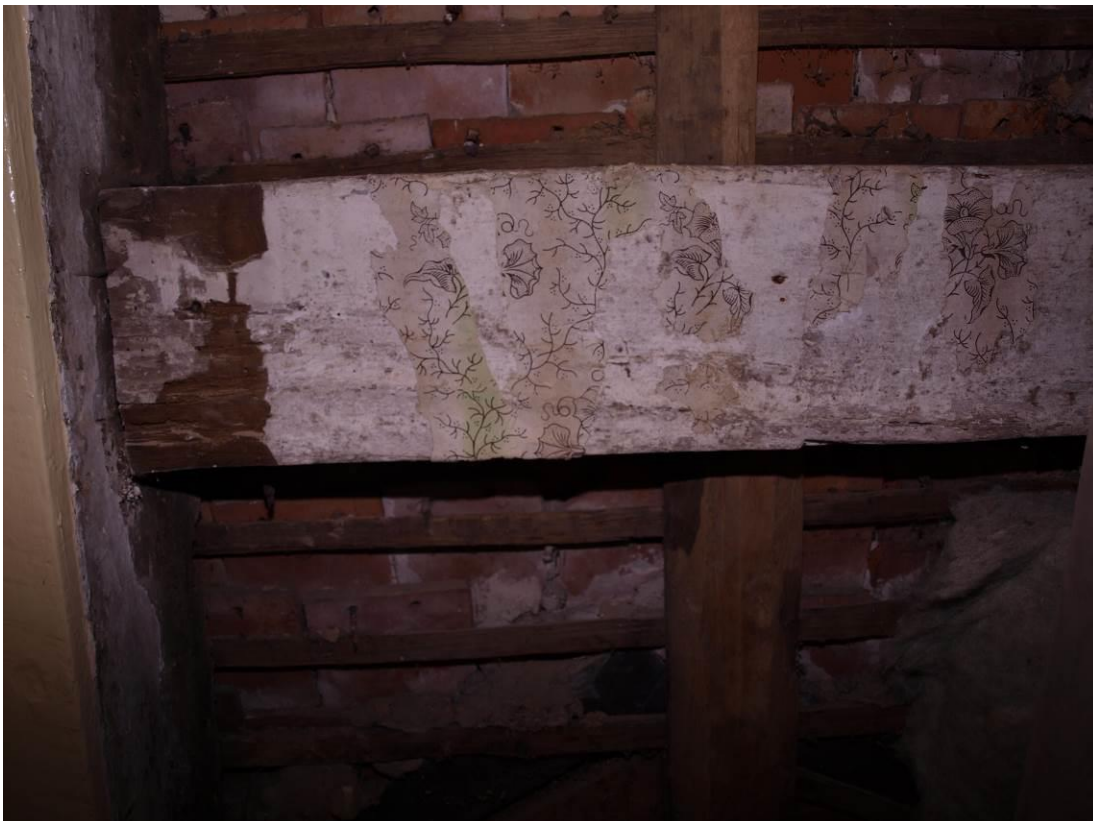
Plate 10: Midrail to north wall of Bedroom 02 (25)

- 5.15 Wood board had been removed from the north wall. The wallplate is substantial and shows hewing marks. It is chamfered, and a plain stop is visible at its western end. A substantial midrail 220mm wide is located west of the window, and is tenoned to the west jowl post. It has a groove on its upper face for staves and the wall plate above has stave holes; the staves would have carried the original daub infill. The underside of the midrail is heavily weathered and there is no evidence of mortices. Fragments of decorative wallpaper survive on the midrail and the jowl post (Plate 10).

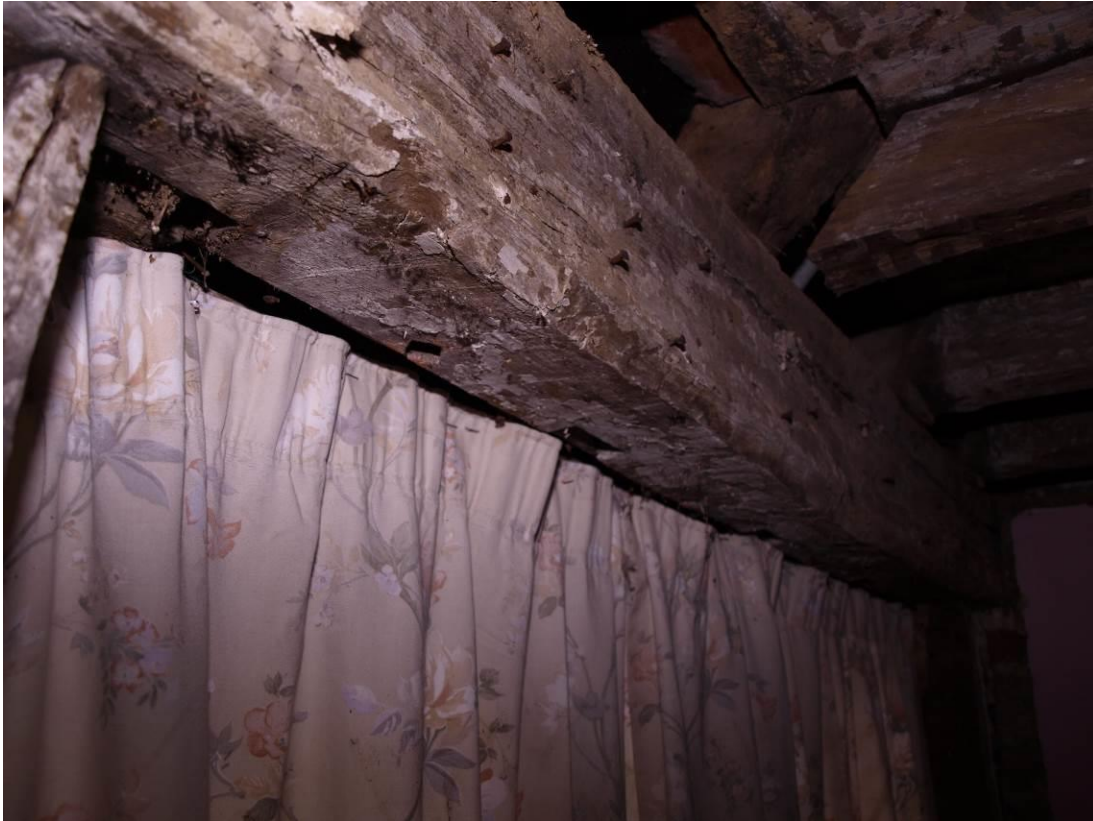
Plate 11: Head of window opening on north wall of Bedroom 02 (24)

- 5.16 The window on the north wall is a later window; however evidence survives showing originally there was a slightly smaller window in this location. The jambs have been hacked back to allow the insertion of the later, larger window. Mortices for the original cill are visible within the jambs showing it was higher than the level of the existing cill. The head of the window was integral to the tie beam, and was moulded externally with an ovolo moulding. Three square and four smaller, diamond-shaped mortices show that the window was of four lights with three rectangular mullions and four intermediate vertical bars (Plate 11). To the east of the window, two small daub panels survive above and below the midrail. The later, eastern wall (forming the party wall with 2 Dove Cottages) is partially exposed at the northern end and is of brick. The exposed stack on the east wall is constructed of orange-red brickwork with grey-blue tones; the bricks measure 230-240mm x 60mm.

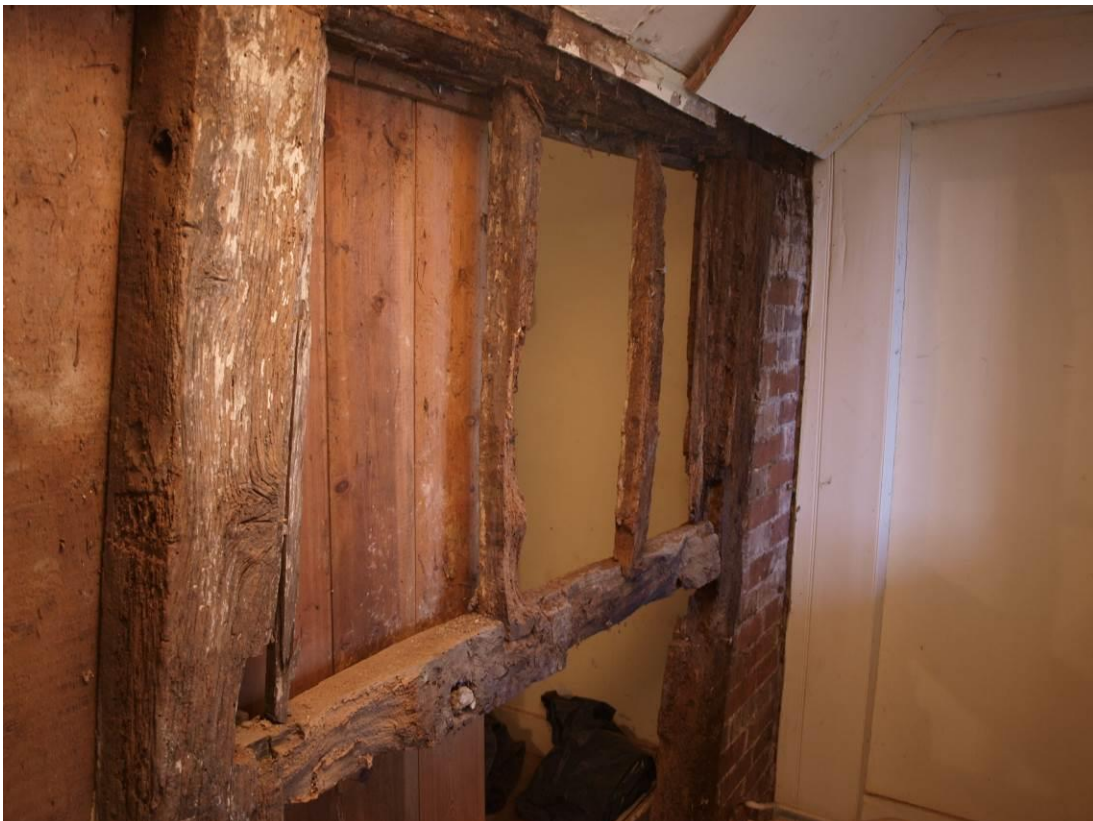
Plate 12: Original window in south wall of Bedroom 02, viewed from the landing to the south (17)

- 6.2 Elsewhere in the building, the current programme of works had exposed some elements of the original early 17th century timber frame, including a former window in the landing partition which confirms this was originally the rear external wall of the building. A matching window existed in the position of the existing window to Bedroom 02.
