**ARCHAEOLOGICAL MONITORING AND RECORDING**

**CABLE LAYING WORKS AT THE**  
**CHURCH OF THE HOLY TRINITY, CHRISHALL, ESSEX**

**ASE Project No: E8111**  
**Site Code: CIHT 14**

**ASE Report No: 2014078**  
**OASIS ID: 168699**

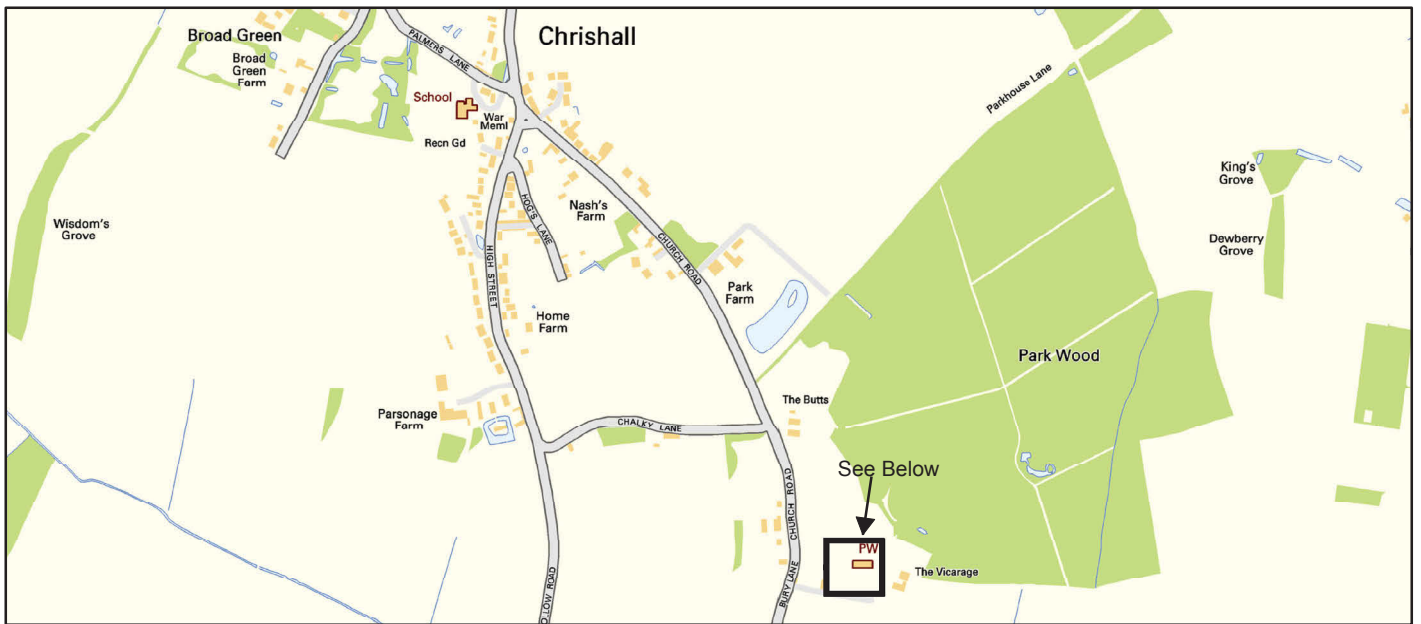
© <b>Archaeology South-East</b>		Church of The Holy Trinity, Christall	Fig. 1
Project Ref: 8111	Feb 2014	Location of monitored cable laying works	
Report Ref: 2014078	Drawn by: APL

- 1.1.3 The archaeological work consisted of a programme of monitoring and recording during the excavation of a series of trenches associated with an upgrading of the electrical power supply. This upgrade involved the installation of a new power cable through the churchyard to replace the existing overhead cable, located along the churchyard's northern boundary (Figure 1).

- 3.1.2 However, due to adverse weather conditions at the commencement of works, a proposal was put forward to lay the majority of the cable using an impact mole in order to reduce the amount of ground disturbance along the access route to the church. Following consultation with the ECC Place Services monitoring officer, this method was accepted and monitoring was then restricted to short sections of trenching, some of which was hand dug, and a series of pits (launch and reception pits) dug along the proposed mole-ing route across the churchyard (Figure 1)

4.2.2 The pits were located c.15m apart and did not penetrate below the subsoil. No archaeological remains were exposed. The pit locations can be seen on Figure 1 and their dimensions are given in table 2, below:

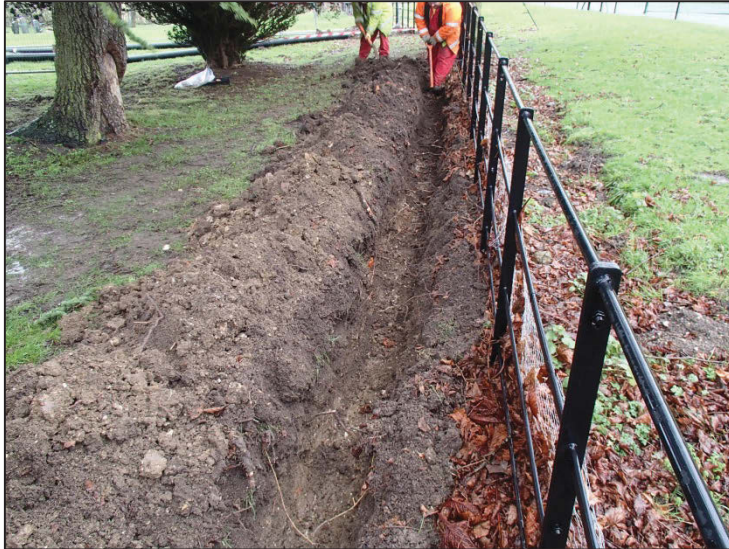
4.1.1 The excavation of a length of trench along the eastern boundary of the churchyard was monitored. The trench measured 17m long, 0.25m wide and ranged in depth between 0.4 and 0.6m (Figure 2). This excavation revealed a topsoil measuring c.0.3m thick and beneath this a compact silty clay subsoil, but did not penetrate below this layer to expose the underlying undisturbed natural deposit. No archaeological remains were encountered. Hand-dug excavations were also carried out to the immediate northeast of the chancel. However, these were carried out along the route of existing cables and were therefore wholly confined to areas of recently disturbed ground; as a consequence they were only monitored during their initial stages.

Figure 2. Trench along eastern boundary, looking north

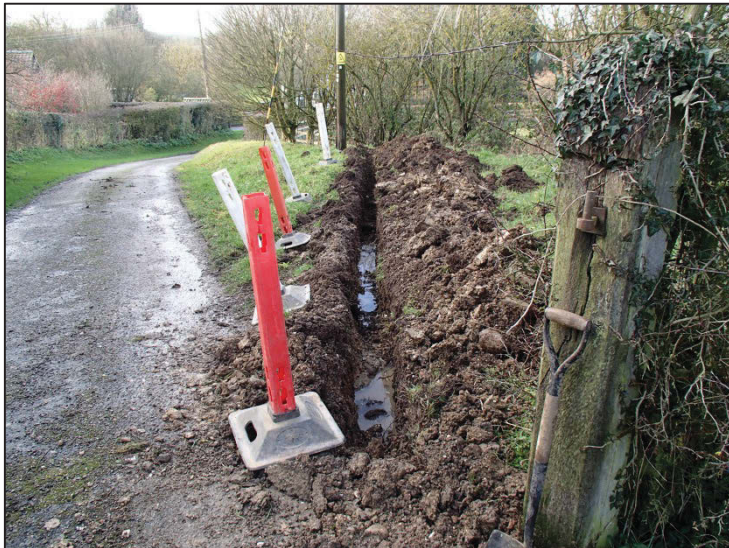
4.1.2 An additional length of open trenching was monitored from the northern gatepost of the churchyard gateway to the exterior pole west of the churchyard (Figure 3). This trench measured c.13m long, 0.25m wide and also had a depth ranging from 0.4 to 0.6m. It revealed subsoil at its base, and did not expose any archaeological remains.

Figure 3. Trench running west from churchyard gateway, looking west

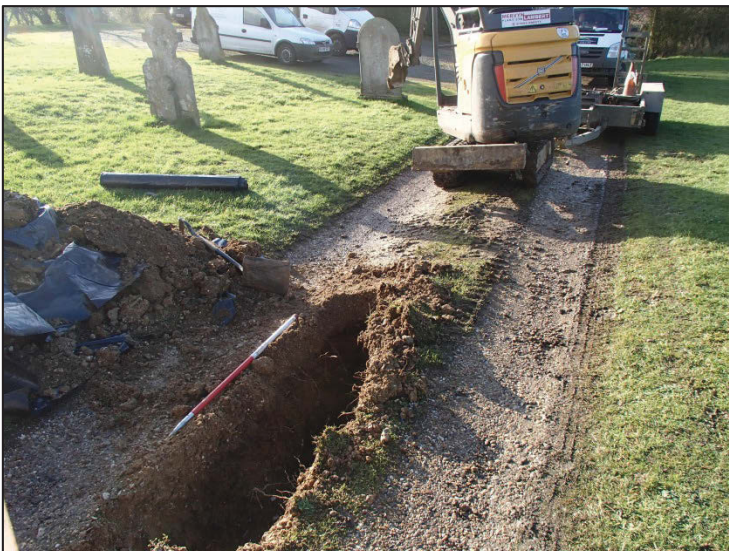
Pit number	Dimensions (m)
1	1.5 x 0.5 x 0.6 deep
2	1.8 x 0.4 x 0.8 deep
3	1.5 x 0.4 x 0.6 deep
4	1.6 x 0.4 x 0.7 deep
5 (Figure 4)	1.5 x 0.4 x 0.65 deep
6	1.5 x 0.4 x 0.6 deep
7	2 x 0.25 x 0.6 deep

Figure 4. Launch and reception pit 5, looking west (1m scale)
