**FORMER PUBLIC BATHS AND WASH-HOUSE,
HIGH STREET, HORNSEY, LONDON BOROUGH OF HARINGEY, N8 7QB**

HISTORIC BUILDINGS RECORD

HISTORIC BUILDINGS RECORD
(English Heritage Level 3)

Site Code: PBH14
Project No. 6572
Report No. 2014094

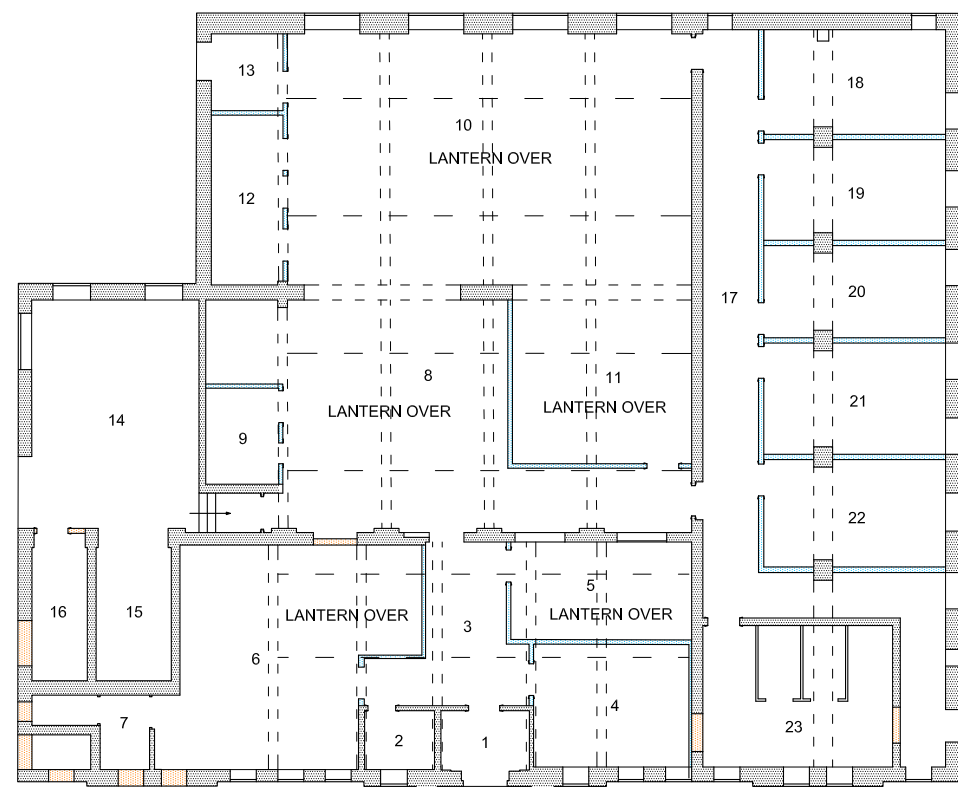
GROUND-FLOOR PLAN

- 6.7 The building is divided into a series of irregular spaces of varying areas. The front door leads into a small rectangular lobby (Room 1) adjacent to which is a small WC (Room 2). Both of these rooms have doors leading north into a larger lobby area (Room 3), the east and west extents of which is formed by inserted timber-stud-and-plasterboard partitions. Rooms 1 and 2 have painted, but unplastered, brick walls. The lower part of the brick walls are formed using glazed bricks with a rounded top creating a step at half-height. There are no glazed bricks on the northern face of the walls dividing Rooms 1 and 2 from Room 3. The doors have concrete lintels and moulded timber architraves with two flat outer orders and an inner ovolo mould. The door to Room 2 appears to be original: this has nine glazed panes over two vertical recessed panels (Plate 16).

- 6.8 Rooms 3, 4, 5 and 6 are subdivided from a larger space bounded by brick walls by narrow partitions formed by plasterboard nailed to regularly-spaced timber studs. The doors in these partitions have softwood timber architraves incorporating narrow bolection moulds. The brick walls surrounding these rooms to the east, west and north have glazed bricks to half-height, although the eastern wall of Room 4 has been covered with plasterboard, hiding a blocked door into Room 17. A door leads from Room 3 into the large room to the north. A recess to the west on the northern side of this door suggests that there was a window adjacent to this door (Plate 20). There are two large windows in the north wall of Room 5 which have been partially blocked (Plate 17) and there is a blocked door in the north wall of Room 6. To the west a door leads into Room 7, an 'L'-plan space divided into a WC cubicle to the west and an area for a wash basin to the south. This room would originally have been lit by two windows in the south and west walls, but both have been blocked in brickwork. That to the south had been converted into a door prior to its being blocked.

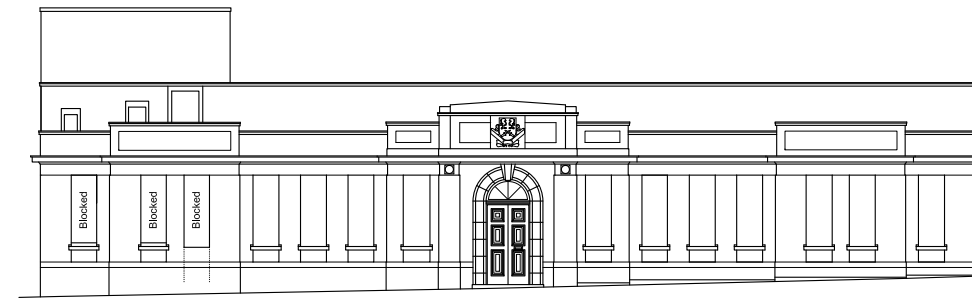
FRONT (SOUTH) ELEVATION

- 6.2 The principal (south) elevation is symmetrical about the central feature doorway. This is the most ornate elevation of the building, incorporating a moulded cornice at the base of the parapet, above the wide band of off-white stone. In the centre is a portico with a recessed area around the door. The door itself is a double-leaved, wooden door with raised and fielded panels surrounded by moulded applied fillets (Plate 11). It is surmounted with a semi-circular fanlight within a bolection-moulded stone surround with a stepped and projecting boss. On either side are projecting piers. The stone band at the top of these piers has a plain medallion. The parapet above this doorway has a central projecting panel, in the centre of which is a stone relief of the Hornsey Borough Council coat of arms and motto 'FORTIOR QUO PARATIOR' ('The stronger because the better prepared'). The parapet above this is topped with a stone cap differing from the plain, flat coping on either side.

- 6.3 There are seven window openings on either side of the doorway, all of the same height and width and with the same stone cill. All are fitted with hopper-

head windows fitted with reinforced glass, except the western three, which have been blocked with orange-red bricks. Towards each end of the elevation, two windows are positioned in a projecting section of wall with a parapet of three courses higher than that set slightly behind and on either side.

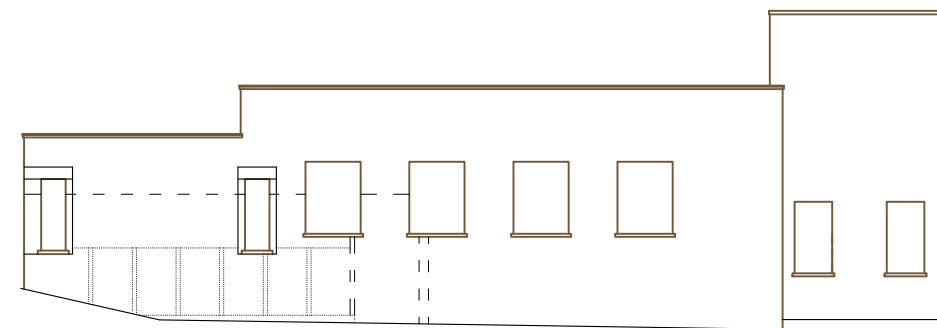
NORTH ELEVATION

- 6.6 The tall tower-like structure forms the western end of the northern elevation (Plate 14). The off-white stone band returns around the corner and caps the two window openings, each of which matches the northern window in the west elevation. The central part of the north elevation has four window openings below a taller parapet and two narrow windows set almost below a lower parapet (Plate 15). All of these windows are surrounded by flat bands of off-white render. There is no stone band along this elevation. Yellow paint and areas of green-painted render, broken by vertical lines of exposed brickwork, with some surface damage, indicate the position of a removed structure. At the base of the green-painted render there is a course of terracotta tiles which suggest that this space was formerly used in a washing capacity, either as part of the wash-house or a bathroom. The outer wall of this removed structure was block-bonded to the existing north elevation and overlapped the third window from the west. The lower parts of the windows to the east would have been blocked by this additional structure, which was divided into at least seven cubicles with one taller area at the western end. The form of the roof is not known, but it met the existing wall in a single horizontal line.

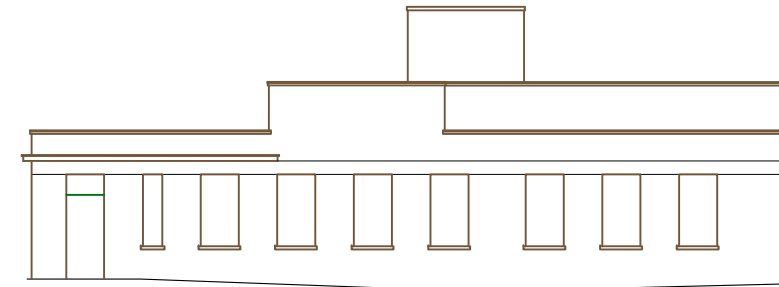
EAST ELEVATION

- 6.4 The cornice from the south elevation continues around the southern end of the east elevation (Plate 12) and the band of off-white stone below the cornice continues along the full length of this wall. The fenestration of this elevation is regular, with seven windows of equal width and height positioned regularly along the wall. At the southern end there is a tall doorway fitted with a modern, metal fire door and to the north of this is a narrow window. These openings are all fitted with metal-framed Crittall-style windows with reinforced glass and hopper-head openings at the top. The central part of the parapet rises 16 courses above the parapet on either side, forming the end of the lantern in the roof.

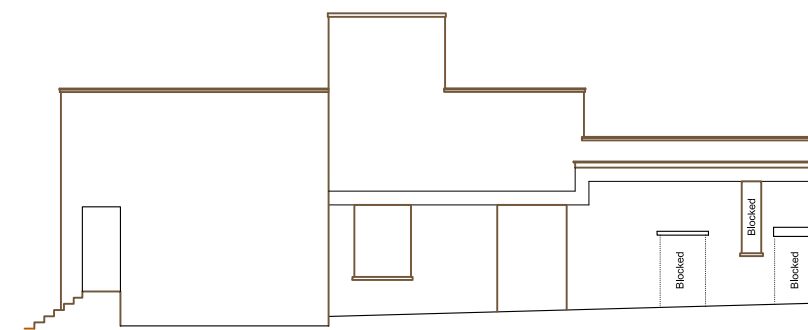
WEST ELEVATION

- 6.5 The west elevation also bears the return of the cornice from the south elevation, and the band of off-white stone, which steps down to the south of the large doorway leading into the boiler house (Plate 13). To the north of this doorway there is a wide opening fitted with a Crittall-style window and with the same concrete cill as the windows in the front and east walls. A narrow, taller window is positioned at the south end of the elevation, in between two doorways which lie below concrete lintels. All three of these openings are blocked in brickwork. The window is original but the two doorways have ragged jambs which suggest that they have been cut into the wall, or widened after they were initially formed. In this elevation too there is a taller section of wall, which continues north into the west wall of a tower-like structure which rises in the north-western corner of the structure, over the boiler house. The northern part of the west elevation is positioned back from the lane. This wall is plain, constructed in the same style of brickwork as the rest of the west elevation, with a single fire door in the northern end.

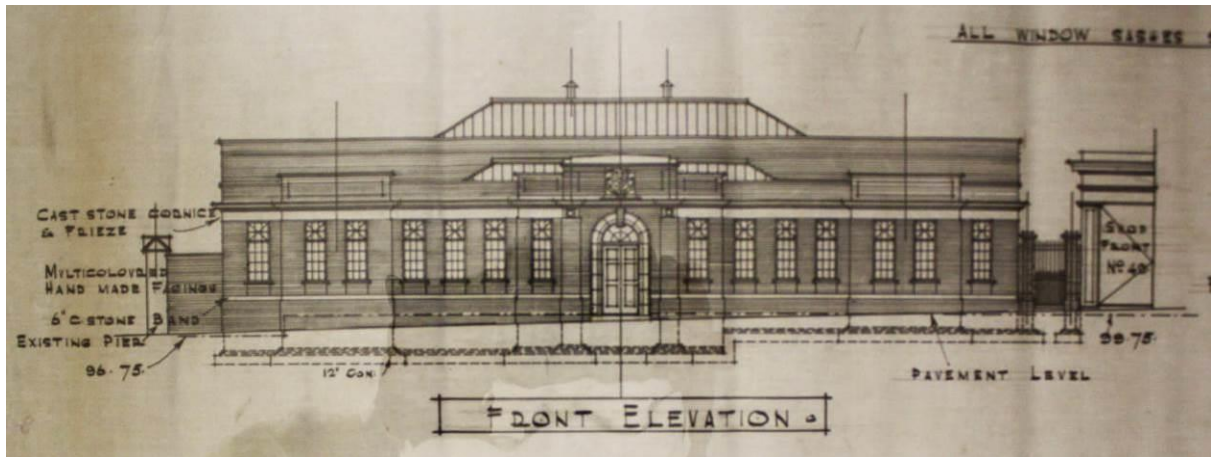
- 5.4 The plans for the initial building were drawn up by the Borough Surveyor (Plates 1-9). The original building was rectangular, with the entrance for the women's baths and the wash-house in the centre of the front elevation and the men's baths entrance in the south end of the east wall. The bath cubicles lay in the eastern part of the building, accessed via segregated waiting rooms to the south. There was no communication between the men's baths spaces and the women's. By far the majority of the building housed the washing space, with a large room dedicated to those waiting to use the washing space and a space to leave prams. A large room to the north was the wash-house, housing wash-troughs and drying racks and a slightly smaller room to the south-west housed the mangles. The boiler room, with large spaces for coal

Plate 1
Proposed site plan of the baths and wash-house (Bruce Castle Museum: Haringey Libraries, Archives and Museum Service)

Plate 2
Ground-floor plan of the proposed original structure (Bruce Castle Museum: Haringey Libraries, Archives and Museum Service)

Plate 3
Roof plan of the proposed original structure (Bruce Castle Museum: Haringey Libraries, Archives and Museum Service)

Plate 4
Front elevation of the proposed original structure (Bruce Castle Museum: Haringey Libraries, Archives and Museum Service)

Plate 5
Longitudinal section of the proposed original structure (Bruce Castle Museum: Haringey Libraries, Archives and Museum Service)

Plate 6
 Cross section of the proposed original structure (Bruce Castle Museum: Haringey Libraries, Archives and Museum Service)

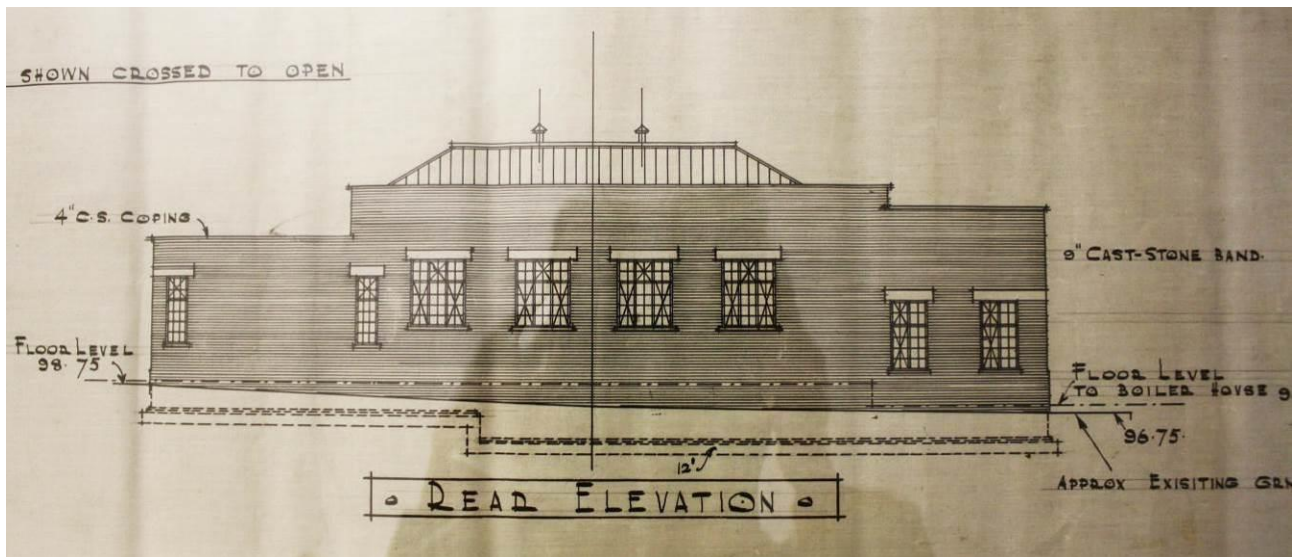
Plate 7
 Rear elevation of the proposed original structure (Bruce Castle Museum: Haringey Libraries, Archives and Museum Service)

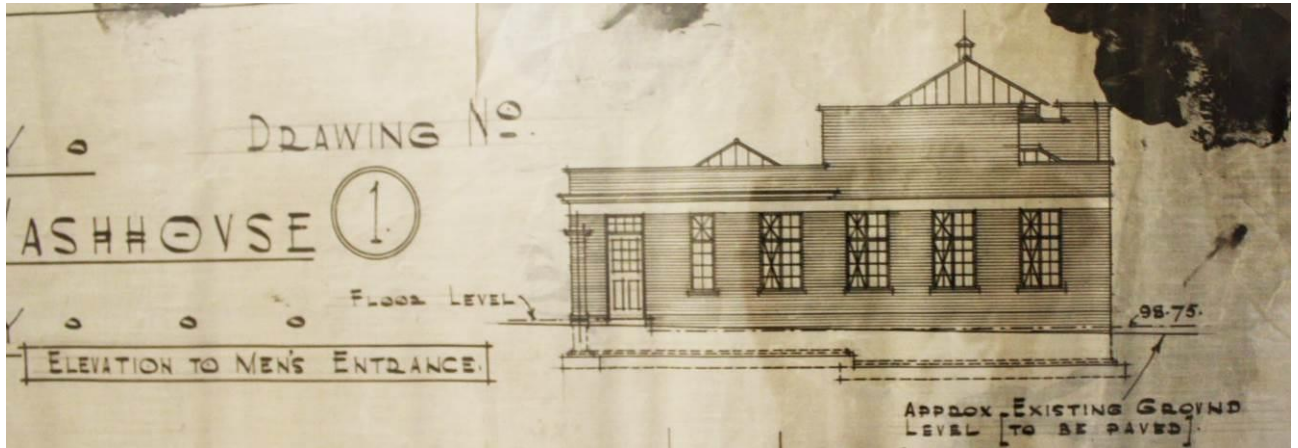
Plate 8

East elevation of the proposed original structure (Bruce Castle Museum: Haringey Libraries, Archives and Museum Service)

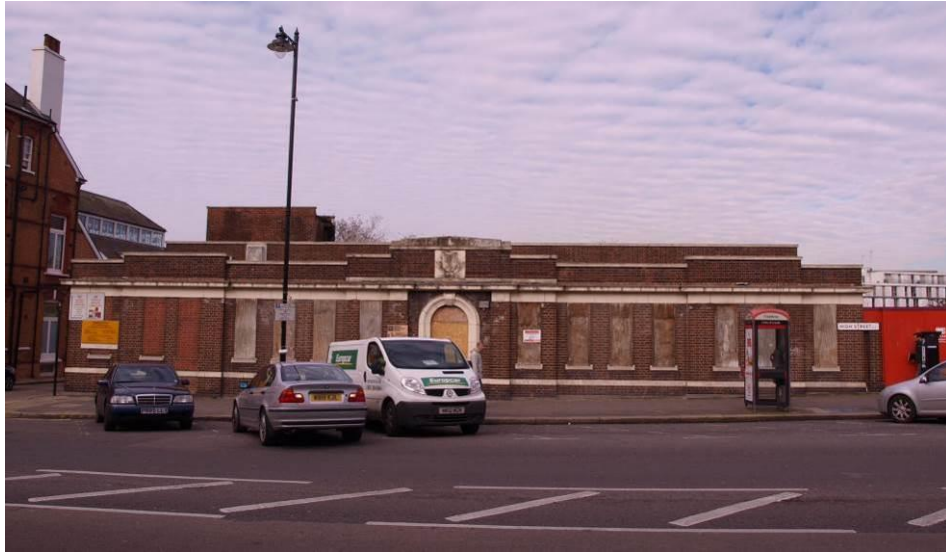
- 6.1 The building is oriented on an east-west alignment, with its principal elevation facing south (Plate 10). It is a single-storey structure of brick construction. The walls are constructed in red-brown bricks with broad varicoloured striping, measuring 220-225mm x 110mm x 68-70mm, laid in Flemish bond in narrow bedding joints in a grey-brown cement-based mortar. There is a band of off-white stone below the cornice on the south, east and west elevations and one narrower band positioned six courses above pavement level. The top of the parapet around the building is capped with concrete. The roof is flat, with three long lanterns aligned parallel to the principal elevation, and the north-western part of the building has a taller roof-line than that to the south.

Plate 10
The principal (south) elevation of the former public baths and wash-house from the south

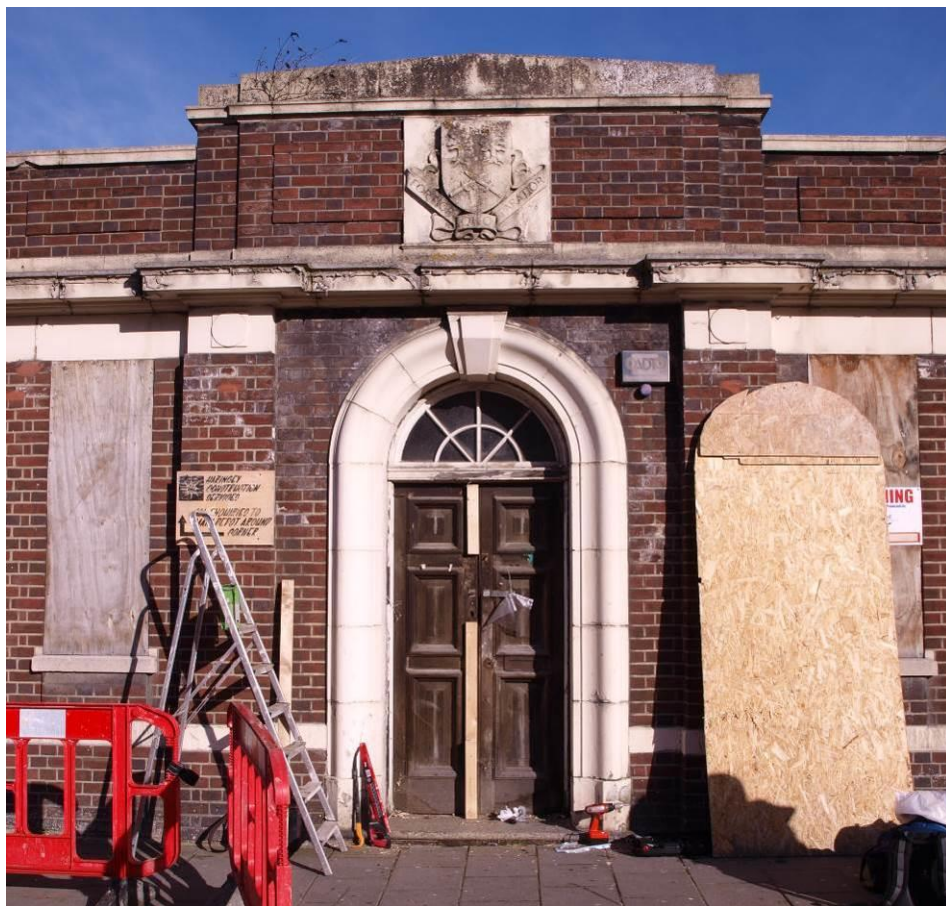
Plate 11
The central doorway in the principal (south) elevation from the south

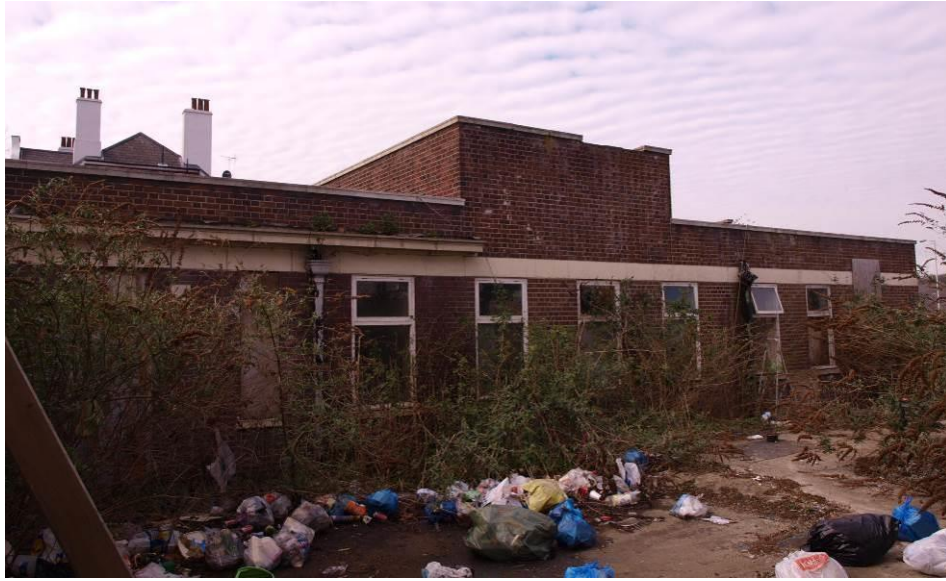
Plate 12
The east elevation from the south-east

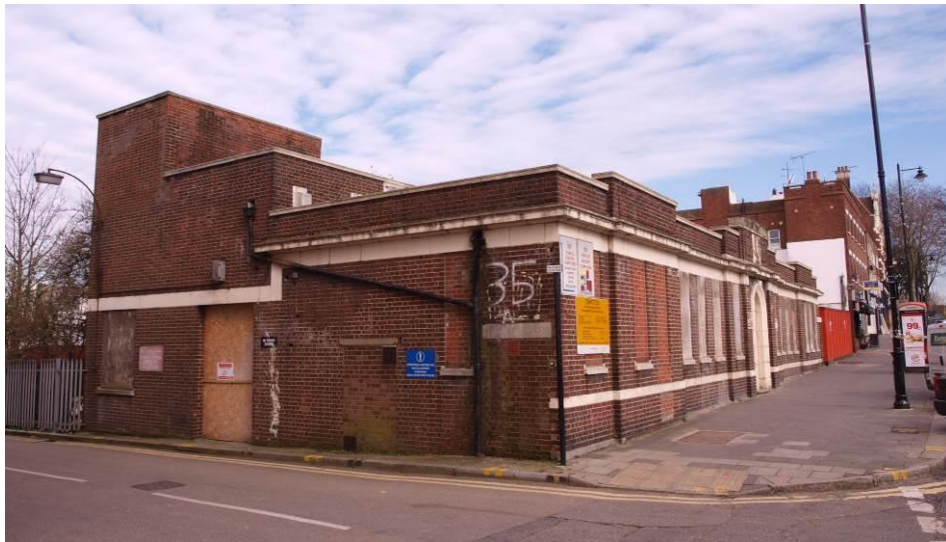
Plate 13
The south part of the west elevation from the south-west

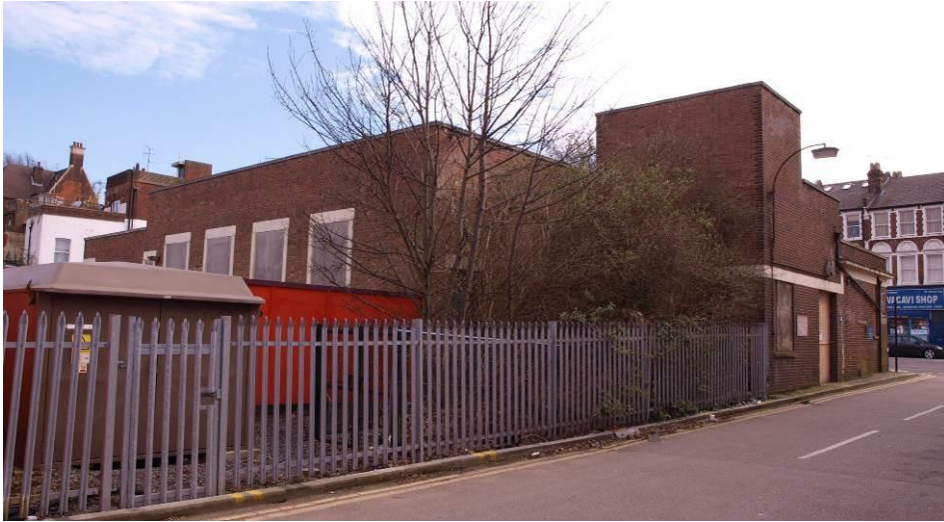
Plate 14

The north-western corner of the structure, showing the tower-like structure rising from the west elevation from the north-west

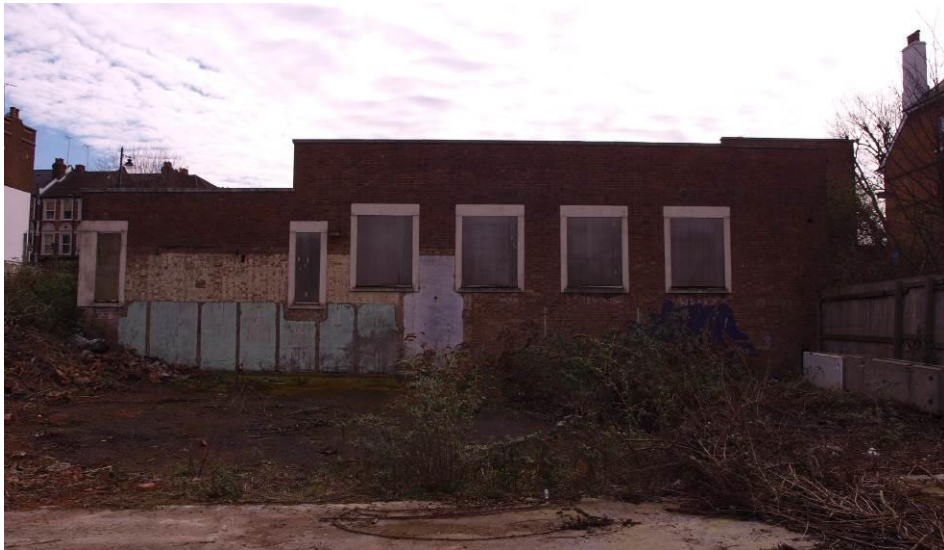
Plate 15

The main part of the north elevation showing the render and paint indicating the position and height of the additional structure (now removed) from the north

- 7.6 By 1955, the building had been extended for a second time by the addition of a structure against the northern wall. This extension has since been removed, but it is probable that the plaster visible on the exterior face of the northern wall is residual from the additional structure. This extension must have been access from the exterior, as there are no openings cut through the northern wall of the earlier building. The treatment of the walls and the line of terracotta tiles at the former floor level suggest that this additional building was divided into small cubicles and may have been used for additional bathing or WC space.
- 7.7 The modern alterations to this building are almost featureless, able to be ascribed a generic late-20th-century date. Further refinement of this date is difficult, given the style of the work and the common materials used.

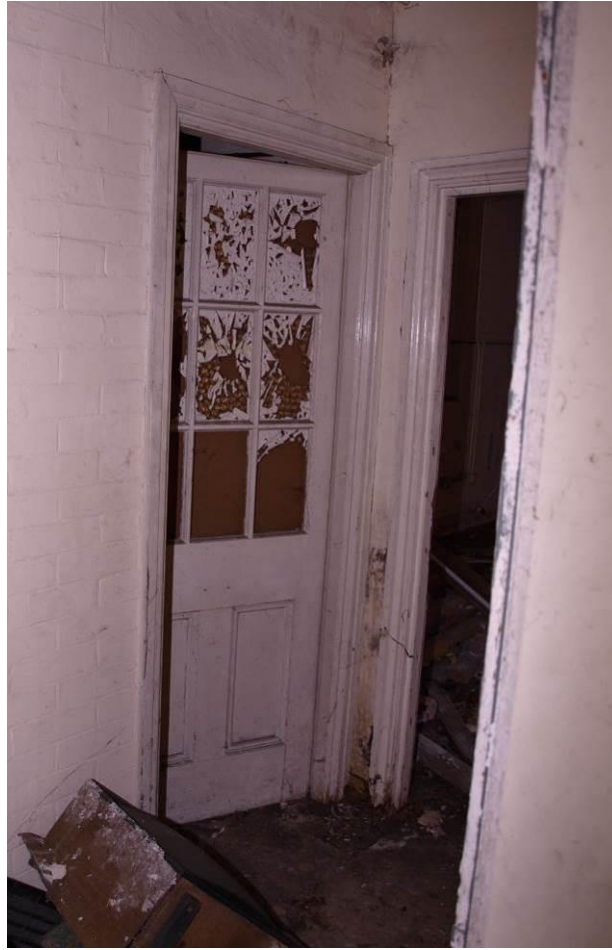
Plate 16
Door leading into Room 2. Photo from the north-east

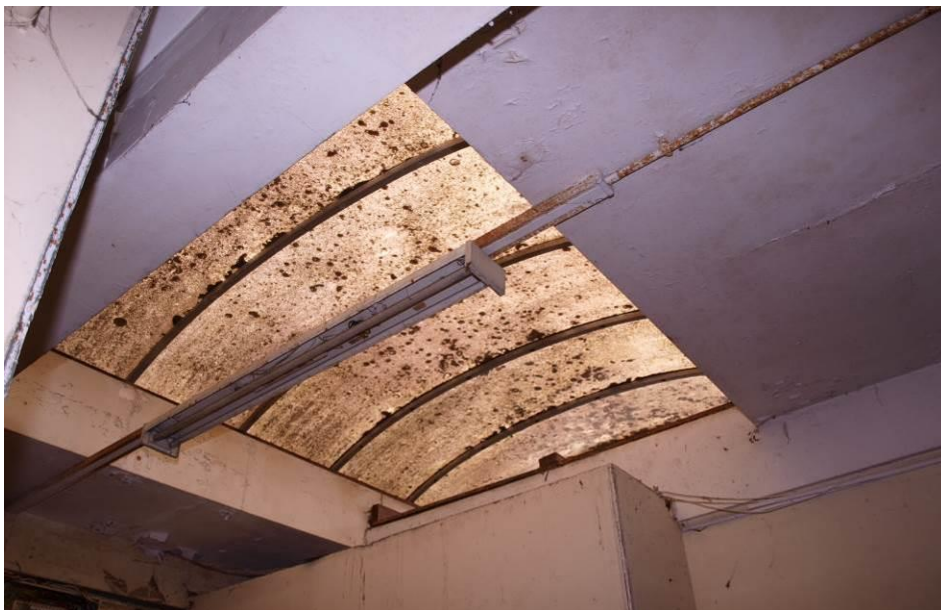
- 6.9 The ceilings over Rooms 1-6 are crossed by boxed-in girders which support the roof and a narrow glazed lantern (Plate 17). This lantern lights Rooms 3, 5 and 6. However, a small skeeling along the northern edge of the ceiling over Room 4 blocks the lantern from within this space (Plate 18).

Plate 17
Roof lantern over Room 3 from the south-west

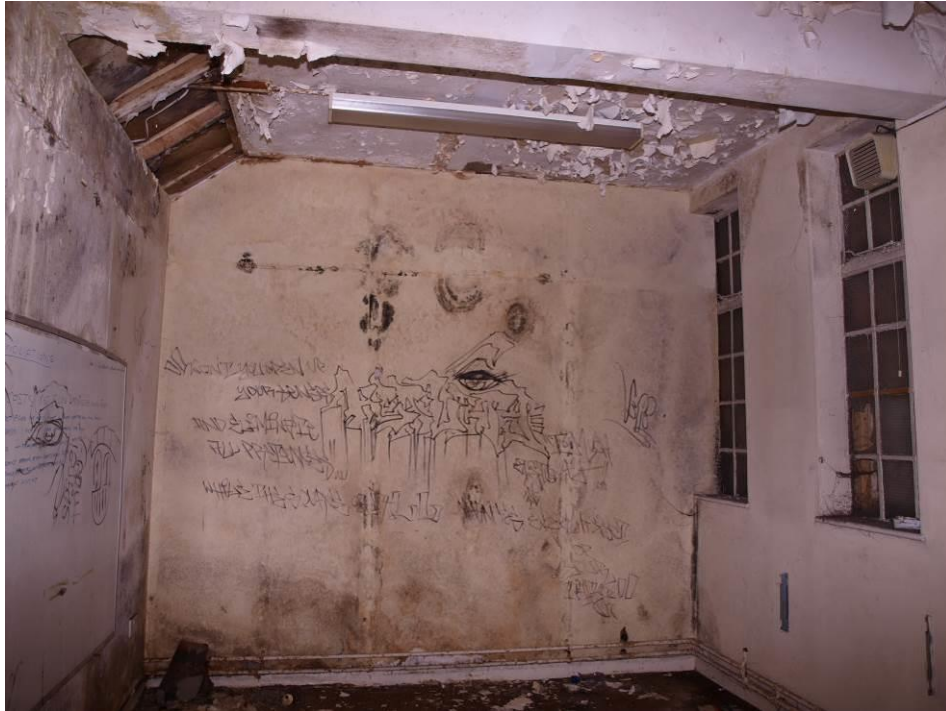
Plate 18
Room 4 from the west showing the skeling blocking the roof lantern

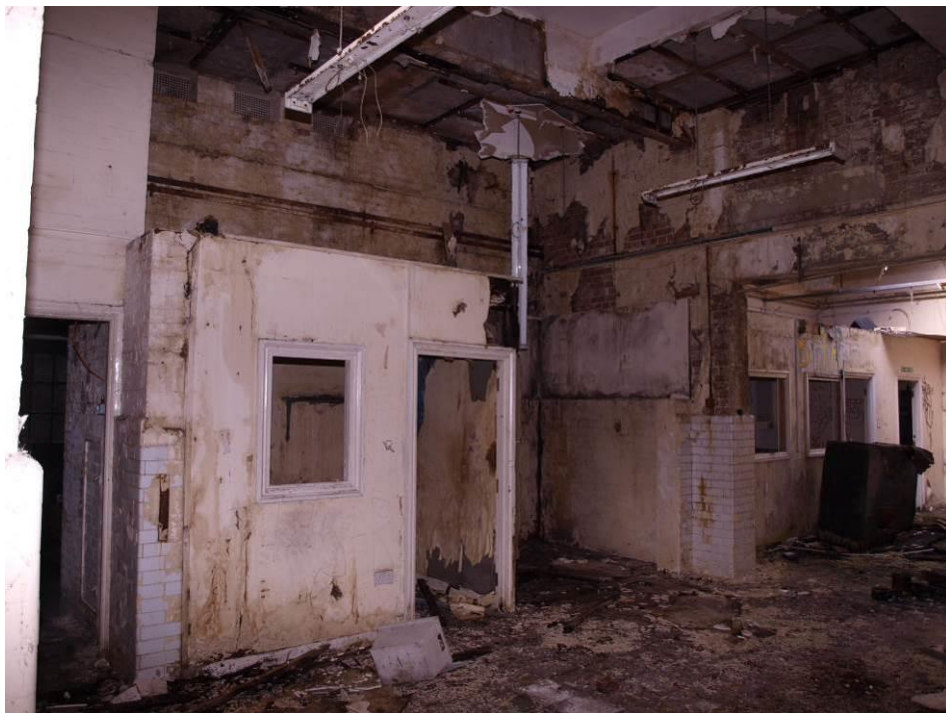
Plate 19
Room 9 from the south-west, showing Rooms 12 and 13 to the right

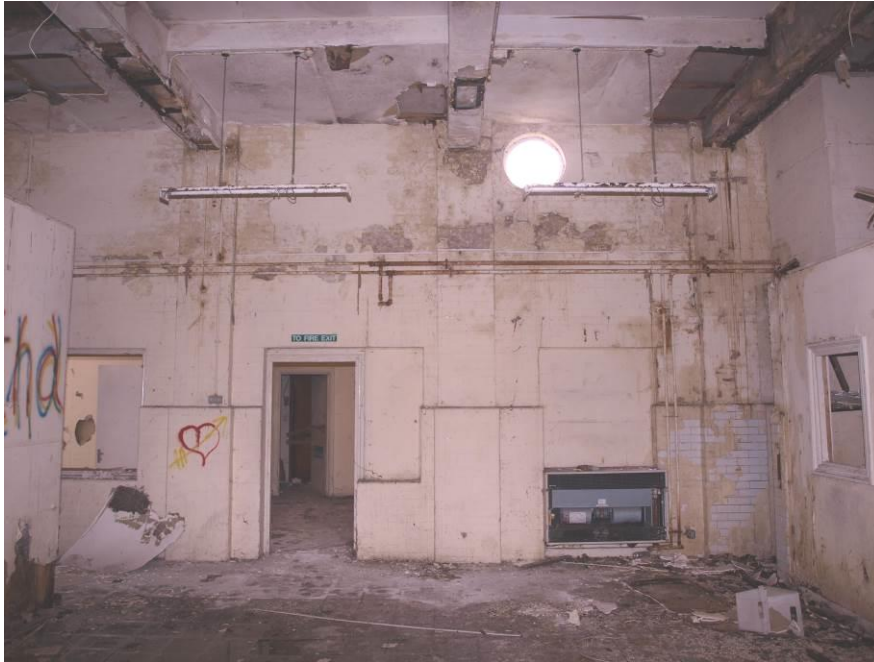
- 6.10 From Room 3, the door leads into Room 8. Rooms 8, 9 and 11 lie to the south of a thick east-west dividing wall which has been pierced by two wide openings. Rooms 10, 12 and 13 lie in the space to the north. Rooms 9, 11, 12 and 13 are formed by plasterboard partitions. The window and door openings in these partitions have modern timber architraves and are covered with inserted ceilings to create rooms of normal height within the larger, loftier areas (Plate 19). The walls around these spaces have glazed bricks rising to approximately a third of the height of the room with painted, unplastered brick above (Plate 20).

Plate 20
Room 8 from the north showing the recess to the west of the door from Room 3 and the oculus in the upper part of the wall

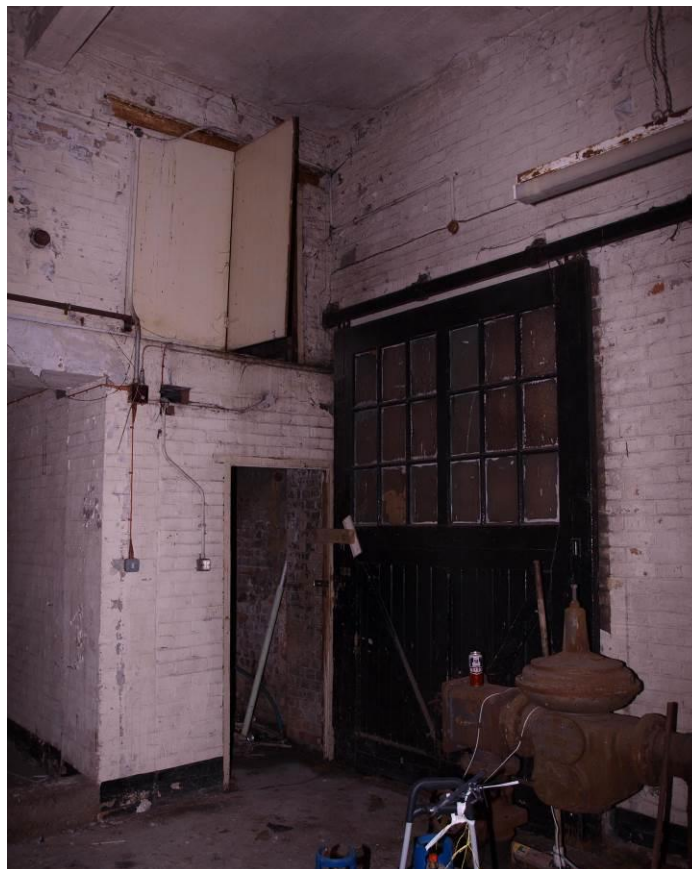
- 6.13 A short corridor to the south of Room 9 leads to the former boiler room (Room 14), served by two large compartments to the south (Rooms 15 and 16). At the western end of the corridor there are three steps leading down into Room 14, which has a lower floor and taller ceiling than the rooms to the east, forming the tower-like structure visible from the exterior. This room is lit by large, Crittall-style windows in the north and west walls, and there is a large sliding door in the western wall, adjacent to Room 16. This door appears to be the original. It has 18 glazed panes in the upper part, separated into two panels of nine panes. Below this are two wide panels of vertical timber planks, with diagonal struts. The door is suspended from an iron runner fixed to the wall (Plate 21).

- 6.14 Rooms 15 and 16 are formed by brick walls and are ceiled at approximately half the height of Room 14, with storage space above (Plate 21). Room 15 has no door, but the wide opening to Room 16 has been made smaller by an inserted brick partition, in which is a modern door. At the south end of this space is the blocked doorway in the west elevation.

Plate 21
The door leading west from Room 14. Note the storage space above the compartments (Rooms 15 and 16)

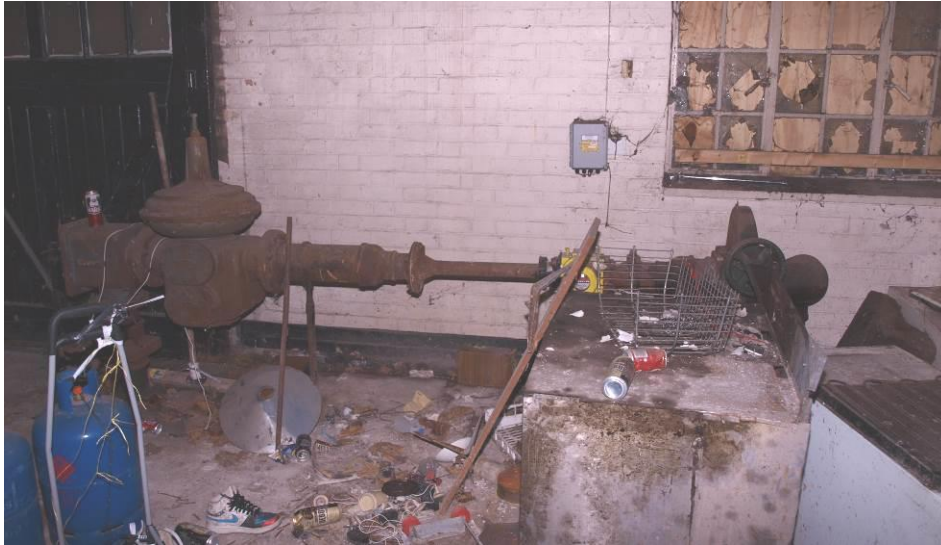
- 6.15 Some cast-iron plant (Plate 22) survives in Room 14, although it may not be the original boiler plant. The top of the largest part states that it is a Crawford Governor, made by Jeavons Engineering Co. Tipton.

Plate 22
The surviving plant in Room 14

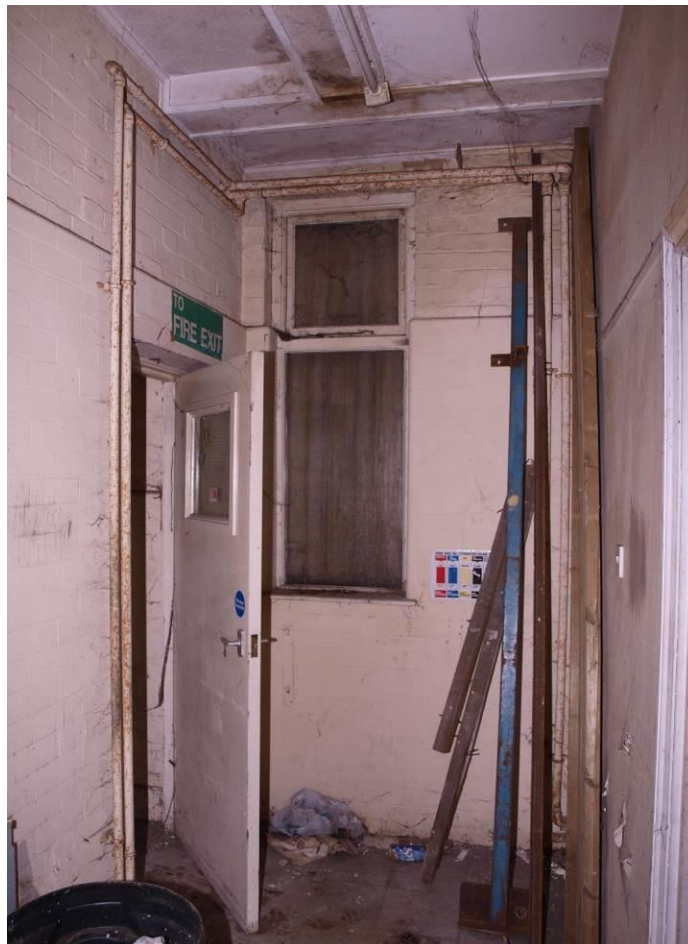
Plate 23
The northern end of Room 17 from the south, showing the higher level of the glazed brick part of the walls

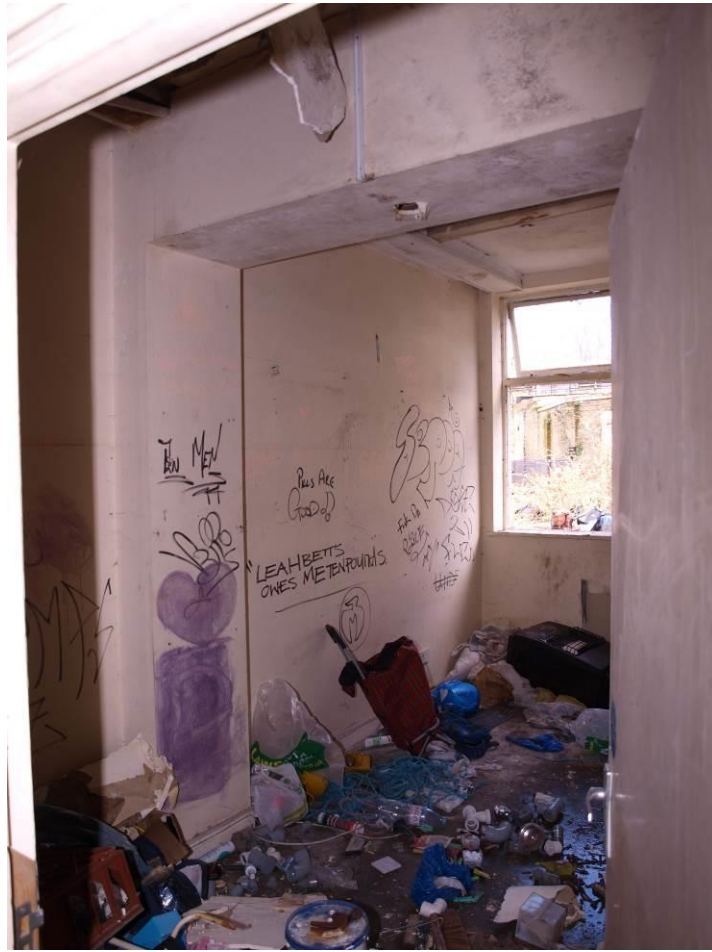
Plate 24
Room 20 from the south-west showing the wall which has been cut to create the room

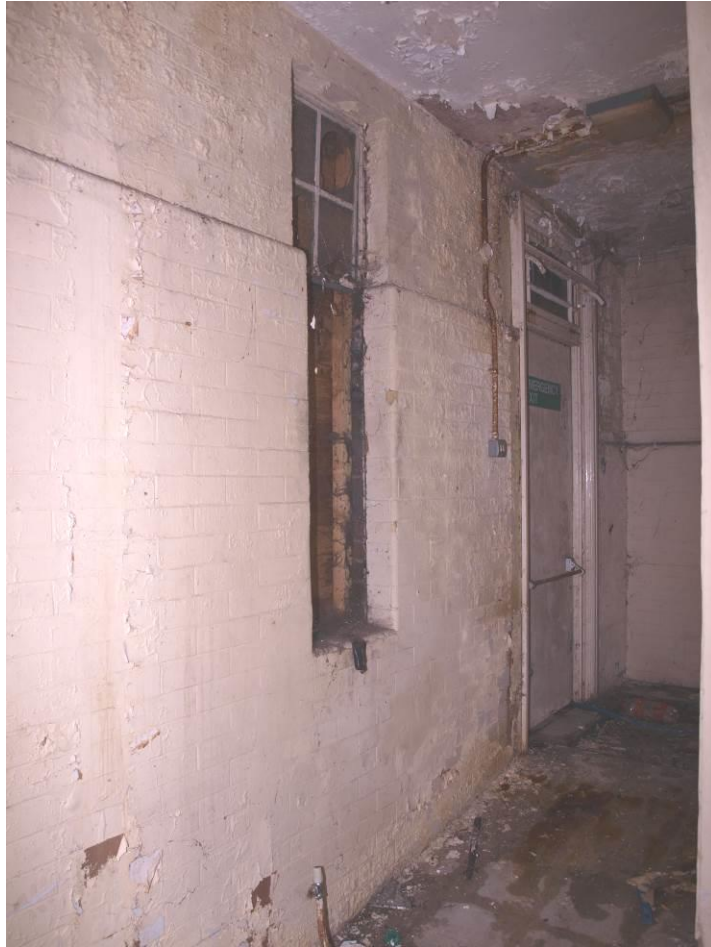
opposite the exterior door in the south end of the east wall of the building. The ground level in Room 17 ramps upwards towards this doorway (Plate 25) as the floor level within the rest of the building is lower than the ground level to the east of the structure.

Plate 25
The south end of Room 17 from the north-west, showing the change in floor level and the former men's entrance doorway
